# FACILITY CONDITION ASSESSMENT

Willard Elementary  
301 Madre Street  
Pasadena, California 91107

154554.22R000-013.354

September 8, 2022

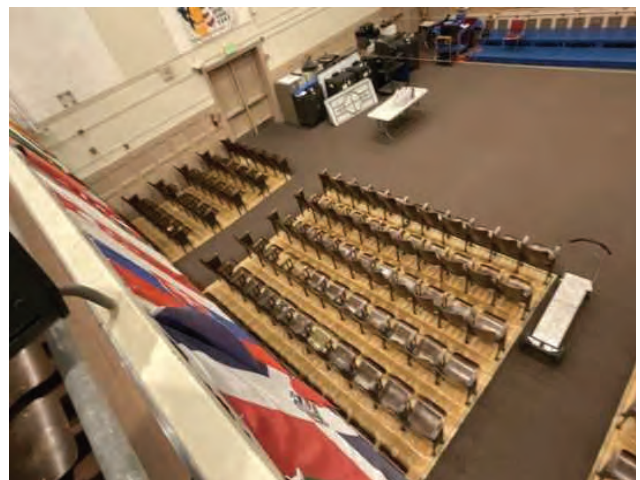
18 - AUDITORIUM WOODEN FIXED SEATING

A small percentage of seats are broken/heavily worn - AssetCALC ID: 3797377

Uniformat Code: E2010  
Recommendation: **Replace in 2023**

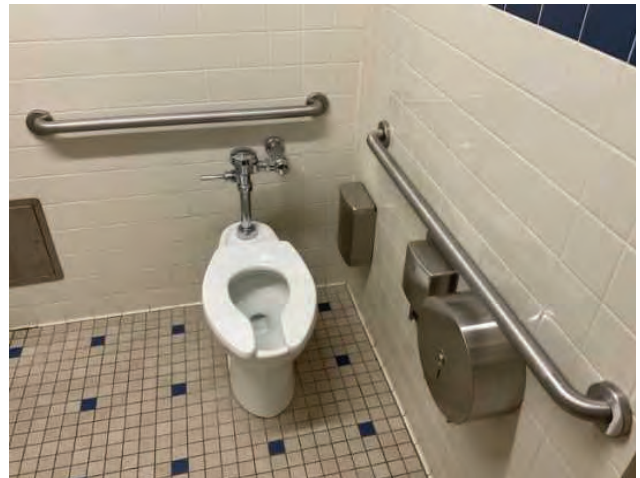
22 - ADA TOILET STALL

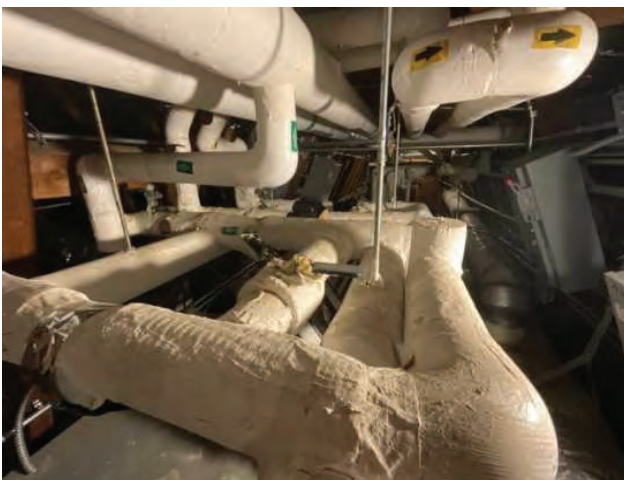
23 - HVAC HYDRONIC PIPING SYSTEM

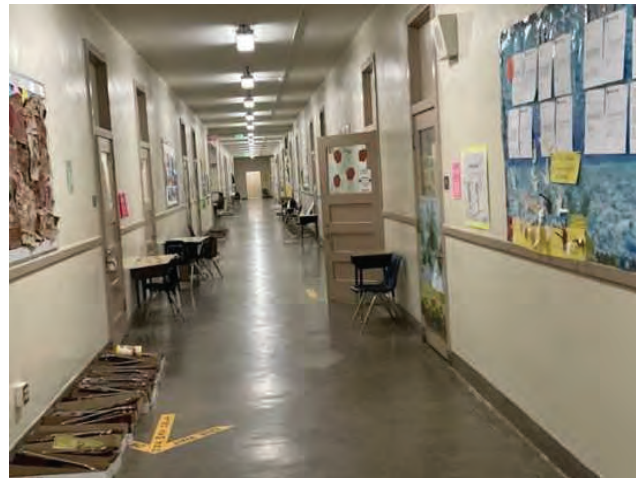
28 - POLISHED CONCRETE FLOORING

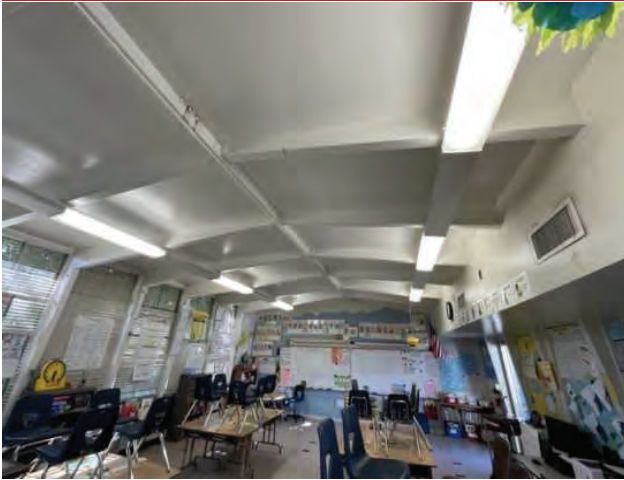
31 - INTERIOR LIGHTING SYSTEM

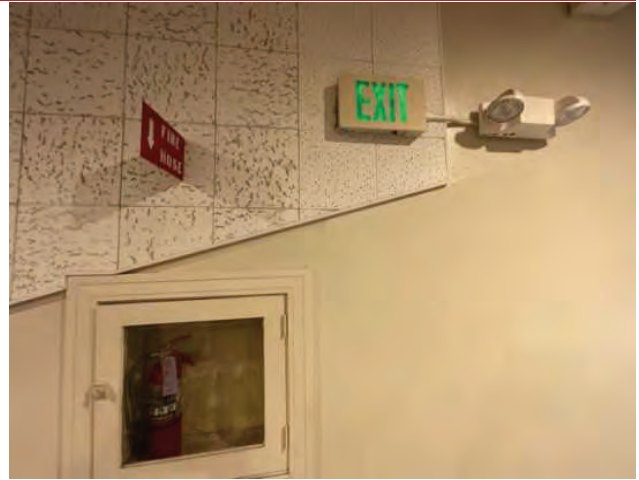
32 - EMERGENCY EXIT AND LIGHTING

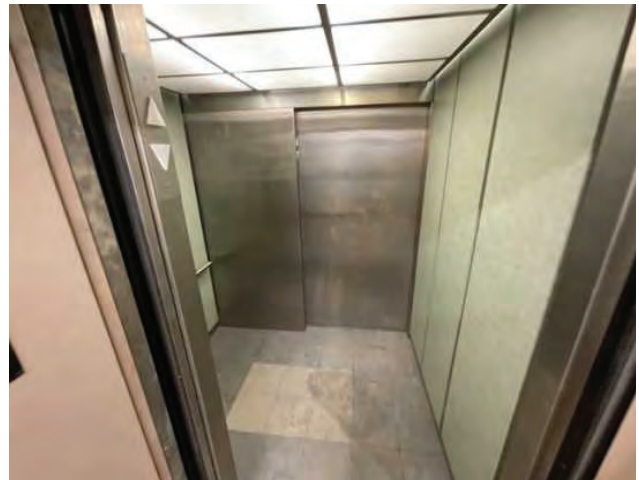
34 - PASSENGER ELEVATOR FINISHES

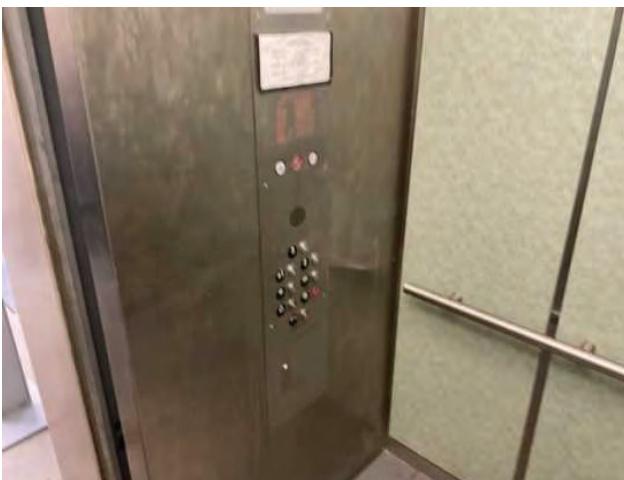
35 - IN-CAB CONTROLS/EMERGENCY CALL  
PANEL

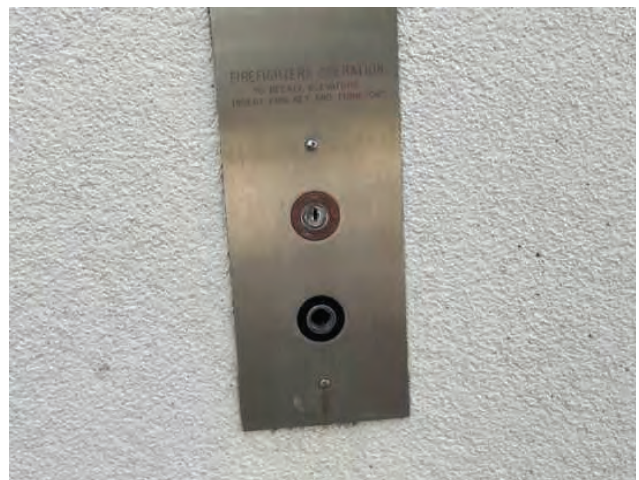
36 - ELEVATOR 1ST FLOOR NO TUMBLER
