# FACILITY CONDITION ASSESSMENT

## **DLR Group**

Eliot Arts Magnet Academy  
2184 North Lake Avenue  
Altadena, California 91001

September 8, 2022

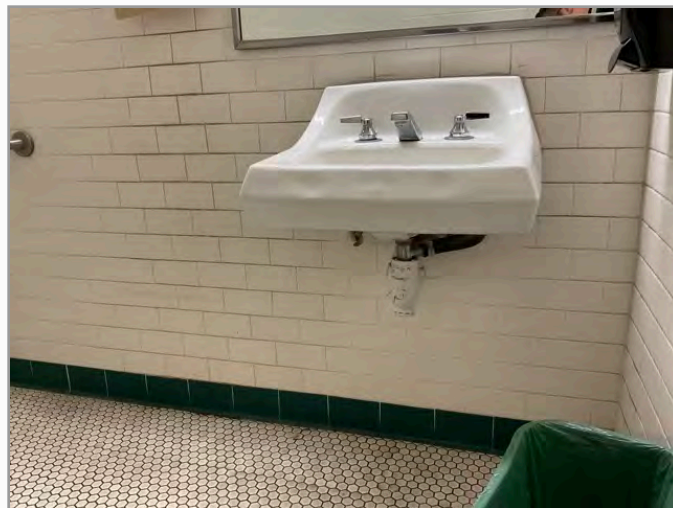
Sink and faucet handles

| Question | | Yes | No | NA | Comments |
|---|---|---|---|---|---|
| 4 | Is the plumbing piping under lavatories configured to protect against contact ? | | ✗ | | Some restrooms are missing piping projection. |
