# Carnevale Elementary School and DelSesto PK-8 School

October 21, 2026

# Existing School Conditions Report

# **Structural Existing Conditions Report**

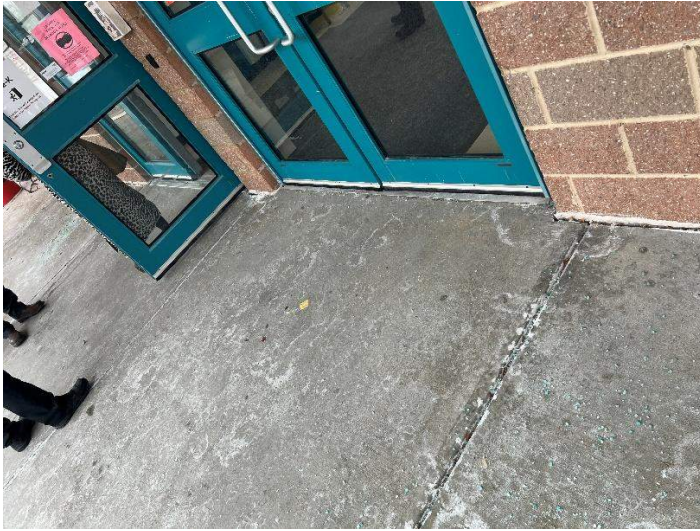
Front entrance pad exhibits separation from the building.

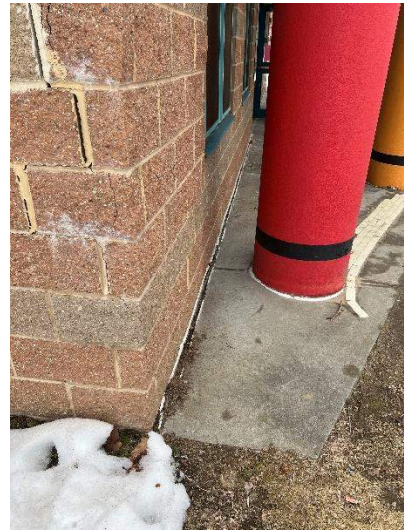
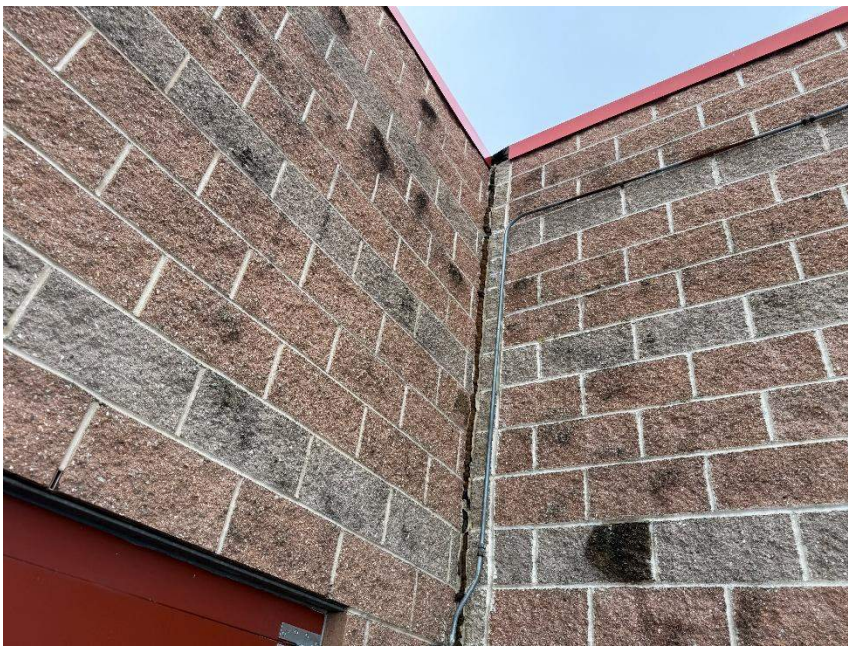
Exterior façade exhibits structural movement, resulting in separation of the veneer masonry from the CMU backup wall.

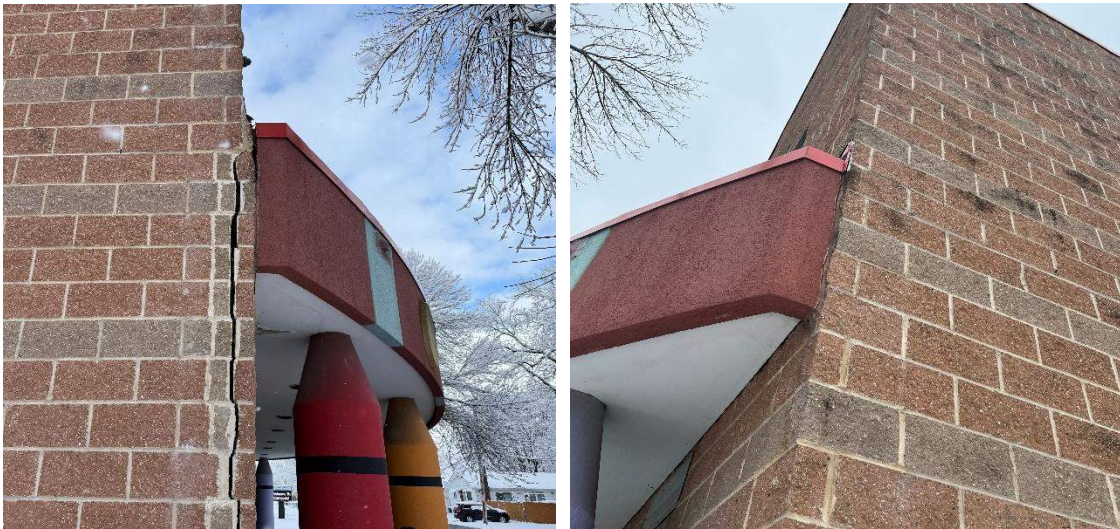
Front entrance canopy exhibits structural movement, resulting in separation of the veneer masonry from the CMU backup wall.

Front Entrance Canopy structural movement

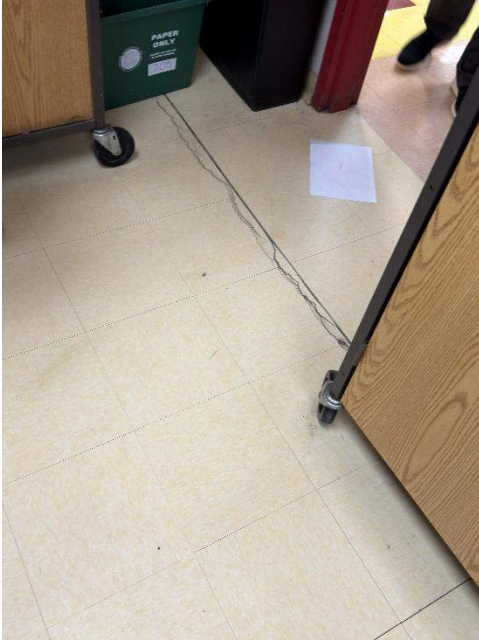
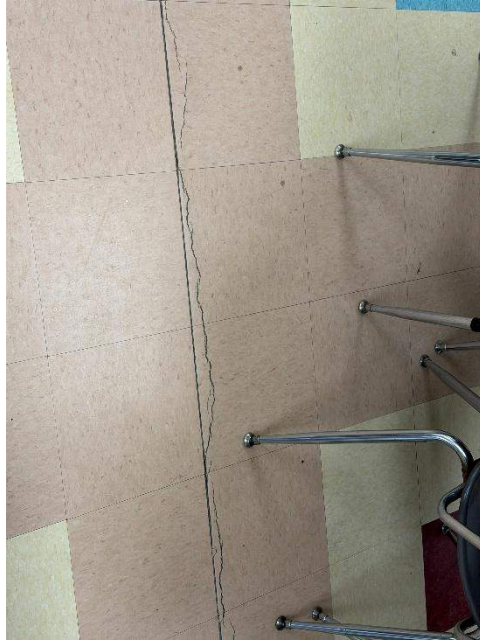
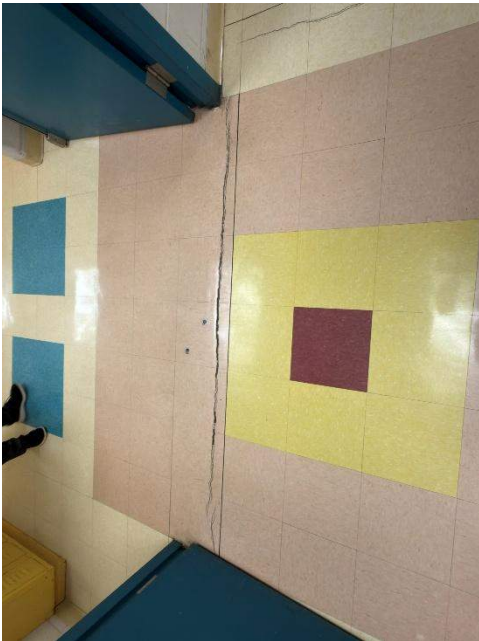
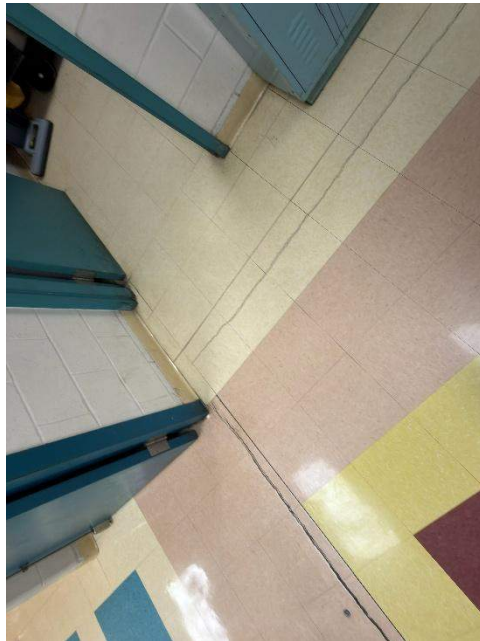
Interior CMU block separation and cracks

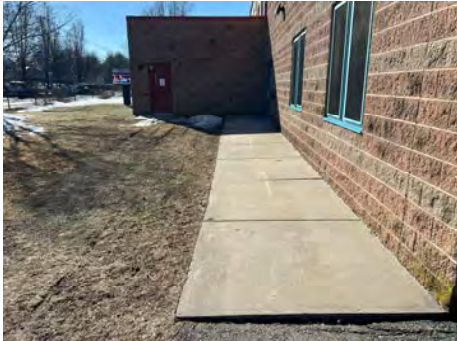
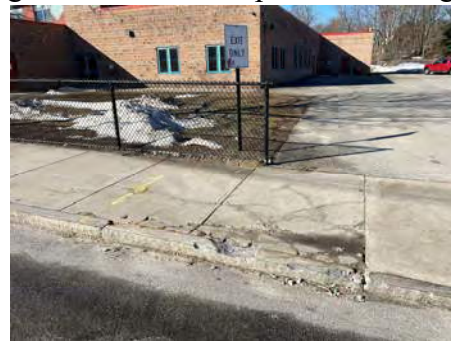
- Curb was in moderate condition throughout and non-compliant surfacing

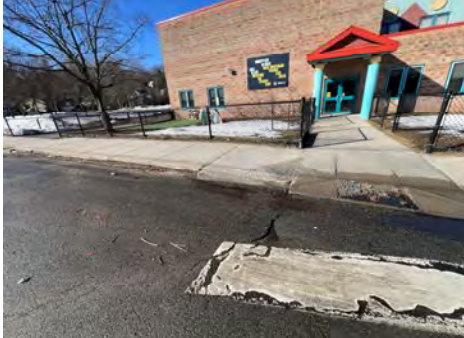
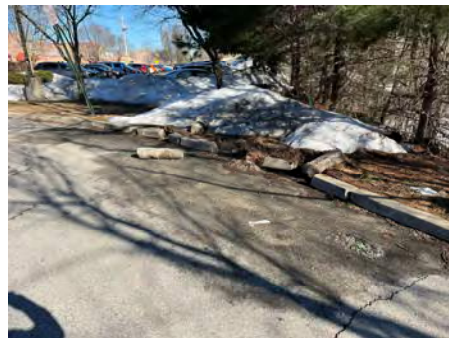
- Springfield Street Curbing in poor condition

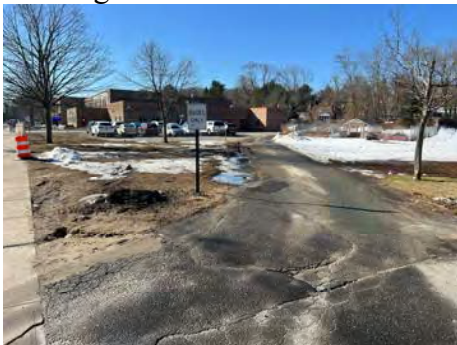
- Ponding noted in area of recent bus loop addition

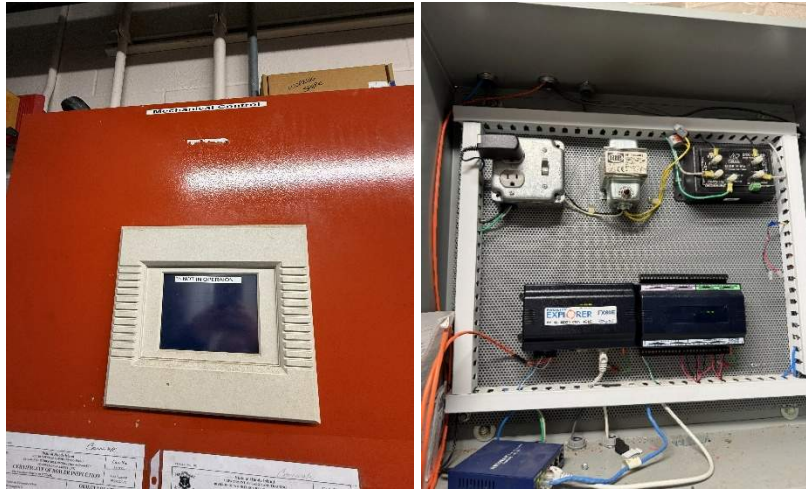
The BMS system in this building appears to include a mix of legacy Andover Controls and newer Johnson Controls Facilities Explorer open protocol. Overall system architecture and integration should be verified to ensure the BMS is not contributing to the temperature comfort problems.

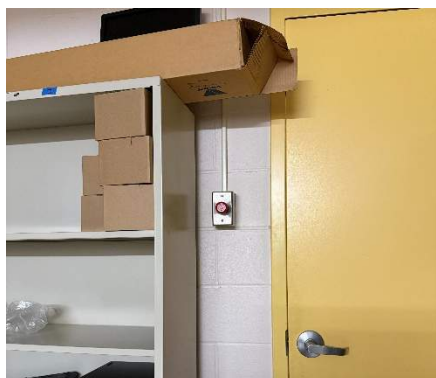
There is a plunger style mushroom switch located in the first floor MDF room. There are no labels on the switch and it is unclear what its purpose is.

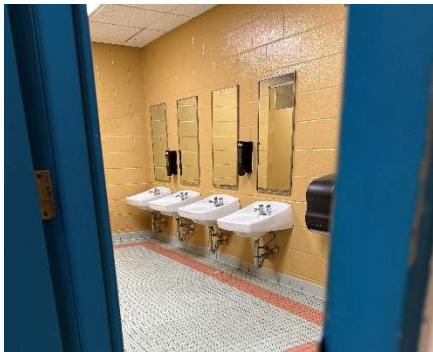
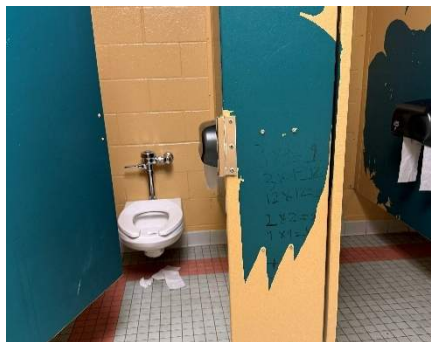
Bathroom lavatory sinks are all missing trap wrap on the piping below and all use manually metered faucets versus sensor-type. **These should be updated to touch less sensor-type for improved ADA accessibility.**

Water closets all have manual flush valves and **should be updated to automatic/sensor-type for improved ADA accessibility.**

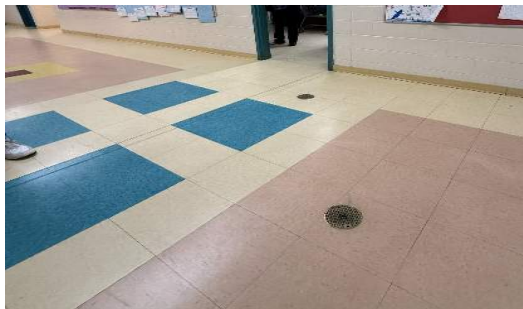
Floor clean outs observed, do not appear to have the same settling condition as was noted in the DelSesto building next door.

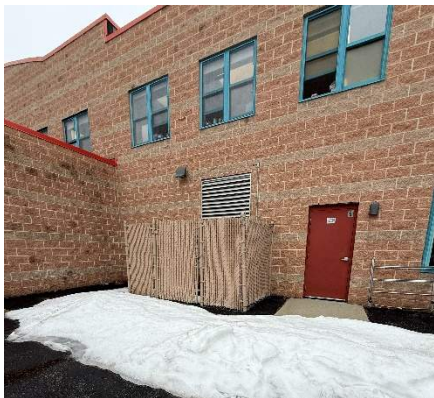
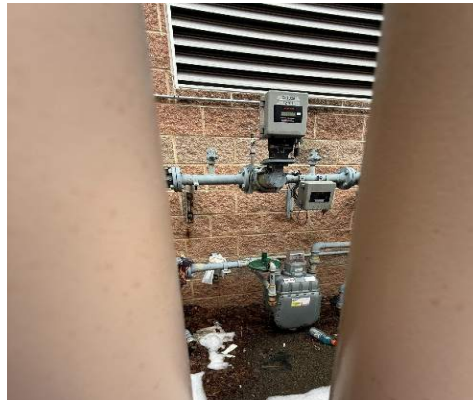
The Natural Gas service enters the building in the 1<sup>st</sup> floor Boiler Room with the meter outside enclosed in a locked cage.

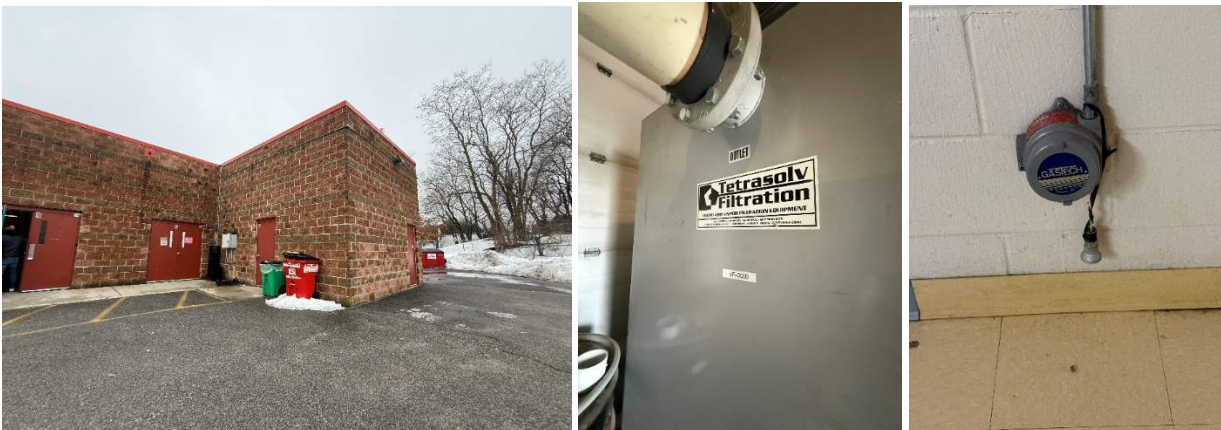
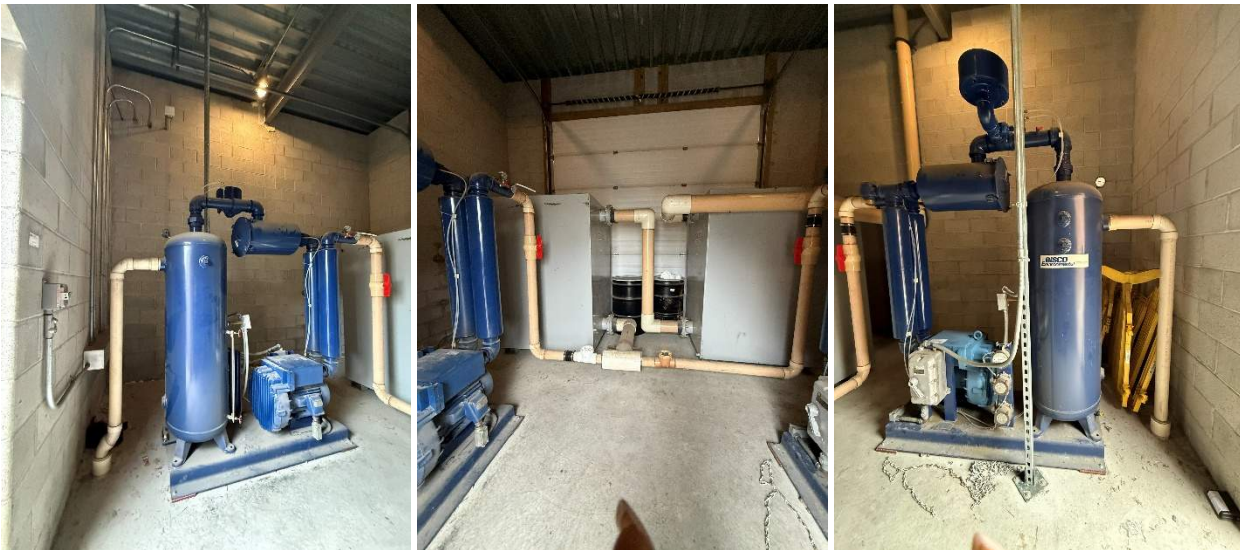
There is equipment in an attached storage shed beside the kitchen that provides continuous monitoring of soil gases due to this site previously having been a landfill and prior wetlands.

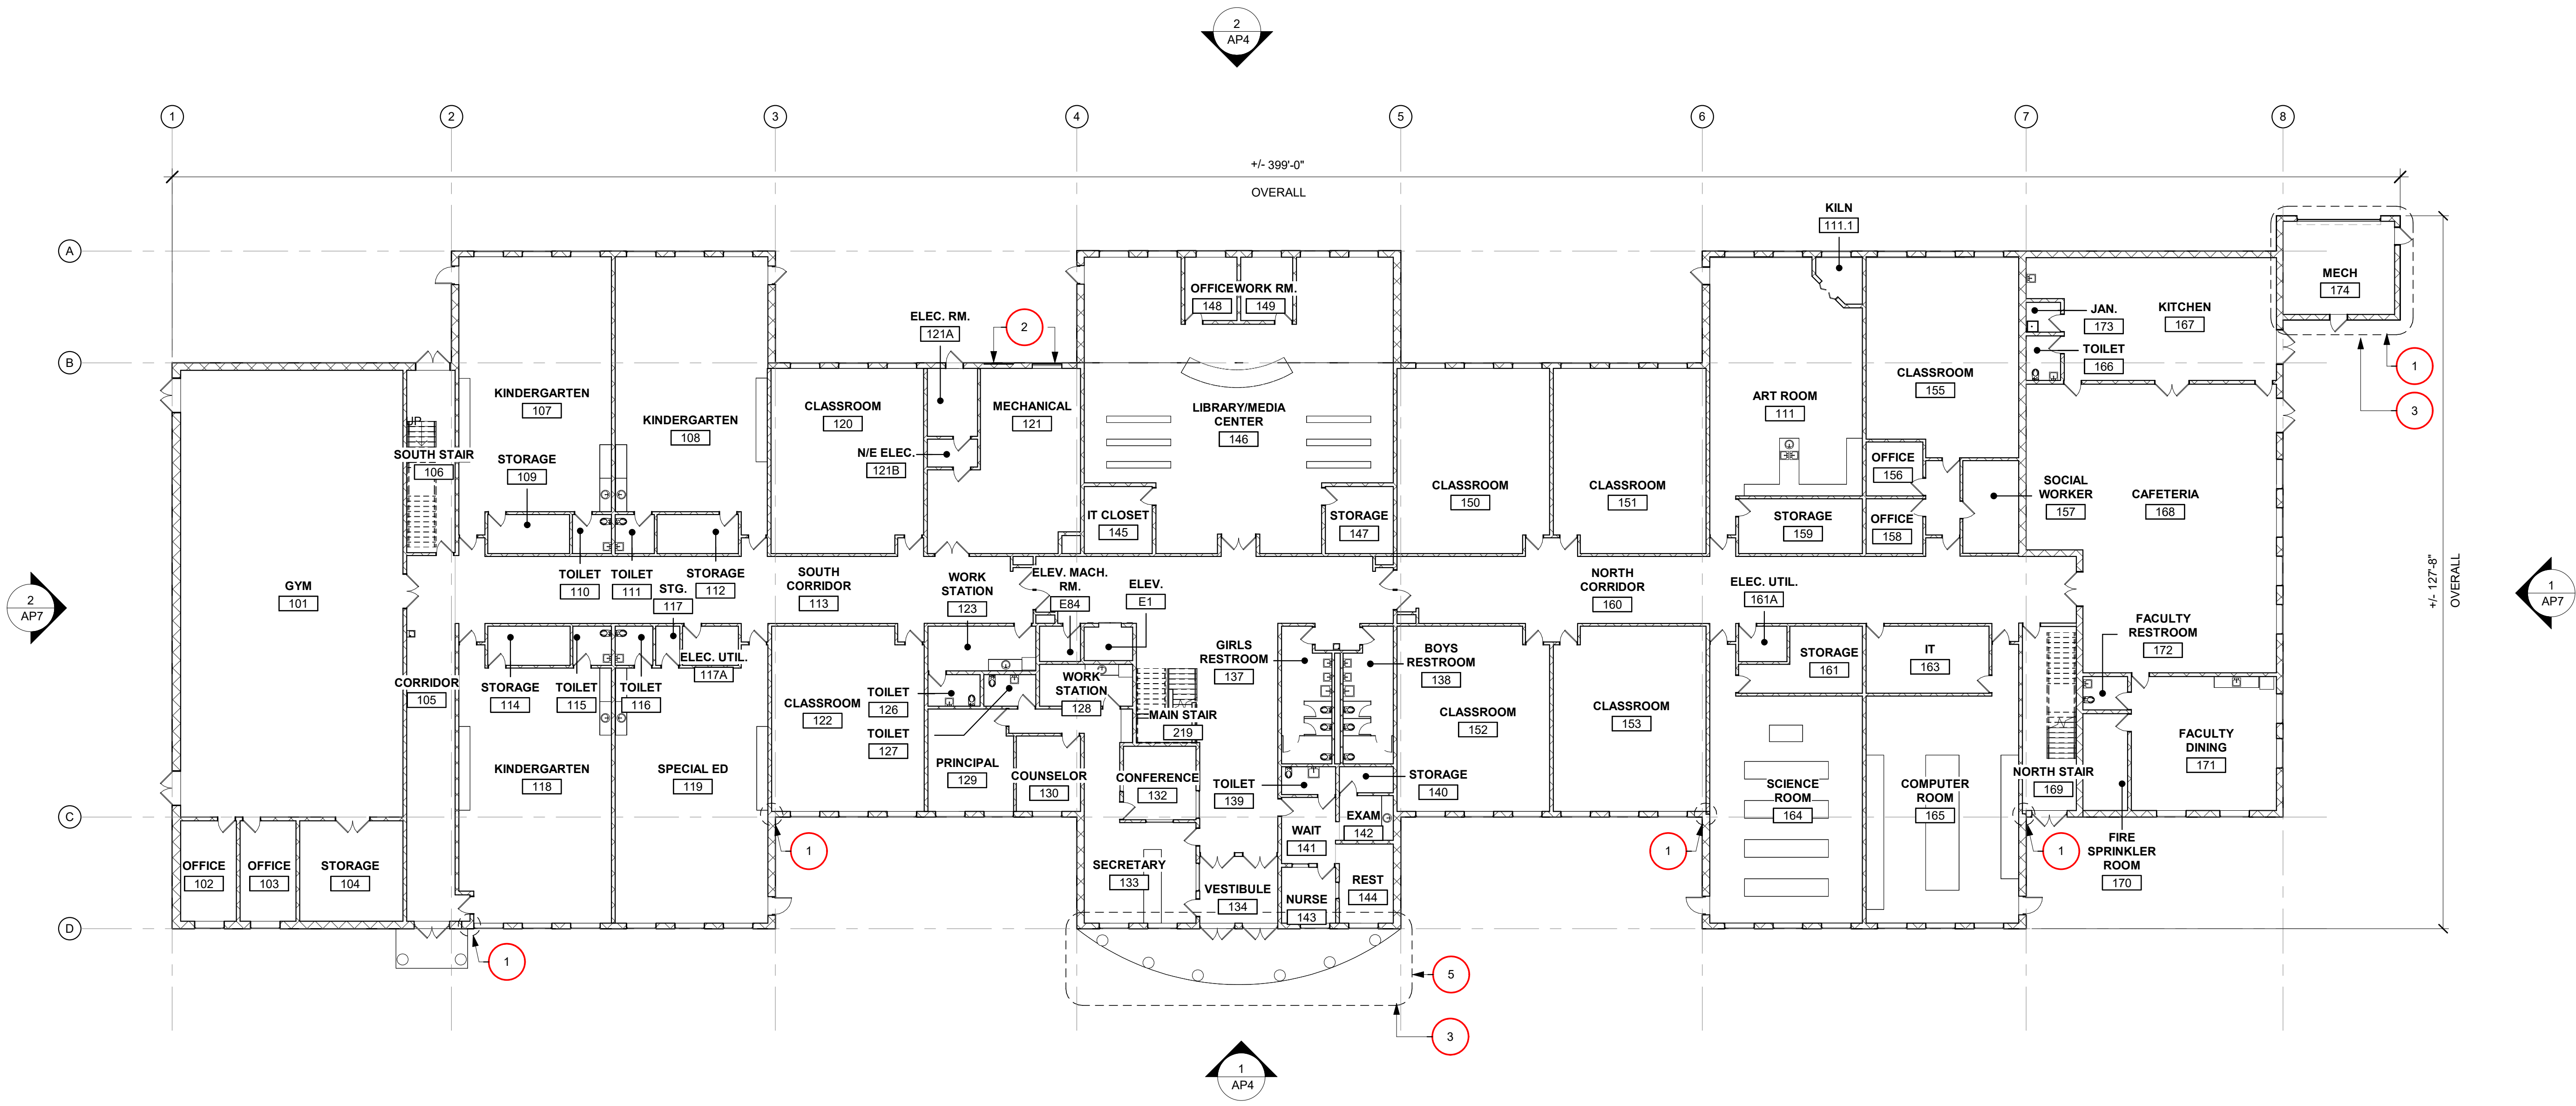
EXISTING FLOOR PLAN - LEVEL 1

- 1 CMU CRACKING IS OCCURRING DUE TO UNEVEN SETTLEMENT.
- 2 DIRT/MOLD GROWTH OCCURRING AT LOUVERS
- 3 OTHER DIRT/MOLD GROWTH OCCURRING
- 4 FLOOR/WALL CRACKING OCCURRING DUE TO UNEVEN SETTLEMENT
- 5 EXTERIOR CANOPY IS SPLITTING FROM THE CMU FACADE.

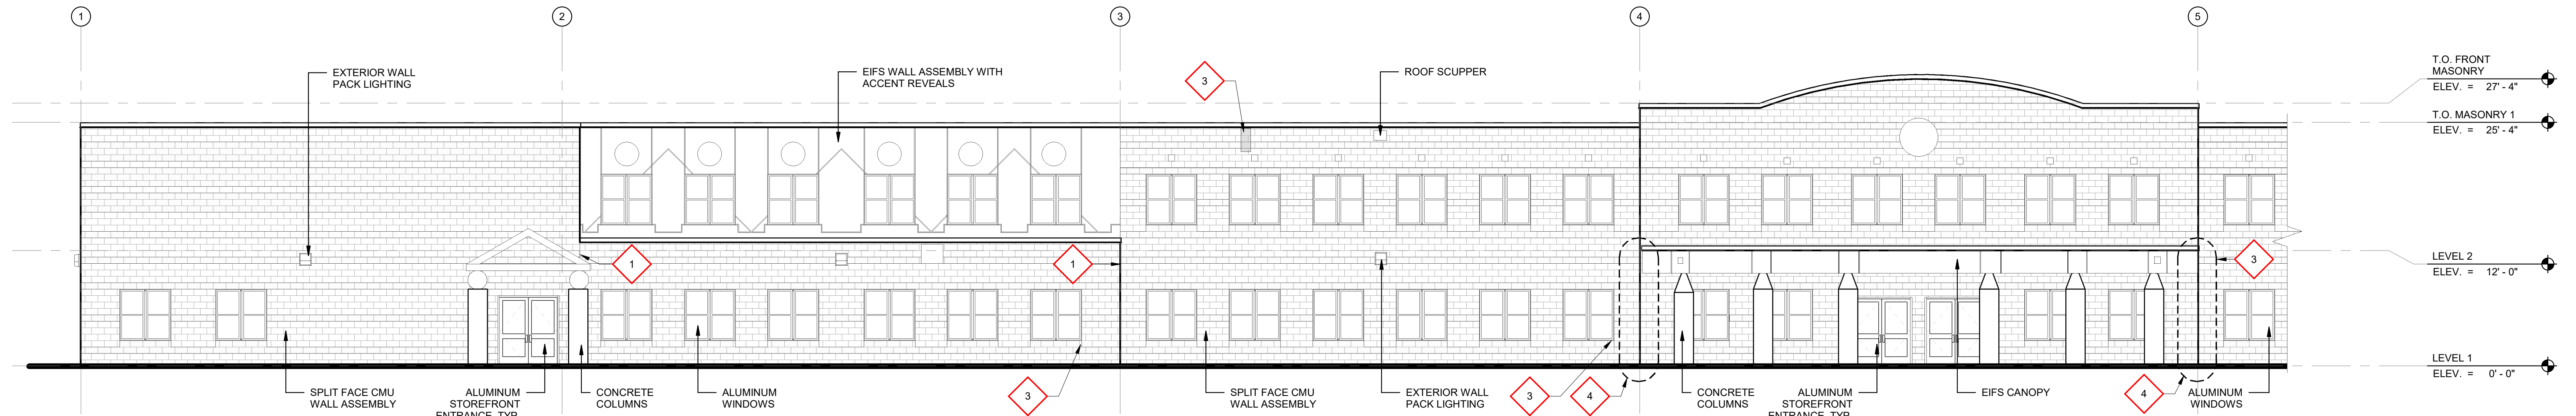
① ENLARGED EAST ELEVATION - A  
1/8" = 1'-0"

- ① CMU CRACKING IS OCCURRING DUE TO UNEVEN SETTLEMENT.
- ② DIRT/MOLD GROWTH OCCURRING AT LOUVERS
- ③ OTHER DIRT/MOLD GROWTH OCCURRING
- ④ EXTERIOR CANOPY IS SPLITTING FROM THE CMU FACADE

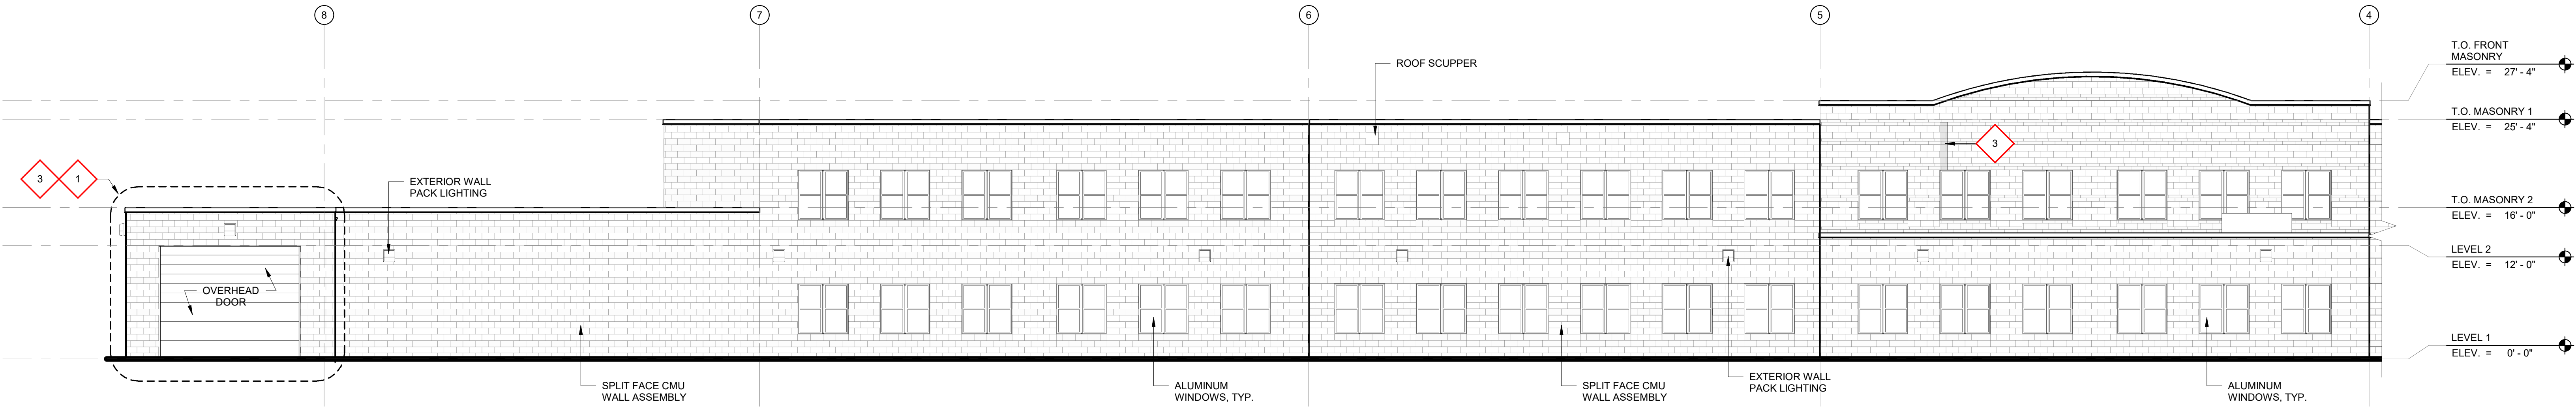
1 ENLARGED WEST ELEVATION - A  
1/8" = 1'-0"

- 1 CMU CRACKING IS OCCURRING DUE TO UNEVEN SETTLEMENT.
- 2 DIRT/MOLD GROWTH OCCURRING AT LOUVERS
- 3 OTHER DIRT/MOLD GROWTH OCCURRING
- 4 EXTERIOR CANOPY IS SPLITTING FROM THE CMU FACADE

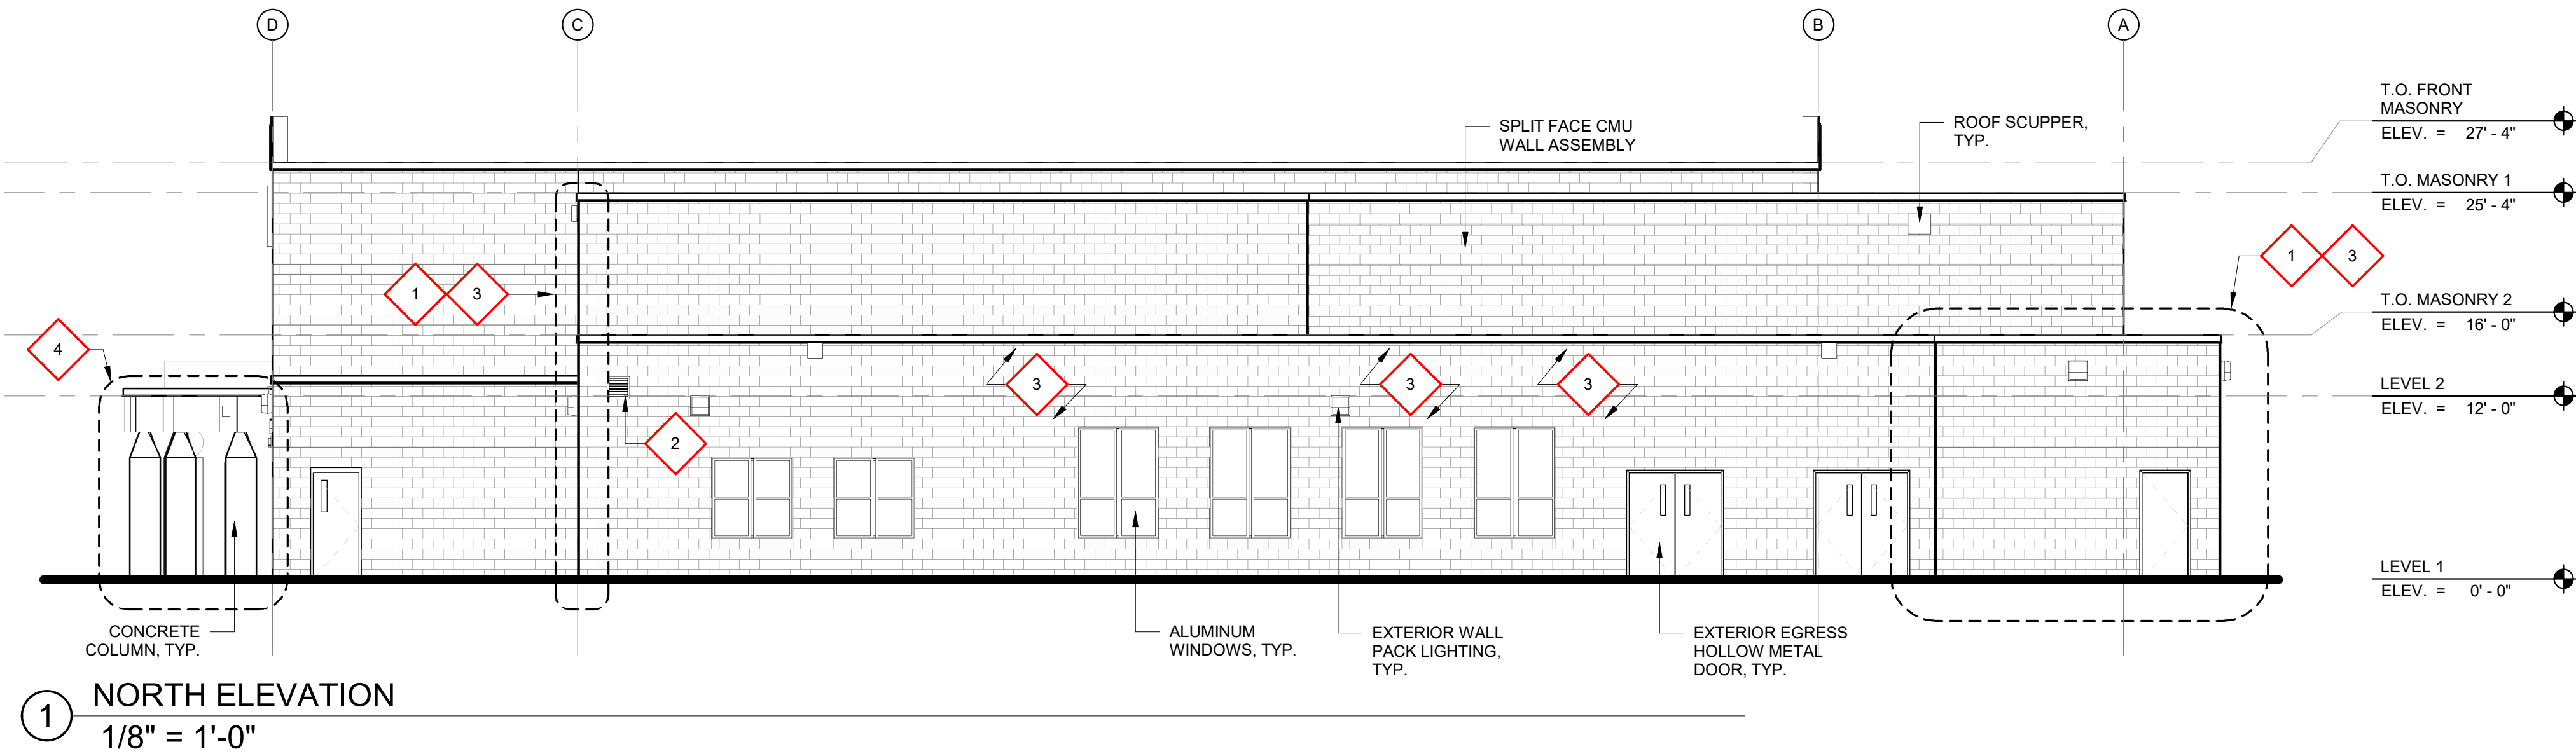
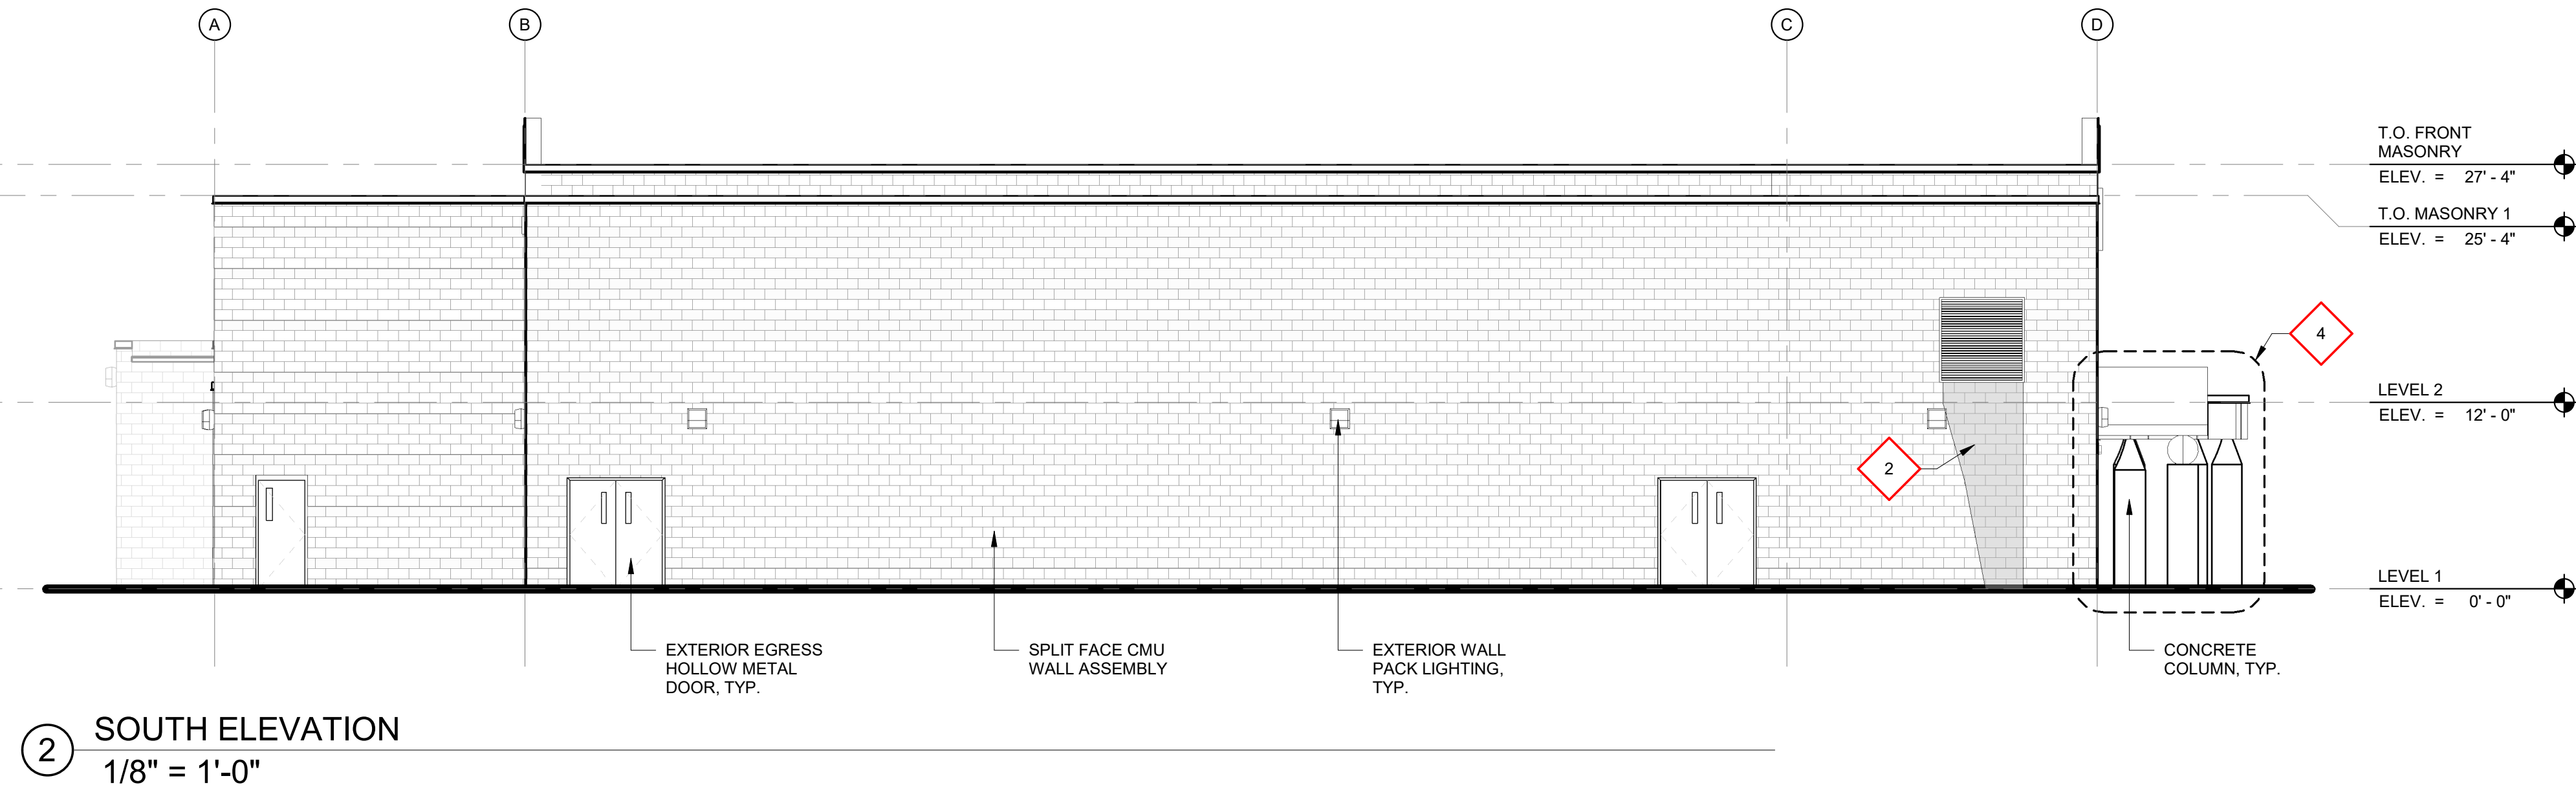
- 1 CMU CRACKING IS OCCURRING DUE TO UNEVEN SETTLEMENT.
- 2 DIRT/MOLD GROWTH OCCURRING AT LOUVERS
- 3 OTHER DIRT/MOLD GROWTH OCCURRING
- 4 EXTERIOR CANOPY IS SPLITTING FROM THE CMU FACADE

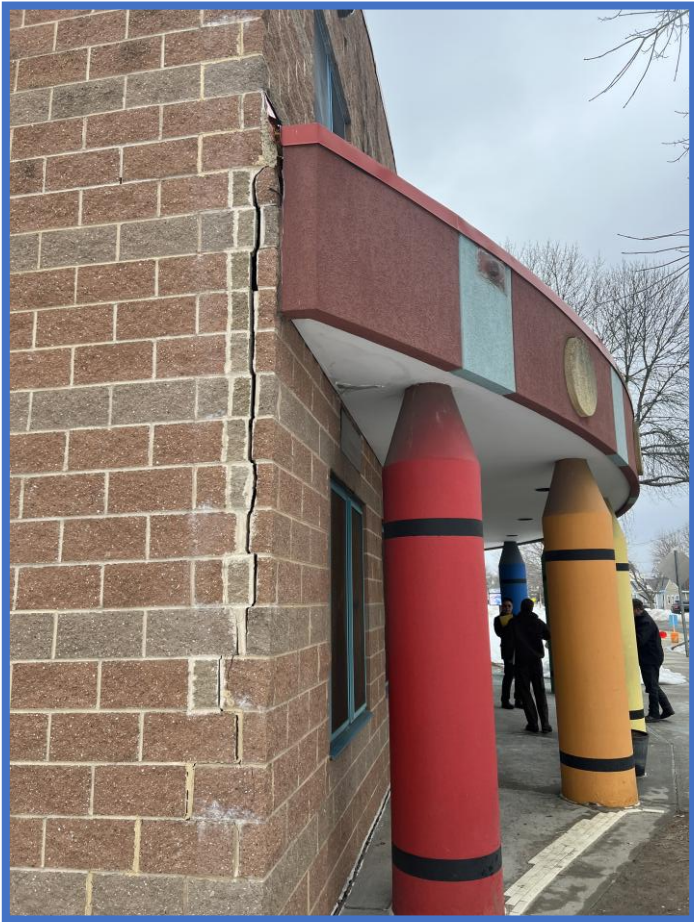
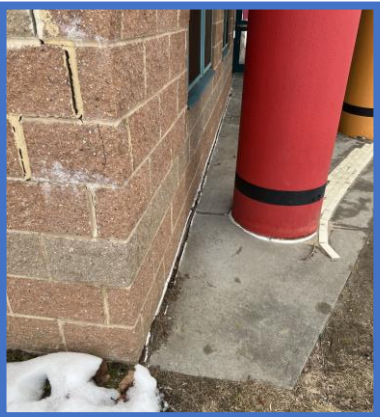
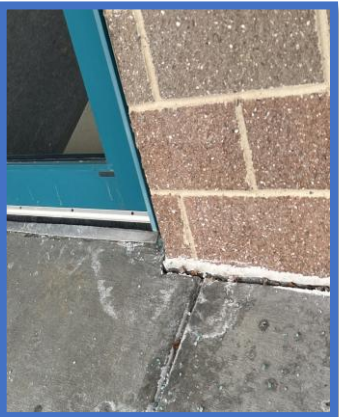
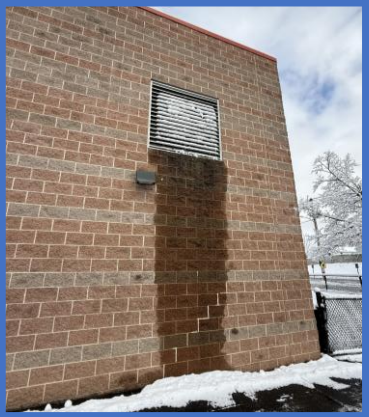
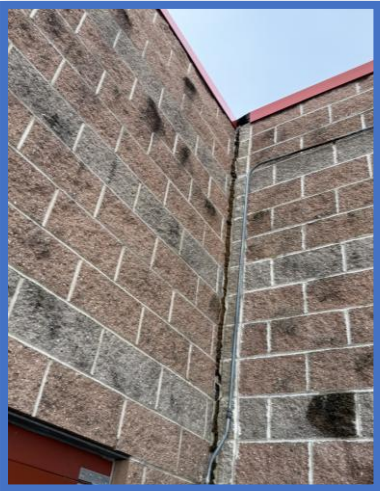
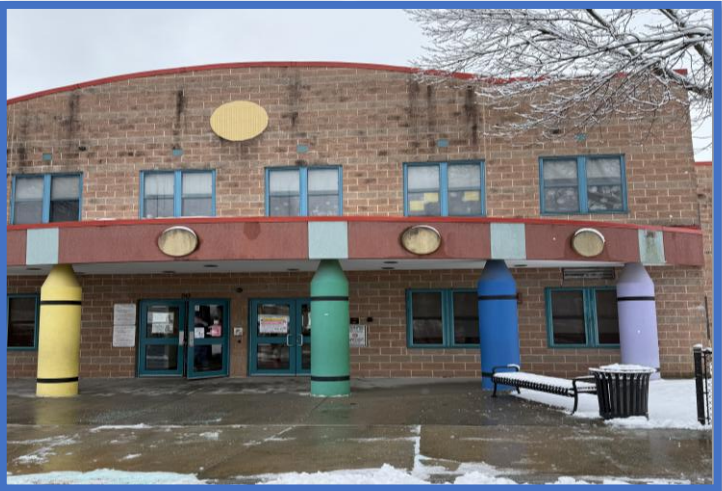
- The exterior façade requires cleaning, to remove staining, biological growth, and accumulated debris
- The exterior entry pad exhibits separation from the building.

Overall, exterior façade conditions range from good condition at masonry to poor condition at fenestration. Addressing these issues now will protect the building and increase longevity.

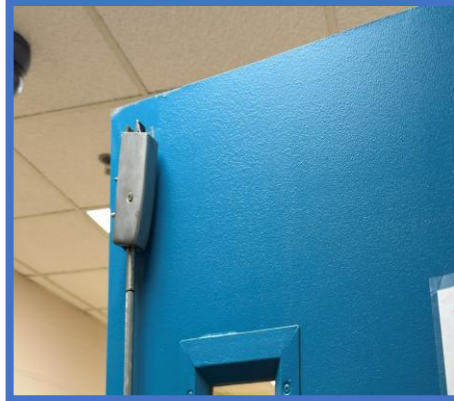
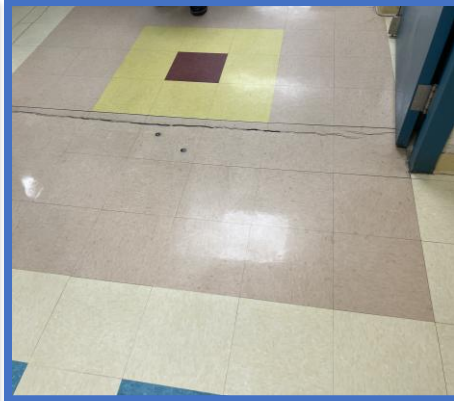
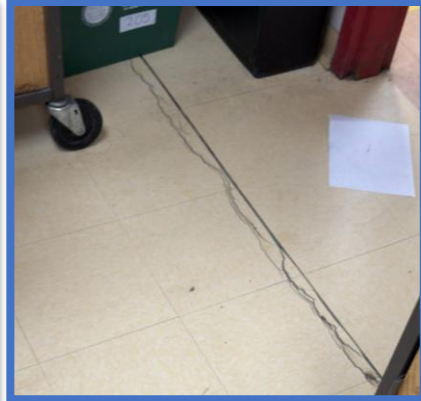
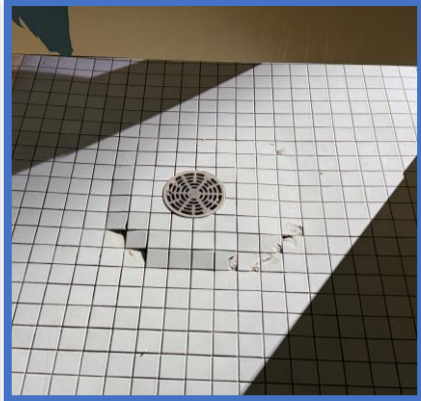
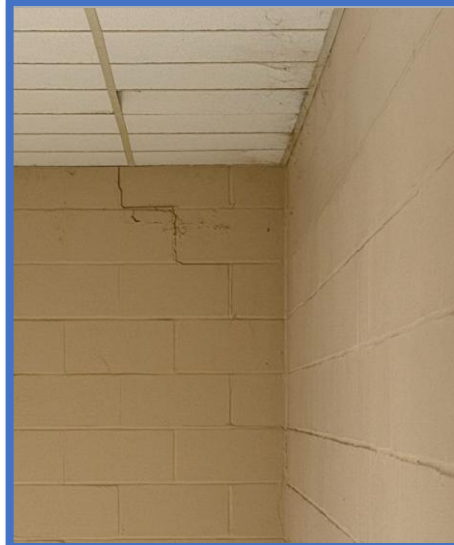
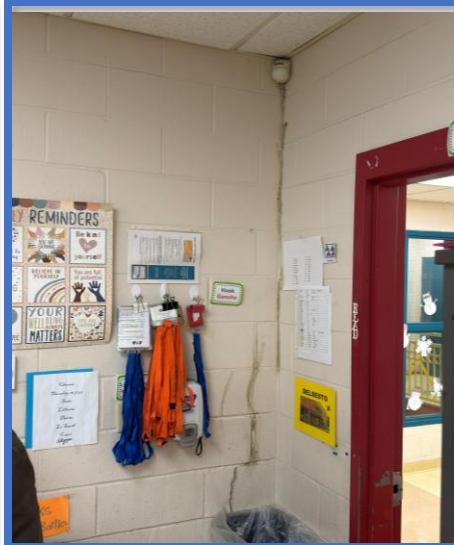
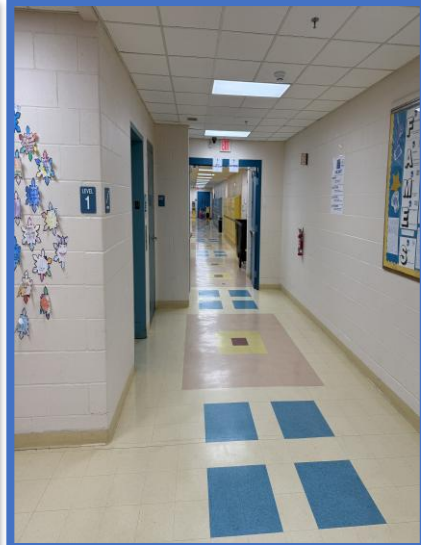
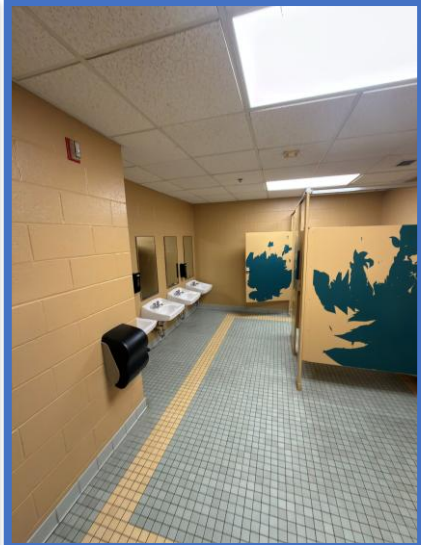
- Panic hardware throughout the building are damaged, missing, or non-functional.
- Interior masonry cracks.
- Interior finishes require repainting due to wear, deterioration, and general aesthetic degradation.
- Flooring materials show wear and deterioration in select areas.
- Bathroom floor drains are improperly pitched, resulting in inadequate drainage and standing water

Overall, the interior spaces reflect years of use and are in need of modernization.

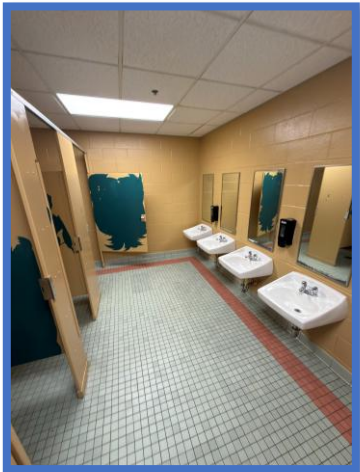
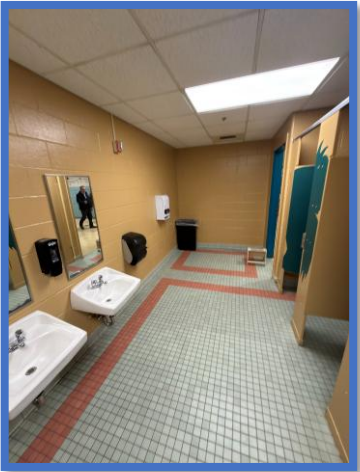
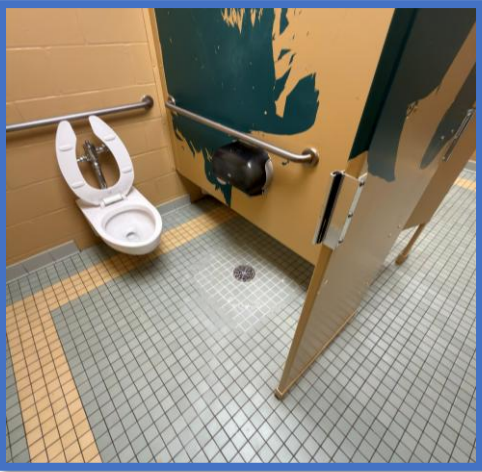
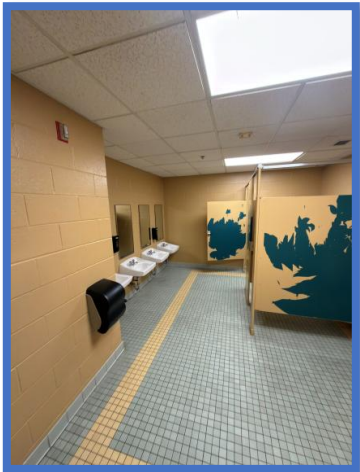
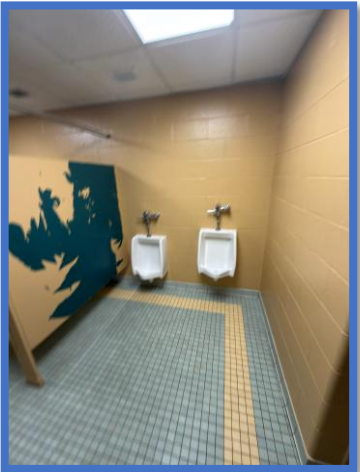
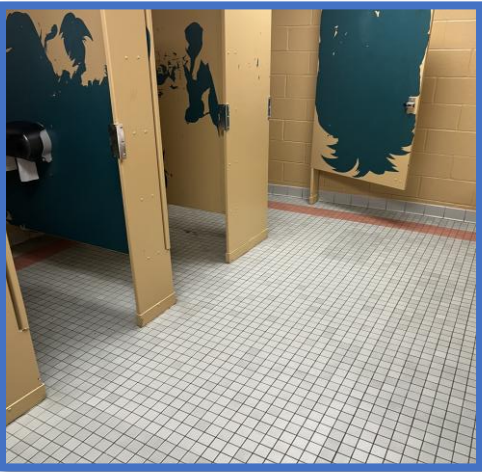
**ADA**  
➤ Gang restroom facilities require upgrades to meet current accessibility standards.

Overall, the building has several ADA code deficiencies, which can be addressed through renovation. However,

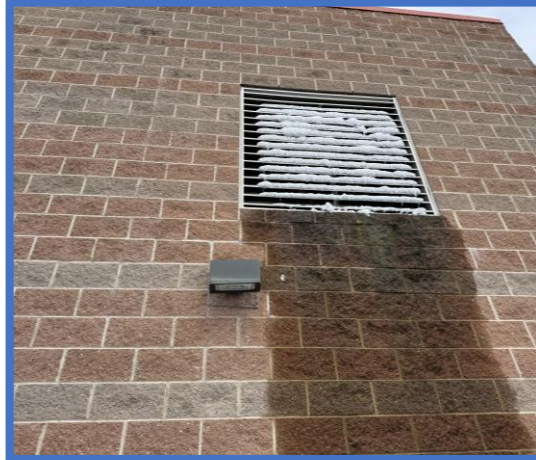
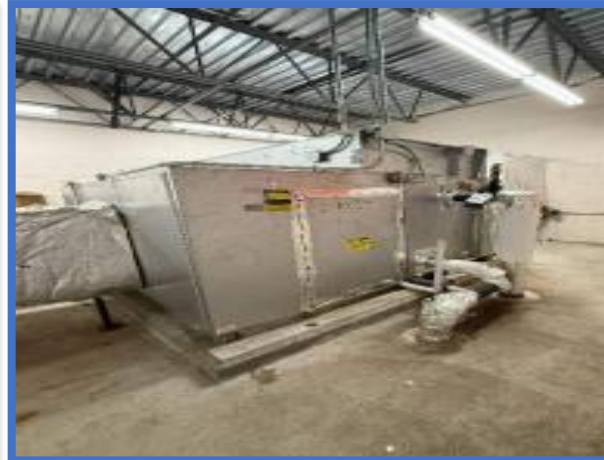
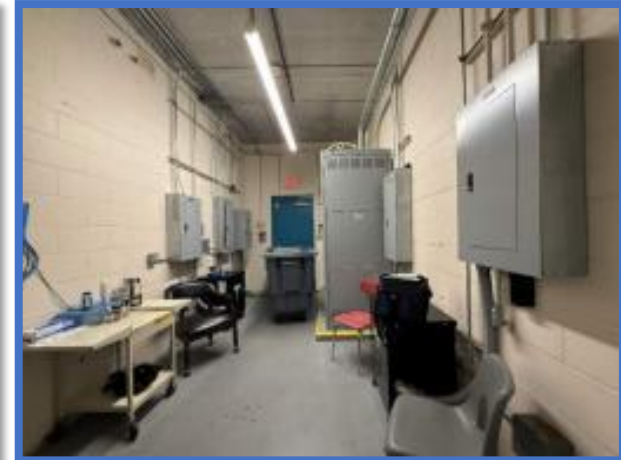
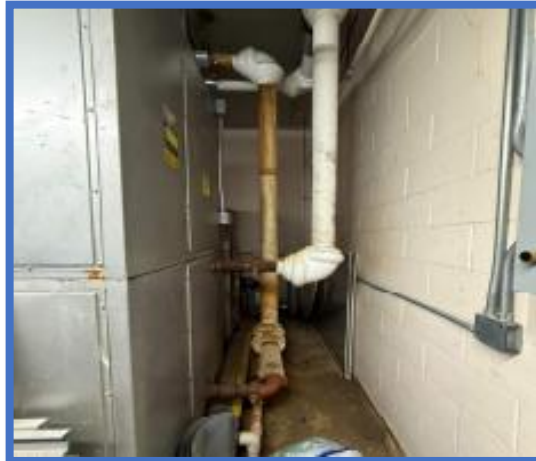
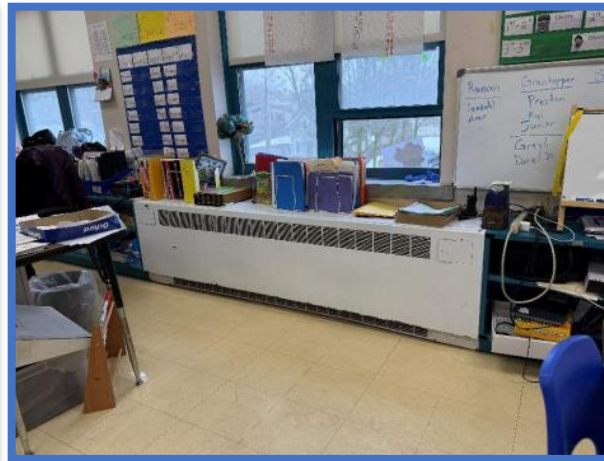
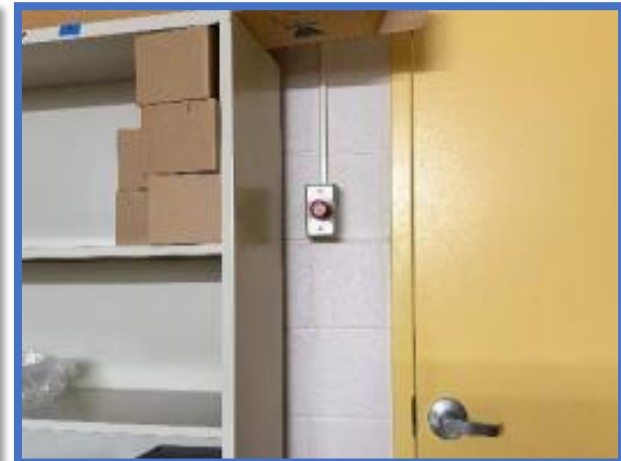
- Existing Water pipe insulation should be replaced.
- Elevator room exhaust fan needs to be reviewed if still operational.
- Classroom unit ventilators may need repair or to be replaced.
- Outdoor air dampers may not be closing fully and should be reviewed and maintained if fix frost build up at exterior louvers.
- Replacement of the chiller and pumps within the next five years.

Overall, the mechanical system requires some maintenance and replacements needed to continue longevity of the building.

- MDF room lacks labels for unknown lighting switches.

Overall, the electrical system do not require updating to meet current energy efficiency and code requirement.
