# Carnevale Elementary School and DelSesto PK-8 School

October 21, 2026

# Existing School Conditions Report

# **Structural Existing Conditions Report**

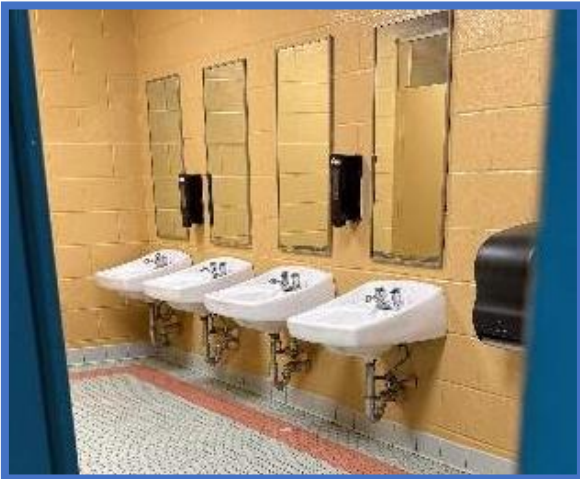
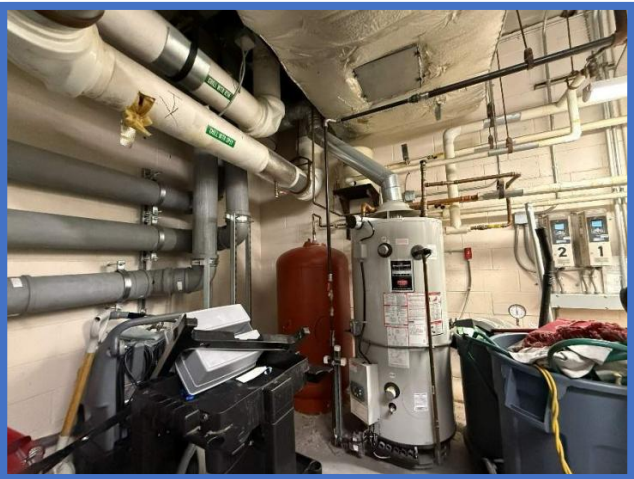
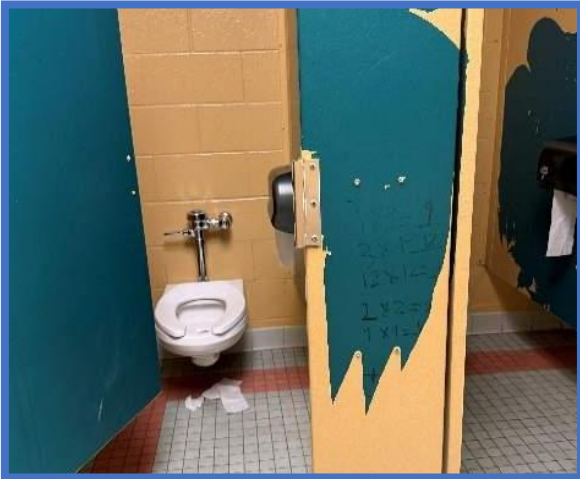
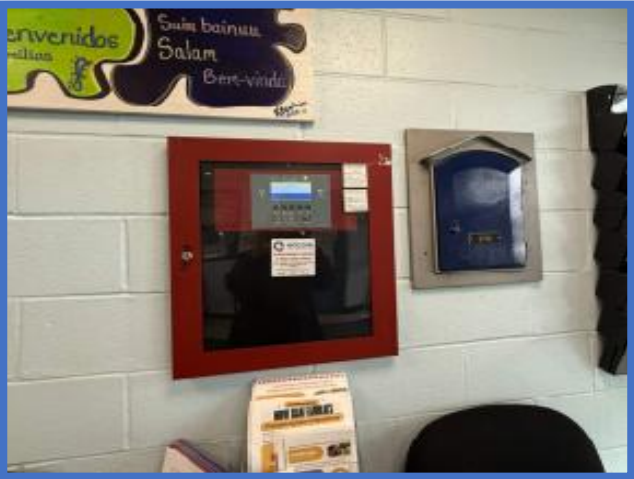
- Bathroom lavatory sinks are missing pipe wrap underneath sinks.
- Sinks are all manual with knobs need to change to lever hands.
- Toilets are all manual flush.

- The fire alarm panel is not an annunciator type panel which is now required in k-12.
- Fire pumps are required now by code to be on emergency power.

Overall, the fire suppression system is at the end of its life and requires replacement to be serviceable.
