integrus  
ARCHITECTURE  
and  
a&e  
ARCHITECTS

School District #2  
**Billings Public Schools**  
2018 Facilities Master Plan  
April 2018

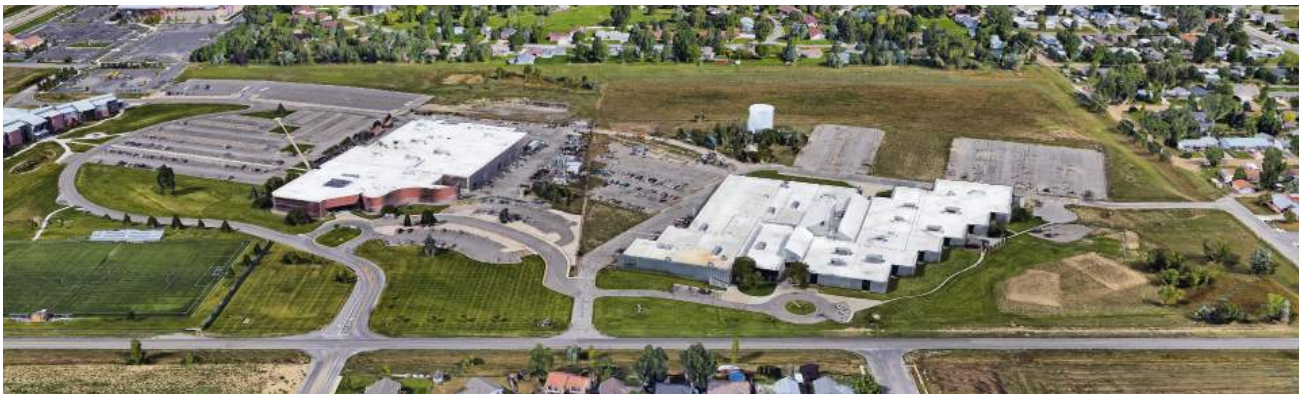
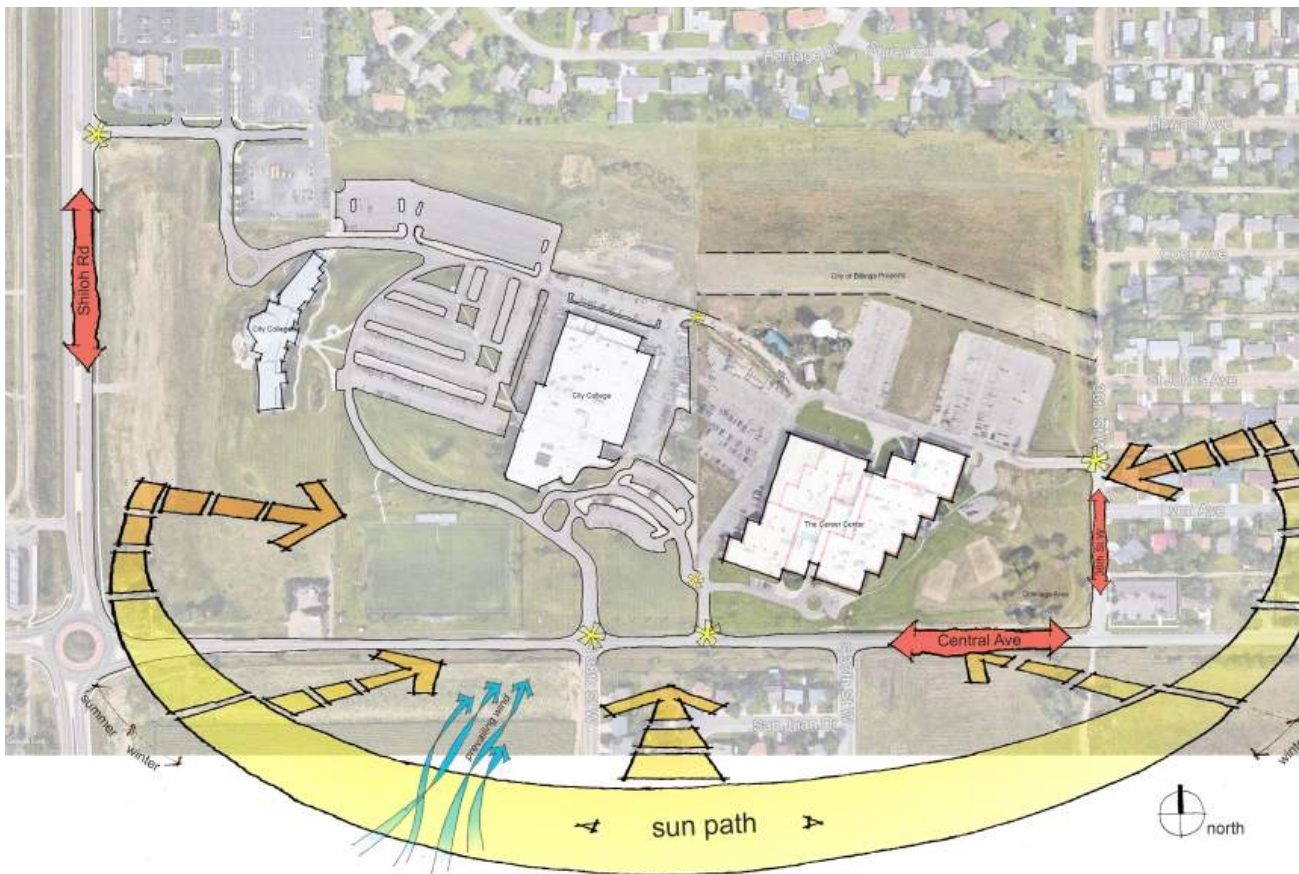
#### Site Analysis

The Career Center site is 26.81 acres with 2.44 acres of city property running east/west across the site. The low topography has a minimal slope with the low point at the southeast corner of the site where there is natural drainage. City utilities are accessed from Central Avenue and fire loop extends around the building. An abandoned fire suppression holding tank is on-site, septic fields are also no longer needed due to connection to city sewer services. City College is directly adjacent and provides vehicular and pedestrian connections between both sites. Main vehicular access is off of Central Avenue with visitor parking to the south and main student and teacher parking to the east and north of the building. Future improvements along Central include a round about at 38th street and possibly 36th street and a metro bus stop at these locations. Development of 36th street could be a possibility if access to the site was emphasized along 36th street.

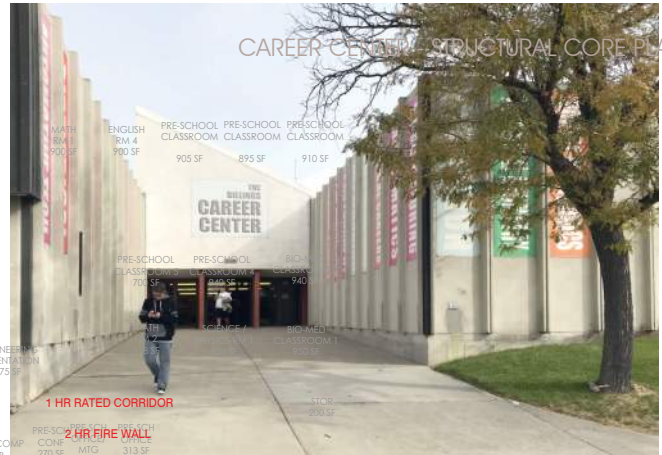
The Career Center is a one story precast concrete building with cast concrete features and insulated metal panels. The exterior structural system is precast concrete and cmu bearing walls. The interior structure is steel columns, cmu and concrete bearing walls. The floor structure is slab on grade and the roof structure is steel bar joists with metal decking. The roof drainage is formed by tapered rigid insulation. The floors are sealed concrete, some vinyl asbestos tile corridors and ceramic tile in the toilet rooms. The walls are painted concrete and cmu as well as movable wall systems. The ceilings are gypsum board on furring. There are aluminum frame windows and doors as well as hollow metal frame doors. The HVAC system is multiple roof top units.

The structural system of the building has created significant challenges to form physical connections between fabrication labs and classrooms spaces. The building is organized into 3 main areas; fabrication spaces to the east, commons space in the center, and classroom instruction to the west. Administration offices are located in the center of the building, using cameras and intercoms for building access security. Daylighting opportunities are not available to most of the spaces. Most instructional spaces are compartmentalized with minimal opportunities for small group breakout or collaboration areas.

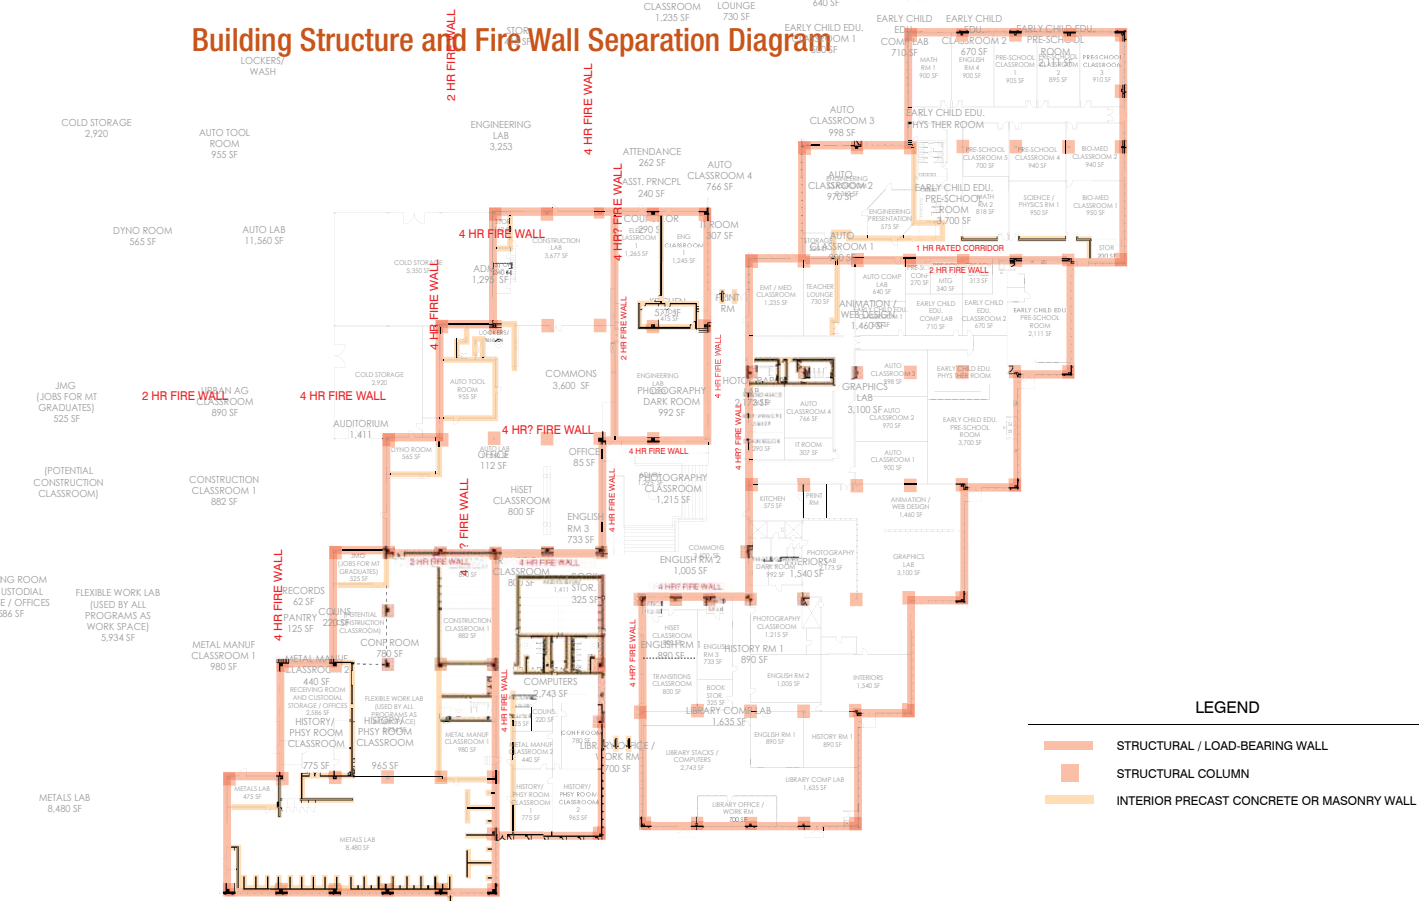
CAREER CENTER STRUCTURAL CORE PLAN

## Building Structure and Fire-Wall Separation Diagram

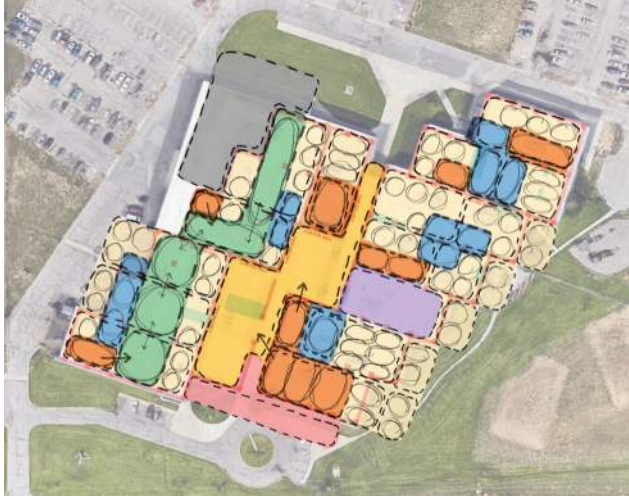
## Renovation and Addition

This concept renovates all existing spaces and creates additional classrooms, fabrication labs, and administration around the perimeter of the existing structure.

- Creates a new facade at the south and east for new visual presence on Central Ave
- One main entry at the south facade, difficult adjacency to parking
- Majority of spaces still have no access to daylight
- Existing 4hr fire walls and structure limit connection within the building for cross discipline collaboration
- Possible phasing options, but would disrupt use throughout school year

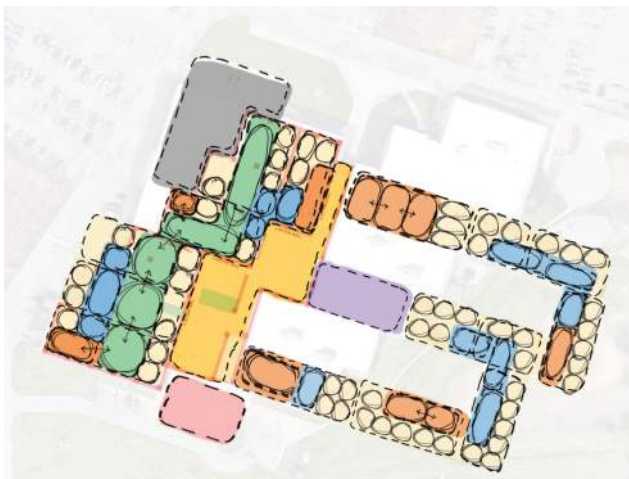
## Renovation / Demolition and Addition

This concept renovates the high bay fabrication spaces, demolishes the east half of the existing building, and creates new classrooms, labs, library, and administration.

- Creates a new entry and facade to the public along Central Ave
- New entry to south creates difficult adjacency to parking
- New classrooms and labs have access to daylight
- Minimal connection from fabrication labs to other classrooms
- Requires phasing that would not allow use of building throughout school year

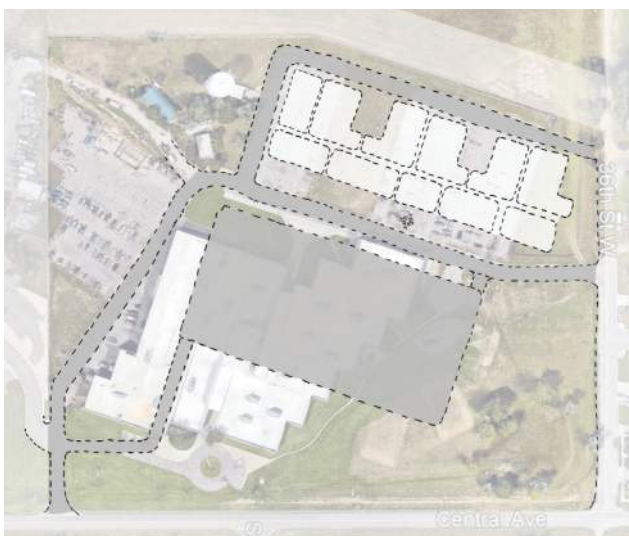
## New Construction

This concept creates a new 2-story building north of the existing facility. Spaces are organized along a central spine for maximum access to daylight and ease of supervision. Parking is located south of the new building and allows options for campus connections to City College.

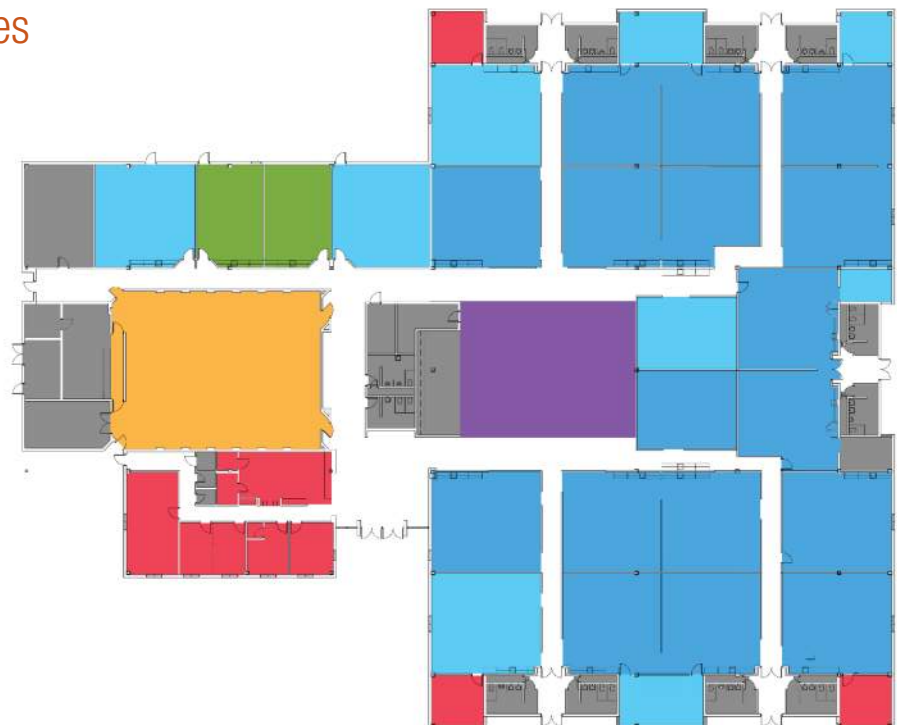
### Existing Program Spaces

CLASSROOM
SPECIAL SERVICES
LIBRARY
ADMINISTRATION
MEP/TOILET/KITCHEN
COMMONS/CAFE
GYMNASIUM
MUSIC/ART

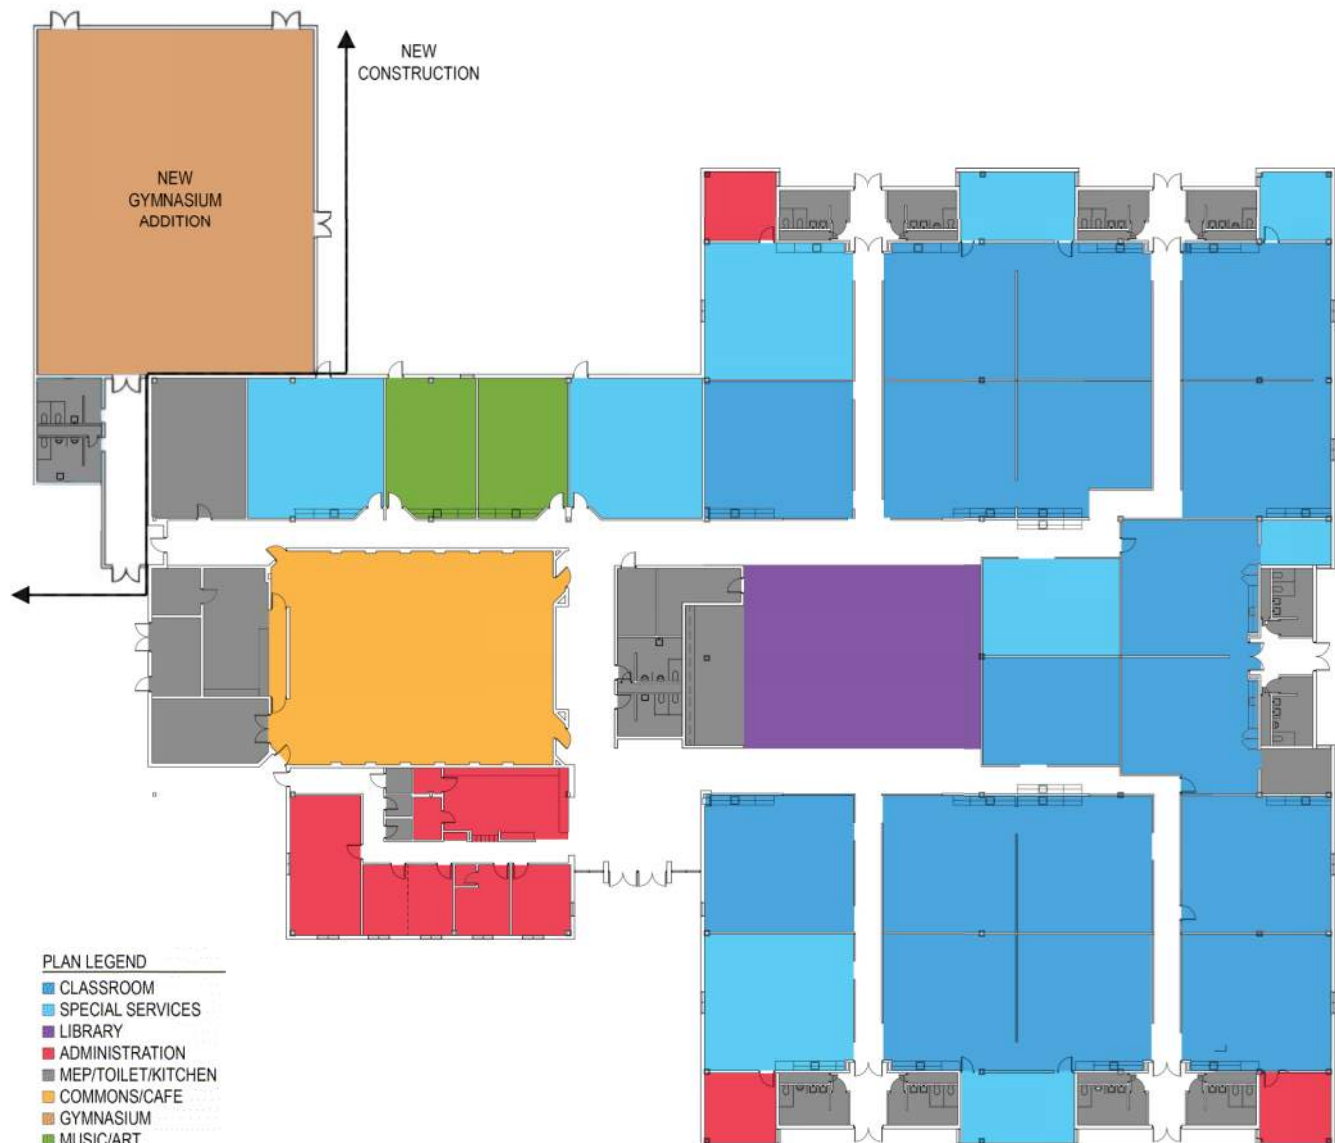
### Potential Floor Plan Diagram

Recommendations From 2013 master plan are being carried over for the 2018 master plan. The recommendations include:

- Repurpose existing gymnasium to Cafeteria.
- Create a multi-purpose room addition and associated restrooms.

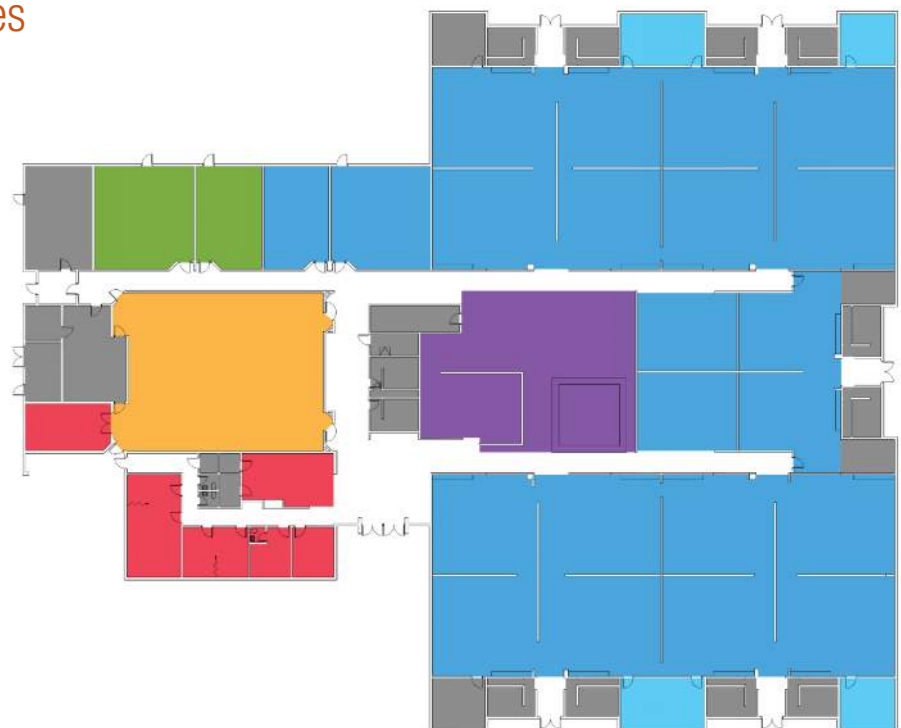
### Existing Program Spaces

CLASSROOM
SPECIAL SERVICES
LIBRARY
ADMINISTRATION
MEP/TOILET/KITCHEN
COMMONS/CAFE
GYMNASIUM
MUSIC/ART

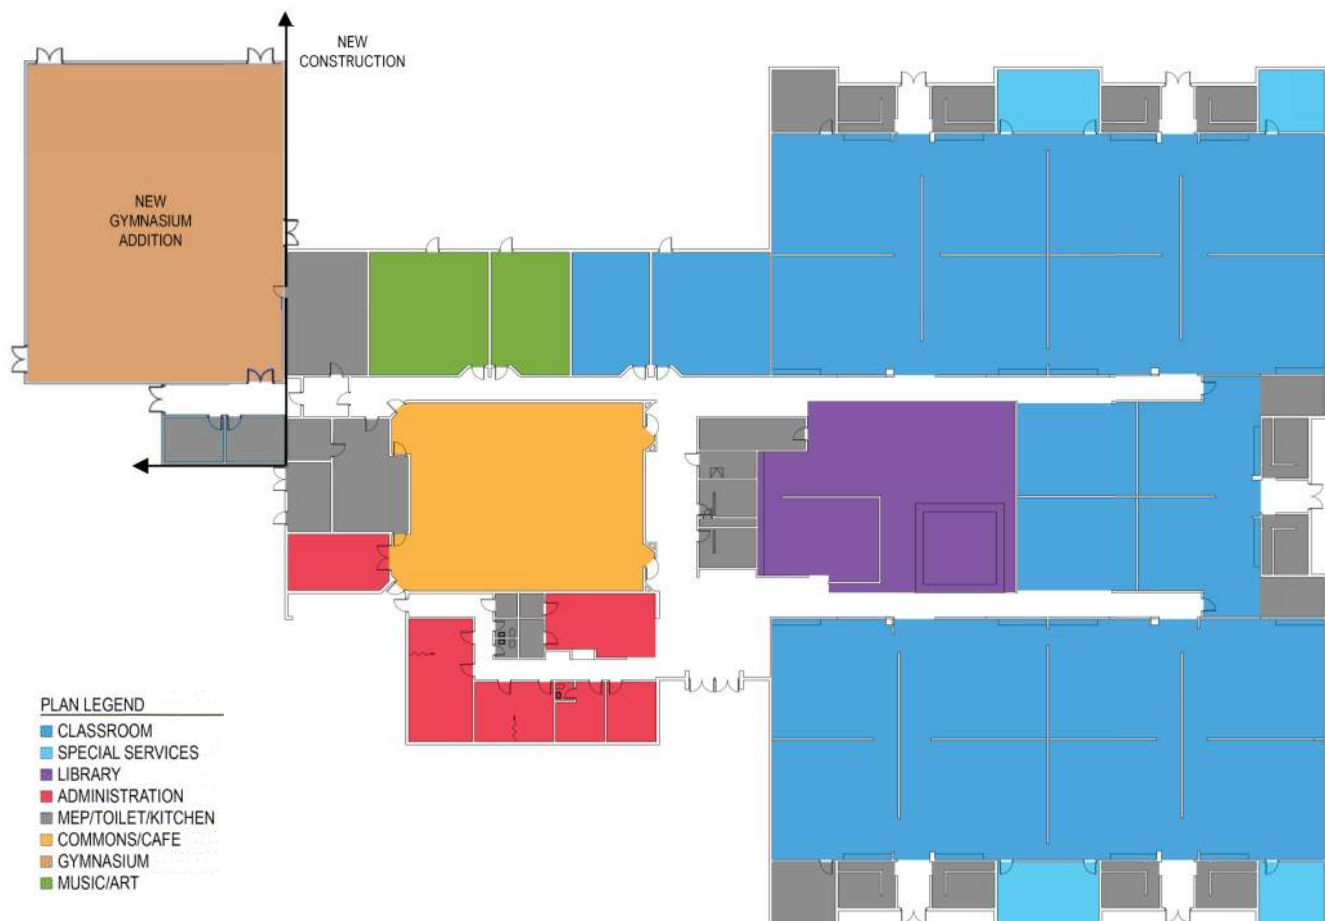
### Potential Floor Plan Diagram

Recommendations From 2013 master plan are being carried over for the 2018 master plan. The recommendations include:

- Repurpose existing gymnasium to Cafeteria.
- Create a multi-purpose room addition and associated restrooms.

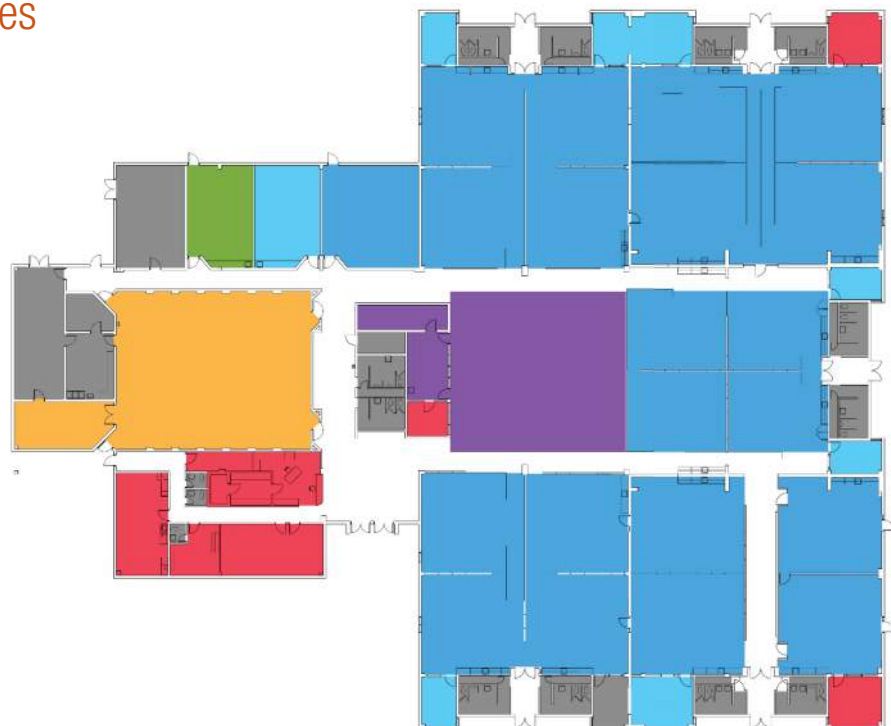
### Existing Program Spaces

CLASSROOM
SPECIAL SERVICES
LIBRARY
ADMINISTRATION
MEP/TOILET/KITCHEN
COMMONS/CAFE
GYMNASIUM
MUSIC/ART

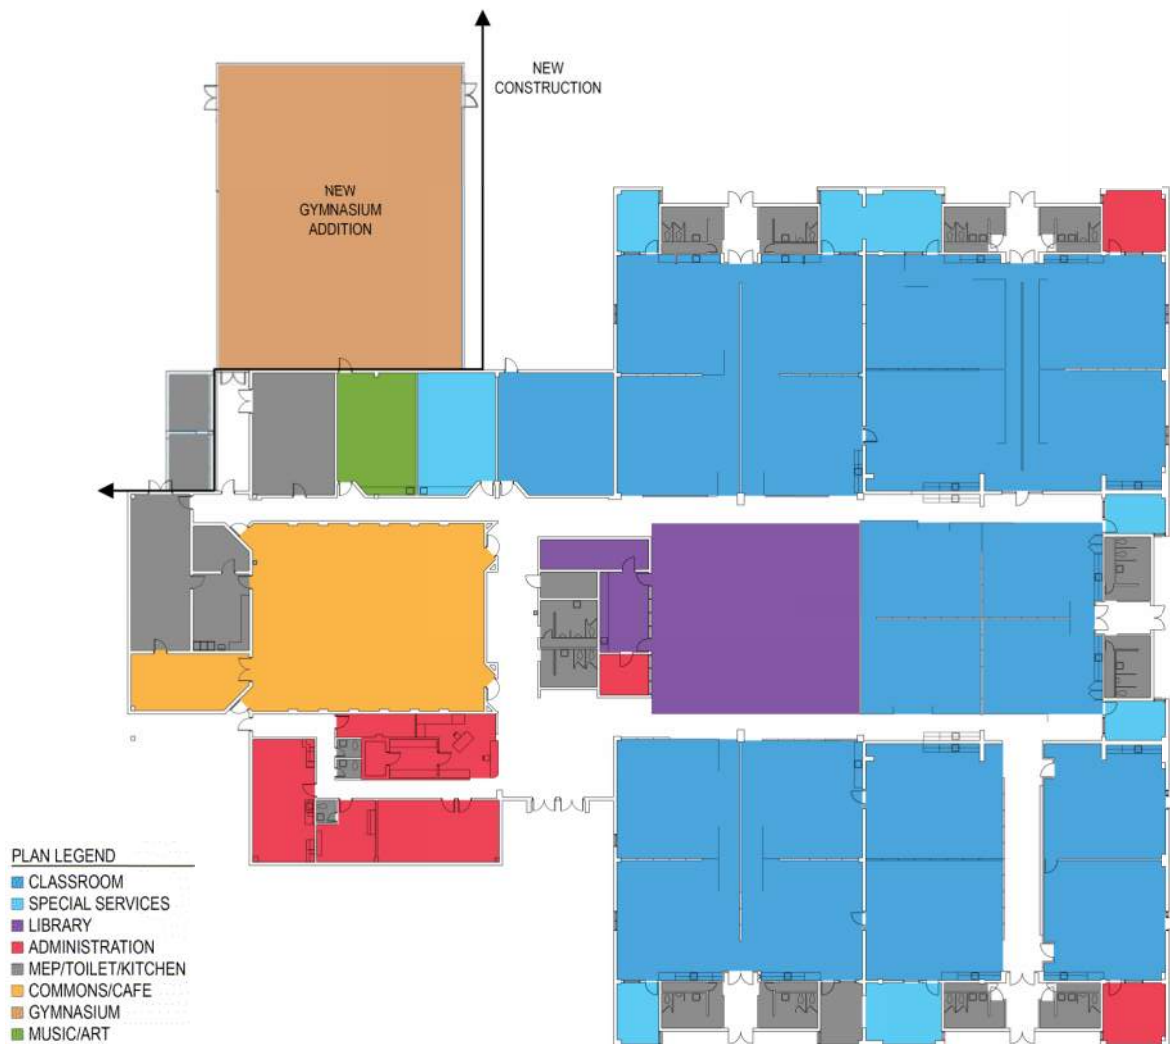
### Potential Floor Plan Diagram

Recommendations From 2013 master plan are being carried over for the 2018 master plan. The recommendations include:

- Repurpose existing gymnasium to Cafeteria.
- Create a multi-purpose room addition and associated restrooms.

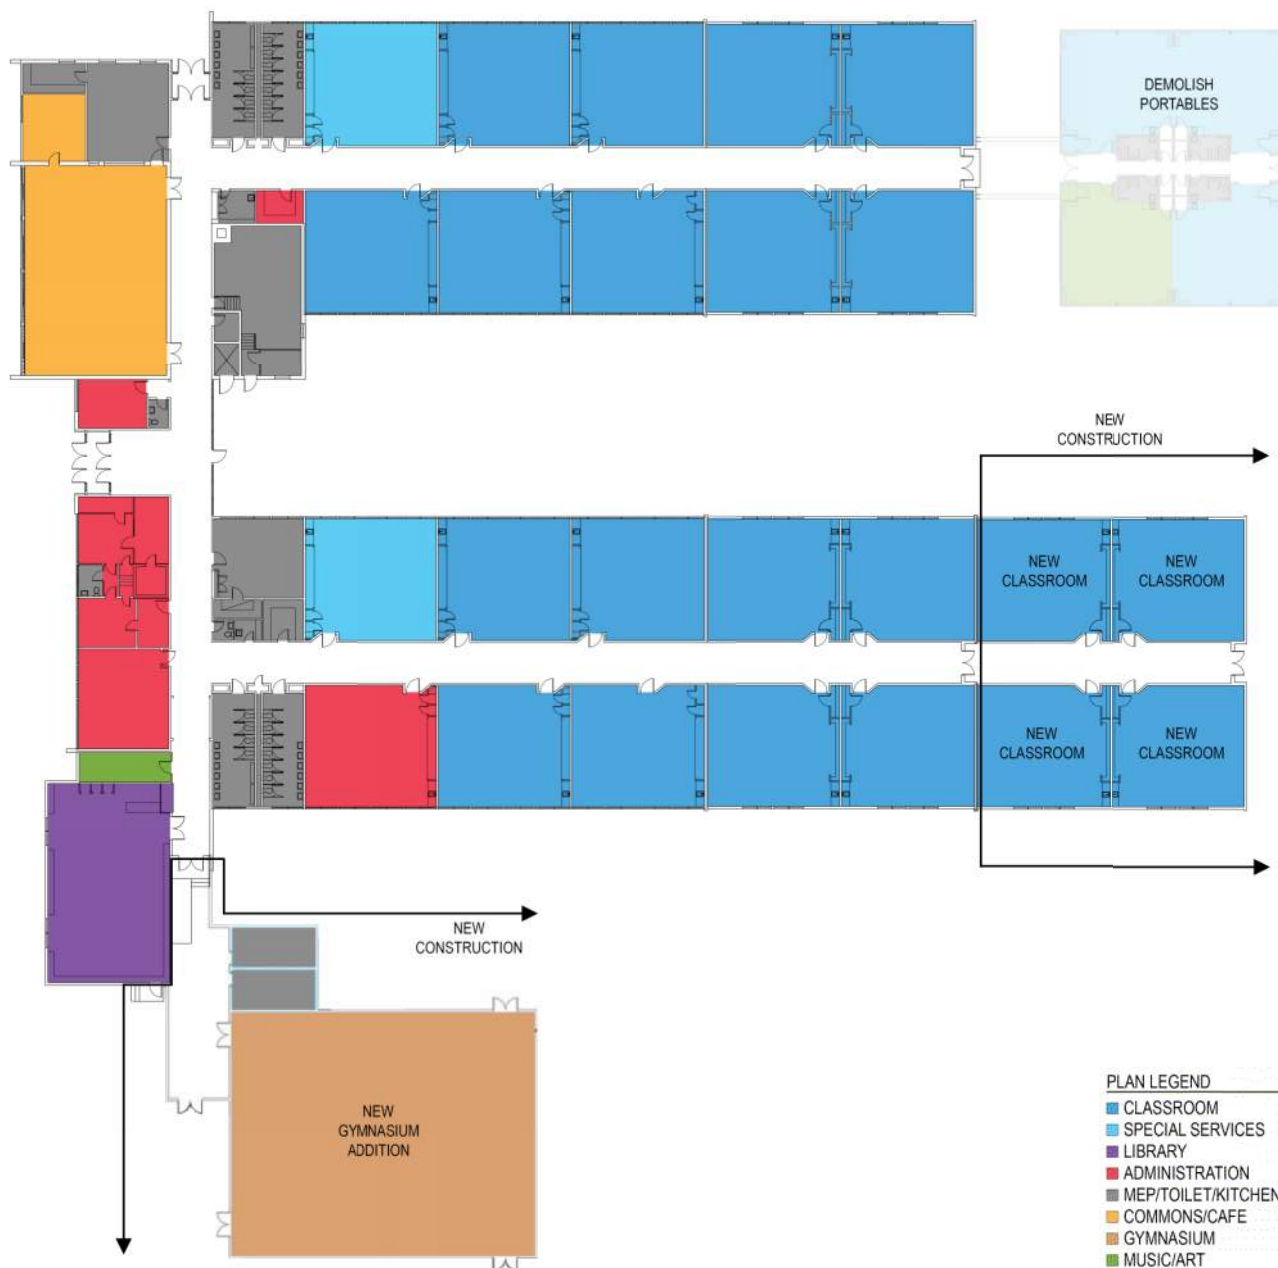
Potential Floor Plan Diagram

Recommendations From 2013 master plan are being carried over for the 2018 master plan for a multi-purpose room. The district's goal of eliminating portable classrooms requires the addition of four classroom spaces based upon 2017 demographic projections. The recommendations include:

- Repurpose existing gymnasium to Cafeteria.
- Create a multi-purpose room addition and associated restrooms.
- Demolish existing portable classrooms and an addition of 4 new classrooms

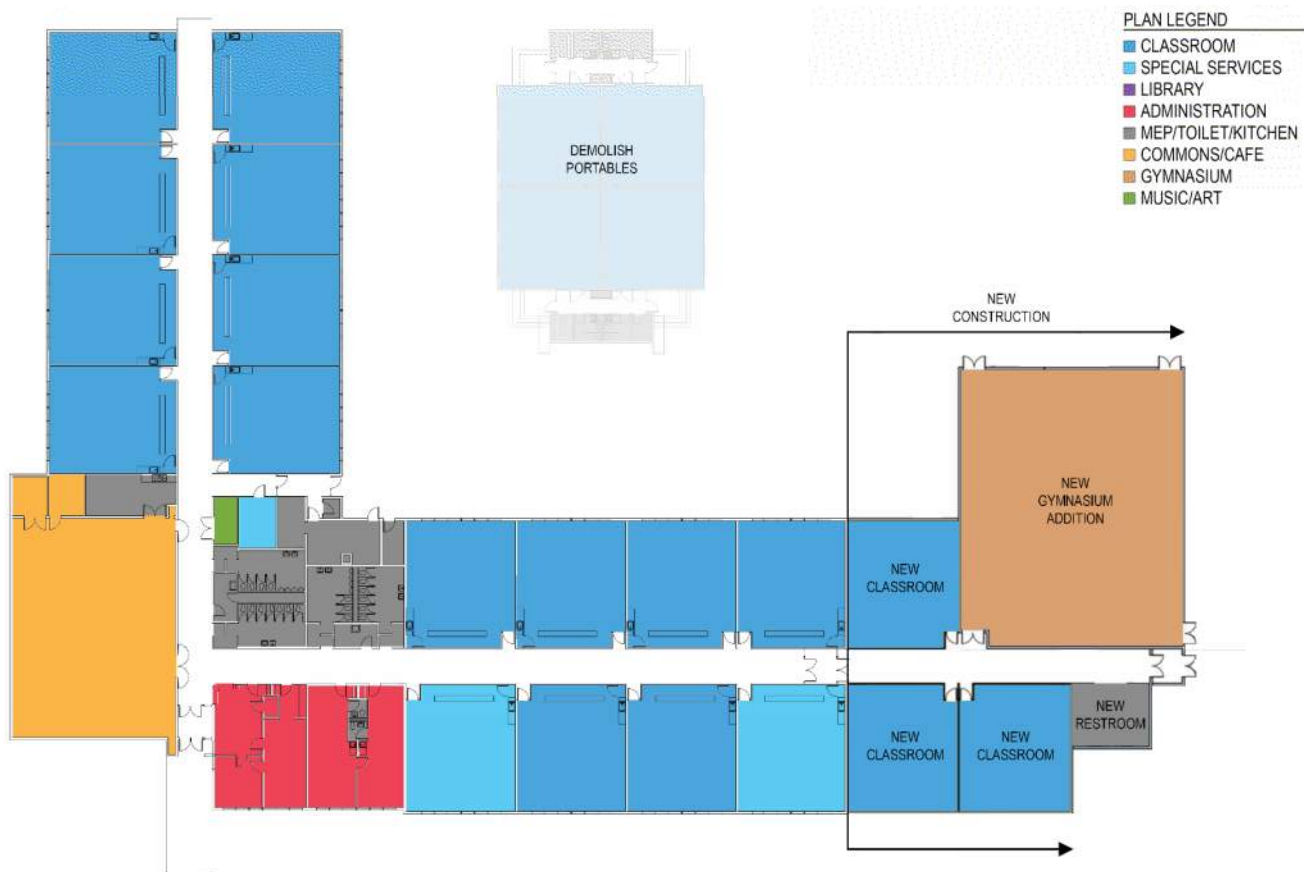
Potential Floor Plan Diagram

Recommendations From 2013 master plan are being carried over for the 2018 master plan for a multi-purpose room. The district's goal of eliminating portable classrooms requires the addition of three classroom spaces based upon 2017 demographic projections. The recommendations include:

- Repurpose existing gymnasium to Cafeteria.
- Create a multi-purpose room addition and associated restrooms.
- Demolish existing portable classrooms and an addition of 3 new classrooms

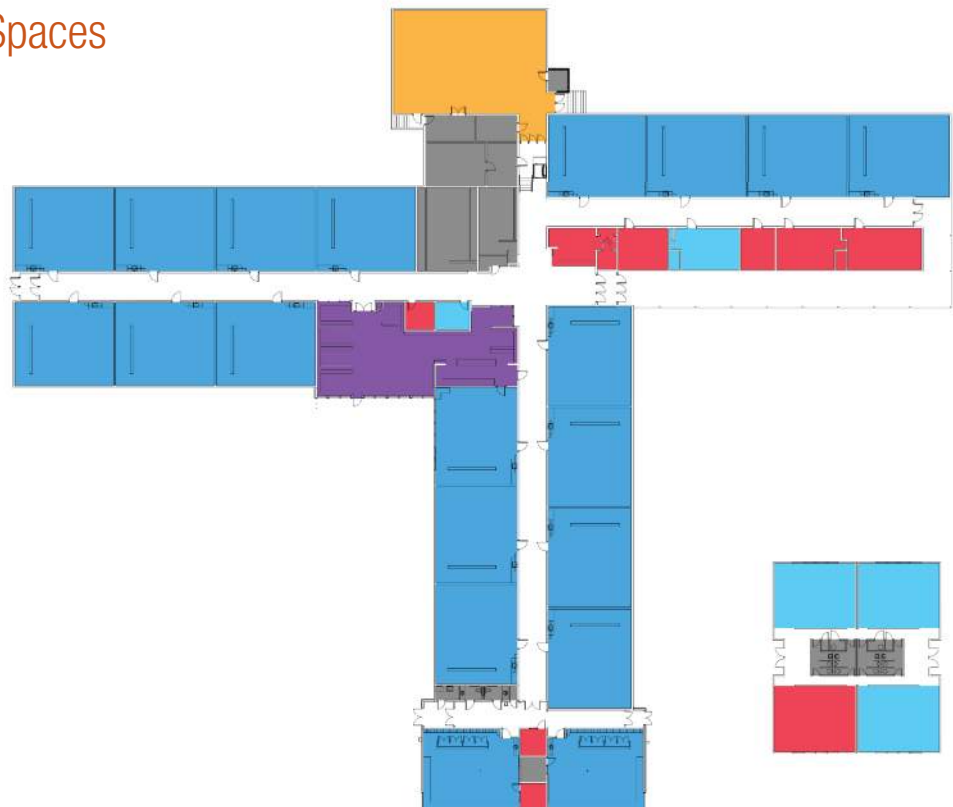
### Existing Program Spaces

PLAN LEGEND	
CLASSROOM	
SPECIAL SERVICES	
LIBRARY	
ADMINISTRATION	
MEP/TOILET/KITCHEN	
COMMONS/CAFE	
GYMNASIUM	
MUSIC/ART

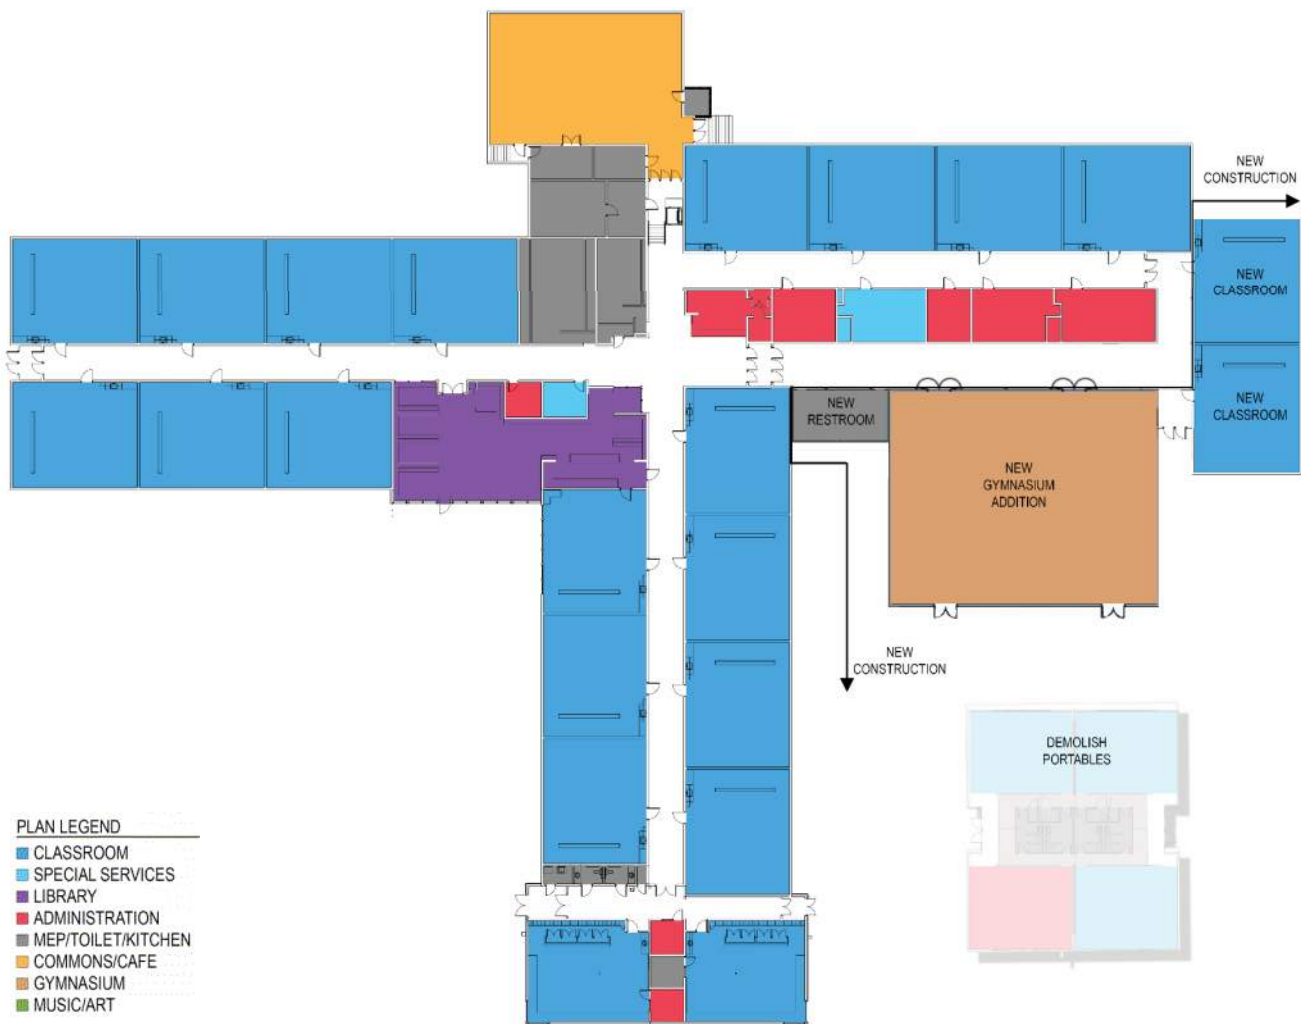
### Potential Floor Plan Diagram

Recommendations From 2013 master plan are being carried over for the 2018 master plan for a multi-purpose room. The district's goal of eliminating portable classrooms requires the addition of four classroom spaces based upon 2017 demographic projections. The recommendations include:

- Repurpose existing gymnasium to Cafeteria.
- Create a multi-purpose room addition and associated restrooms.
- Demolish existing portable classrooms and an addition of 2 new classrooms

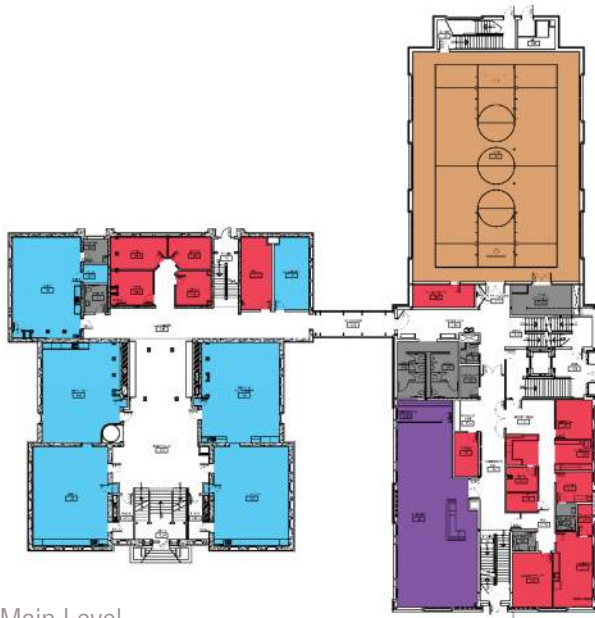
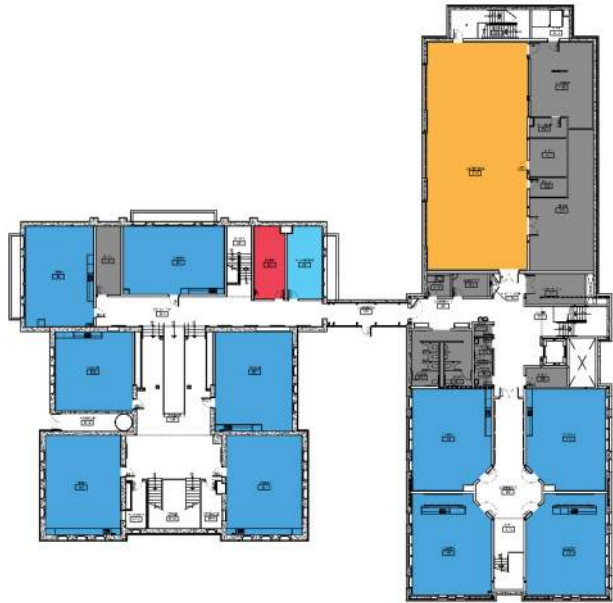
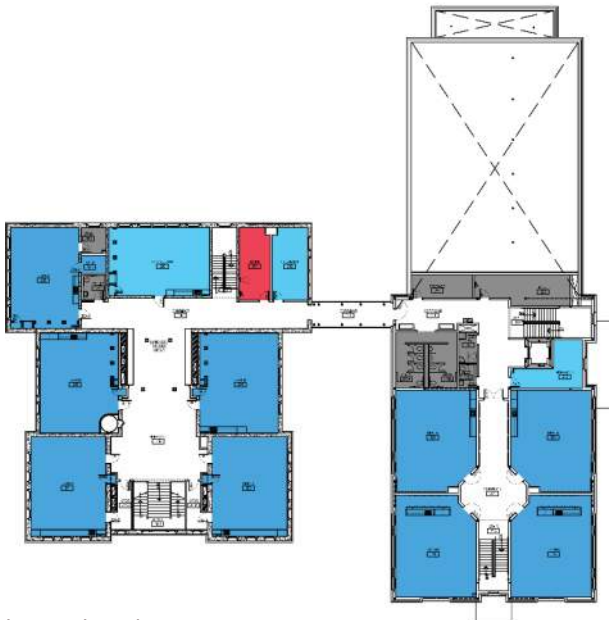
### Existing Program Spaces

Main Level

Upper Level

Lower Level

PLAN LEGEND	
<span style="color: blue;">■</span>	CLASSROOM
<span style="color: lightblue;">■</span>	SPECIAL SERVICES
<span style="color: purple;">■</span>	LIBRARY
<span style="color: red;">■</span>	ADMINISTRATION
<span style="color: gray;">■</span>	MEP/TOILET/KITCHEN
<span style="color: orange;">■</span>	COMMONS/CAFE
<span style="color: brown;">■</span>	GYMNASIUM
<span style="color: green;">■</span>	MUSIC/ART

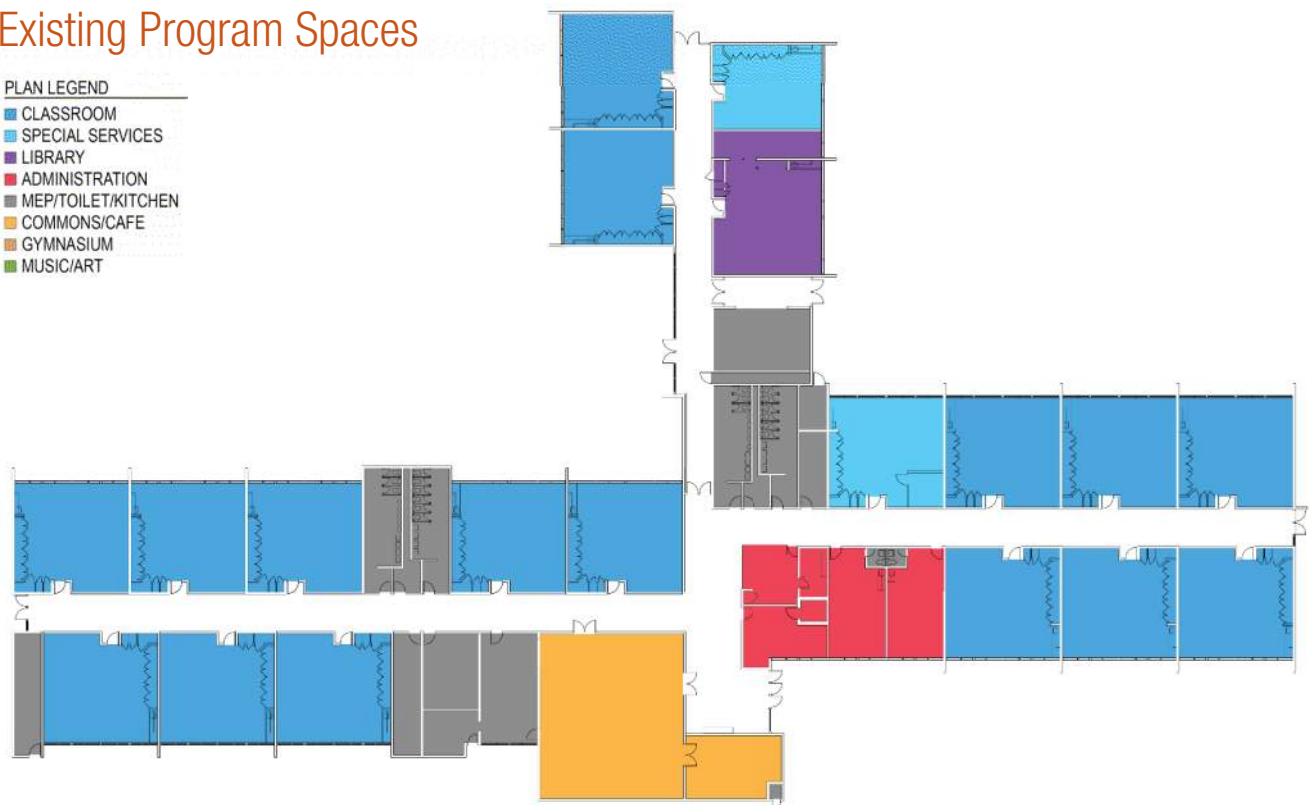
### Existing Program Spaces

PLAN LEGEND	
<span style="color: blue;">■</span>	CLASSROOM
<span style="color: lightblue;">■</span>	SPECIAL SERVICES
<span style="color: purple;">■</span>	LIBRARY
<span style="color: red;">■</span>	ADMINISTRATION
<span style="color: grey;">■</span>	MEP/TOILET/KITCHEN
<span style="color: orange;">■</span>	COMMONS/CAFE
<span style="color: yellow;">■</span>	GYMNASIUM
<span style="color: green;">■</span>	MUSIC/ART

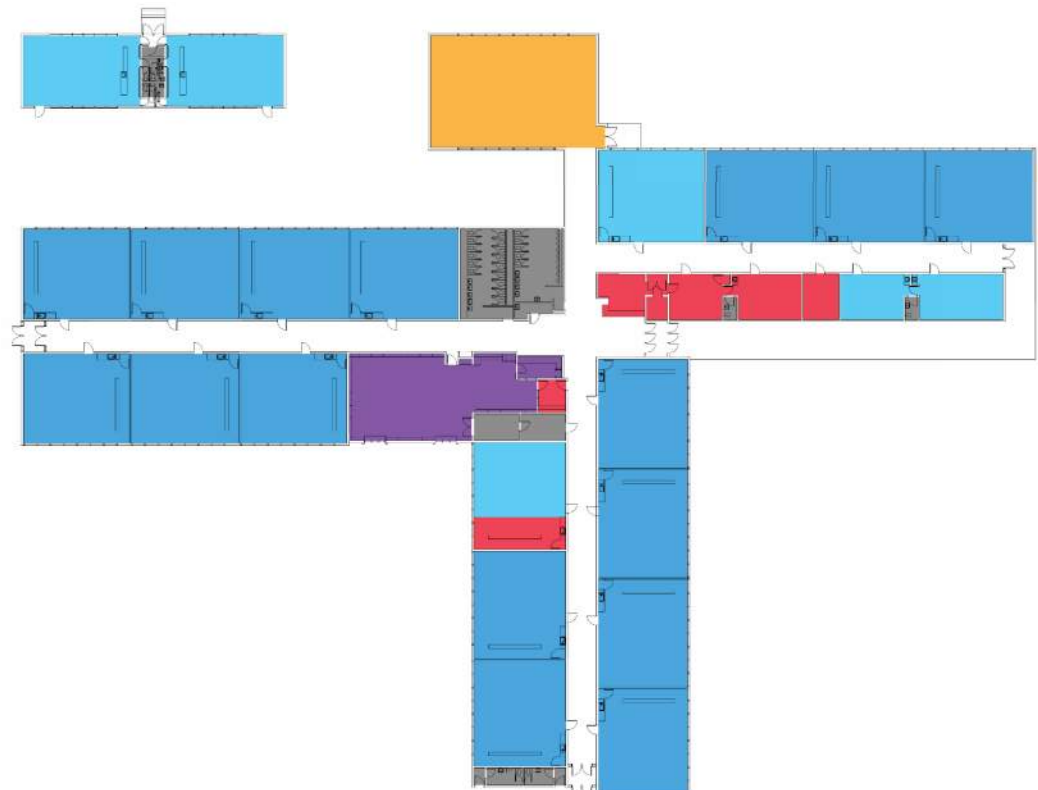
### Existing Program Spaces

- CLASSROOM
- SPECIAL SERVICES
- LIBRARY
- ADMINISTRATION
- MEP/TOILET/KITCHEN
- COMMONS/CAFE
- GYMNASIUM
- MUSIC/ART

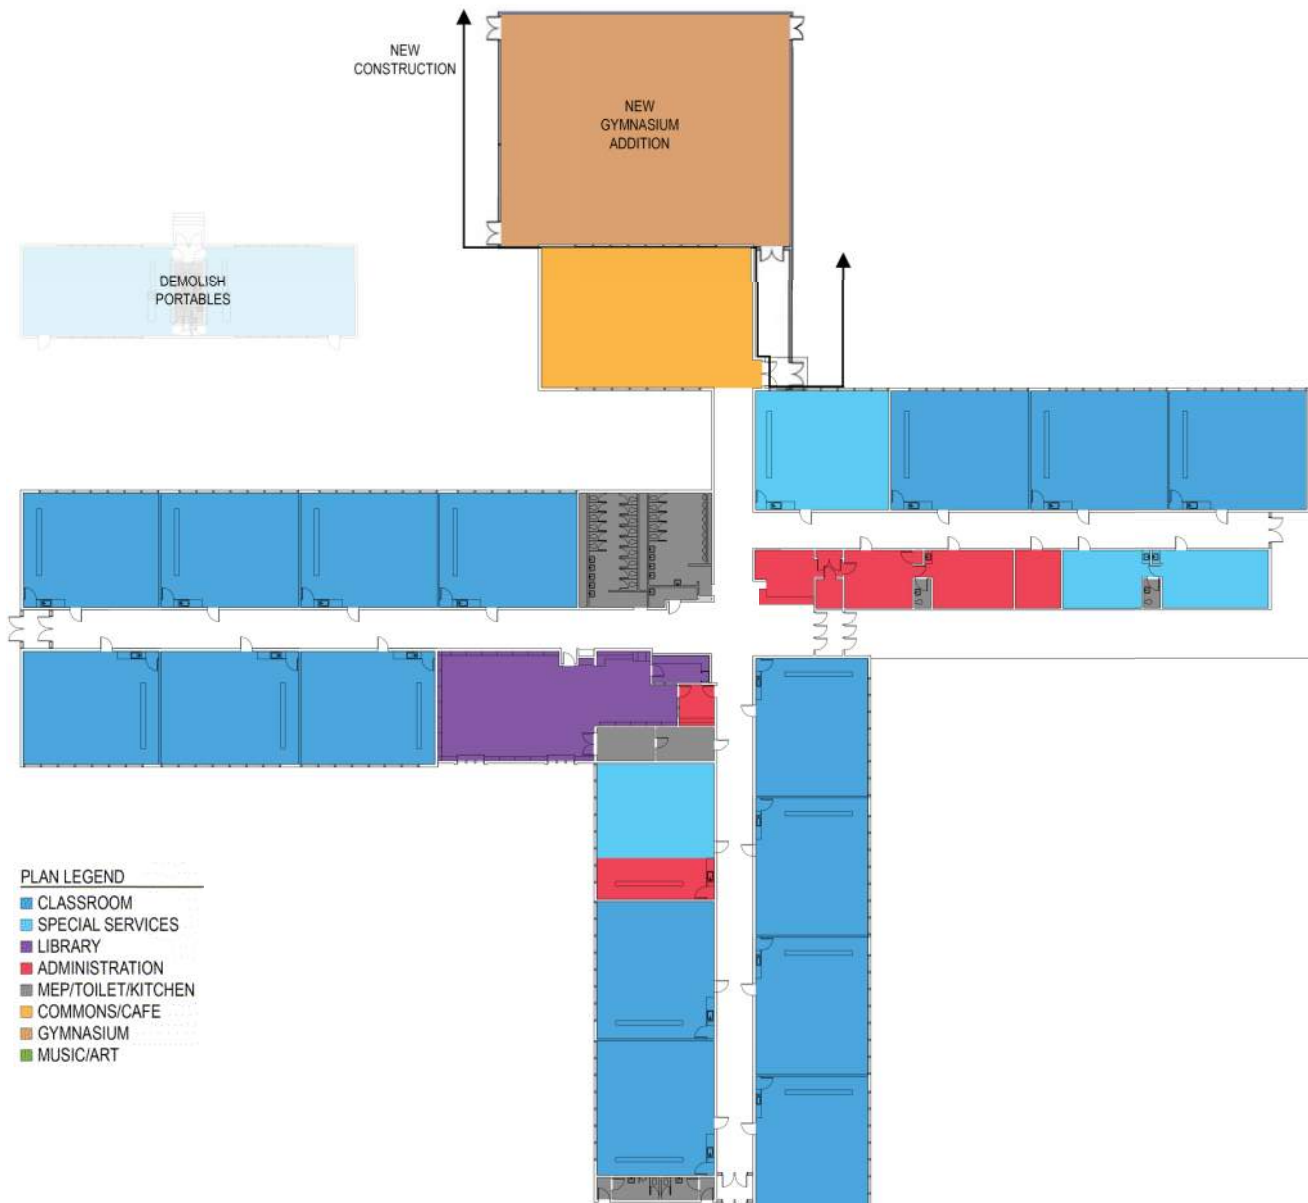
### Potential Floor Plan Diagram

Recommendations From 2013 master plan are being carried over for the 2018 master plan for a multi-purpose room. The district's goal of eliminating portable classrooms are shown below. The recommendations include:

- Repurpose existing gymnasium to Cafeteria.
- Create a multi-purpose room addition and associated restrooms.
- Demolish existing portable classrooms

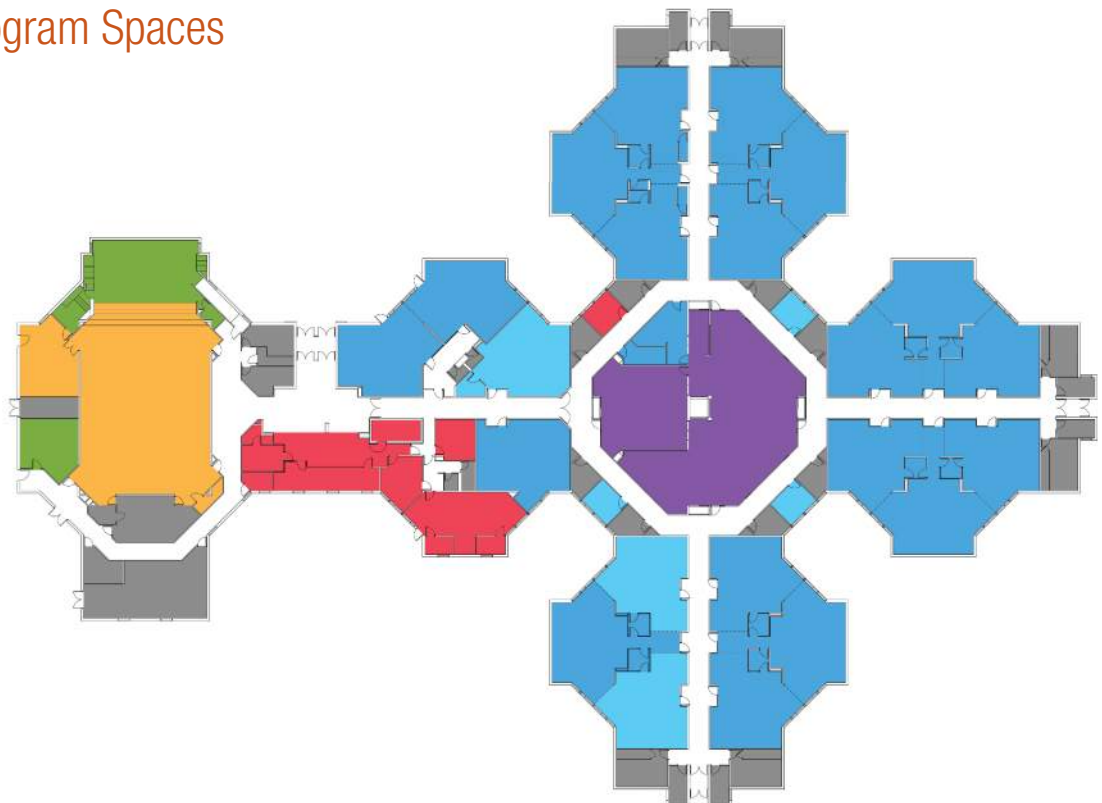
### Existing Program Spaces

PLAN LEGEND	
<span style="color: blue;">■</span>	CLASSROOM
<span style="color: lightblue;">■</span>	SPECIAL SERVICES
<span style="color: purple;">■</span>	LIBRARY
<span style="color: red;">■</span>	ADMINISTRATION
<span style="color: grey;">■</span>	MEP/TOILET/KITCHEN
<span style="color: orange;">■</span>	COMMONS/CAFE
<span style="color: brown;">■</span>	GYMNASIUM
<span style="color: green;">■</span>	MUSIC/ART
