Air Quality Measurements
Woburn Street School
Wilmington, MA
10/06/2020

PREPARED FOR:
Wilmington Public Schools

ENVIROTEST LAB, INC.
639 WASHINGTON STREET
DEDHAM, MA 02026
781-329-1133

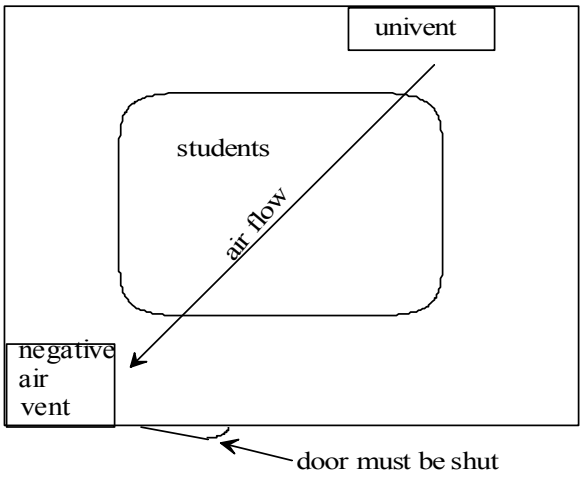
Diagram 1.0

The recommended air current in the classrooms should always follow a path that flows across the occupants of an area (diagram 1.0). A typical problem that arises is when the classroom door is opened (diagram 2.0), this causes the air current in the classroom to pull air in from the hallway instead of through the unit-ventilator fresh air duct. thereby allowing no change of classroom air.
