integrus  
ARCHITECTURE  
and  
a&e  
ARCHITECTS

School District #2  
**Billings Public Schools**  
2018 Facilities Master Plan  
April 2018

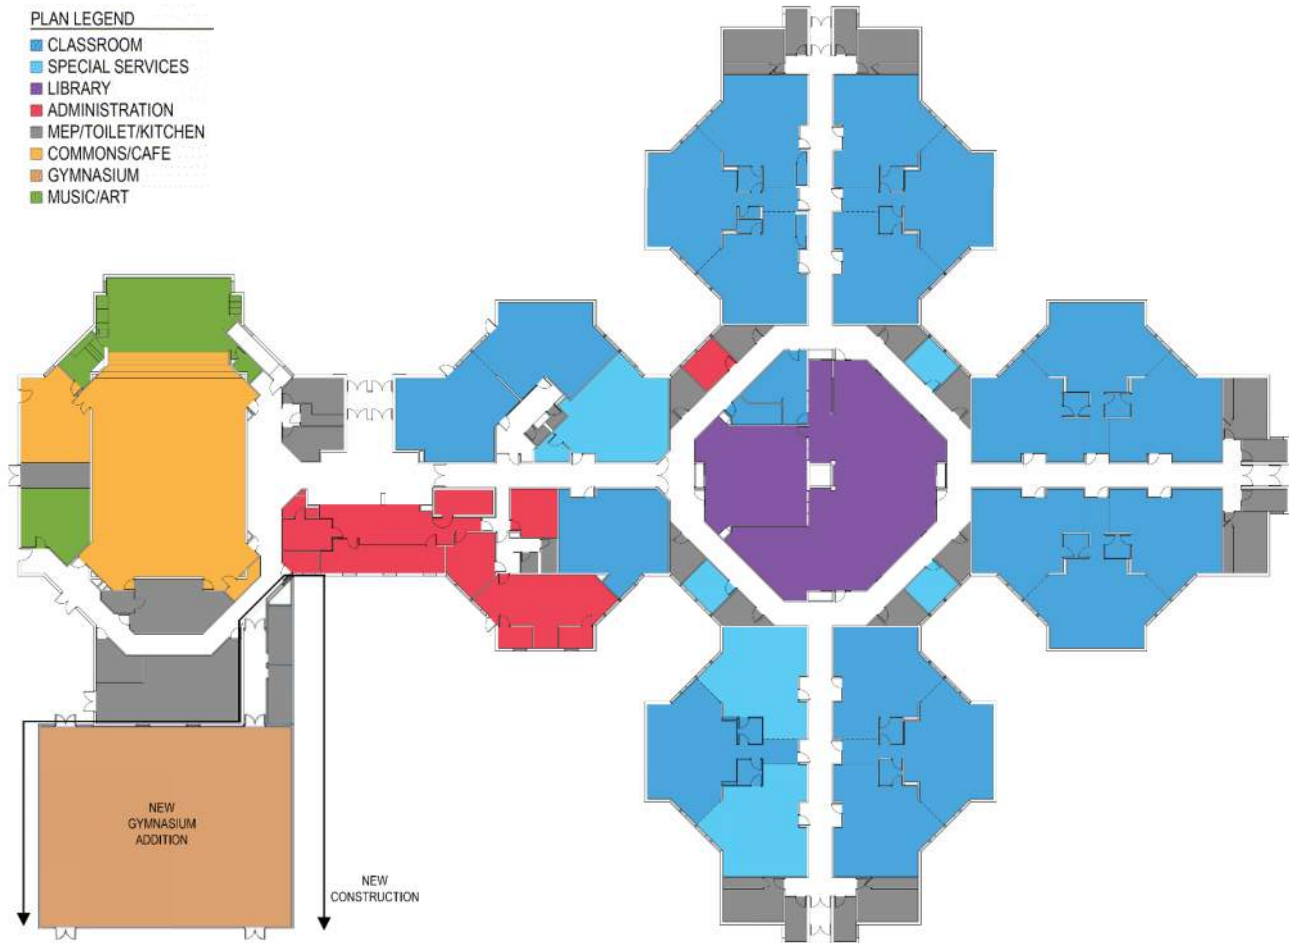
Potential Floor Plan Diagram

Recommendations From 2013 master plan are being carried over for the 2018 master plan. The recommendations include:

- Repurpose existing gymnasium to Cafeteria.
- Create a multi-purpose room addition and associated restrooms.

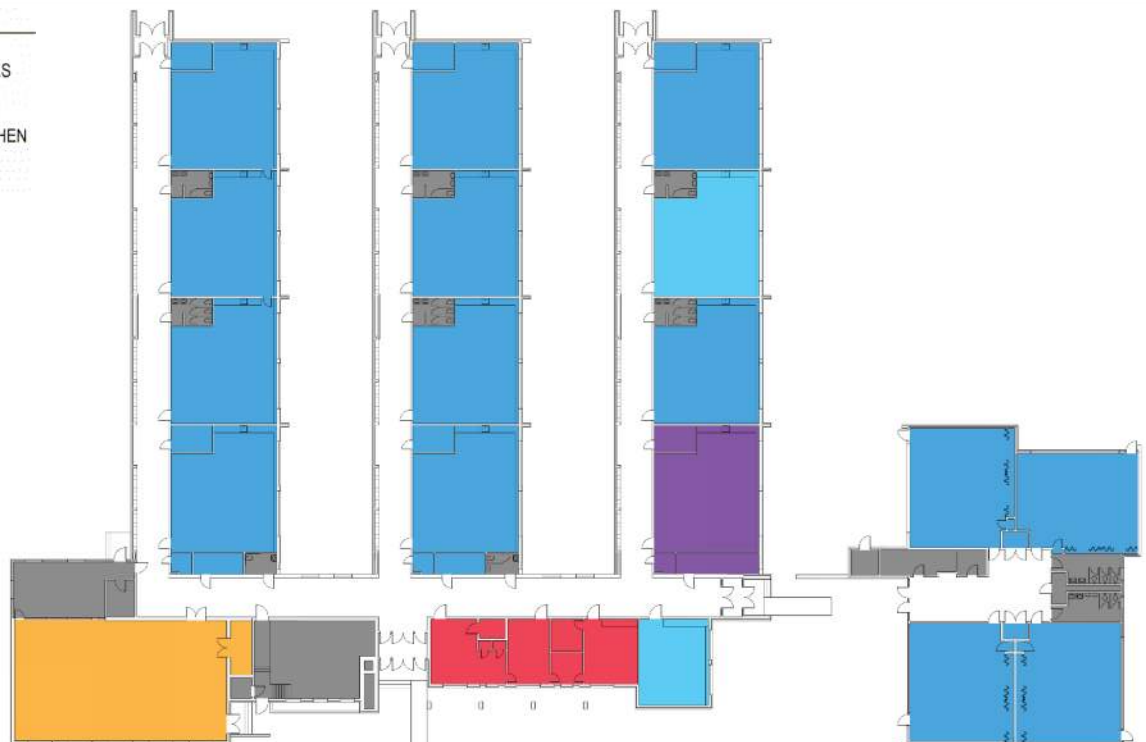
### Existing Program Spaces

CLASSROOM
SPECIAL SERVICES
LIBRARY
ADMINISTRATION
MEP/TOILET/KITCHEN
COMMONS/CAFE
GYMNASIUM
MUSIC/ART

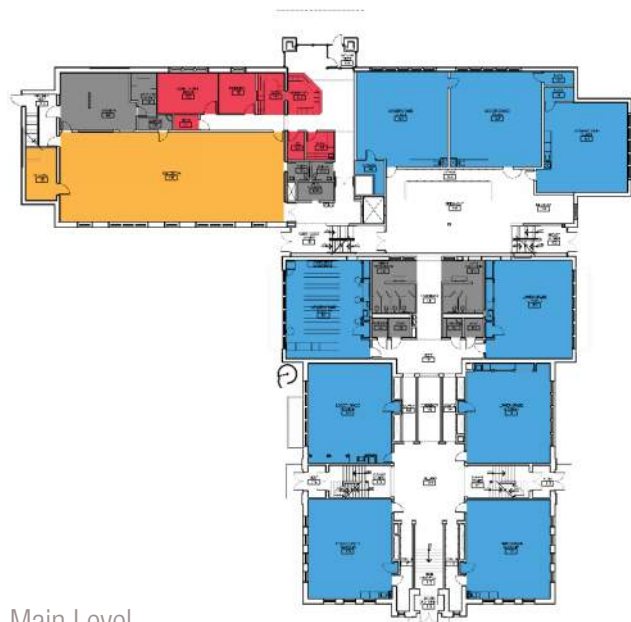
### Existing Program Spaces

Main Level

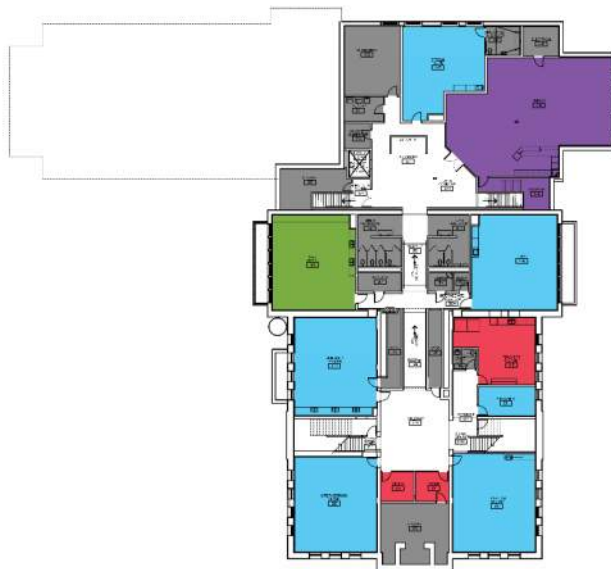
Upper Level

PLAN LEGEND	
<span style="color: blue;">■</span>	CLASSROOM
<span style="color: lightblue;">■</span>	SPECIAL SERVICES
<span style="color: purple;">■</span>	LIBRARY
<span style="color: red;">■</span>	ADMINISTRATION
<span style="color: grey;">■</span>	MEP/TOILET/KITCHEN
<span style="color: orange;">■</span>	COMMONS/CAFE
<span style="color: brown;">■</span>	GYMNASIUM
<span style="color: green;">■</span>	MUSIC/ART

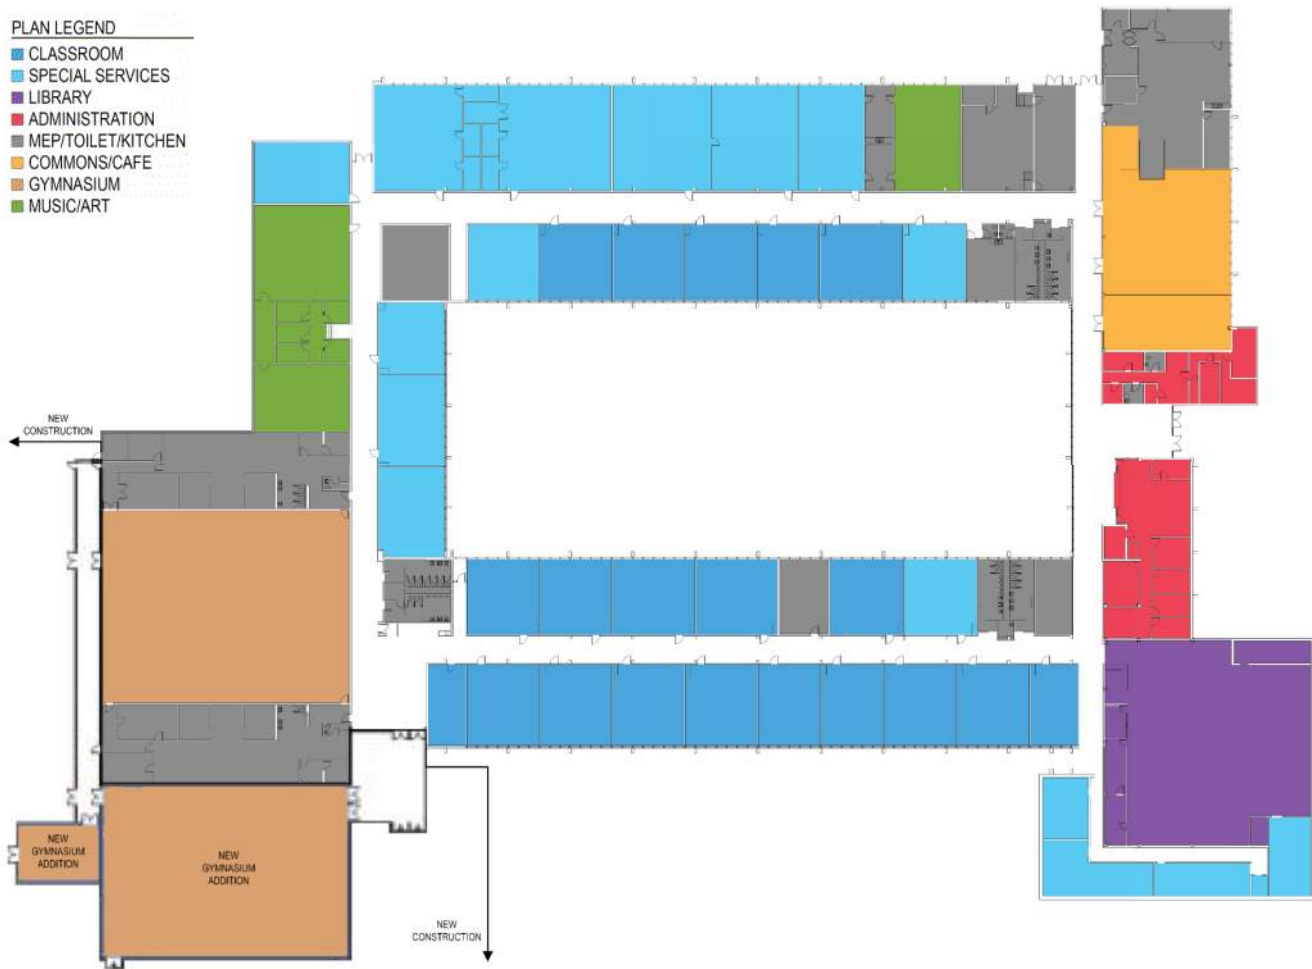
Potential Floor Plan Diagram

Recommendations From 2013 master plan are being carried over for the 2018 master plan. The recommendations include:

- A new Auxiliary Gymnasium addition

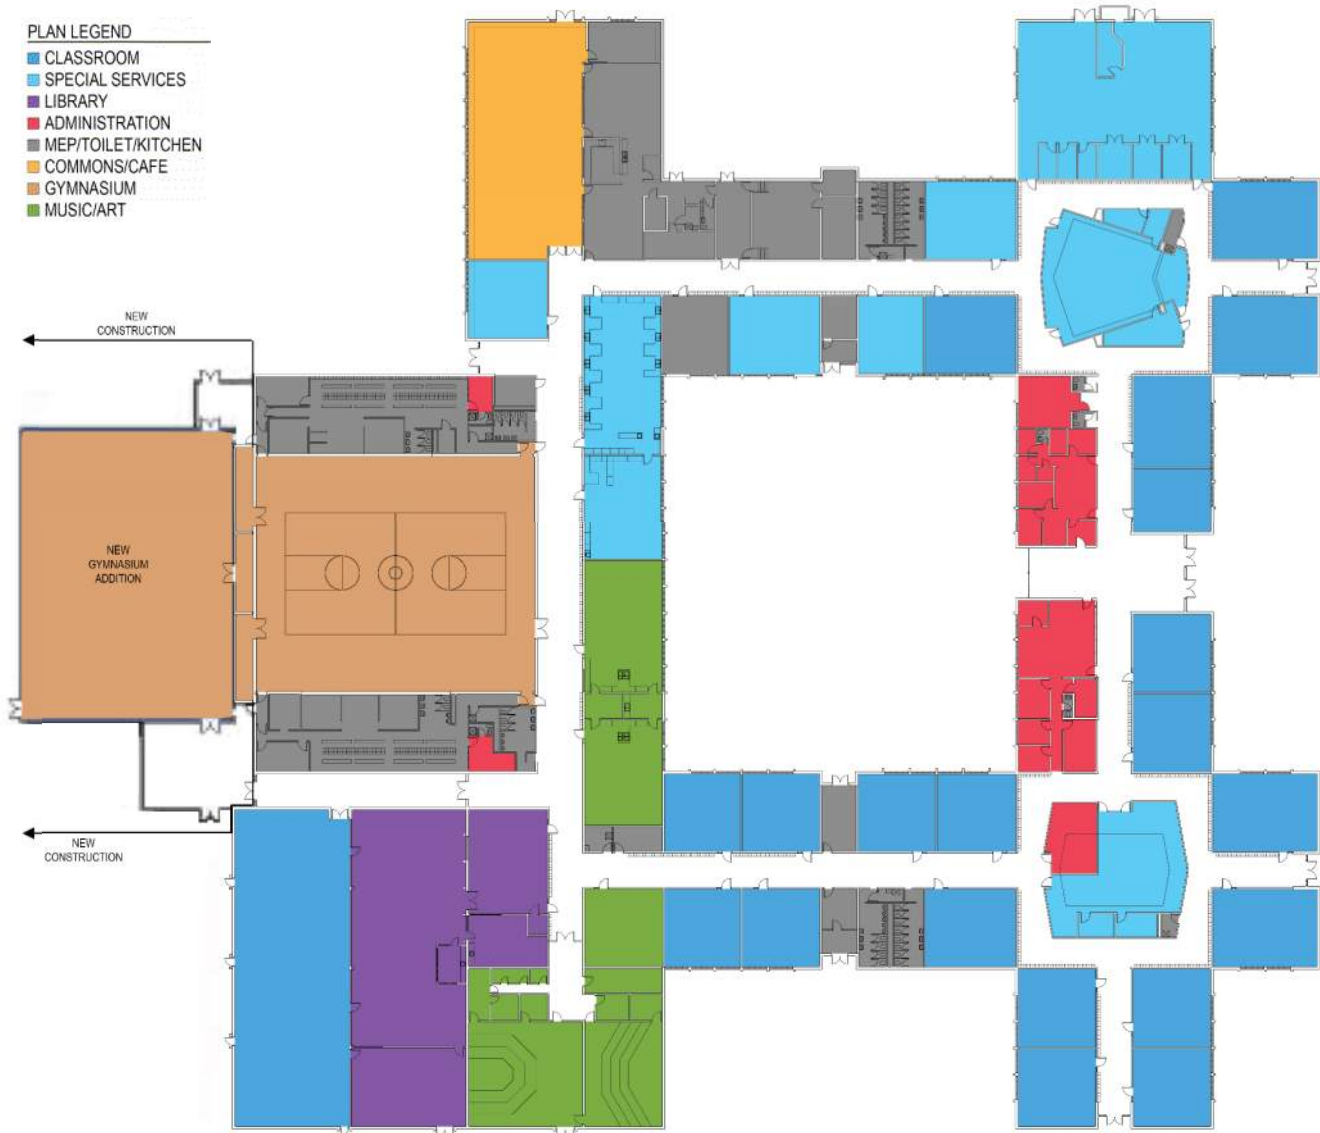
Potential Floor Plan Diagram

Recommendations From 2013 master plan are being carried over for the 2018 master plan. The recommendations include:

- A new Auxiliary Gymnasium addition

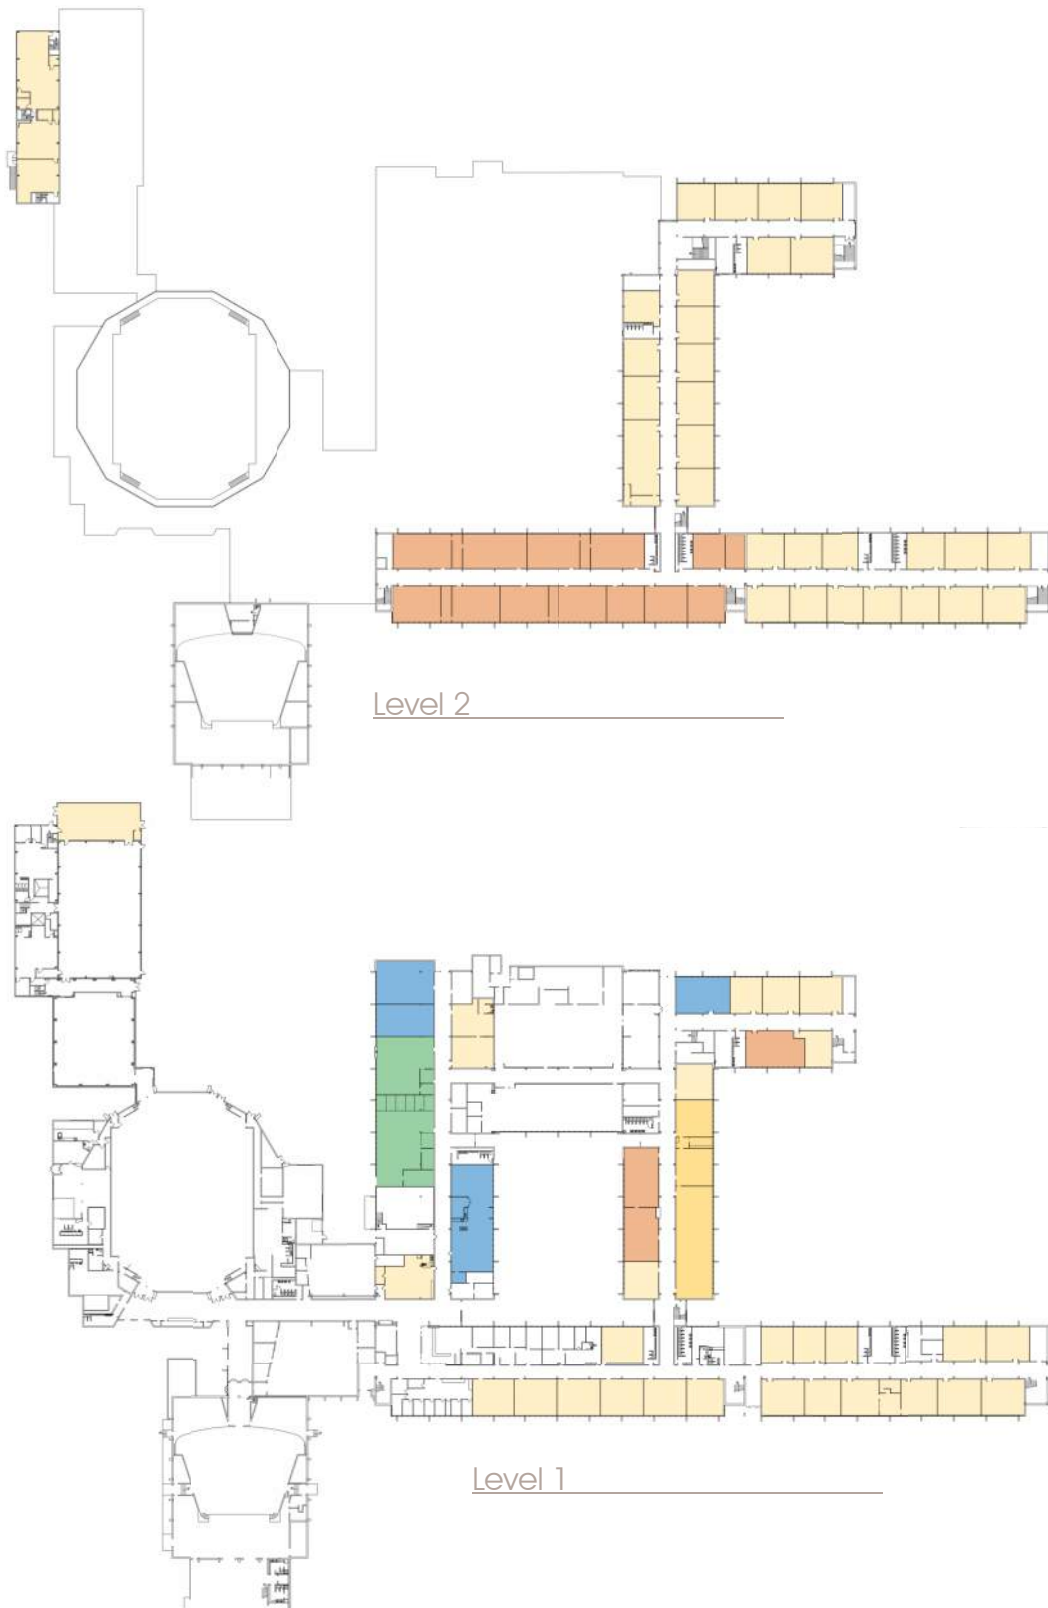
Fabrication Labs

Flexible Labs

General Labs

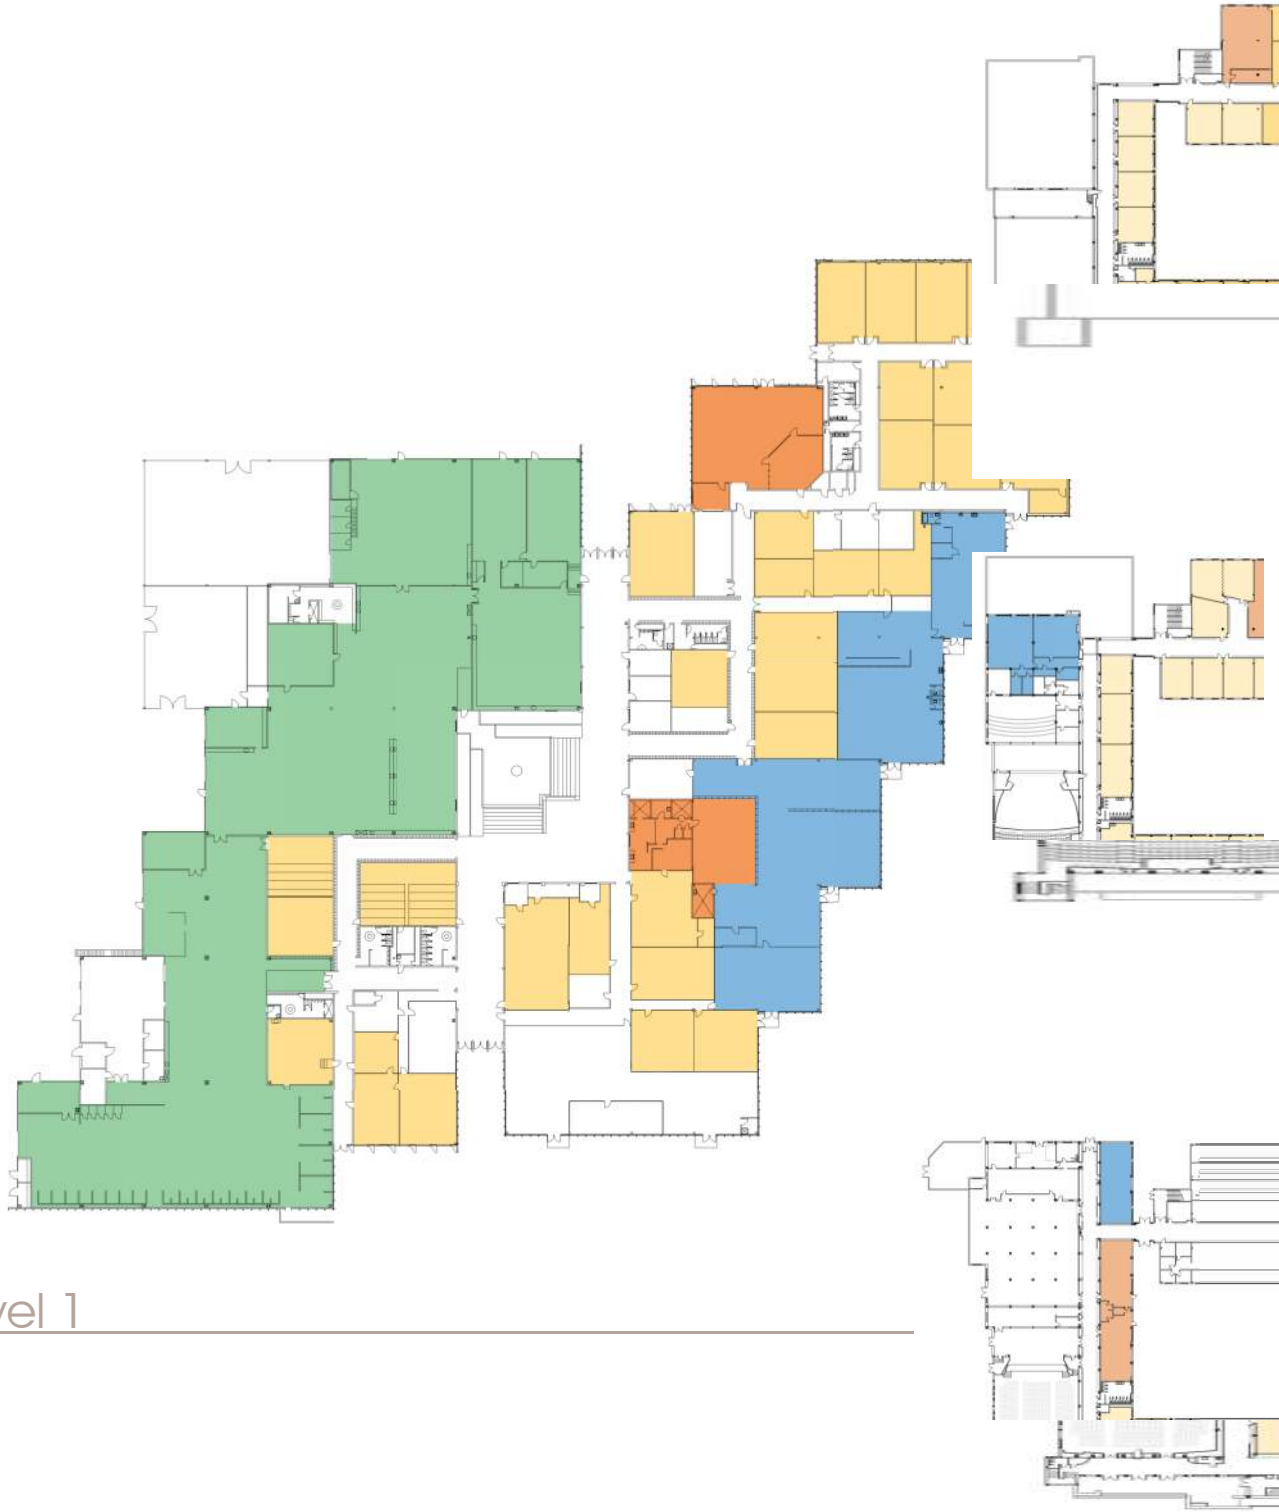
Level 1

Fabrication Labs

Specialized Labs

General Labs

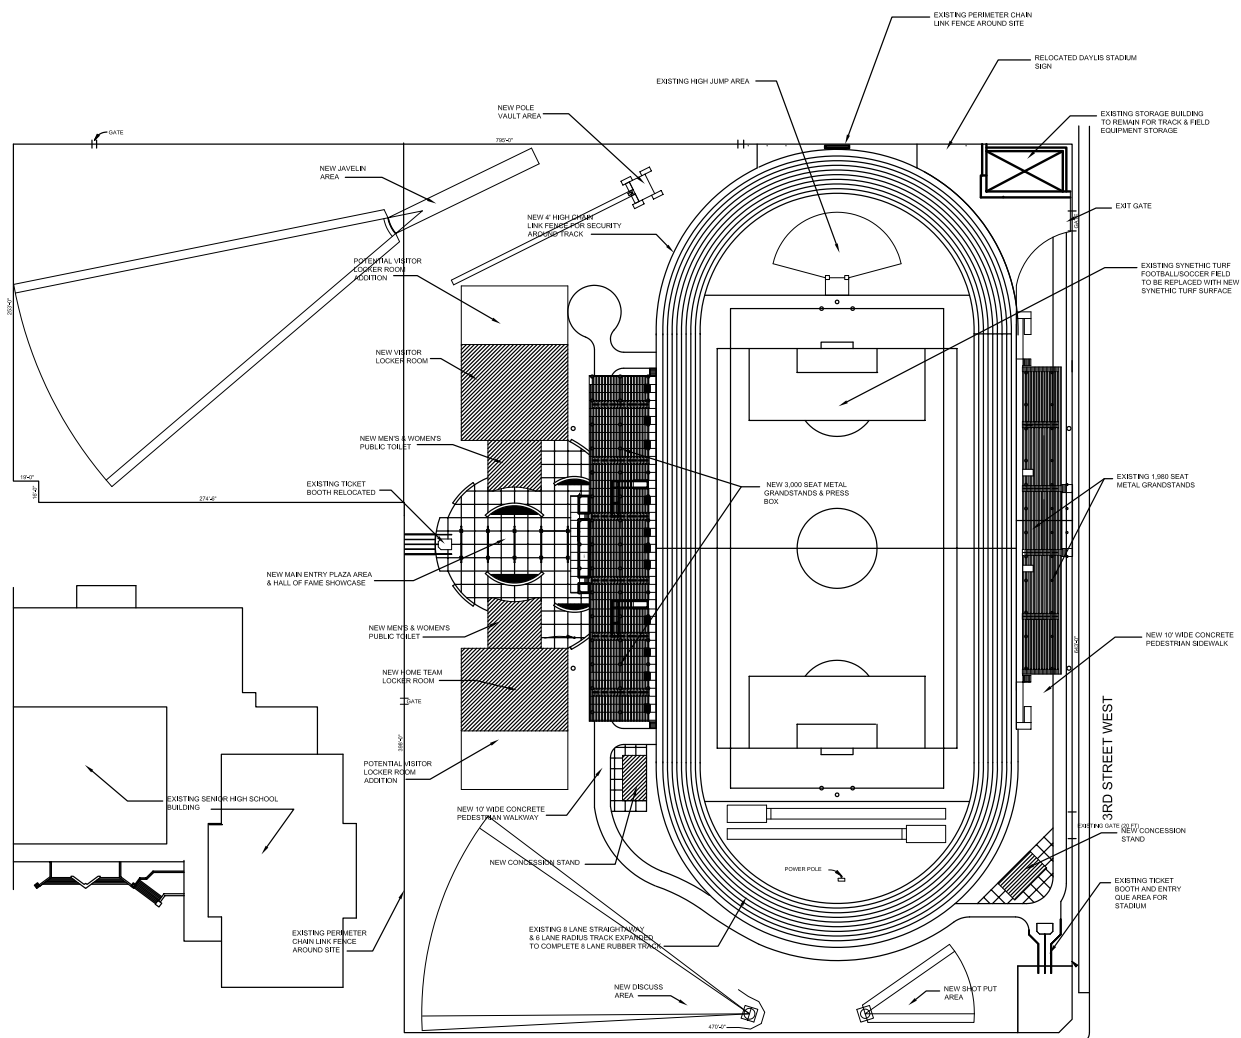
## Daylis Stadium Master Plan

The bleachers and existing grandstand will be demolished and replaced with a new 3,000 seat pre-engineered metal grandstands on the west side of the stadium with a press box. Locker rooms will be constructed for home and visitors and the public restrooms will be capable of serving 5,000 people.

Site Improvements include updates around the track and new support structures for track and football storage. A new 8' high decorative vertical picket perimeter fence will replace the existing chain link fence. Various alternates are included for the locker rooms, lighting, and track. The alternates are captured in the cost summary below.

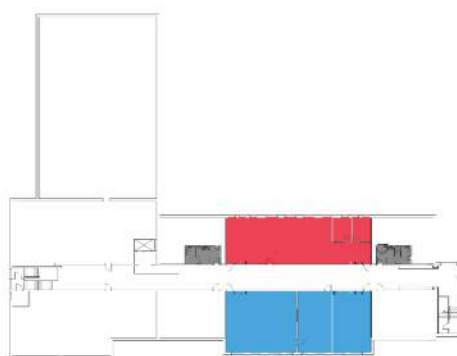
Level 4

- CLASSROOM
- SPECIAL SERVICES
- LIBRARY
- ADMINISTRATION
- MEP/TOILET/KITCHEN
- COMMONS/CAFE
- GYMNASIUM
- MUSIC/ART

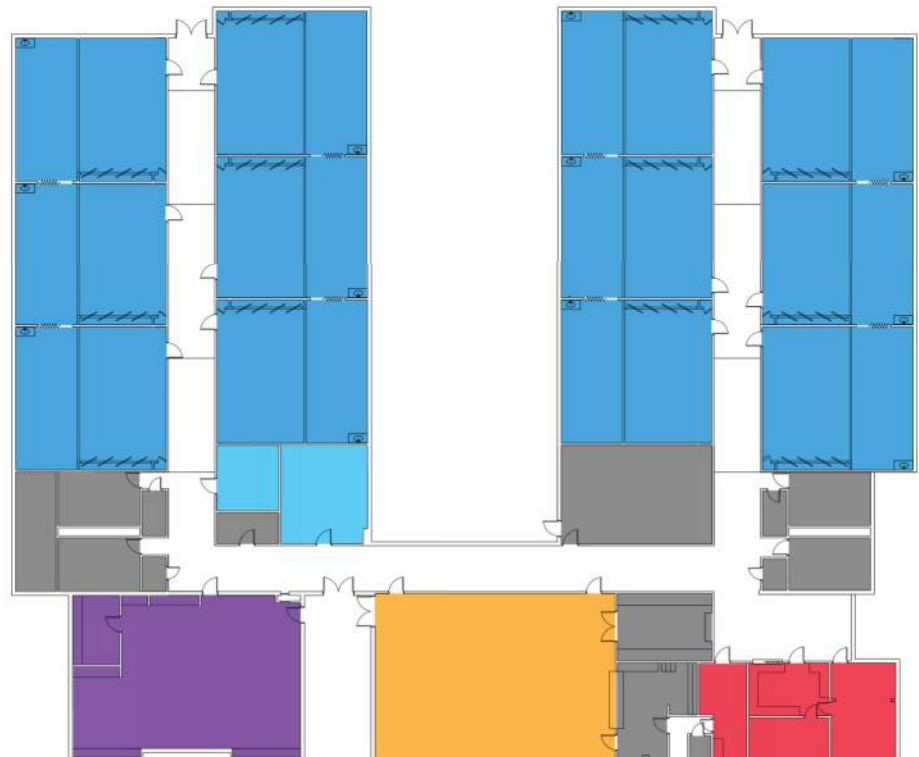
### Existing Program Spaces

CLASSROOM
SPECIAL SERVICES
LIBRARY
ADMINISTRATION
MEP/TOILET/KITCHEN
COMMONS/CAFE
GYMNASIUM
MUSIC/ART
