# HAZARDOUS MATERIALS ASSESSMENT

**REPORT  
FOR  
HAZARDOUS MATERIALS IDENTIFICATION STUDY  
AT  
FALL RIVER HIGH SCHOOL  
FALL RIVER, MA**

PROJECT NUMBER:  
217 041.00

# EXISTING CONDITIONS BMC DURFEE HIGH SCHOOL

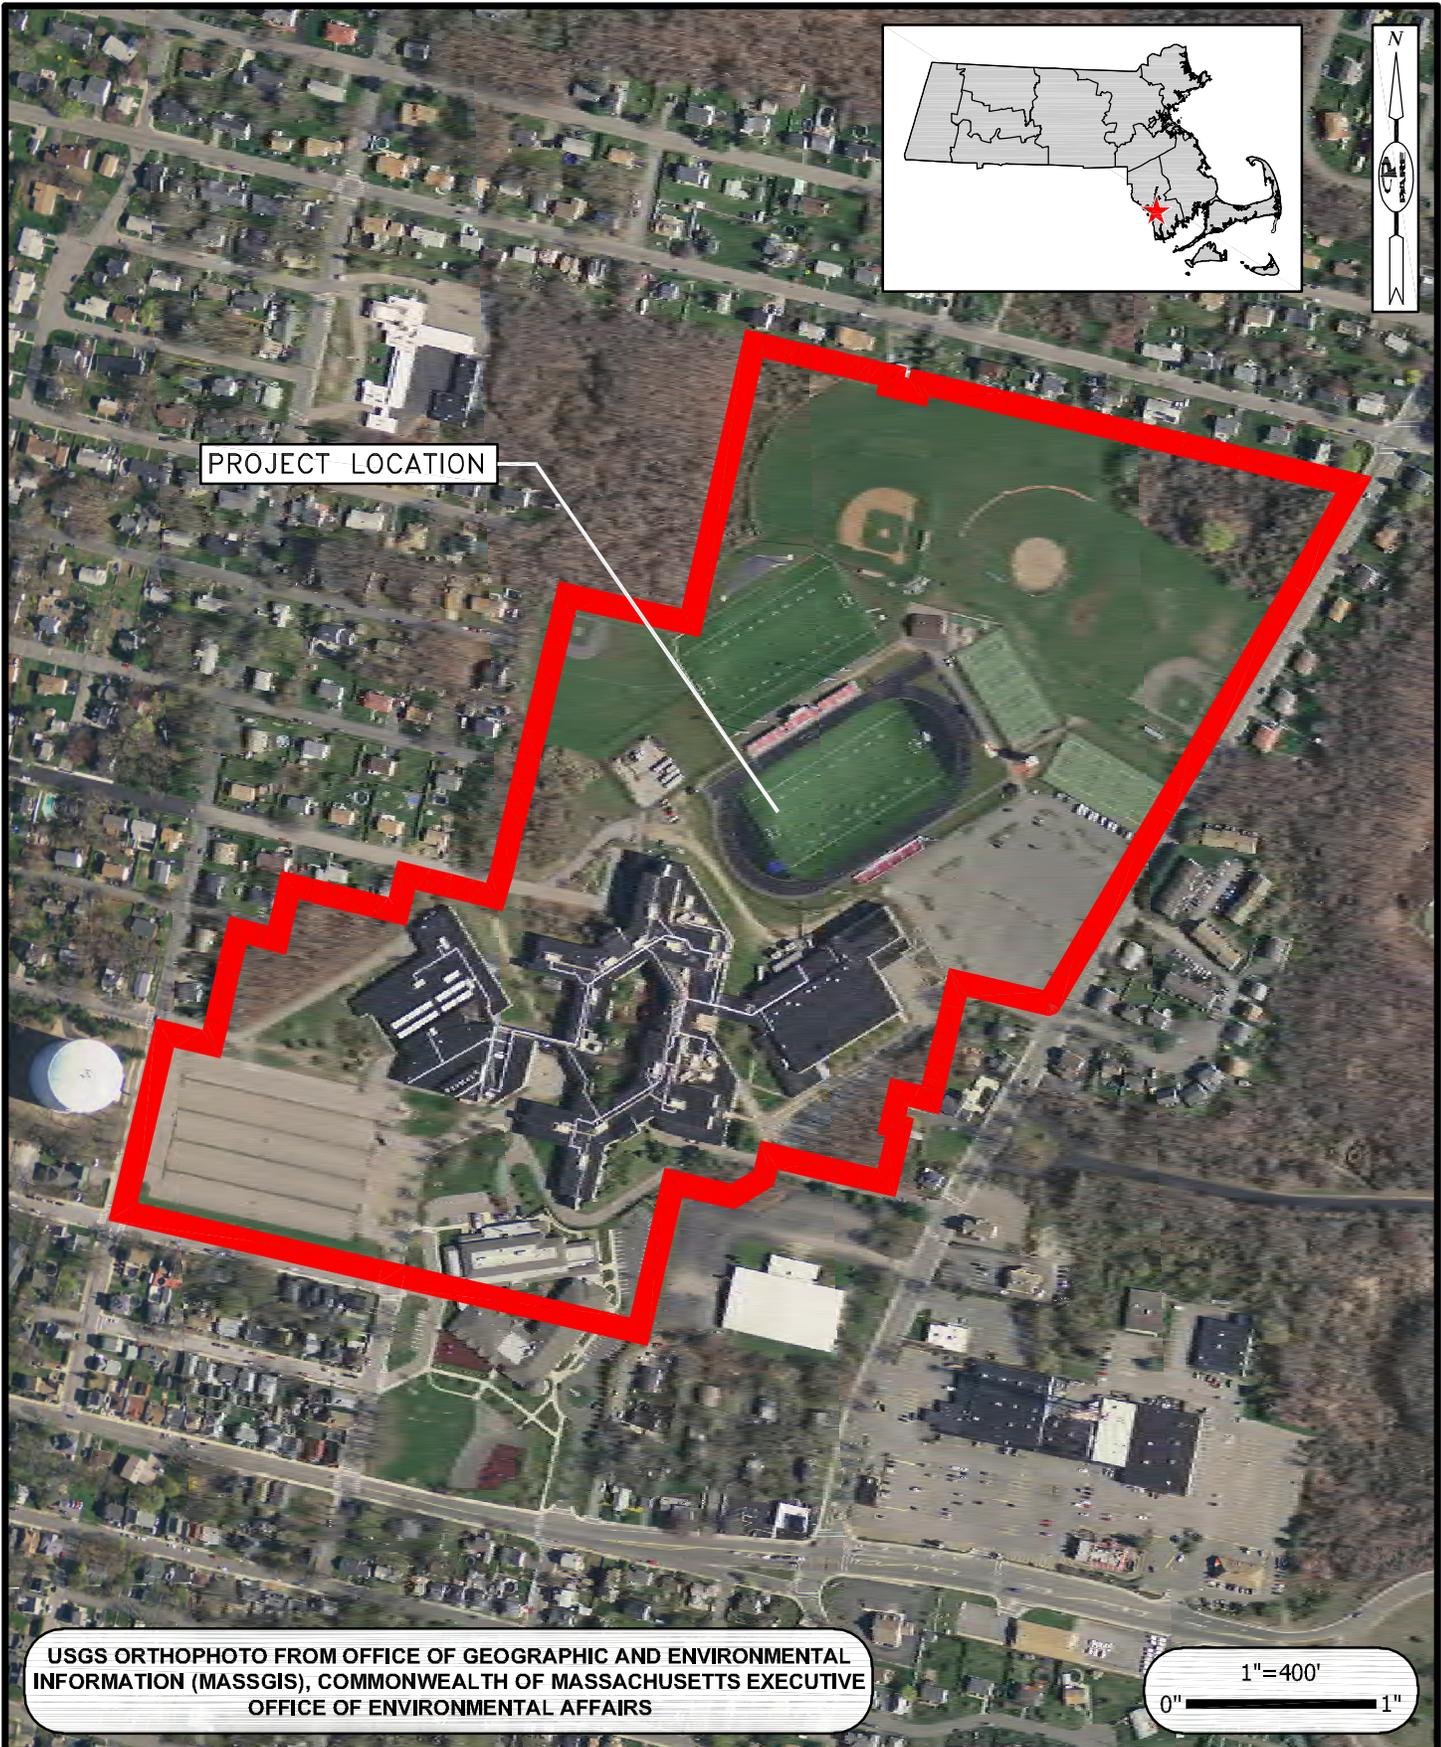
AERIAL PLAN

BMC DURFEE HIGH SCHOOL  
360 ELSBREE STREET  
FALL RIVER, MASSACHUSETTS

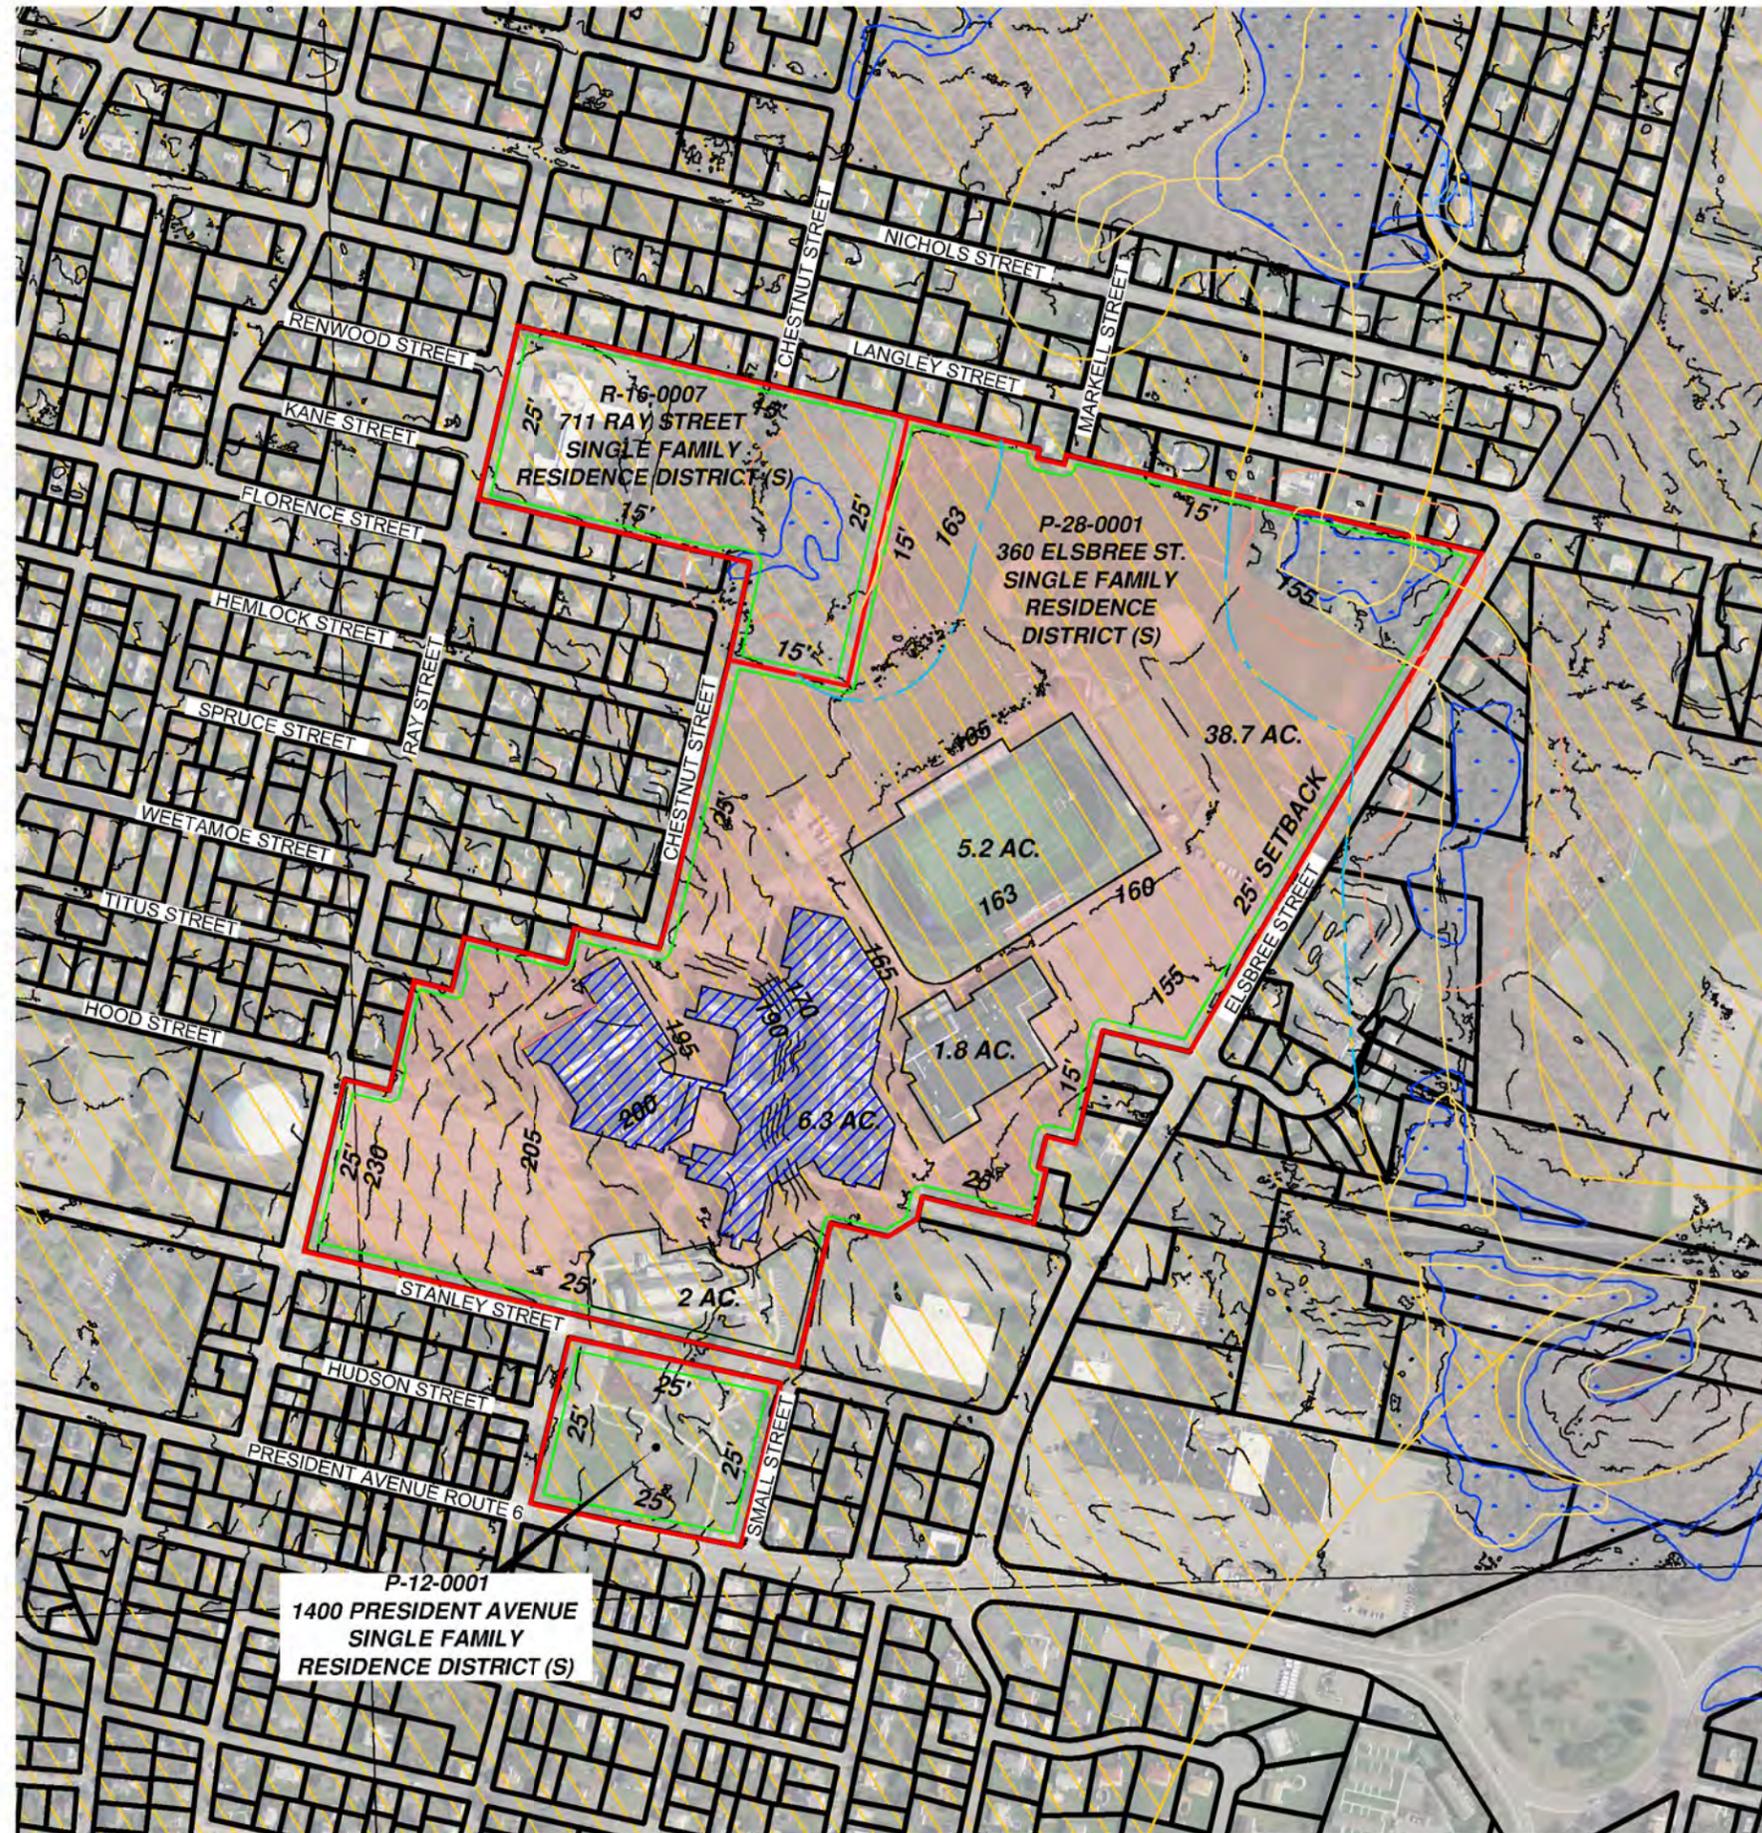
TOTAL AREA OF PROPERTY LIMIT IS 76.91± ACRES  
(INCLUDES P-12-0001, P-28-0001 AND R-16-0007)
