Eanes Independent School District

# Facility Condition Assessment

**FINAL REPORT:** June 5, 2013

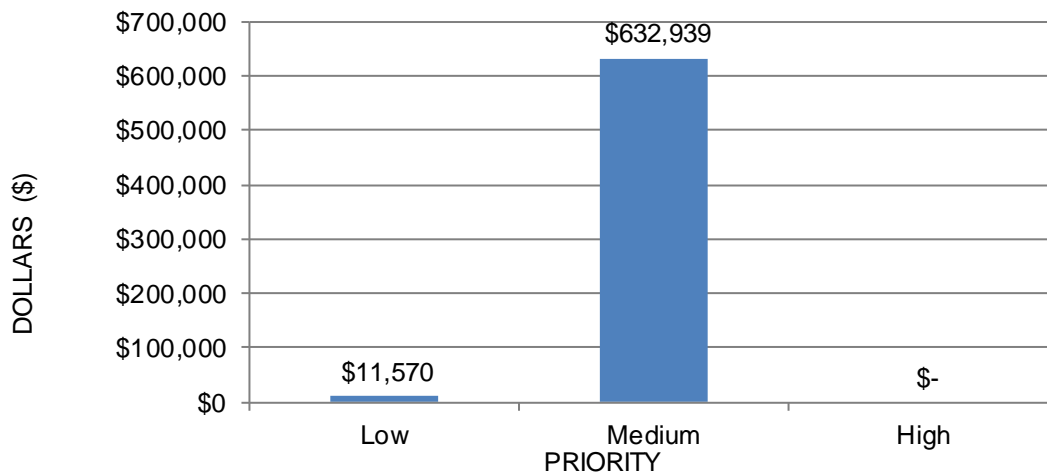
**Figure 13.** Current (2013) Needs By Priority – Barton Creek Elementary School

PlanningDirect allows the grouping of needs by their level of urgency. In order to group needs, a priority of High, Medium or Low is assigned. The figure below shows the facilities needs grouped by priority on a current (2013), 5 year (2018) and 10-year forecast (2023).

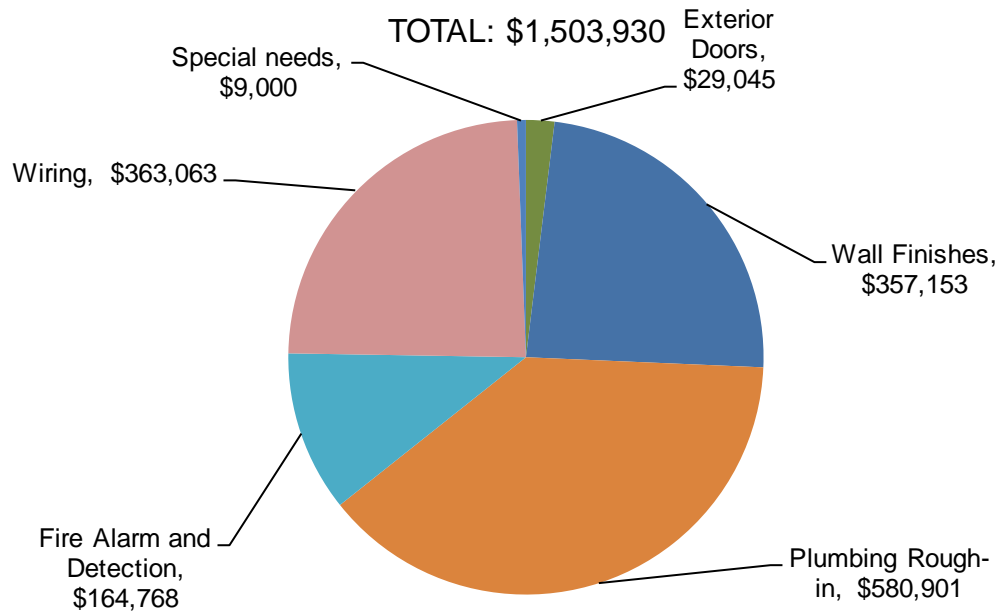
**Figure 24.** Current Needs (2013) – Cedar Creek Elementary School

A summary of the physical condition assessment findings at Cedar Creek Elementary School is shown below. The figures depict the distribution of systems currently beyond useful service life and systems that are expected to be beyond useful service life by the year 2018 and 2023, respectively.

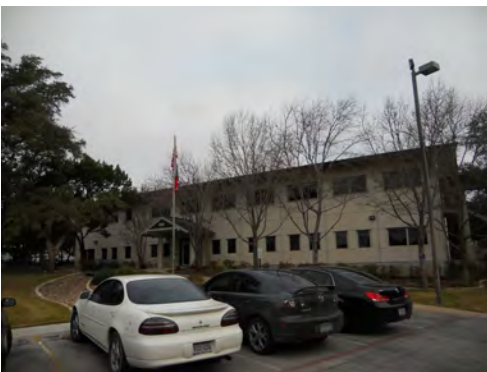
Date of construction	1989	
Type of Construction	Concrete	
Roof	Standing Seam Metal	
Ceilings	Acoustical Ceiling Tiles	
Lighting	Fluorescent Light Fixtures	
Additions/ Renovations	None	
HVAC	Split DX

The Administration Building was a concrete structure. The exterior finish is in good condition; however, there is some staining under an awning that needs to be power washed. Exterior stairwell rails and awning need to be repainted. Windows appear to be original, but in good condition. Windows are single paned, creating an energy saving opportunity when time to replace. Exterior doors appear to be original, but in good condition.

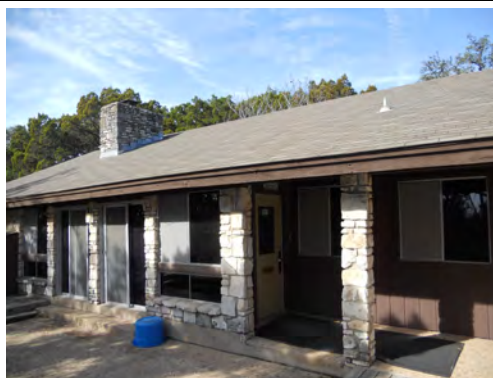
Date of construction	1960		
Type of Construction	Residential structure with masonry exterior veneer.		
Roof	Composition Shingles		
Ceilings	Gypsum panels with textured finish		
Lighting	Florescent, 2 and 4 bulb fixtures		
Additions/ Renovations	None		
HVAC	Two Split DX Systems

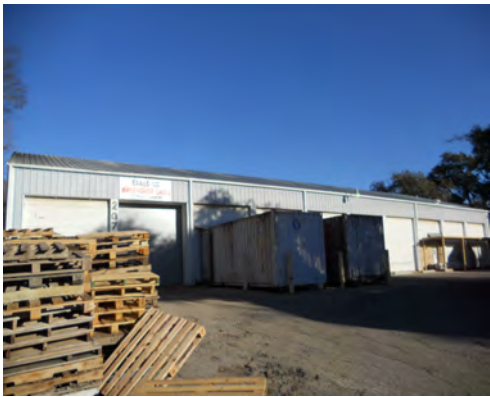
Size (SF)	6350	
Date of construction	1982	
Type of Construction	Prefabricated Metal Building	
Roof	R Panels	
Ceilings	Acoustical Metal Grid	
Lighting	HID fixed fixtures	
Additions/ Renovations	None	
HVAC	Pad Mounted RTU
