POLICE STATION

Address	911 Mountain Road
Building Area/Site	8,955 sf / 2.69 acres
Age/Construction	1988 (33)

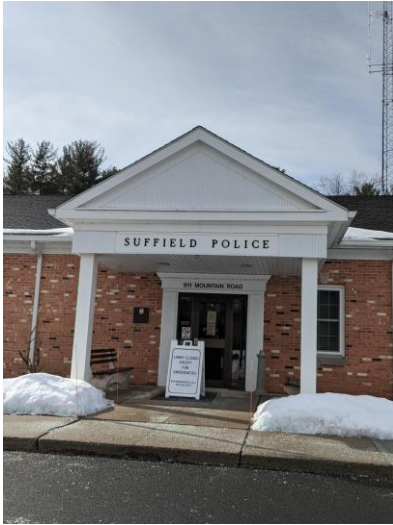
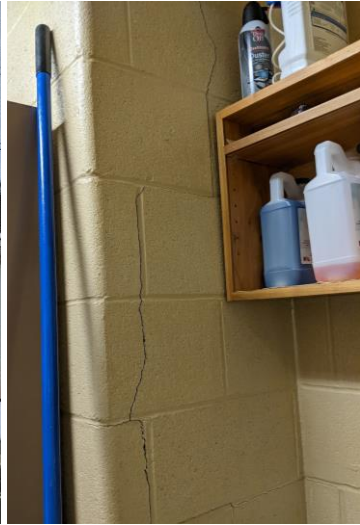
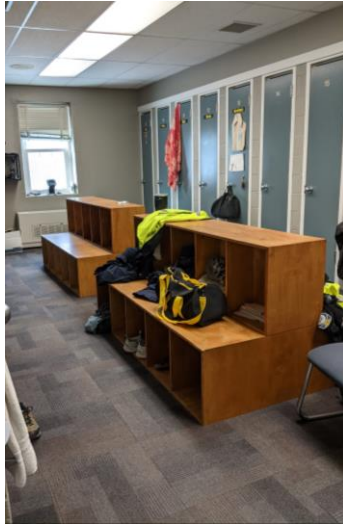
- Minor cracking at sidewalk control joints.
- Rust present at downspout boots.
- New paving and fence.
- Recommend preventative maintenance program to extend useful life.

- In good condition relative to its age well maintained and built.
- Minor snow build up and possible damming at roof valleys.
- Exterior materials have been well maintained.
- Snow melt on roof uneven due to super heating of garage spaces.

- Drywall cracking present at window lintels
- Discoloration of ceiling tiles due to age.
- Relatively minor cracking at multiple interior CMU walls, non structural issue.
