Tecton
ARCHITECTS

FIRST FLOOR PLAN

Existing Conditions Summary...

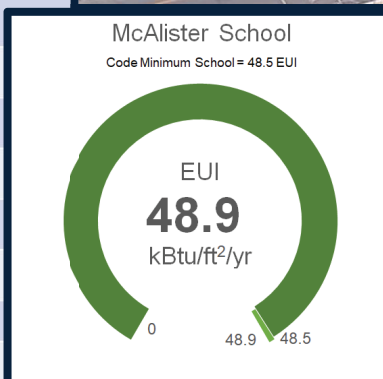
Energy Efficiency
EUI = Energy Use Intensity

**The higher the number, the less
efficient the building.**
**A code baseline EUI is 48.5,
but the lower the better!**
