**SOLICITATION ADDENDUM NO. 2**  
**ITB 21-0006**  
**Mountainside High School Field Turf Remediation**

Carlson Geotechnical (CGT), a division of Carlson Testing, Inc. (CTI), is pleased to submit this geotechnical data report for the Mountainside High School Softball Field. The site is located at 12500 SW 175th Avenue in Beaverton, Oregon. The site is located at 12500 SW 175th Avenue in Beaverton, Oregon, as shown on the attached Site Location, Figure 1. This report was prepared in general accordance with Task 2 outlined in CGT Proposal GP8701, dated October 19, 2019. Written authorization for our services was received on October 24, 2019. A draft version of this report was submitted to BSD on December 16, 2019.

**MOUNTAINSIDE HIGH SCHOOL SOFTBALL FIELD - BEAVERTON, OREGON**  
**Project Number G1905187.A**

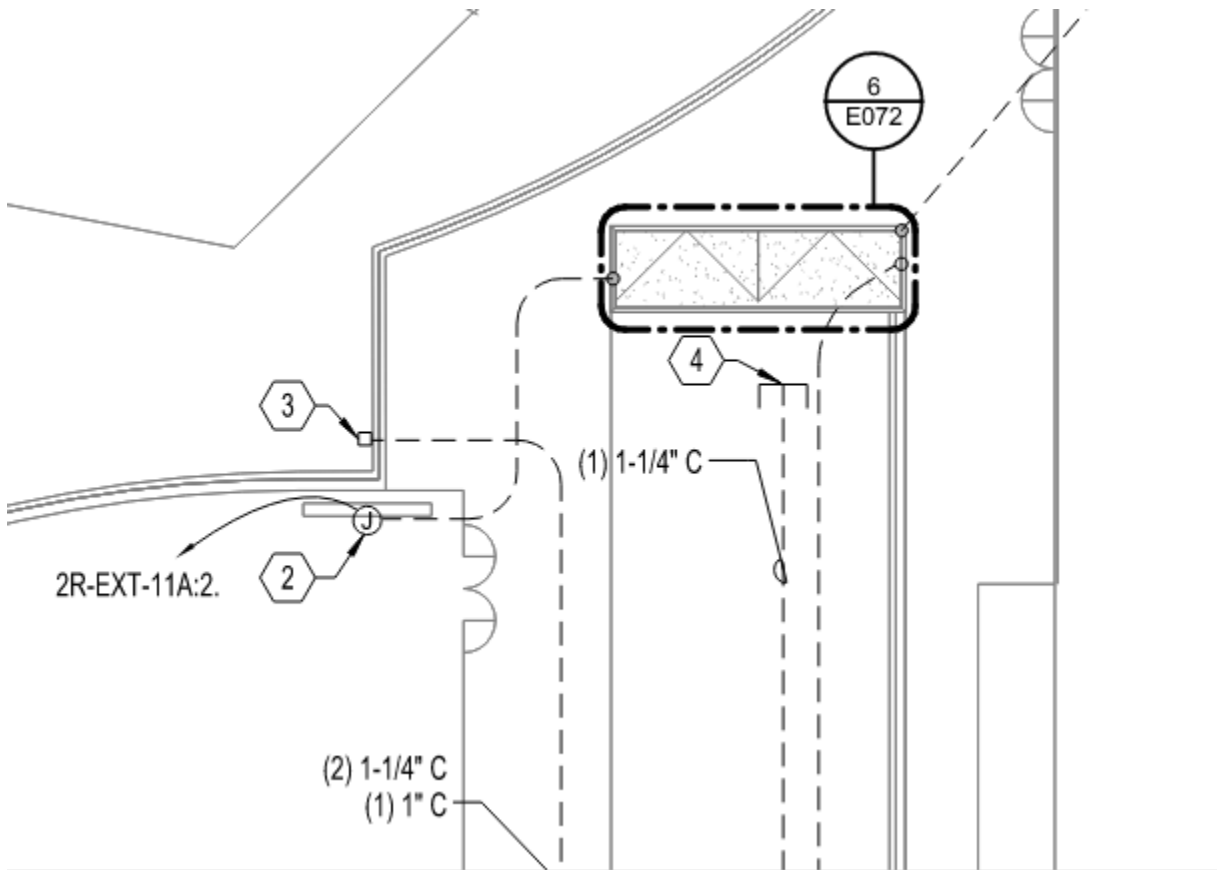
ANSWER: **No, utilities are known to be running across the trenches with the exception of the scoreboard that may be in the vicinity of the work. The electrical conduits to the scoreboard run from the east storage building under the slab to the scoreboard.**

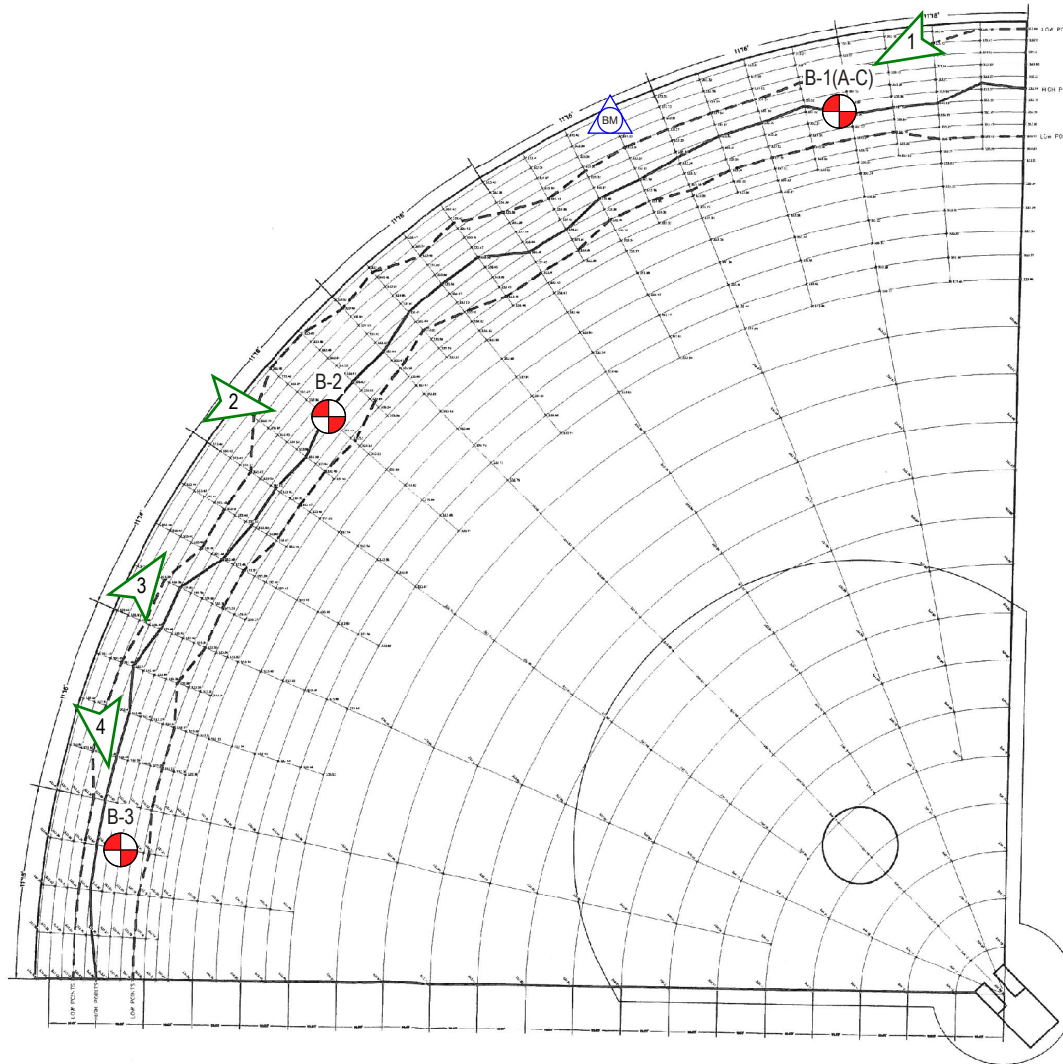
**FIGURE 2**  
**Site Plan**

Our subsurface investigation consisted of five drilled borings (B-1A, B-1B, B-1C, B-2, and B-3) completed on November 18, 2019. The approximate exploration locations are shown on the Site Plan, attached as Figure 2. In summary, the borings were advanced to depths ranging from about 6½ to 8½ feet bgs. Details regarding the subsurface investigation and logs of the explorations are presented in Appendix A. Subsurface conditions encountered during our investigation are summarized below.

The site consists of the Mountainside High School softball field located in the northwest area of the school grounds. The site was bordered by an MSE retaining wall to the north and west, and additional sports fields to the east and south. Outside of the affected (heaved) area of the softball field, the field was generally level to very gently descending to the northwest. Site layout and surface conditions at the time of our field investigation are shown on the attached Site Plan (Figure 2) and Site Photographs (Figure 3).

Our field investigation consisted of five drilled borings completed in November 2019. The exploration locations are shown on the Site Plan, attached to the geotechnical report as Figure 2. The exploration locations shown therein were determined based on measurements from existing site features (outfield fence, scoreboard, etc.) and are approximate. Surface elevations indicated on the logs were estimated based on a temporary benchmark (assumed 100-foot elevation at the top of the nearby retaining wall) shown on the referenced Site Plan and are approximate. The attached figures detail the exploration methods (Figure A1), soil classification criteria (Figure A2), and present detailed logs of the explorations (Figures A3 through A7), as discussed below.

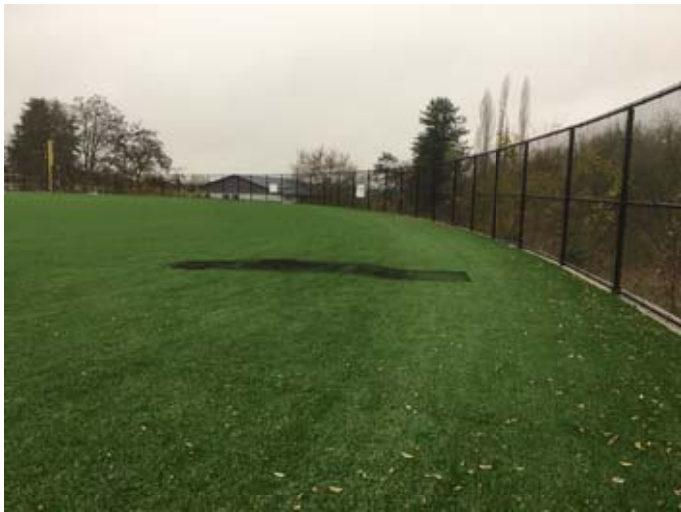
Photograph 1

See Figure 2 for approximate photograph locations and directions. Photographs were taken at the time of our fieldwork.

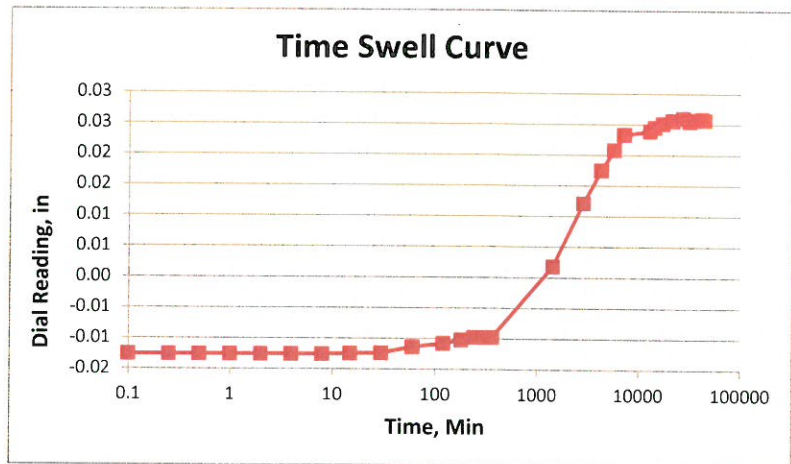
Initial Specimen Height, h:	0.992 in.
Vertical Stress Value	520 psf
Height after Dry Loading, h1:	0.9796 in.
Final Specimen Height, h2:	1.0179 in.
Initial Moisture Content:	110 %
Final Moisture Content:	122 %
Swell strain, $\epsilon_s$	4 %

Following Specimen Inundation	
Time Elapsed (min.)	Reading (in.)
0.1	-0.0126
0.25	-0.0126
0.5	-0.0126
1	-0.0126
2	-0.0126
4	-0.0126
8	-0.0126
15	-0.0125
30	-0.0124
60	-0.0114
120	-0.0108
180	-0.0102
240	-0.0098
1440	0.0018
2880	0.0121
4320	0.0175
5760	0.0208
7200	0.0233
12960	0.0239
14400	0.0245
17280	0.0251
21600	0.0256
27360	0.026
31680	0.0255
36000	0.0257
41760	0.0258
44640	0.0257

Laboratory testing was performed on representative samples collected in the field to provide a measure of the in-situ moisture and swell potential of the subsurface materials, notably the buried bentonite fill described above. Laboratory testing included nine moisture content determinations (ASTM D2216), and three one-dimensional swell tests (ASTM D4546, Method "B"). Results of the moisture content tests are shown on the exploration logs presented in the attached Appendix A. Graphical plots of the swell tests are presented in the attached Appendix B. The swell tests were conducted utilizing a vertical stress equal to 520 pounds per square foot (psf); this value was selected to approximate the in-situ vertical stress experienced by the bentonite layer at the project site due to overlying earthen materials.
