# Town of Vernon Connecticut

## Stormwater Management Plan

### 2020 Annual Report

November 02, 2021

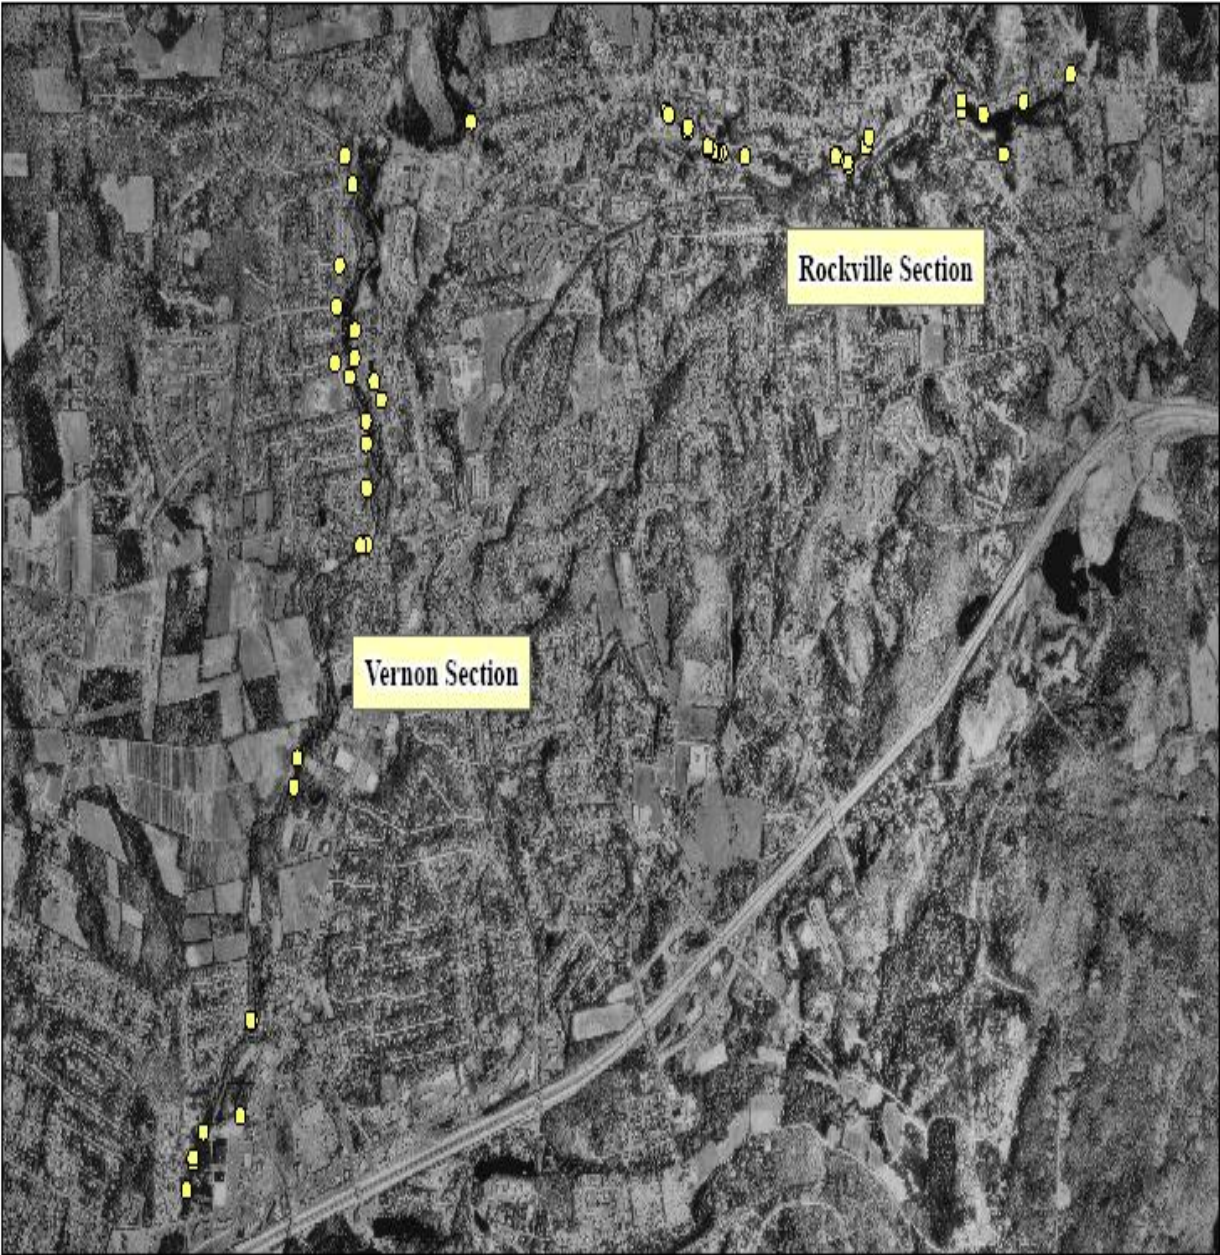
# Vernon Hockanum River Stormwater Outfall Locations

1/4/2010 North Central Conservation District

As outlined in the Scope of Work in the North Central Conservation District NPS Management contract 08-04b, outfalls in the town of Vernon were evaluated and prioritized for repair, retrofit or upgrade in accordance with the MS4 General Permit's Minimum Control Measure Item 6, which requires development and implementation of a program to evaluate conveyances, structures, and outfalls for repair and retrofit. Discharges were categorized into low, moderate, and high priority based on several factors including: the expected pollutant load, the condition of the infrastructure, sedimentation and/or erosion, fish passage, the relative value of the receiving wetland or waterbody as a resource, and the extent of its degradation. In total, district staff identified six moderate priority discharges and five high priority discharges.
