## Pre-Demolition Hazardous Materials Survey

**Former Serna Charter School  
19 South Central Avenue  
Lodi, California**

Terracon Project No. R1207403

**PRE-DEMOLITION HAZARDOUS MATERIALS SURVEY**  
**Former Serna Charter School Campus**  
**19 South Central Avenue**  
**Lodi, California**

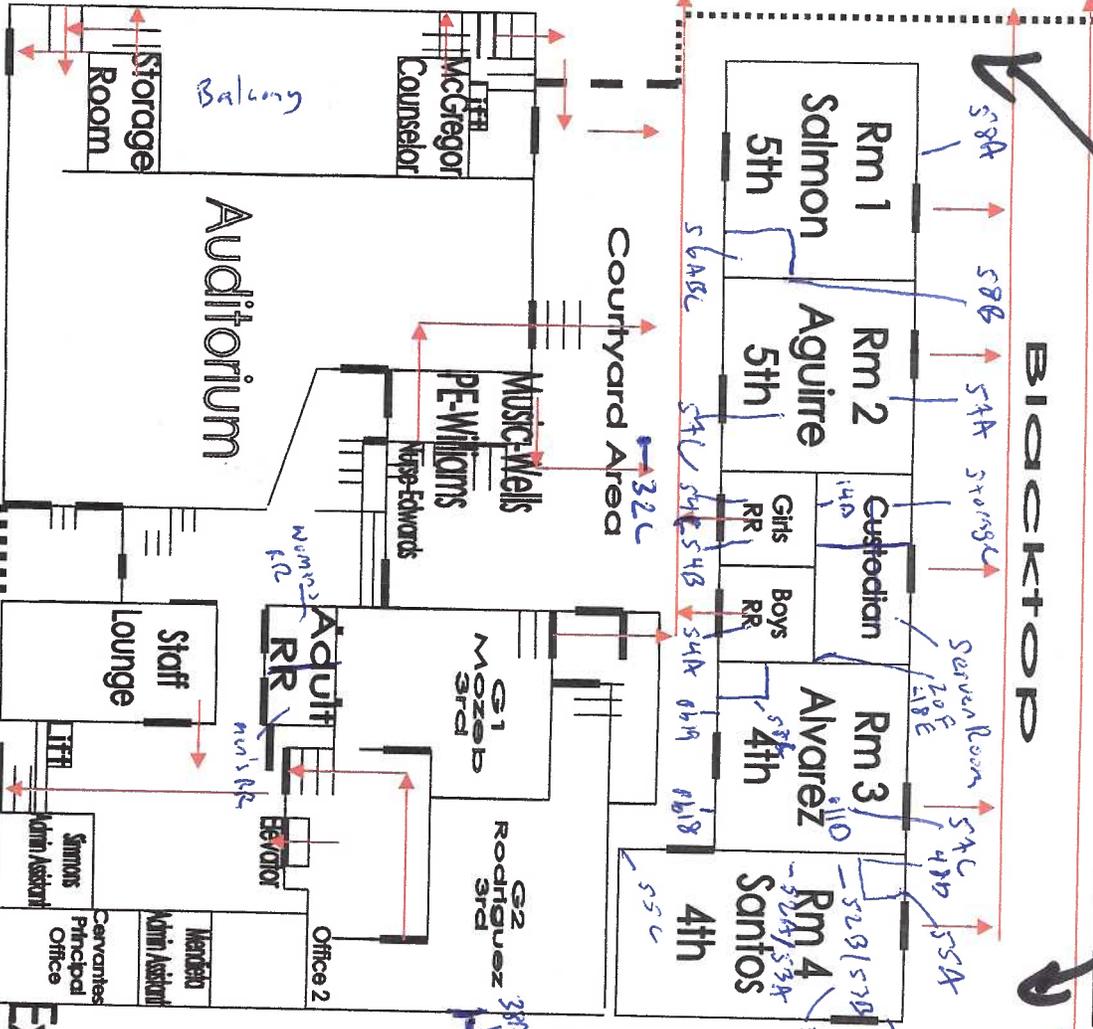
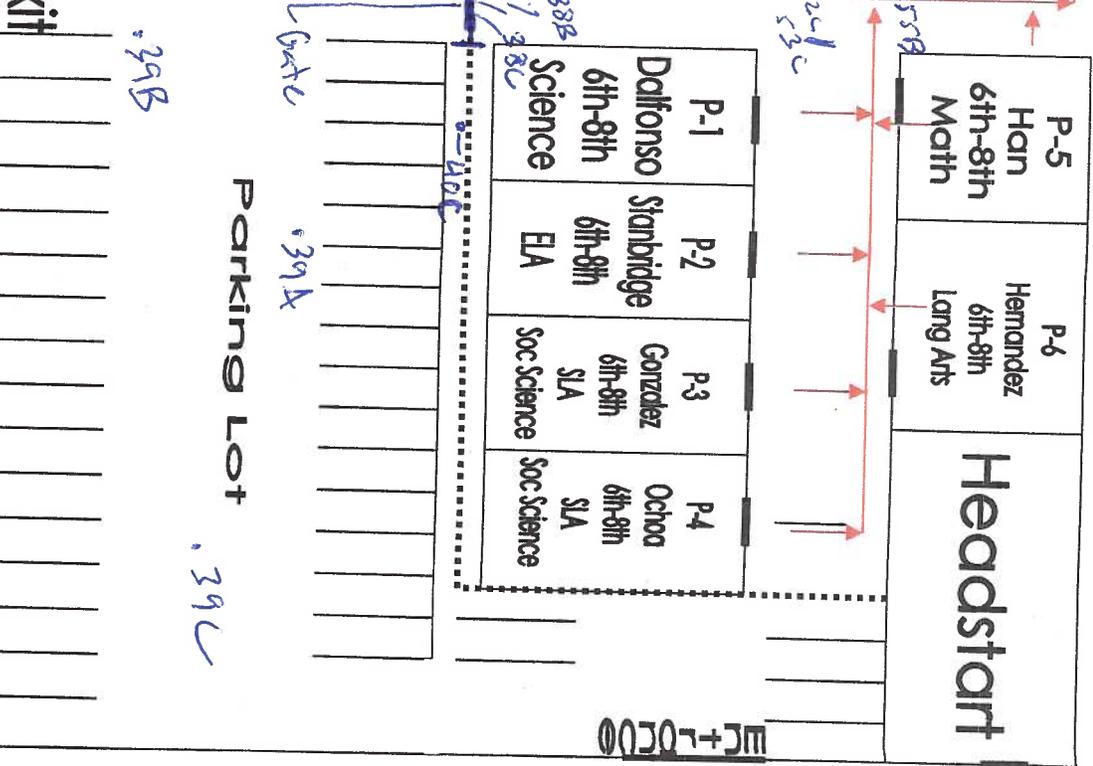
PROJECT: North Wing - Main Level / South wing - Main Level + Balcony Page \_\_\_\_\_

Fire Escape Routes

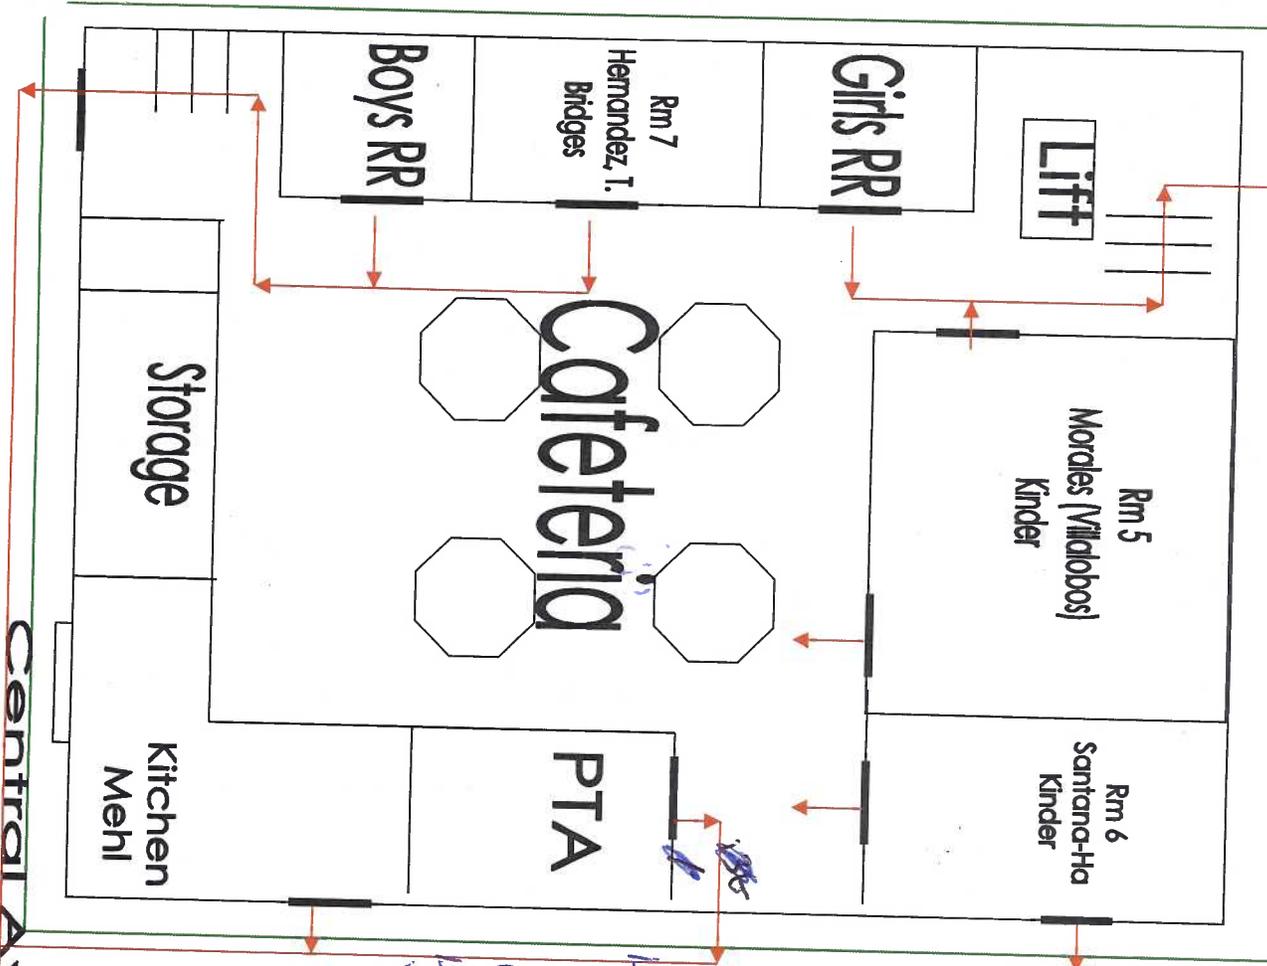
## Basement

# Fire Escape Routes
