Amelia Earhart Elementary School

Amelia Earhart Elementary School - Background Information

Amelia Earhart Elementary School - Existing Conditions Summary Facilities Assessment Needs

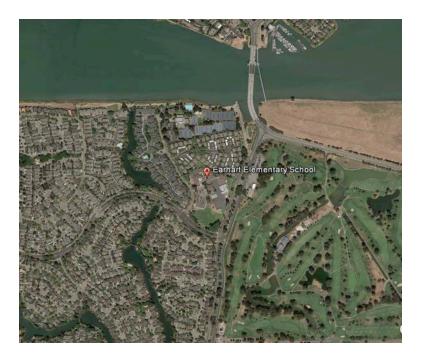
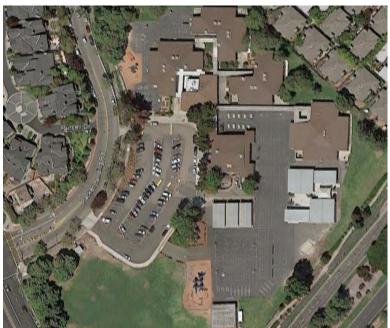
Amelia Earhart Elementary School is constructed on concrete pad foundations with one-story wood-framed, cement plastered walls, and metal roofing. The original campus includes a multi-purpose room with cafeteria, an administration building, and three classroom clusters with six classrooms, and a central resource center. In 1988, classroom cluster "F" was added along with an addition to cluster "E", and a campus wide lighting upgrade.

This site currently serves 618 kindergarten through 5th grade students with thirty-two classrooms, including ten relocatable buildings added since 1992, which serve as classrooms and daycare. A large asphalt playground extends into the area between the multi-purpose room and the classrooms, which serves as the campus focal point.
