Bay Farm Elementary School

Bay Farm Elementary School - Background Information

Alameda Unified School District Facilities Master Plan

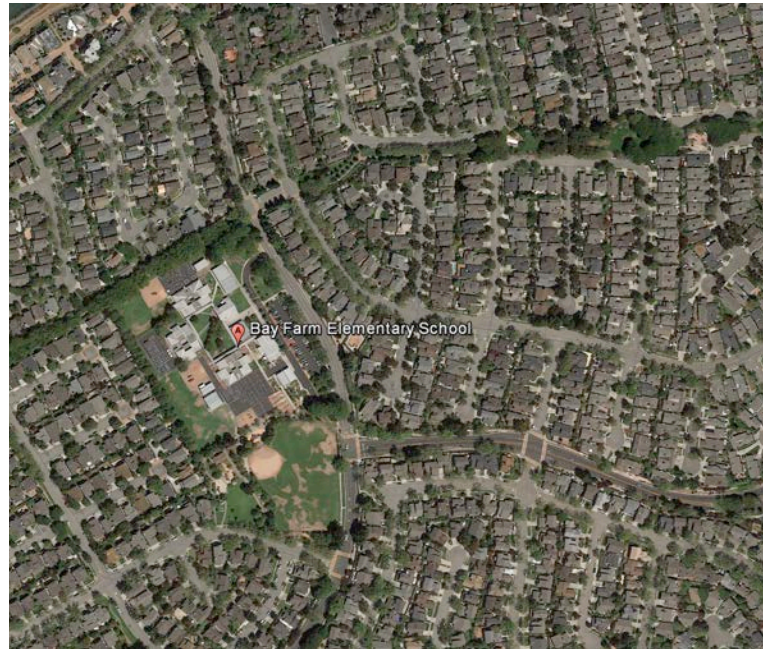
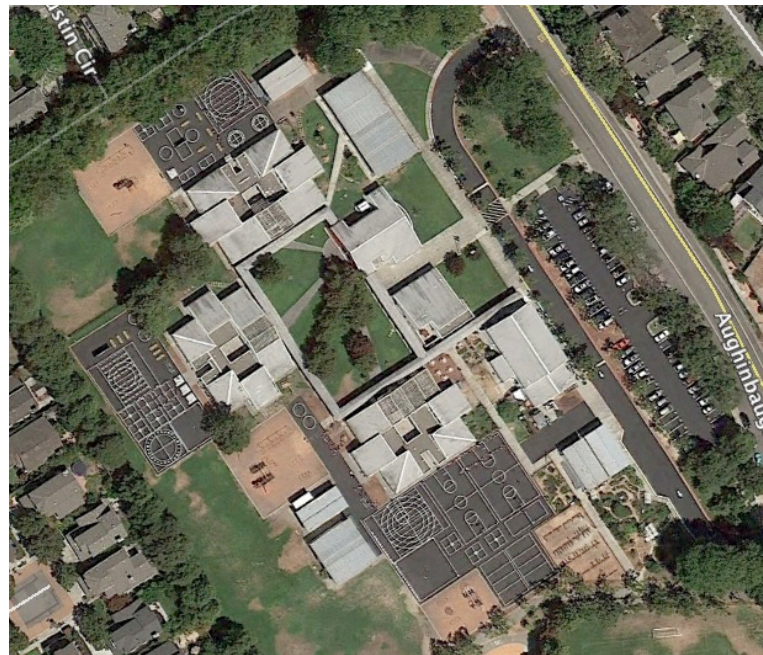
It is constructed on concrete pad foundations with one story wood frame, cement plastered walls, and standing seam metal roofing. The campus was modernized in 2004 using Measure C funds, but only included exterior painting, and repaving of the parking lot and access road. Since 2004, there have been a total of ten portable classrooms placed at this facility. A new roof was installed in 2013.

This campus includes a multi-purpose room with a cafeteria, administration building, media center/library, three classroom clusters with sixteen classrooms, and ten portable classroom buildings.

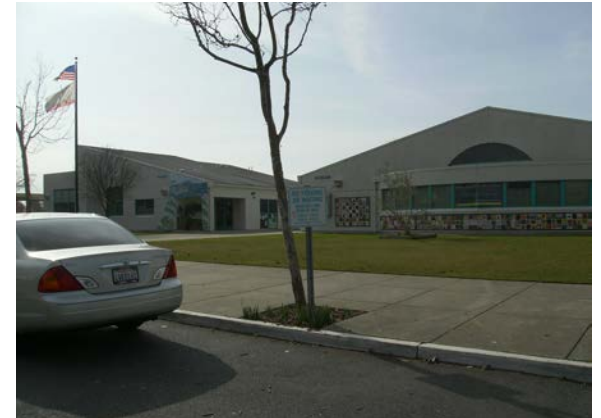
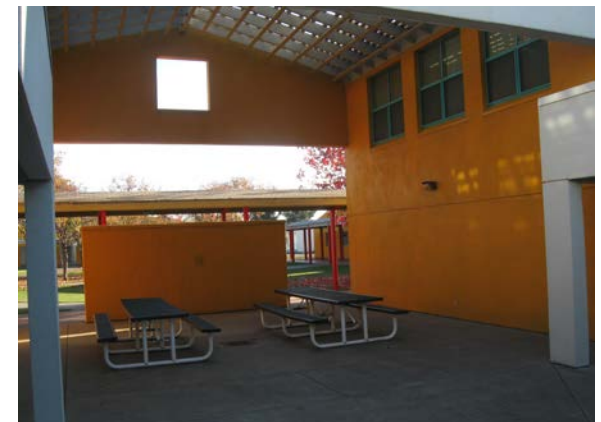
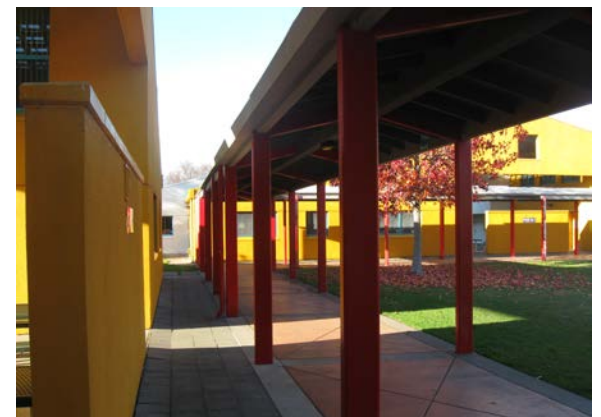
- Secure perimeter fencing is lacking
- Ground subsidence affects throughout site
- Site paving not compliant with accessibility code requirement for slope, cross slope, and obstructions and trip hazards
- Playground pavement is deteriorating and in need of sealing and re-stripping
- Irrigation water supply needs to be separated from domestic supply
- Windows in classroom wings are leaking
- Exterior doors show wear and damage
- Site has no trash enclosure
- Flooring throughout campus is near the end of its useful life
- Interior walls and ceilings need repair or refurbishment
- Ball field drainage is poor
