Franklin Elementary School

Franklin Elementary School - Background Information

Alameda Unified School District Facilities Master Plan

Franklin Elementary School - Master Plan Summary

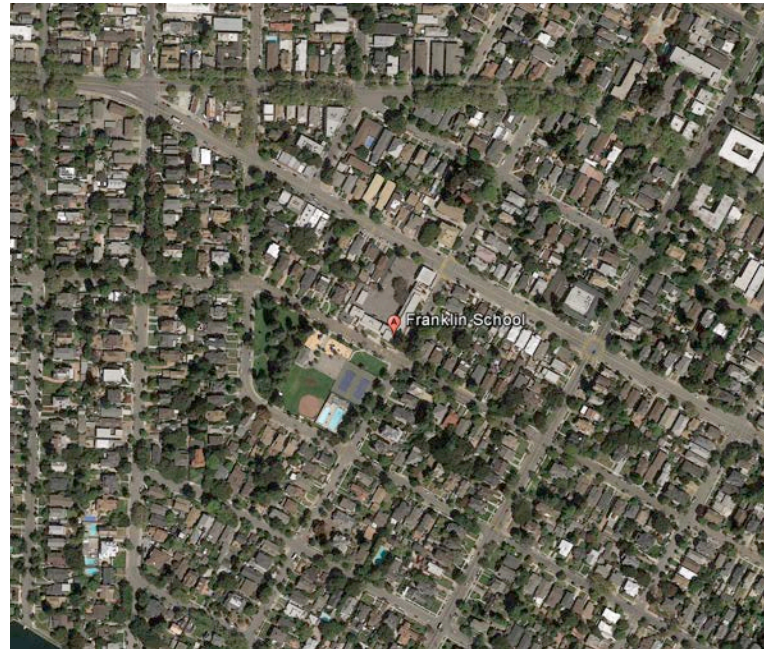
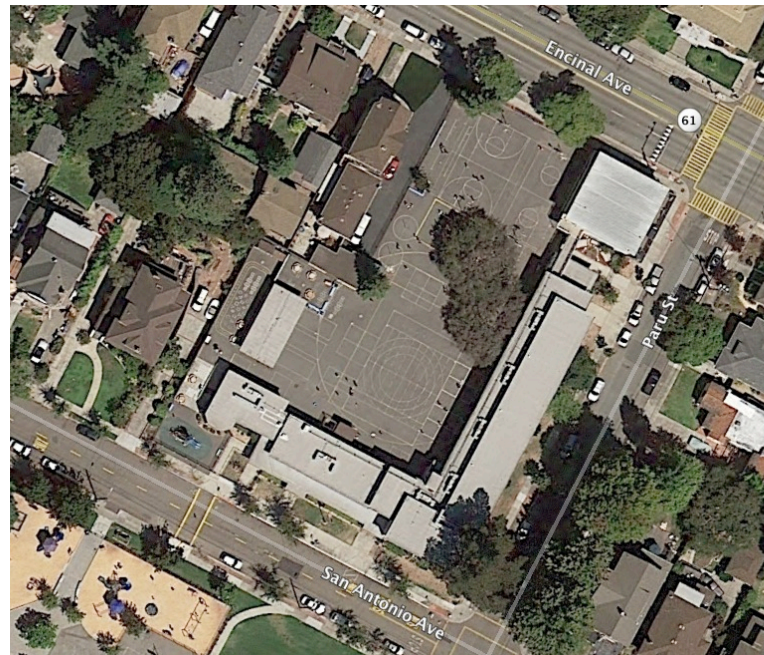
Franklin Elementary School was constructed in 1950 as two-story wood frame building on concrete pad foundations with parapet walls and flat membrane roofing. The administration wing is actually recessed below grade so that mechanical/service spaces are a half-level down and office and staff spaces are a half-level up.

In 1955, a brick and glass corridor enclosure was added to the main entry, which clearly defines it. In 2000, all buildings received a seismic retrofit, along with modernization work resulting in accessibility upgrades of an elevator, exterior ramps, toilet room barrier removal, painting, and fire alarm upgrades. That same year, two-story modular classrooms were also added.

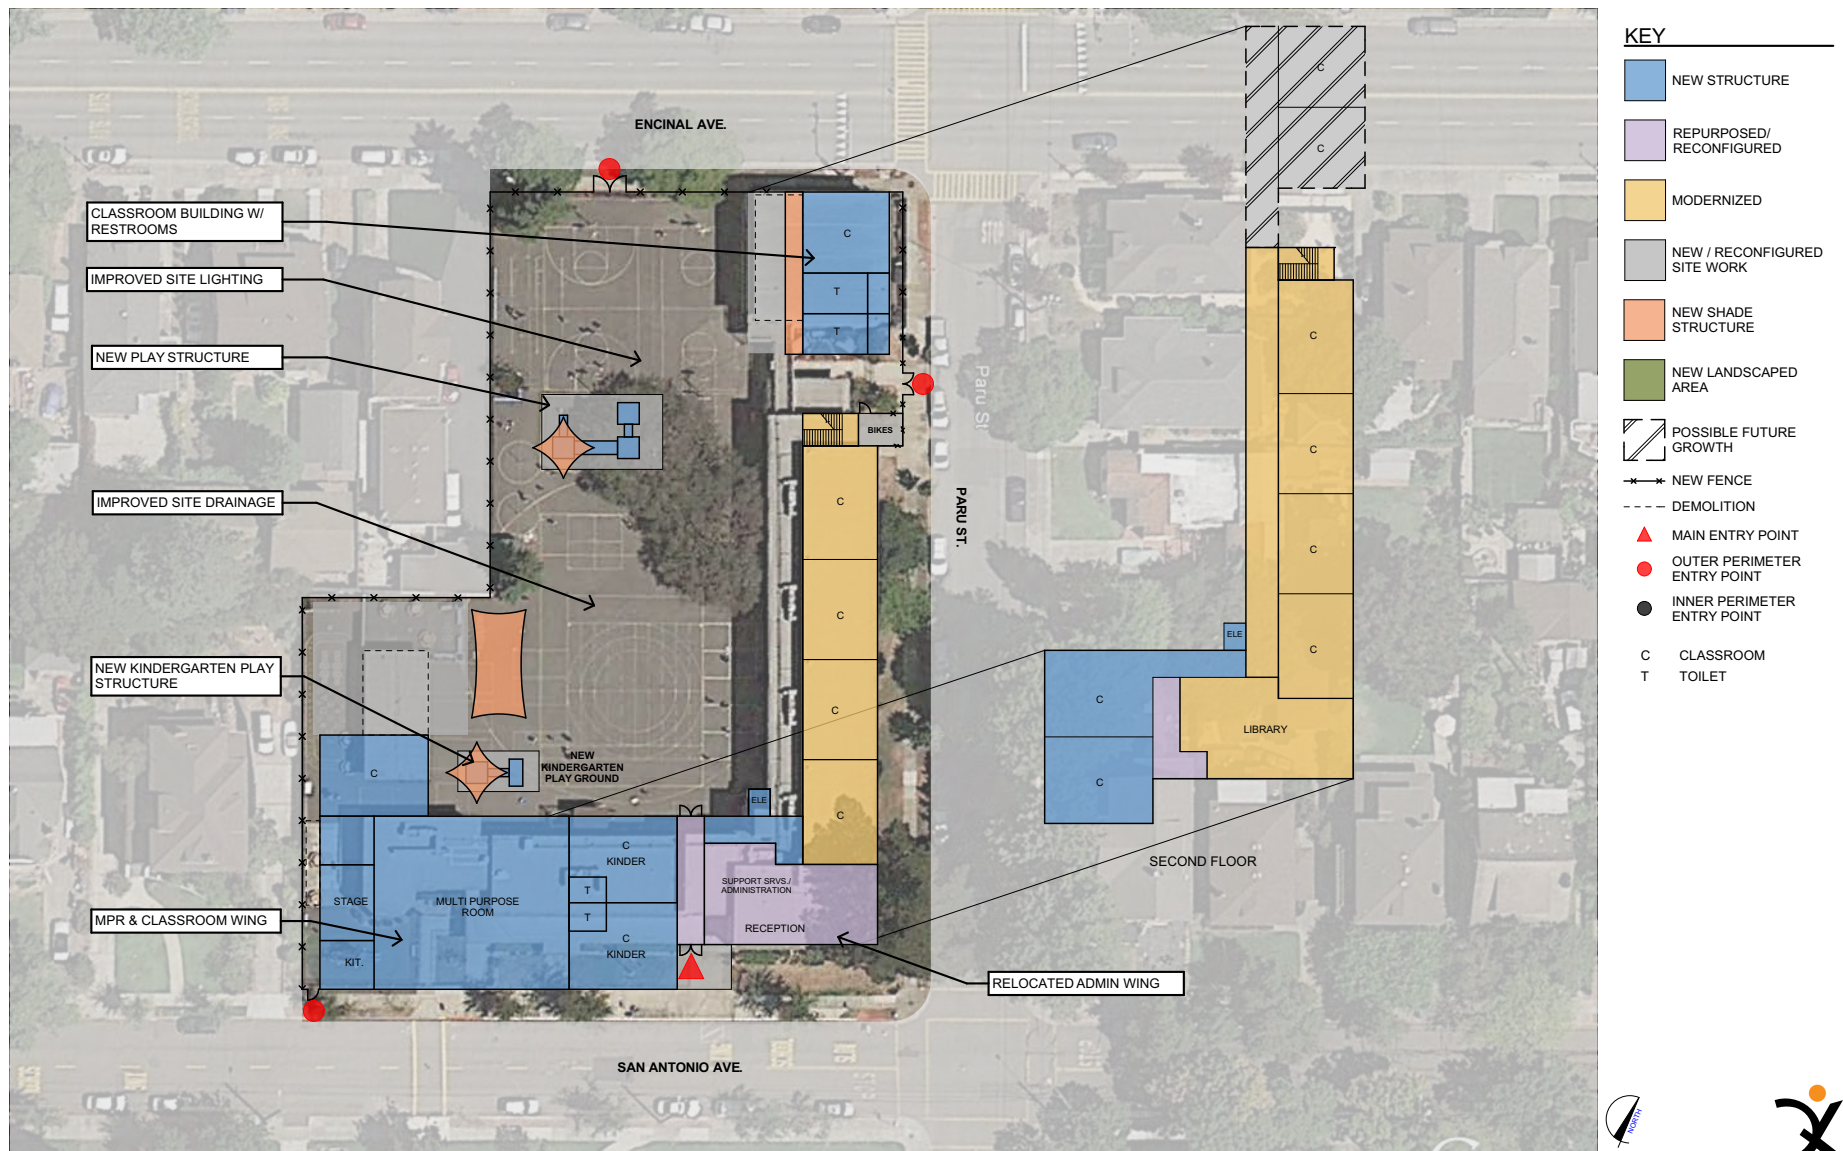
FRANKLIN ELEMENTARY SCHOOL SITE PLAN

- Three additional classrooms
- Replacement of two-story four classroom modular building with a new two-story four classroom addition to existing classroom wing
- New play structure

- Replace the 1024 sq. ft. multi-purpose room with a new adequately sized multi-purpose room that includes a warming kitchen, stage, music classroom, toilet rooms and storage.
- Replace the single existing oversized kindergarten classroom with a new kindergarten wing, that houses 4 classrooms.
- Provide an adequately sized administration space, with a reception area at the primary entrance into campus providing plenty of visibility.
- Provide shade structure for outdoor eating, learning and play.
- Replace modular and portable classrooms nearing end of their service life.
- Modernize media center and expand breakout spaces.
