**Haight Elementary School**  
2025 Santa Clara Ave

## Haight Elementary School - Background Information

## Alameda Unified School District Facilities Master Plan

## Haight Elementary School - Master Plan Summary

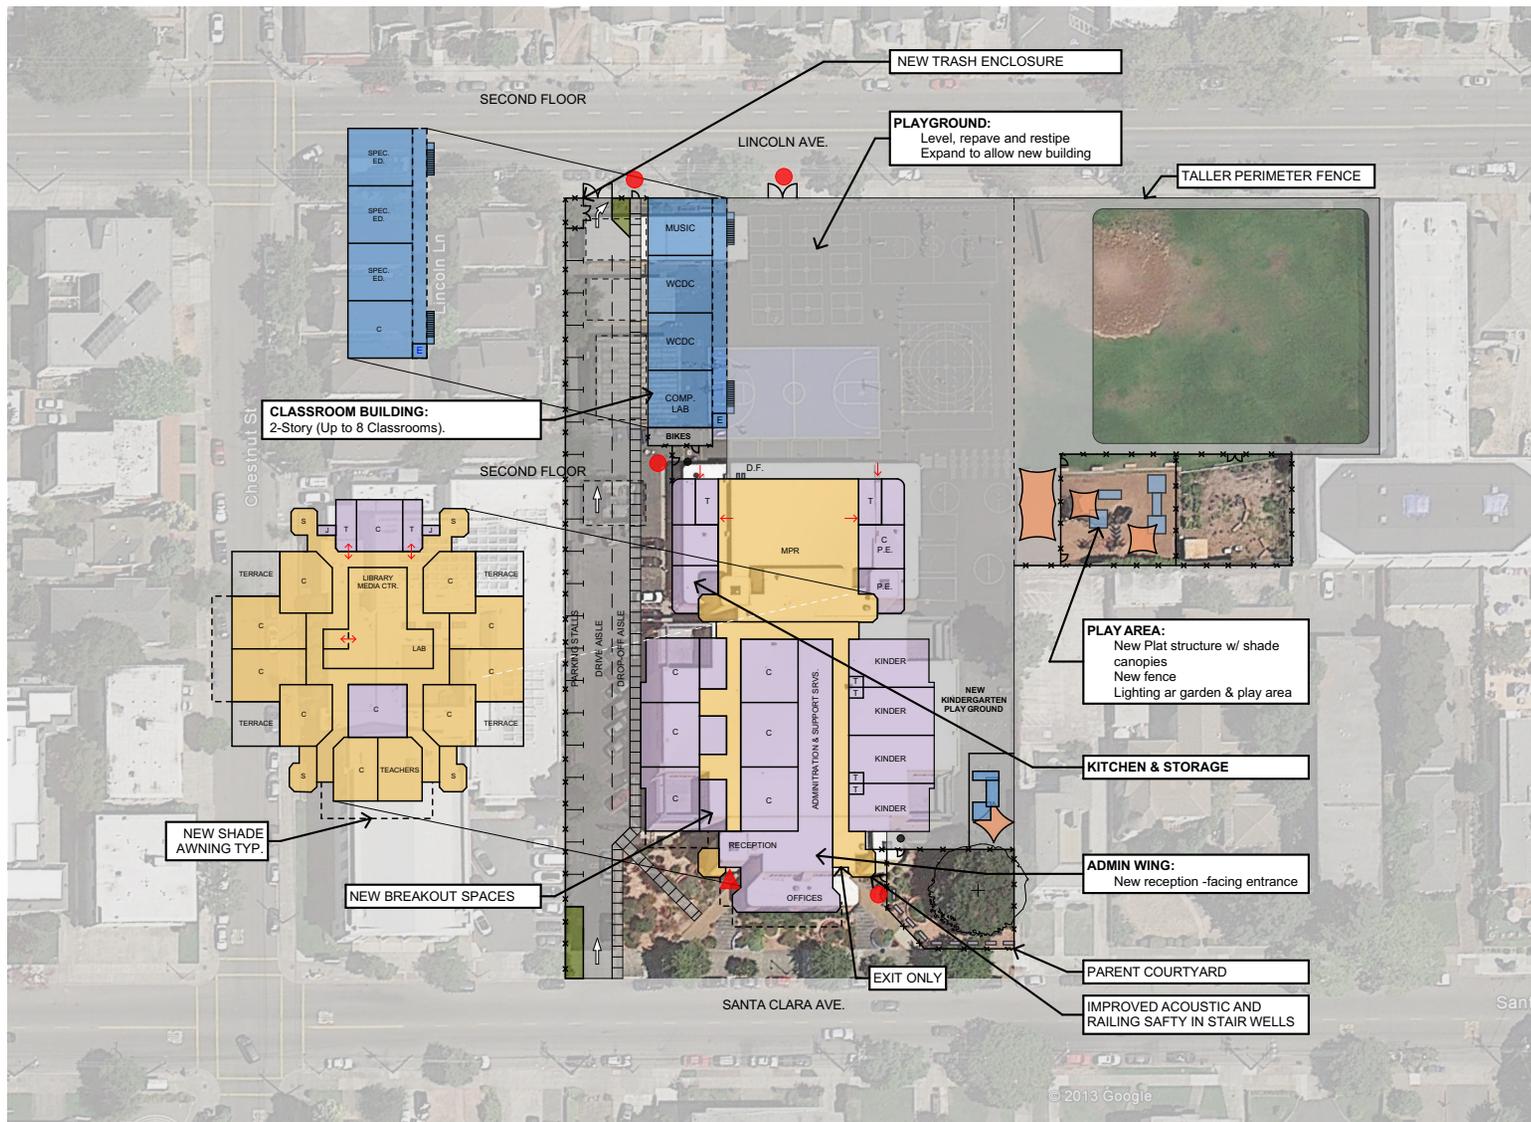
- KEY**
- NEW STRUCTURE
  - RECONFIGURED / EXPANDED
  - MODERNIZED
  - NEW / RECONFIGURED SITE WORK
  - NEW SHADE STRUCTURE
  - NEW LANDSCAPED AREA
  - POSSIBLE FUTURE GROWTH
  - NEW FENCE
  - DEMOLITION
  - MAIN ENTRY POINT
  - OUTER PERIMETER ENTRY POINT
  - INNER PERIMETER ENTRY POINT
  - CLASSROOM
  - TOILET

- Provide new on-site drop-off aisle adjacent to new parking area.
- Reconfigure reception area to front on a single main entry, with additional windows for visibility
- Reconfigure ancillary multi-purpose spaces in a PE classroom and adequate storage space.
- Reconfigure warming kitchen service area to reduce congestion at primary lunchtime entrance.
- Modernize the library/media center and provide folding partition to breakout space.
- Demolish existing boiler system and replace with modern HVAC equipment.

- Shade canopies at play structures and play grounds
- New classroom building to replace portables
- New play structures for each grade division
- New parent courtyard/pick-up area under heritage oak tree at southeast corner of campus
- New running path around perimeter of ball field
