## Maya Lin School - Background Information

## Maya Lin School - Existing Conditions Summary

## Maya Lin School - Master Plan Summary

MAYA LIN SCHOOL SITE PLAN

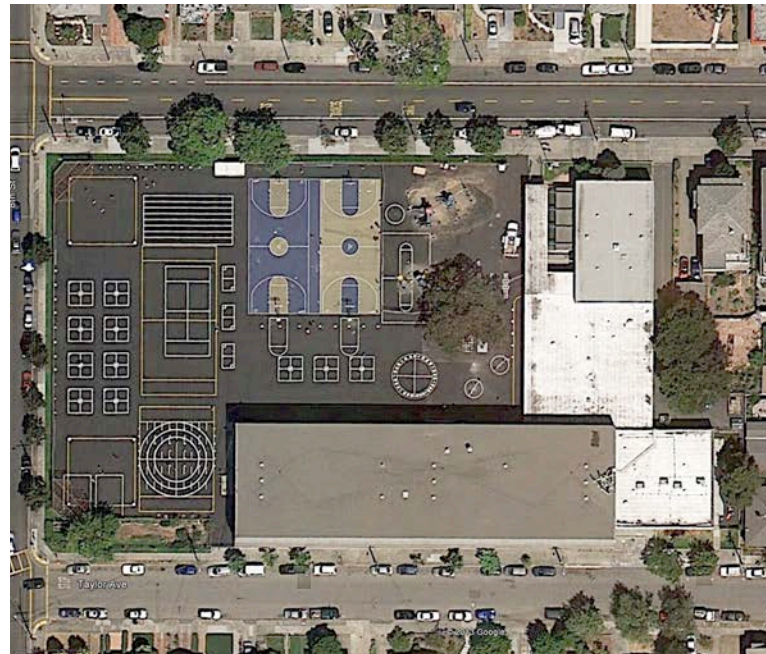
- Playground asphalt exceeds cross-slope and is in poor condition.
- Wood trellis above multi-purpose room entry has deteriorated.
- Exterior windows, doors, roofing, and wall finishes have exceeded their service life.
- Interior wall floor and ceiling finishes have exceeded their service life.
- Multi-purpose room stage lacks an accessible lift.
- Cafeteria kitchen is not in compliance with current health code.
- Mechanical equipment has exceeded its service life.
