BASIS OF BEARINGS

LEGAL DESCRIPTION

THE SOUTHEAST QUARTER OF THE NORTHWEST QUARTER OF THE SOUTHWEST QUARTER OF SECTION 17, TOWNSHIP 27 NORTH, RANGE 4 EAST, WILLAMETTE MERIDIAN, IN THE COUNTY OF SNOHOMISH AND STATE OF WASHINGTON;

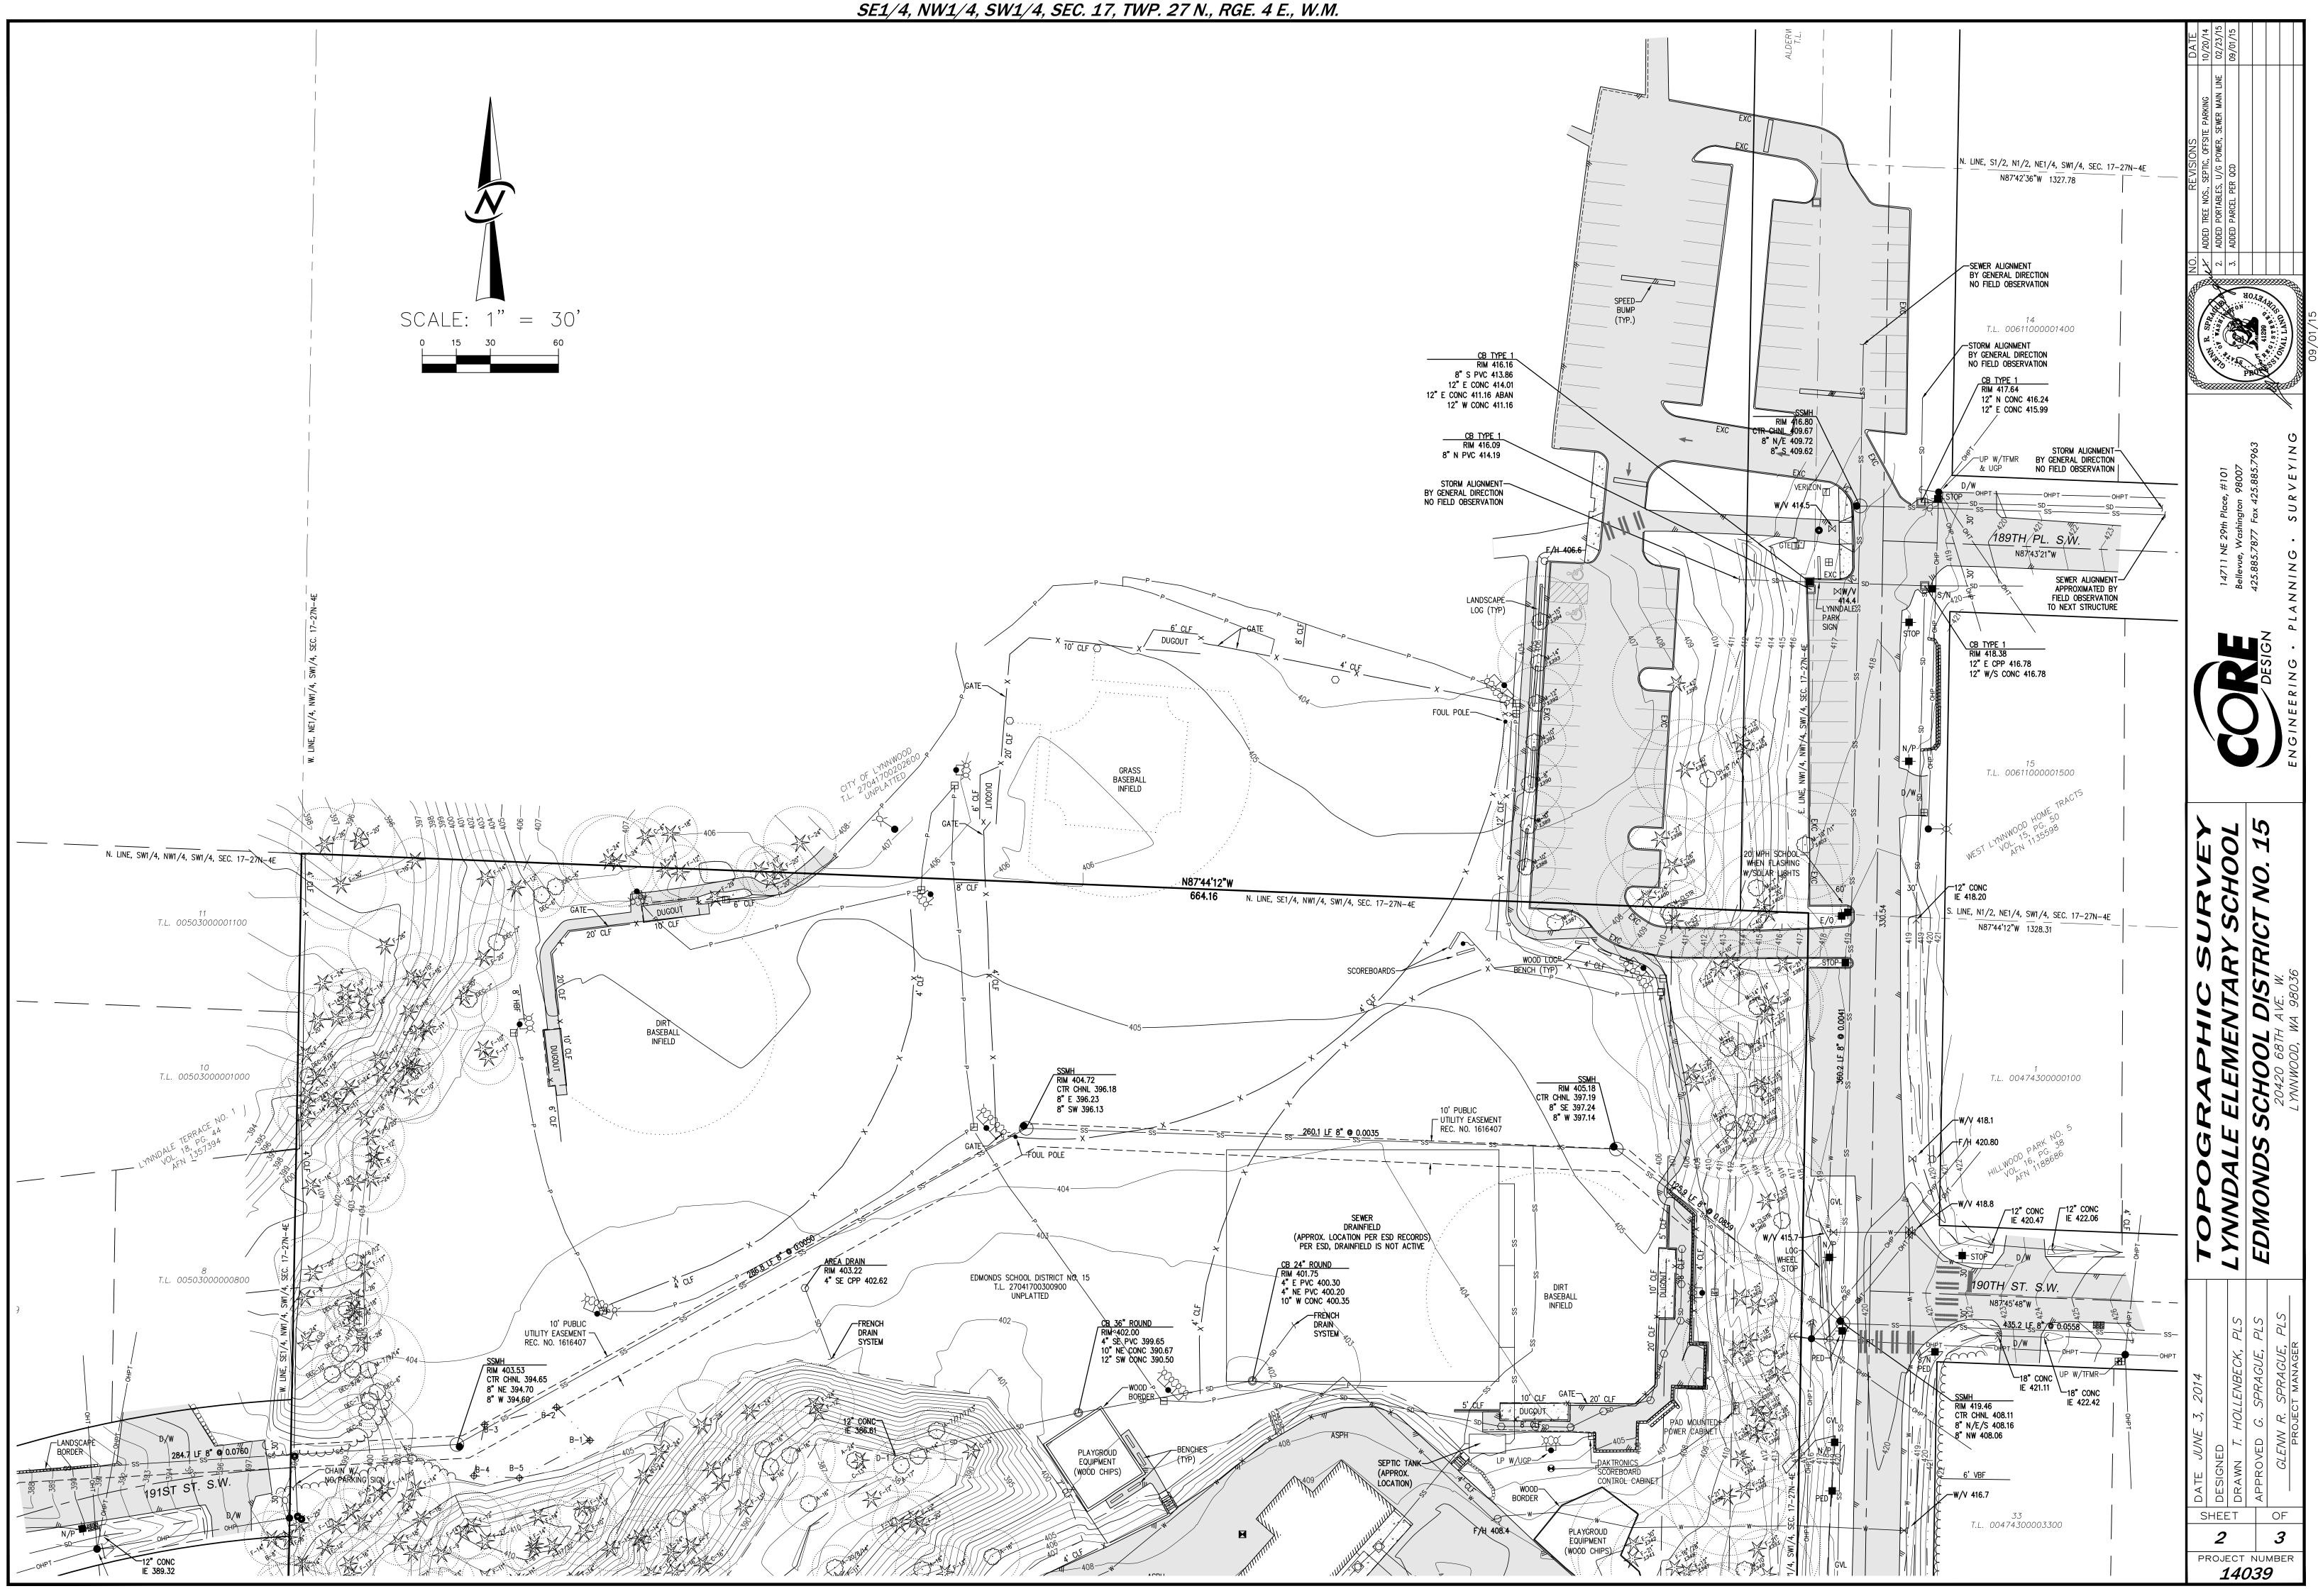
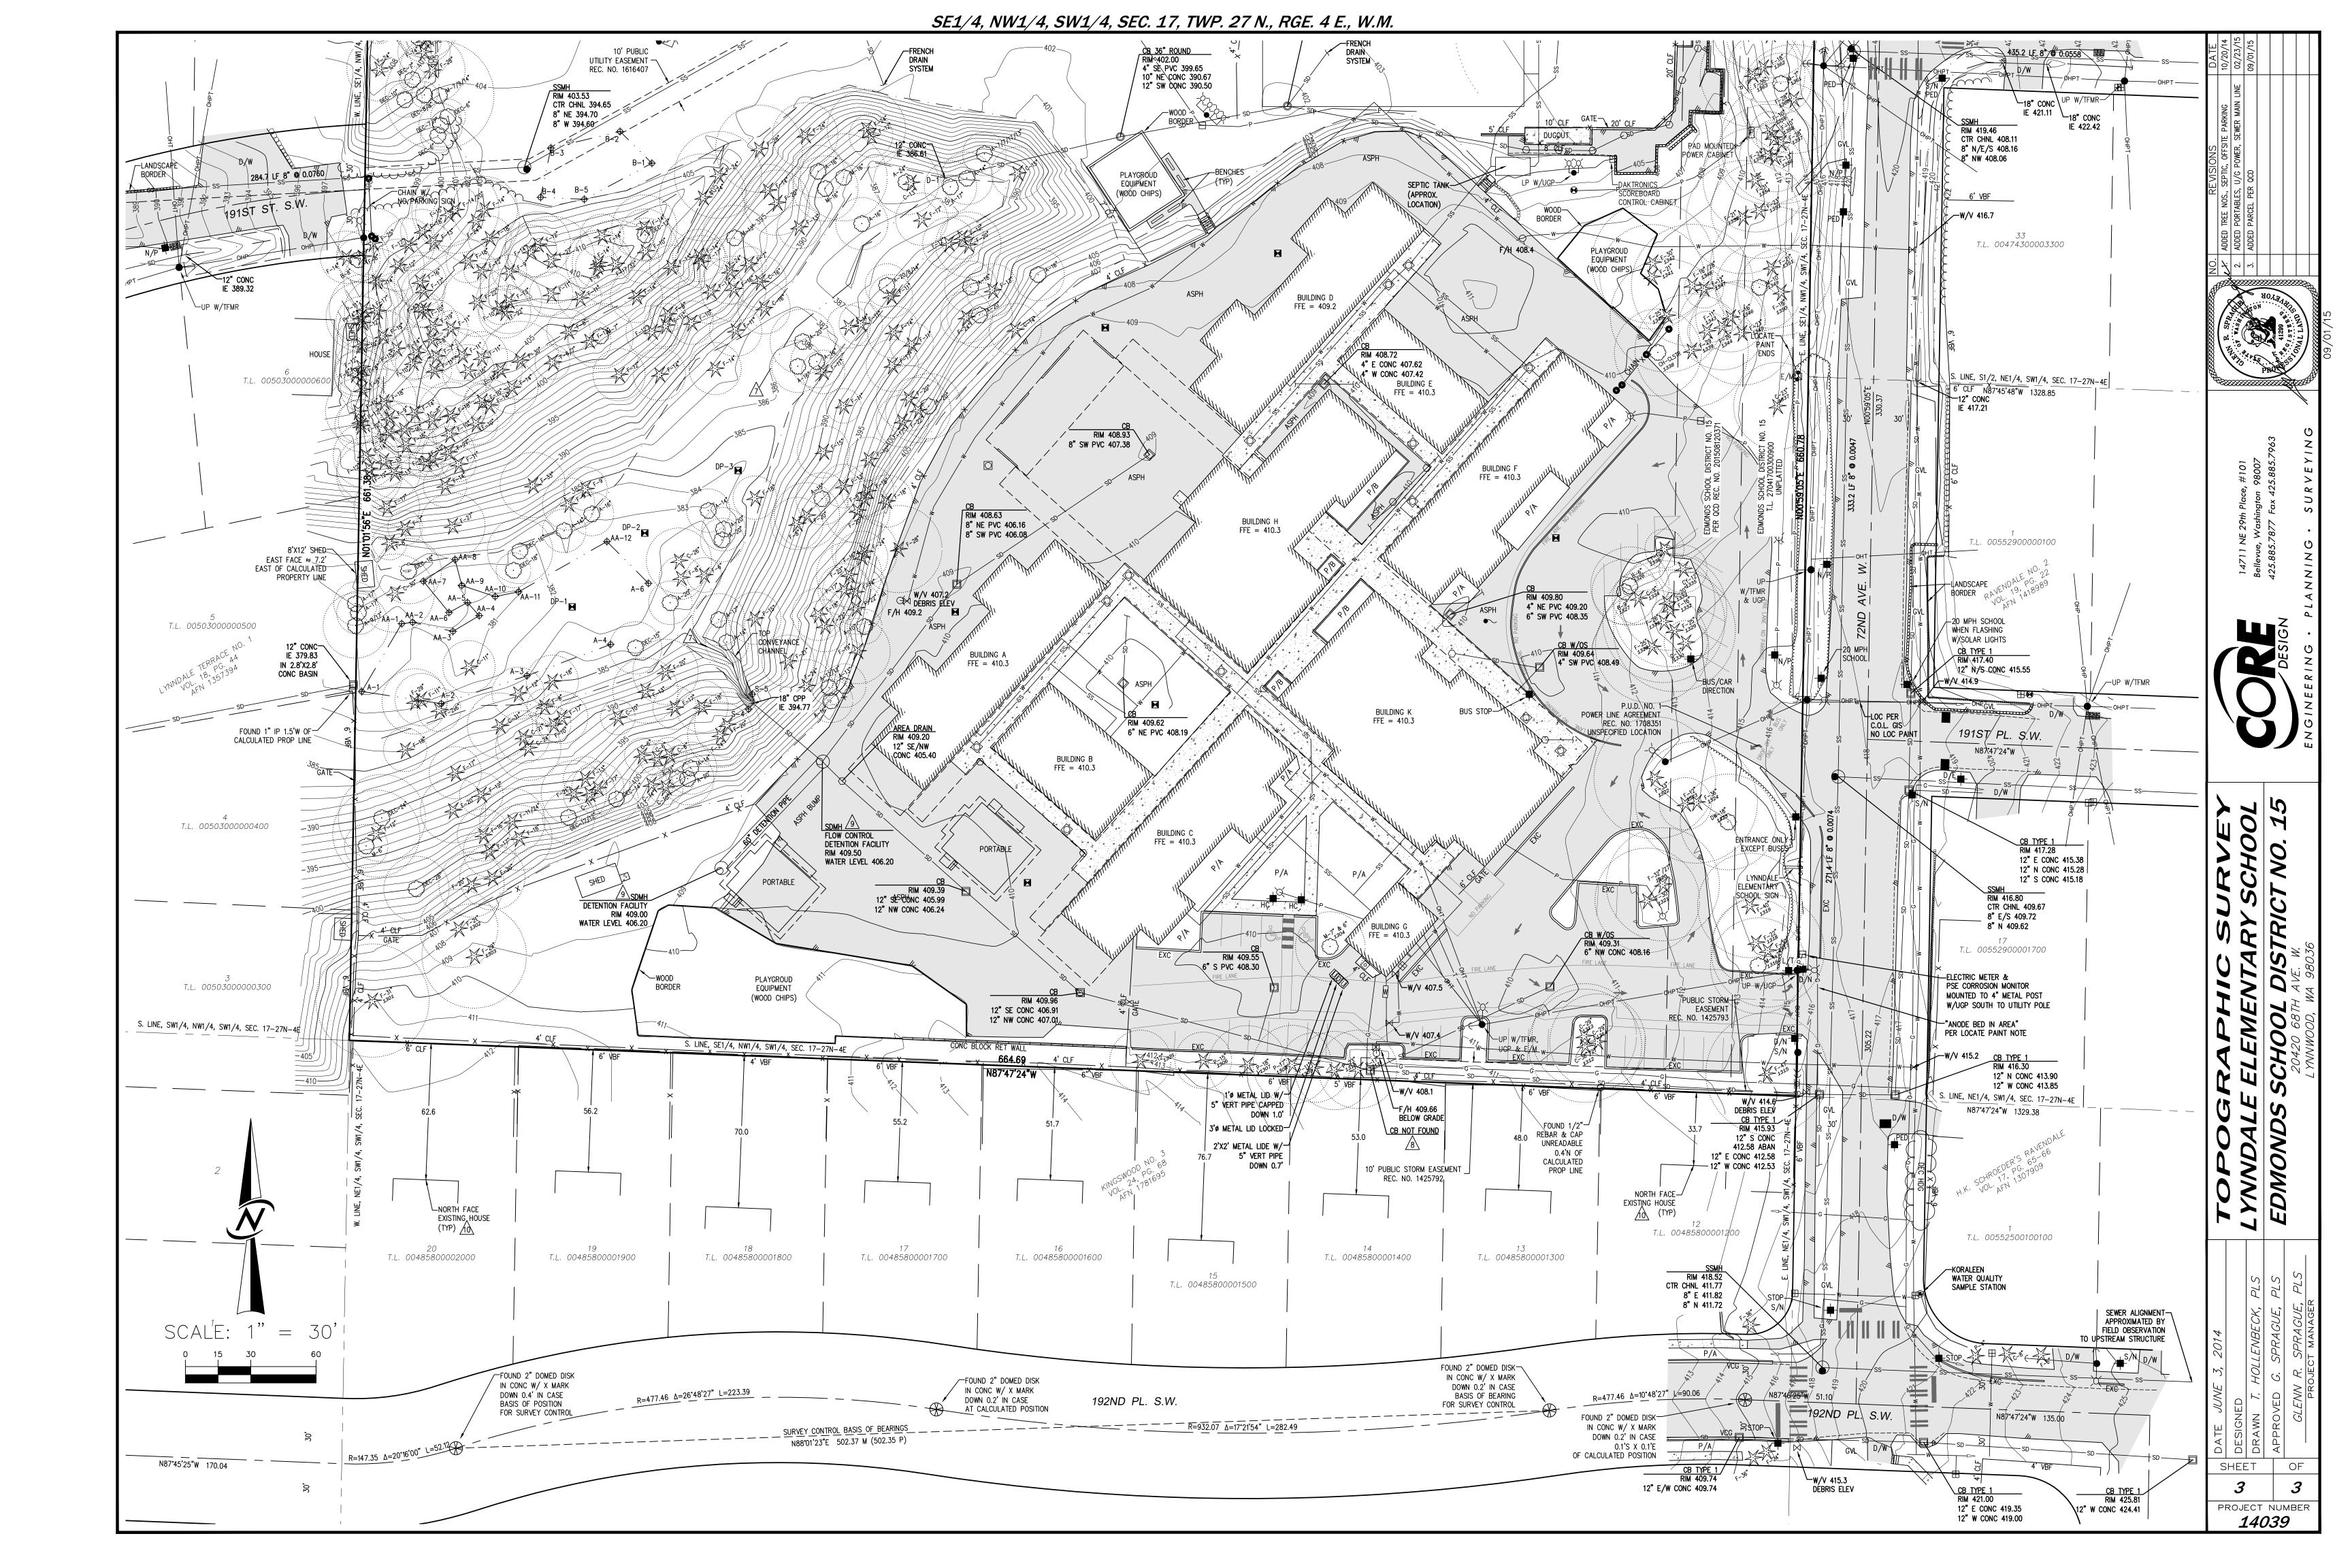
- 2. THIS SURVEY REPRESENTS VISIBLE PHYSICAL IMPROVEMENT CONDITIONS EXISTING ON MAY 30, 2014. ALL SURVEY CONTROL INDICATED AS "FOUND" WAS RECOVERED FOR THIS PROJECT IN MAY, 2014.

- 6. UTILITIES OTHER THAN THOSE SHOWN MAY EXIST ON THIS SITE. UNDERGROUND UTILITY LOCATIONS SHOWN ARE APPROXIMATE ONLY DERIVED FROM UTILITY LOCATE PAINT, SCHOOL DISTRICT RECORDS AND/OR PUBLIC RECORD. PRIVATE WATER AND SEWER LINES SHOWN BETWEEN SCHOOL BUILDINGS ARE SCHEMATIC. UNDERGROUND CONNECTIONS ARE SHOWN AS STRAIGHT LINES BETWEEN SURFACE UTILITY LOCATIONS BUT MAY CONTAIN BENDS OR CURVES NOT SHOWN. CORE DESIGN ASSUMES NO LIABILITY FOR THE ACCURACY OF PUBLIC RECORDS.

- 7. SOME WETLAND, STREAM, AND DRAINAGE FLAGS WERE NOT FOUND AT THE TIME OF THIS SURVEY. CORE DESIGN, INC. FIELD CREWS OBSERVED SOME FLAGS PILED ON THE GROUND IN RANDOM LOCATIONS. THE SOUTHERLY STORM DRAINAGE CHANNEL WAS SURVEYED IN LIEU OF MISSING FLAGS A5, S1-S3, AND S6-S10. THE NORTHERLY STORM DRAINAGE CHANNEL WAS PARTIALLY SURVEYED AND REMAINDER SKETCHED BY FIELD OBSERVATION IN LIEU OF MISSING FLAGS D2-D7.

- 9. STORM DRAIN DETENTION FACILITY STRUCTURES ARE FIELD LOCATED AND THE 60" DETENTION PIPE IS PER THE ABOVE STATED MENG ASSOCIATES PLANSET. PER THE PLANSET THE NORTHEASTERLY MANHOLE IS A FLOW CONTROL STRUCTURE AND THE REPORTED WATER LEVEL ELEVATION IS ASSUMED TO BE THE OVERFLOW ELEVATION OF THE DETENTION FACILITY. AT THE TIME OF THIS SURVEY THE FLOW CONTROL STRUCTURE WAS FULL OF WATER WITH NO PIPES OR RISERS VISIBLE. FALLING WATER SOUNDS WERE REPORTED WITHIN THIS STRUCTURE FURTHER INDICATING THE WATER LEVEL TO BE AT THE OVERFLOW ELEVATION AND A SMALL WATER FLOW WAS OBSERVED AT THE OUTFALL PIPE IN THE RAVINE TO THE NORTHWEST. NO FALLING WATER SOUNDS WERE REPORTED IN THE SOUTHWESTERLY STRUCTURE.

- 10. HOUSES SHOWN SOUTH OF THE SOUTH PROPERTY LINE REPRESENT THE MOST NORTHERLY HOUSE FACE ONLY, POSITIONED PARALLEL TO THE SOUTH PROPERTY LINE, AND DO NOT REPRESENT THE ACTUAL HOUSE DIMENSIONS, CONFIGURATION, OR POSITION RELATIVE TO THE ADJACENT LOT SIDELINES. DIMENSIONS FROM THE SOUTH PROPERTY LINE TO THE NORTH HOUSE FACE ARE ACCURATE TO ± 0.1 '.

- 11. OFFSITE CONTOURS ON PRIVATE PROPERTIES TO THE EAST AND SOUTH AND ON THE WESTERLY PORTIONS OF THE PUBLIC PARK PROPERTY TO THE NORTH ARE ESTIMATED FROM FIELD OBSERVATIONS.
