## Cloonan MS Facility Assessment & Analysis Report

Cloonan Middle  
11 West North Street  
Stamford, Connecticut 06902

StudioJAED  
42 Weybosset Street, Suite 403  
Providence, RI 02903  
401.648.0884

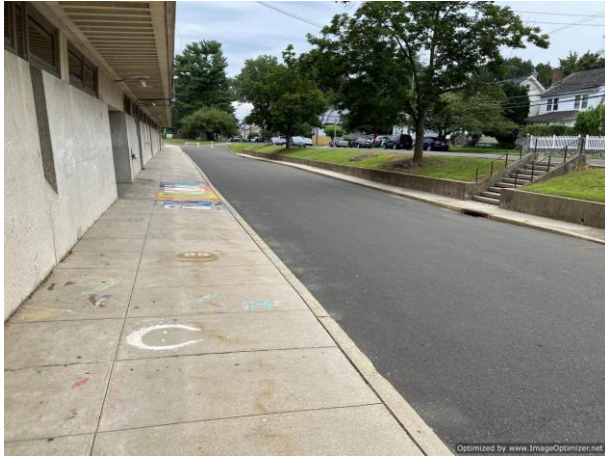
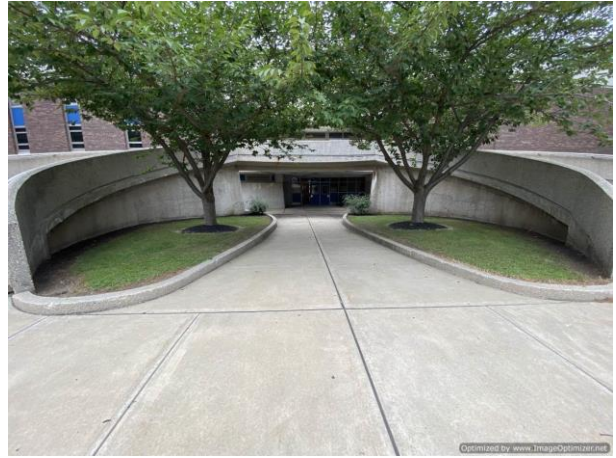
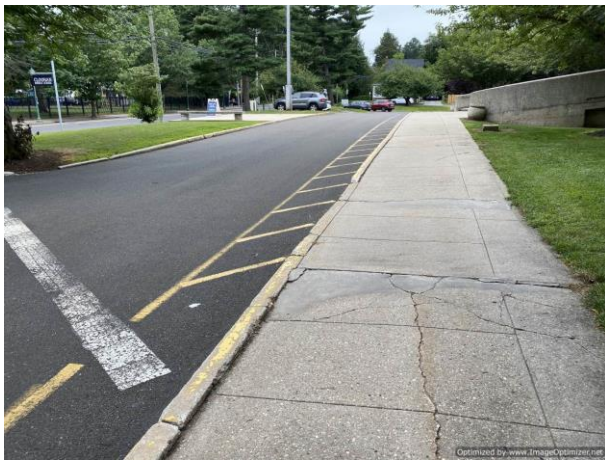
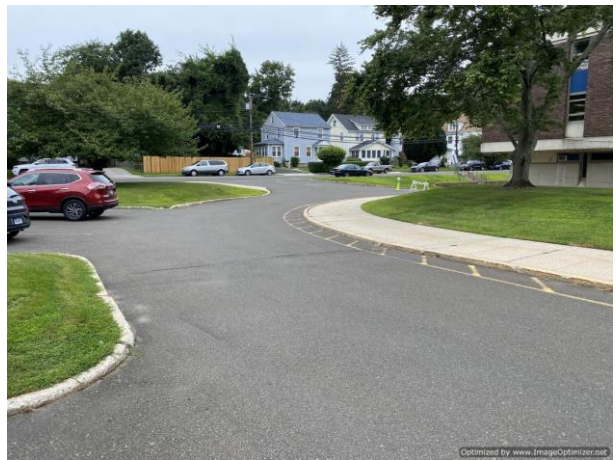
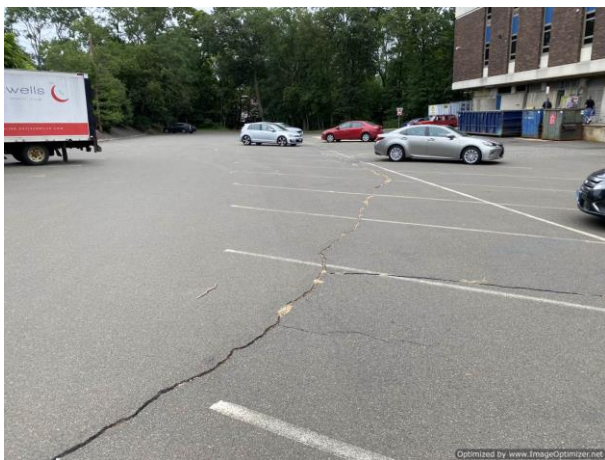
Asphalt/Concrete pavement and asphalt/concrete sidewalks serving vehicular and pedestrian traffic and both are in fair condition. The bus drop-off area and parent drop area converge on the west side of the school and cause safety issues for the school. This layout should be addressed. There are approximately 103 spaces in open lots. The paved areas are in fair to good condition with minimal evidence of cracking and pavement section deterioration. All concrete curbing is in poor to fair condition. Concrete paving in the courtyard is in poor condition. Fencing is provided around the generator cooling system at the rear of the building. Site lighting seems sufficient but should have a photometric done to verify. The perimeter fencing is in good condition with isolated sections of damage. Grass play areas/fields, as well as constructed play areas were not on this site. Storm water from the roofs, landscaped areas, and paved areas flows into on site inlets and catch basins with underground piping connected to the municipal storm water management system. Storm water along the east drive flows into the adjacent river.

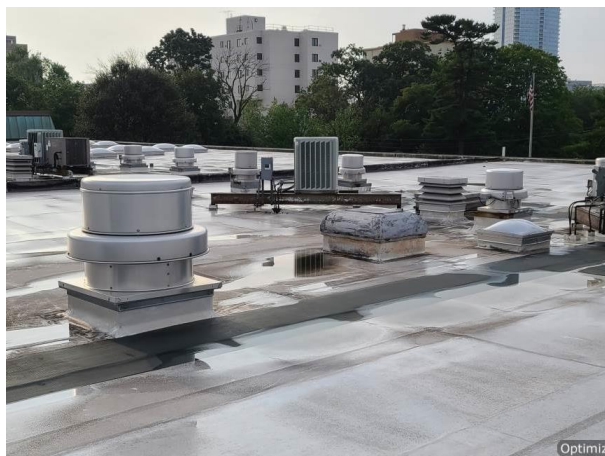
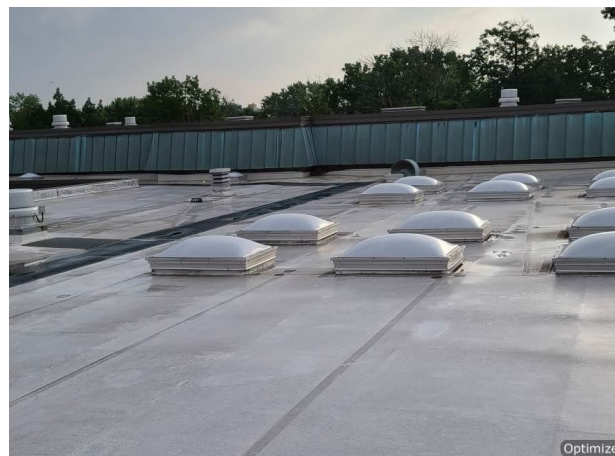
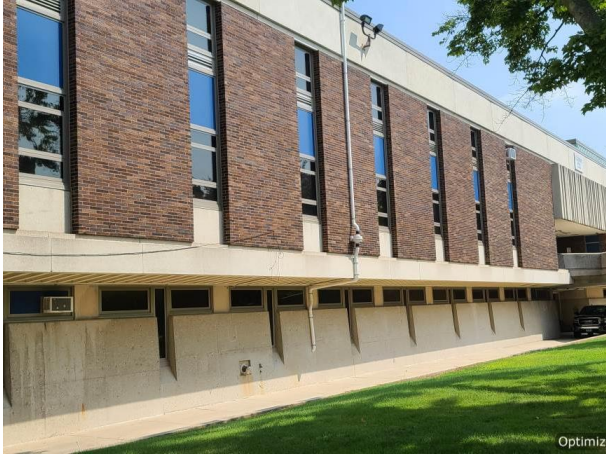
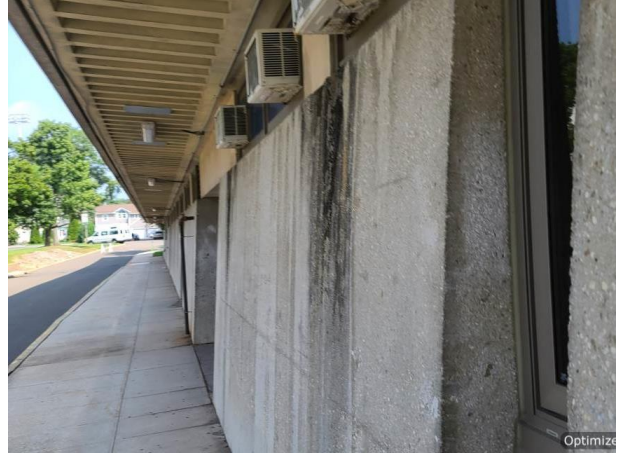
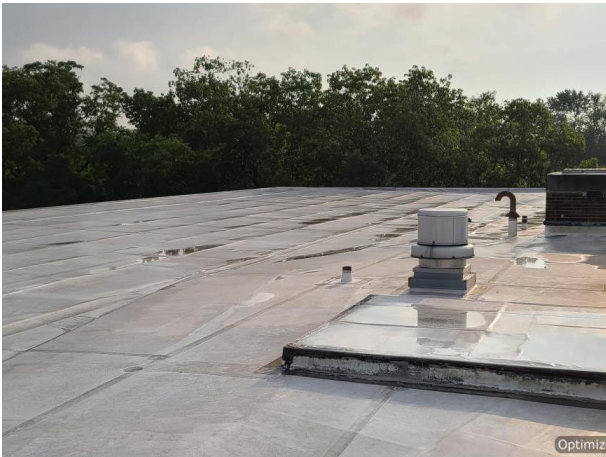
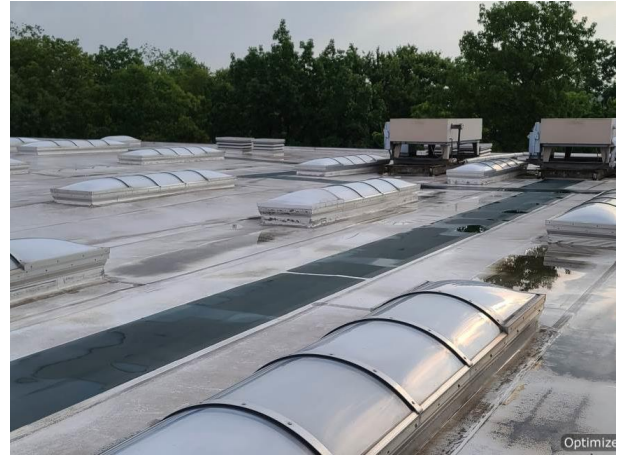
Cloonan Middle is approximately 164,155 square feet and is a three storey structure. The building is concrete encased steel column frame with concrete-topped metal decks. Steel beams provide support at the second floor and reinforced concrete beams provide support at the first floor. The roof assembly is comprised of flat roofs with single-ply membranes. The exterior wall finish is Brick veneer and pre-cast and cast in place concrete panels. There is no evidence of significant settlement or structural failure.

The exterior building envelope is in fair condition. It is recommended that the deteriorated EPDM roofing be replaced. The exterior façade is in need of repair and cleaning.

Interior floor finishes include resilient tile, polished stone, ceramic tile, carpet, wood, quarry tile and painted concrete slab and are in fair condition. Interior wall finishes include painted drywall, painted concrete, painted CMU, exposed brick, and ceramic tile and are in fair condition. Interior ceiling finishes include exposed structure, suspended acoustic tiles, exposed structure with fireproofing, painted concrete, painted CMU, and painted drywall and are in fair condition. Casework and countertops are in poor condition and in need of replacement. All interior doors are worn and approaching the end of their useful life. Classroom and conference room projection equipment should be replaced.

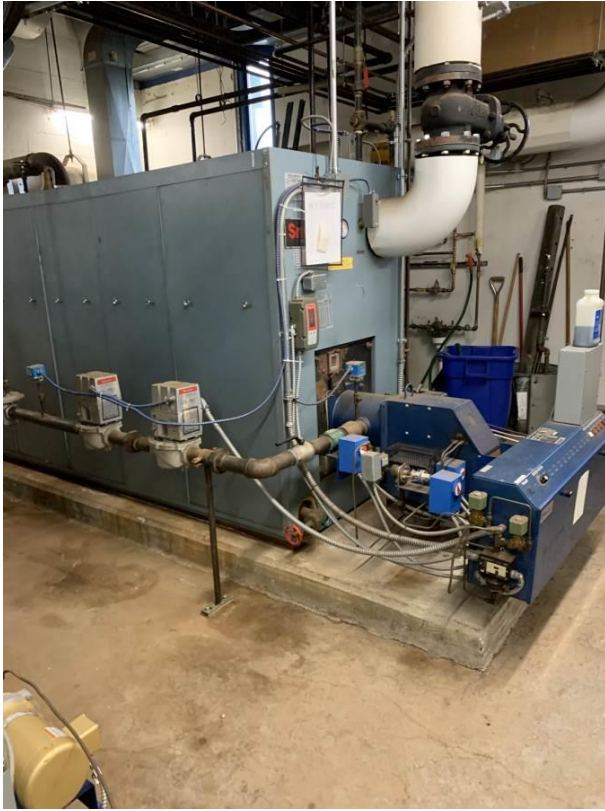
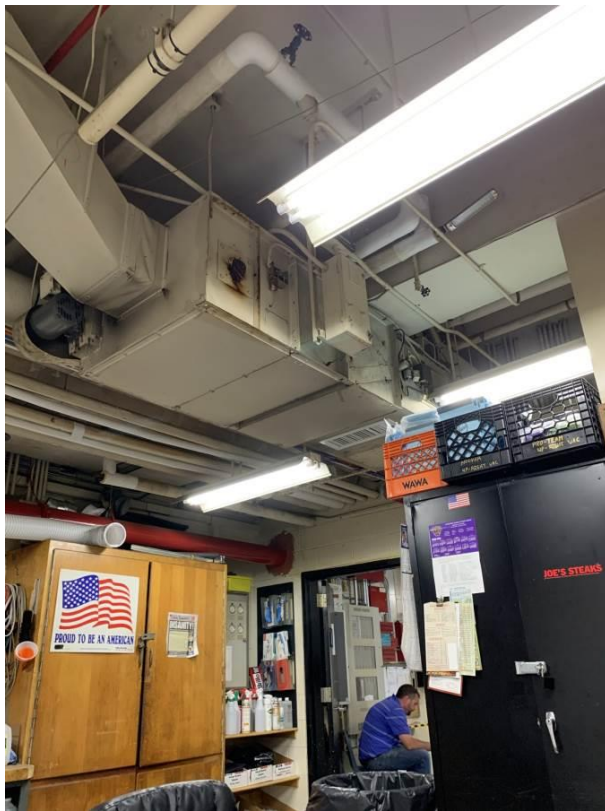
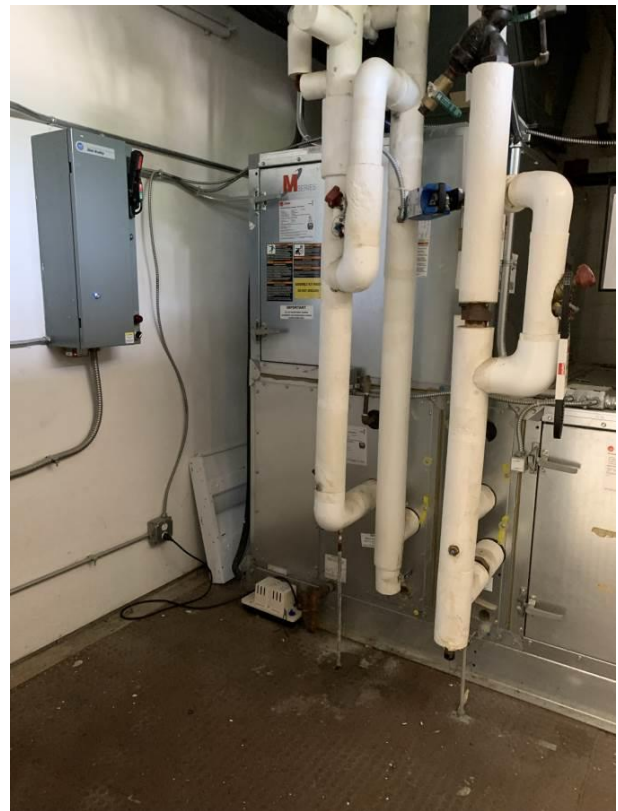
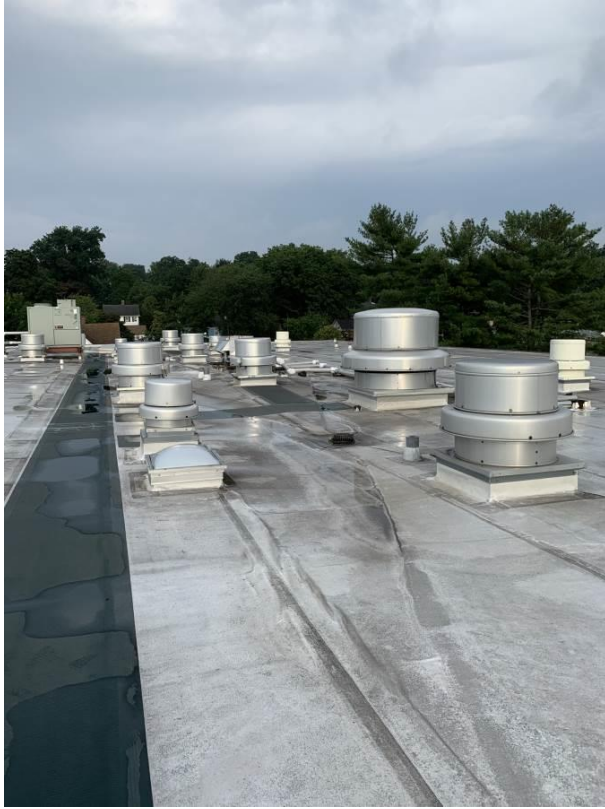
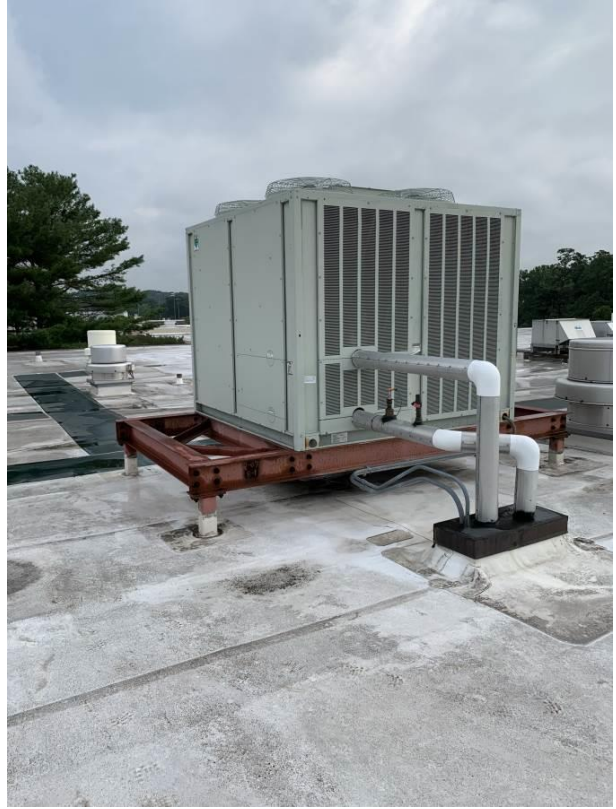
Cloonan Middle was originally constructed in 1967. Some mechanical systems have been renewed in the years following original construction, the latest of which are approximately noted as:

- (2) Hot Water Boilers, Burners – 2003
- (1) Hot Water Boilers and Burner – 2020
- Heating Water Pumps, Fuel Oil Transfer Pumps – 2003
- Fuel Oil Transfer Pumps – 2020
- Unit vents and Floor Fan Coil Unit – 2000
- Condensing Units – 2003
- Classroom Air Handling Units – 2008
- Gym Air Handling Unit – 2010
- Chiller – 2005
- Centrifugal Roof Exhausters – 2010
- Kitchen Hood, Exhaust Fans, and Makeup Air Fan – 2010

Most mechanical systems will need to be replaced within the 10 year study period, other than the boilers, burners, and pumps that were replaced in 2020.

The mechanical system at Cloonan MS does not provide adequate ventilation or air conditioning. Based on existing equipment conditions and an initiative to add air condition building-wide, the District-Wide Summary: 10 Year Forecast Cost Analysis contains an allowance for the wholesale system replacement including demolition of the current system including central plant and distribution. This approach takes into consideration only select capital improvement needs in the Deferred Maintenance & Asset Renewal Report not impacted by system replacement.

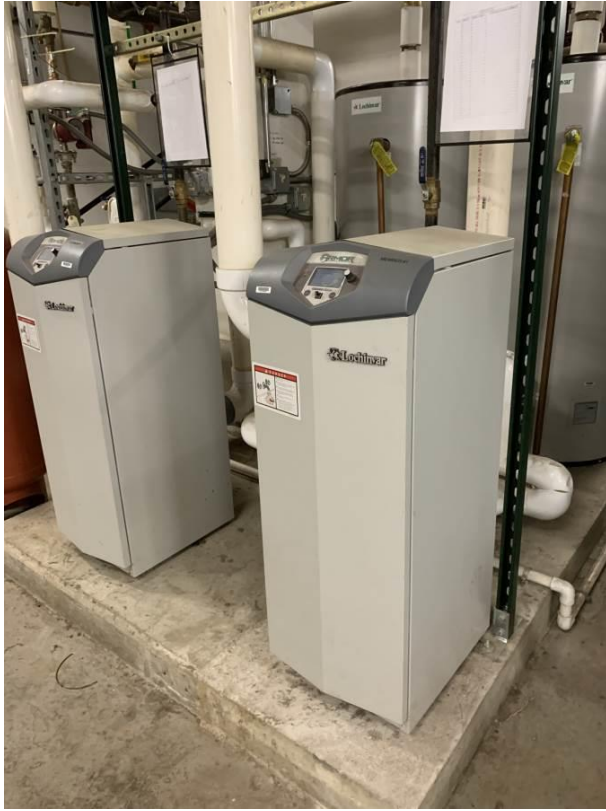
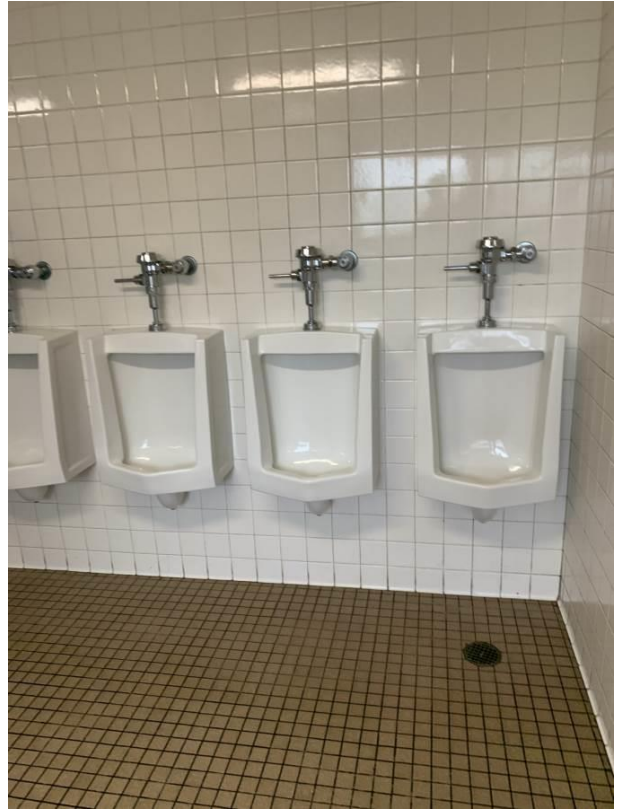
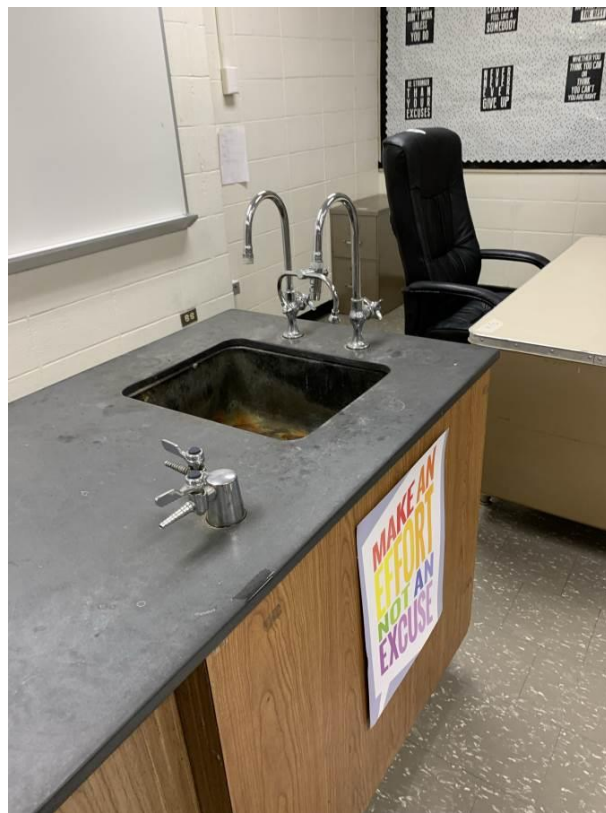
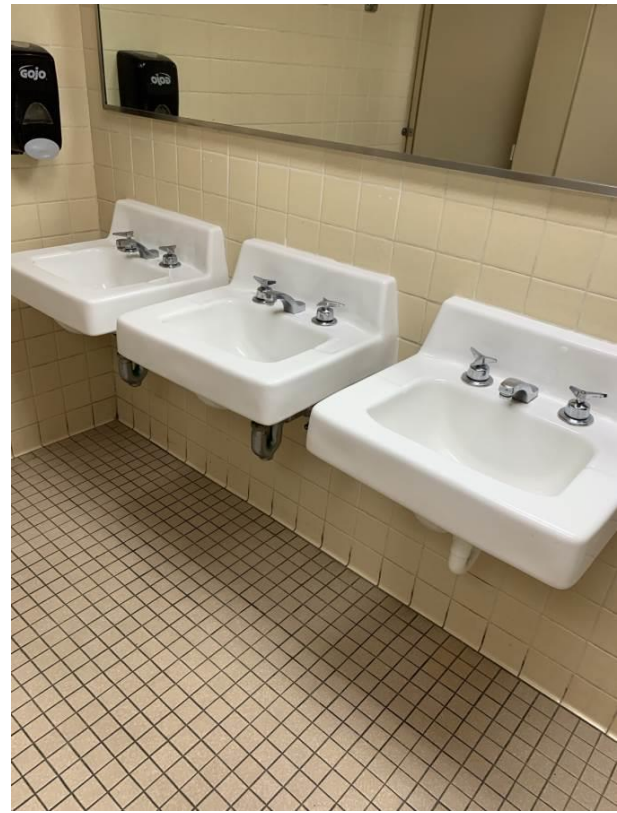
- Domestic Water Piping System
- Sanitary Piping System
- Laboratory Gas Piping and Fixtures
- Mop and Utility Sinks
- Showers
- Drinking Fountains

All major plumbing systems, including domestic and sanitary piping, should be replaced within the 10 year study period.

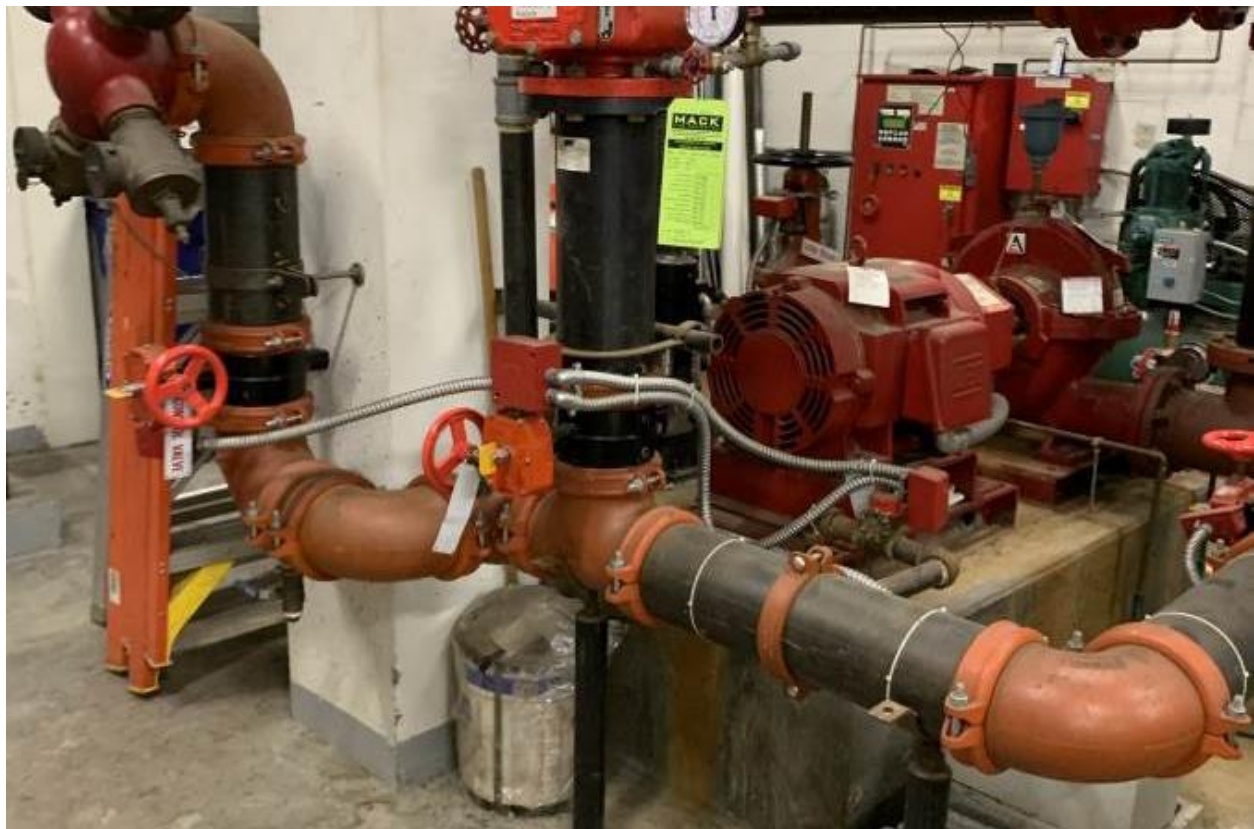
The sprinkler system in the main building was installed in 2009 and will reach the end of its useful life in 18 years so. It will not need to be replaced within the 10 year study period. However, the Fire Pump that was installed in 2009 will reach the end of its useful life in 3 years and therefore will need to be replaced within the study period.

Main building fire alarm system is old but functional (the fire alarm system was being checked by the school and factory rep during the assessment). All Classrooms and bathrooms have audio/visual devices. There is a separate fire pump for supply and battery backup for the system.

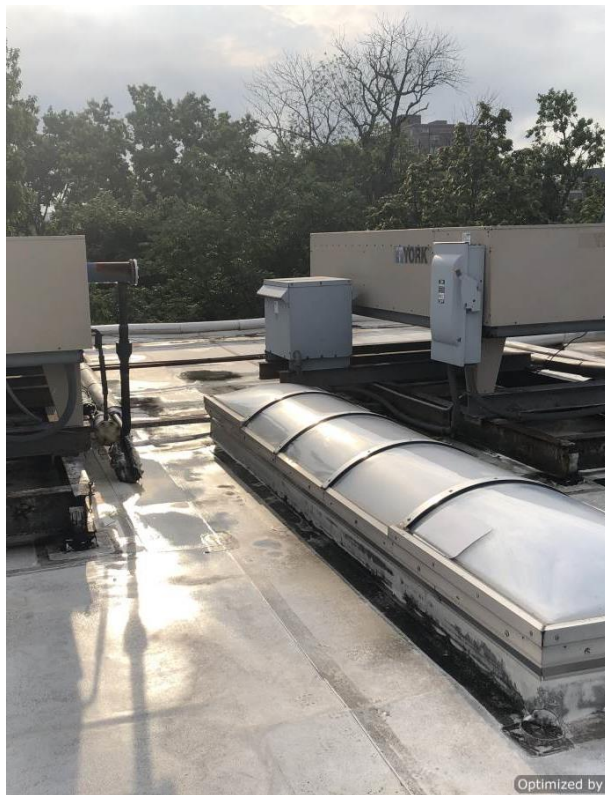
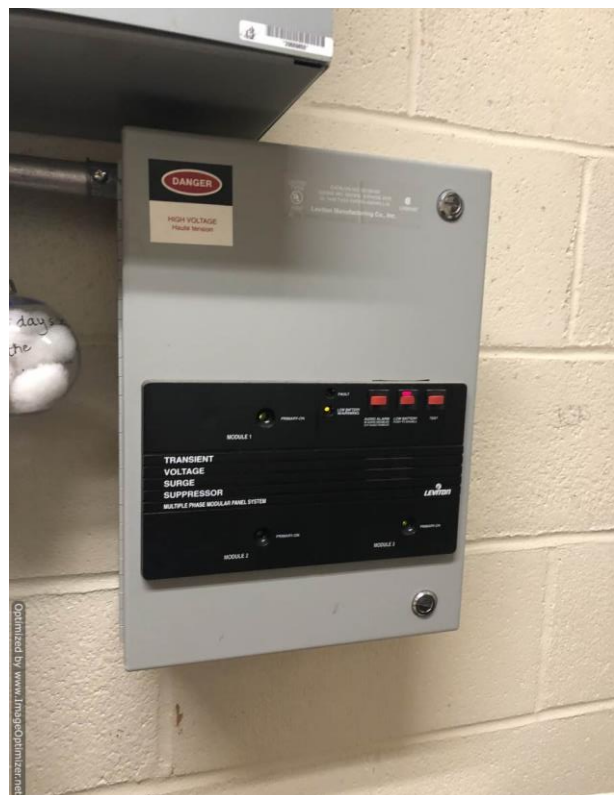
The building is powered by utility owned outdoor pad mounted transformer located in the front of school. Secondary service feeder from this transformer to a transformer in a Utility locked vault in the back of the building. Located in the rear ground floor Switch Gear room is a 1600 amp rated disconnect switch with distribution sections. On each floor there are 480V Transformers with 208V 3PH/120v single phase output. Panels located in the building are powered from these transformers. Branch circuits for outlets, lighting and equipment originate from these panels. Most of the wiring in the building is original since the time of construction. Building's Emergency and Exit lights are powered by a 100 kW diesel/gas converted generator set and automatic transfer switch located in lower level Generator Room. Lighting throughout the school is LED. Light fixtures are either recessed or surface mounted. Classroom lights are controlled by wall switches and motion sensors.

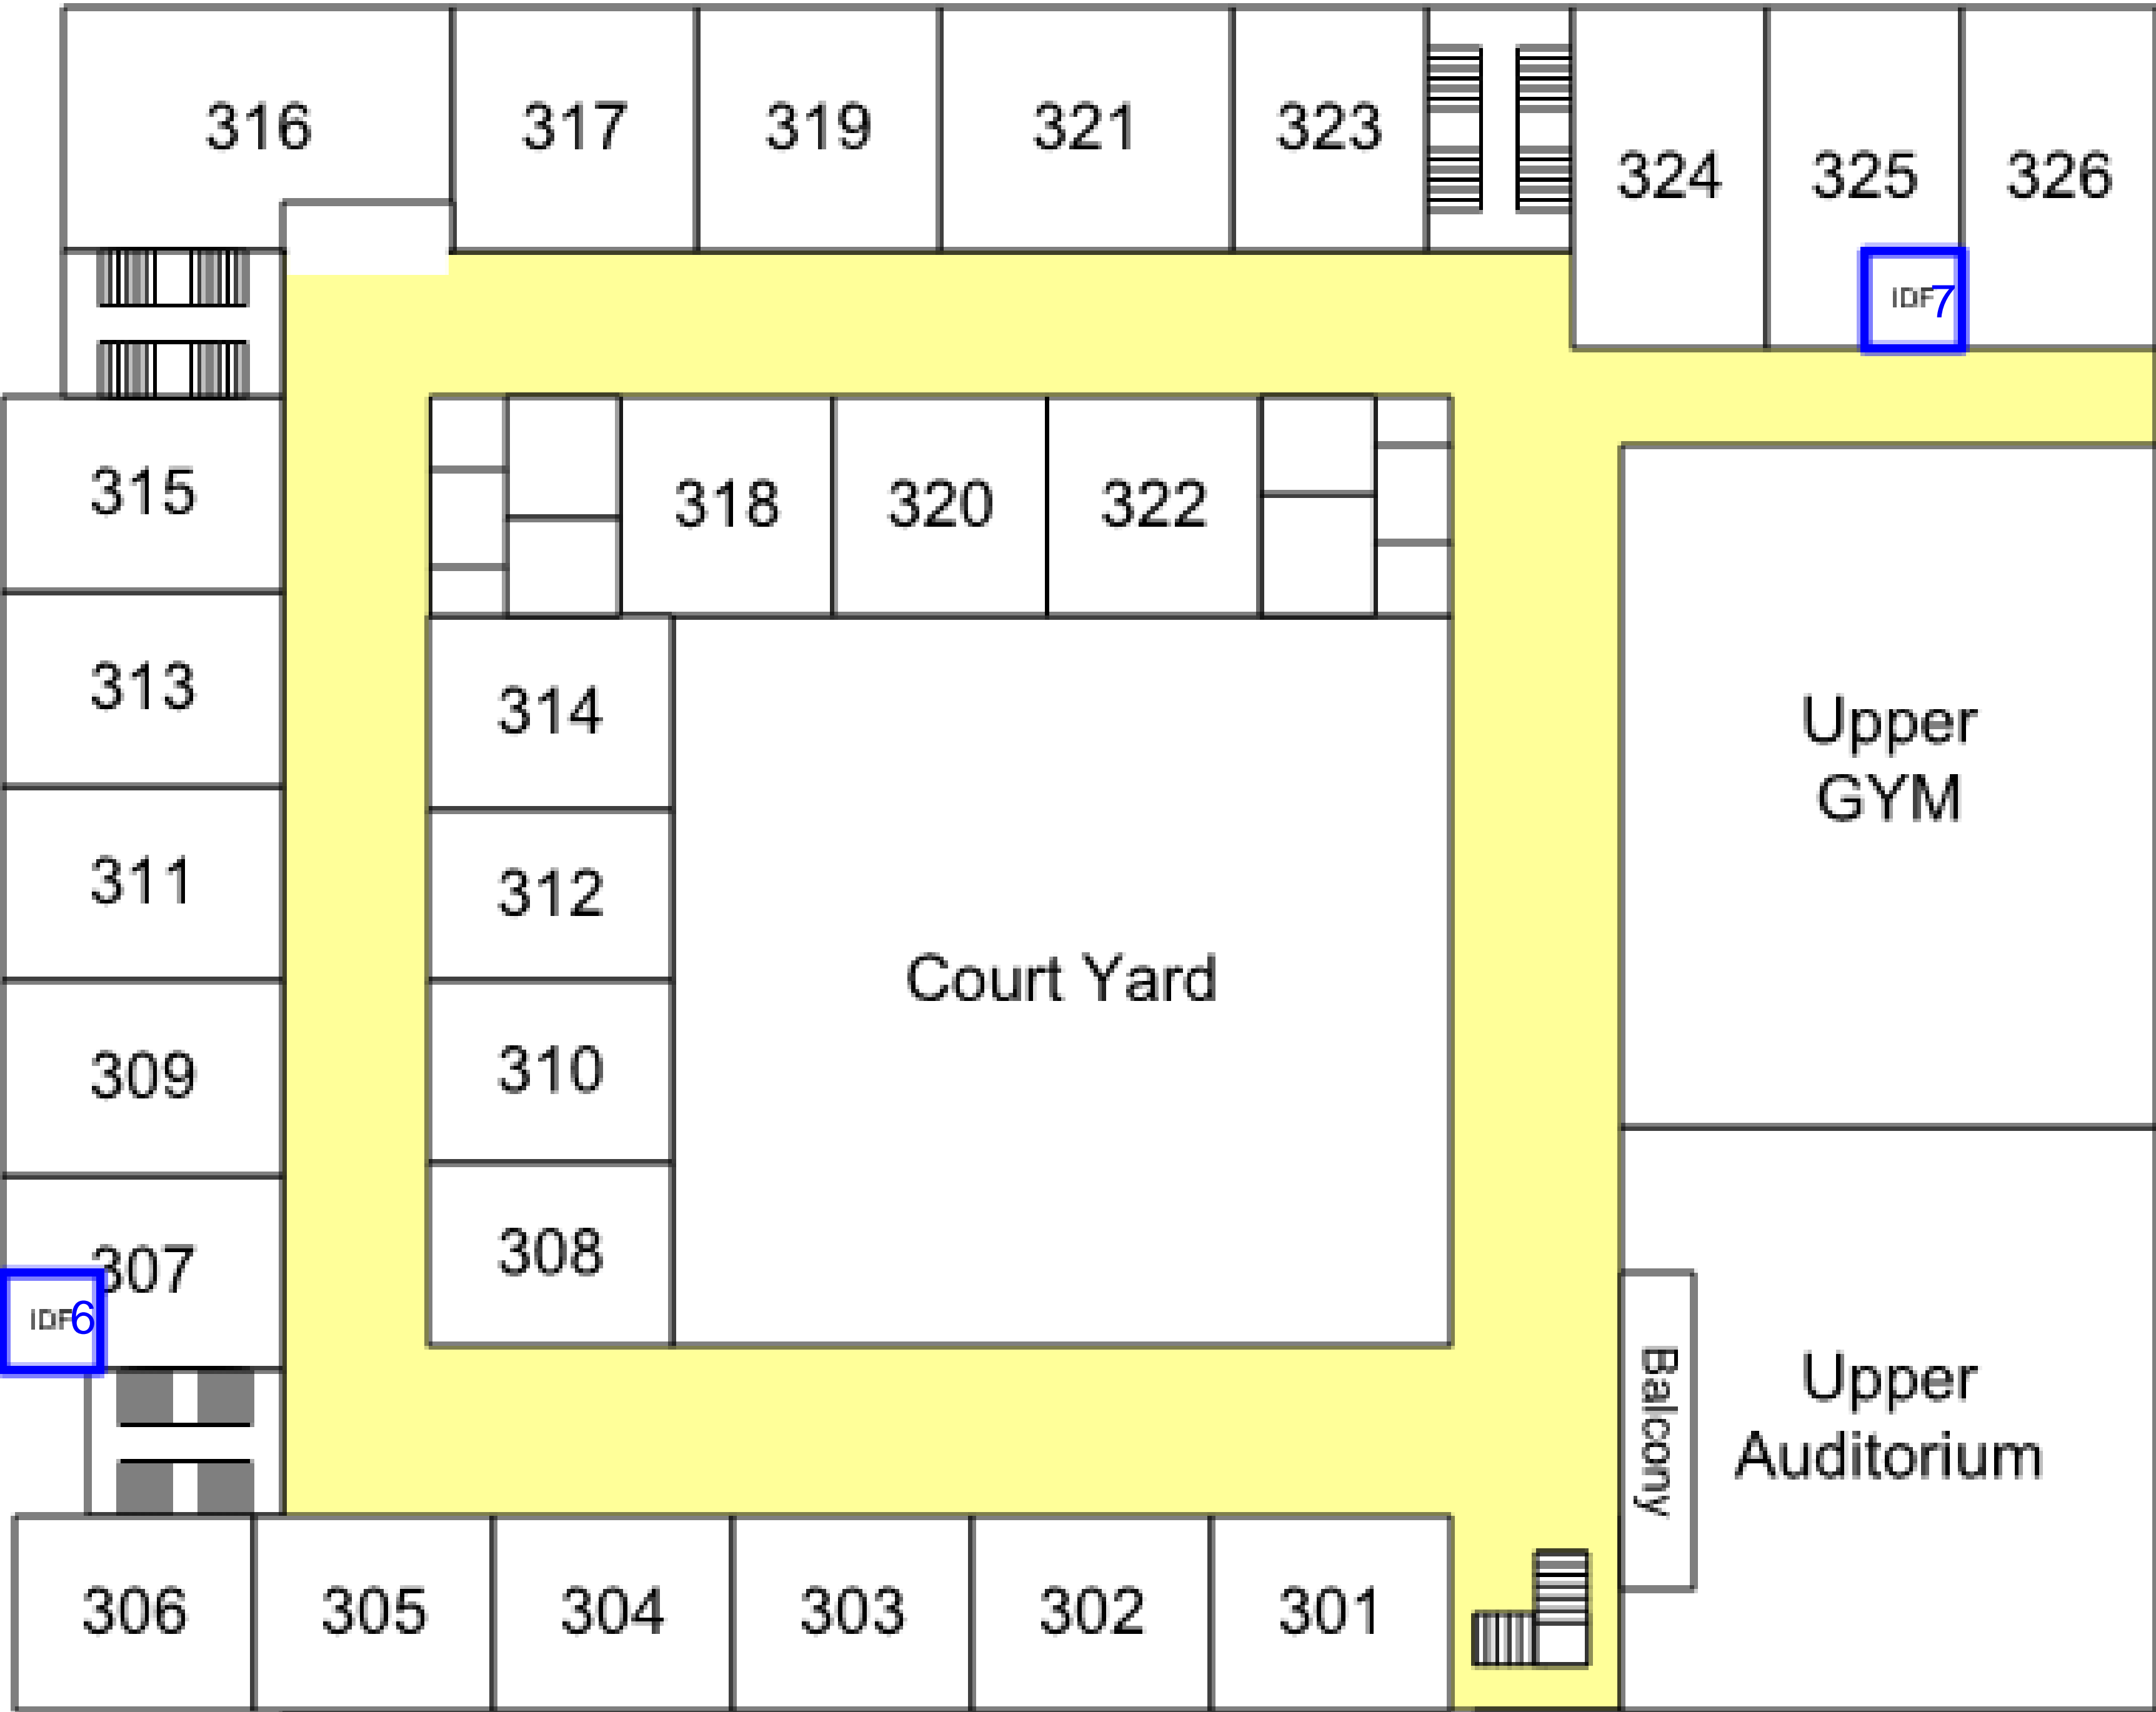
### Second Floor

## LAN Closets Locations

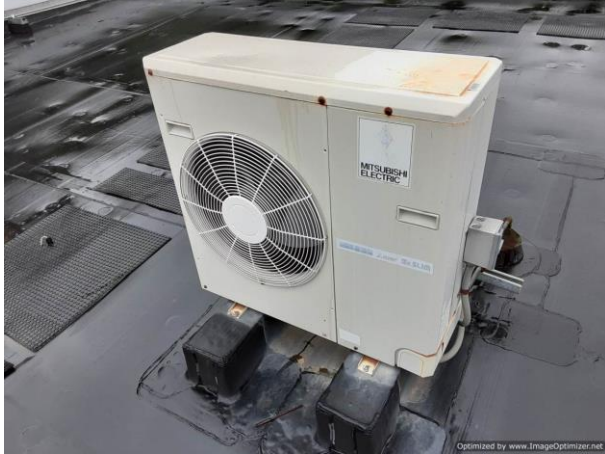
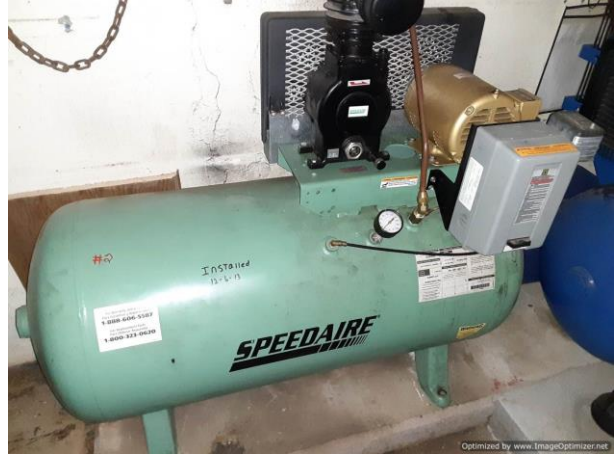
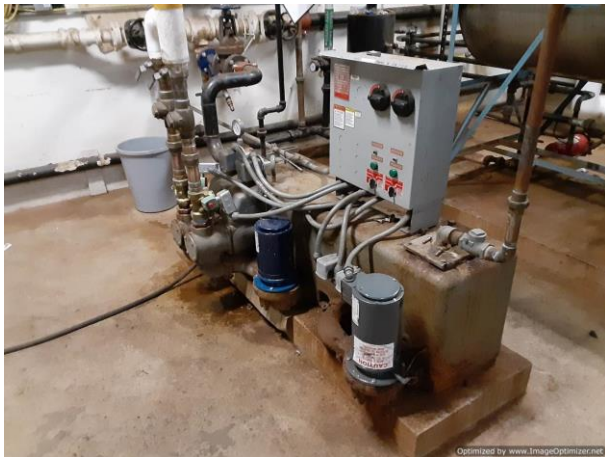
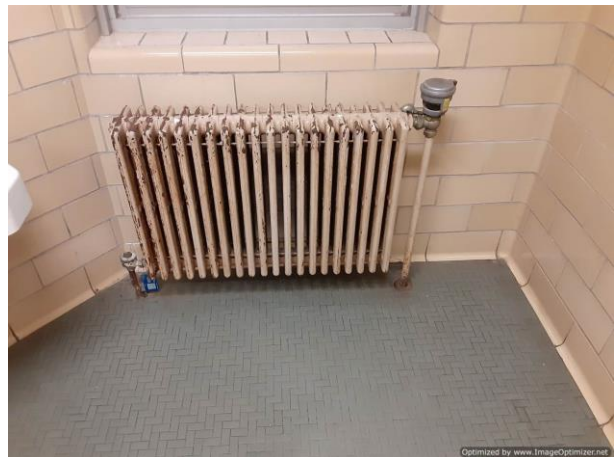
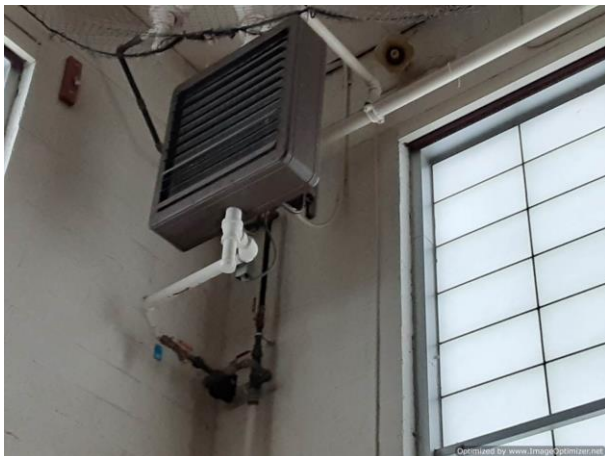
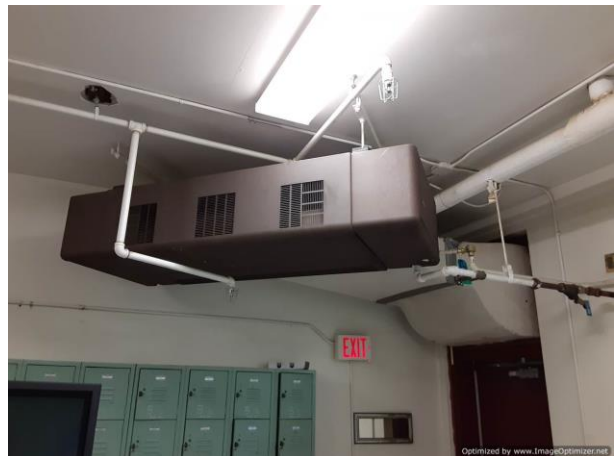
The mechanical system at Dolan MS does not provide adequate ventilation or air conditioning. Based on existing equipment conditions and an initiative to add air condition building-wide, the District-Wide Summary: 10 Year Forecast Cost Analysis contains an allowance for the wholesale system replacement including demolition of the current system including central plant and distribution. This approach takes into consideration only select capital improvement needs in the Deferred Maintenance & Asset Renewal Report not impacted by system replacement.

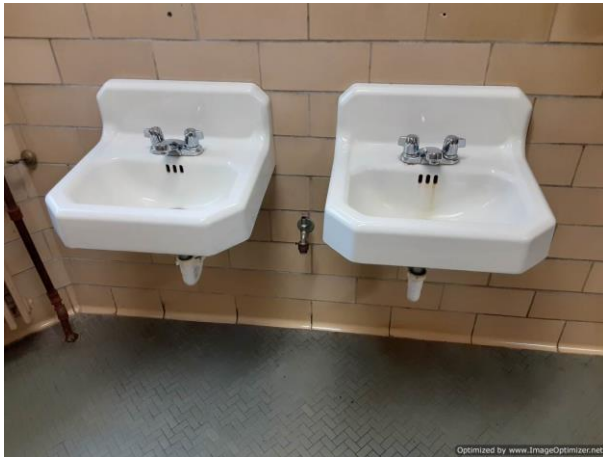
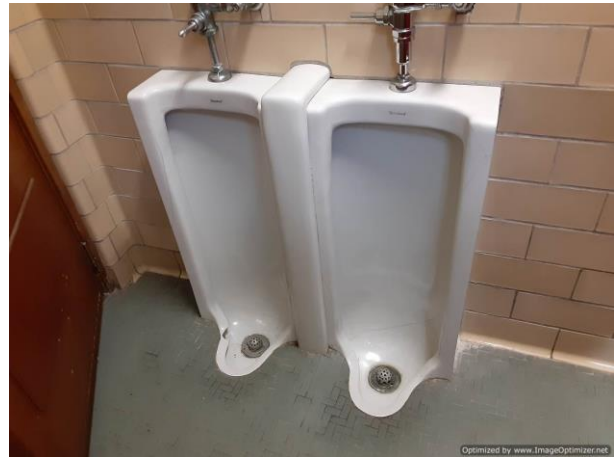
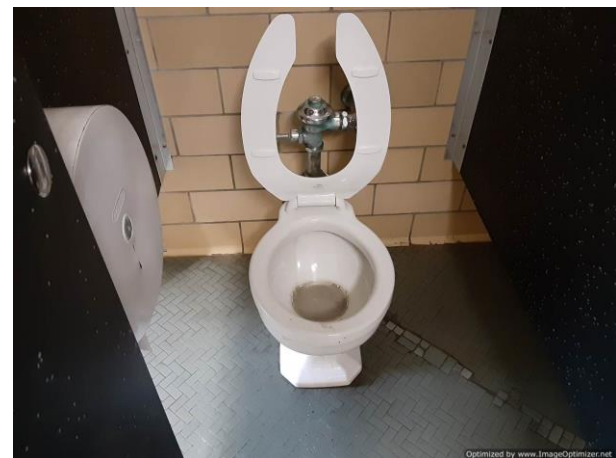
The main building plumbing systems appears to largely be original. Hot water is provided by two gas fired hot water heaters and circulators which were replaced in 2019 as part of the boiler room flood repairs. Fixtures appear to have been replaced sporadically throughout the years on an as needed basis. Water coolers are being replaced with bottle fillers building wide by the district. Fixtures, domestic water and sanitary waste piping should be replaced within the assessment period.

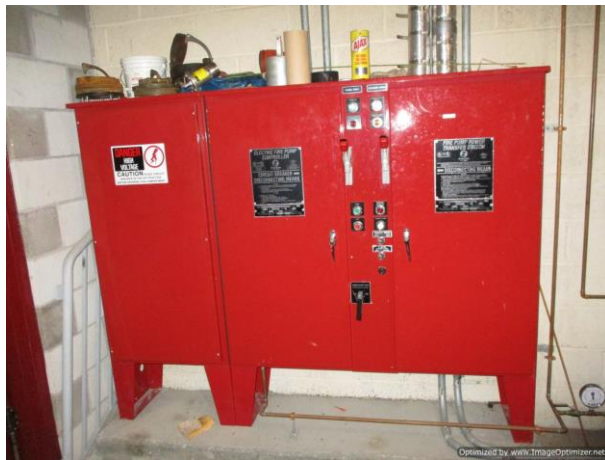
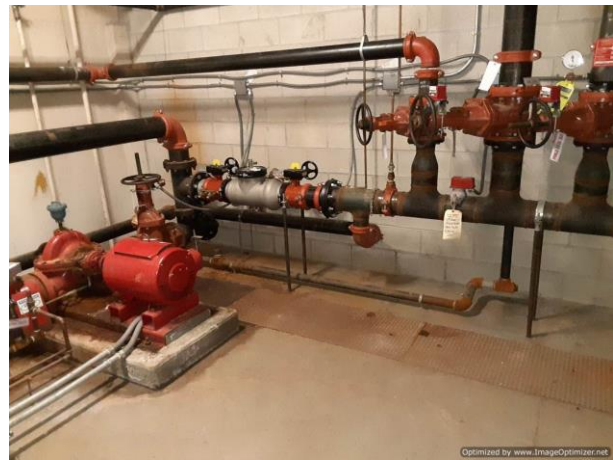
The building sprinkler system was installed in 1997 and will reach the end of its 30 year useful life in 6 years. The sprinkler system, fire pump, jockey pump and controller should be planned to be replaced within the assessment period.

Fire alarm system (Mfg. - EST) was recently installed with wiring and devices. Fire pump rated for 40 hp provides water force for sprinkler system.

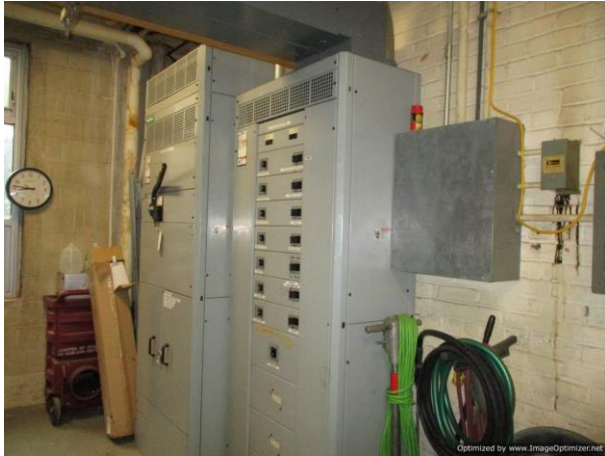
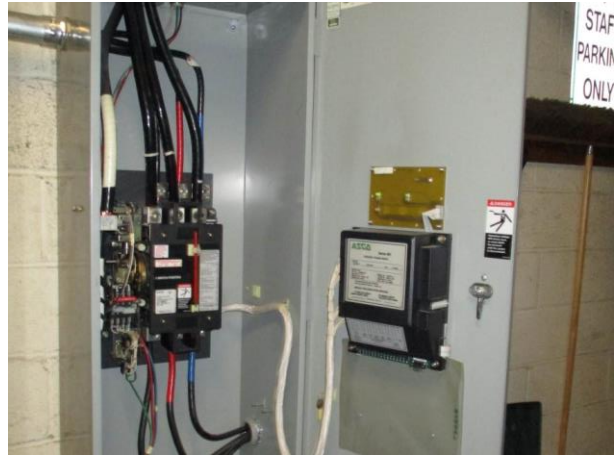
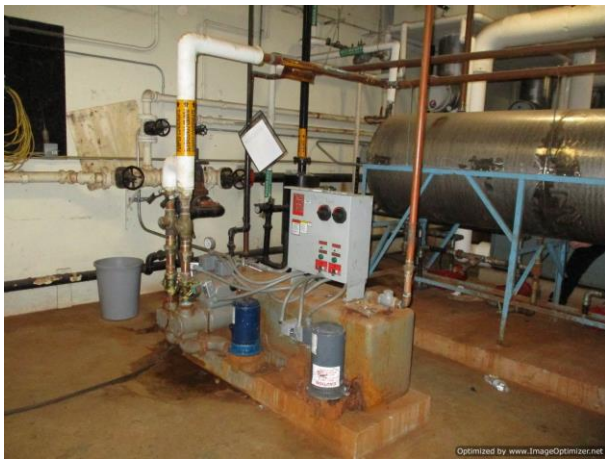
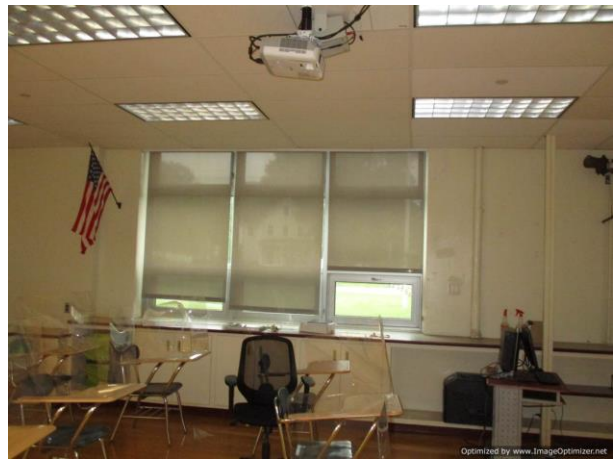
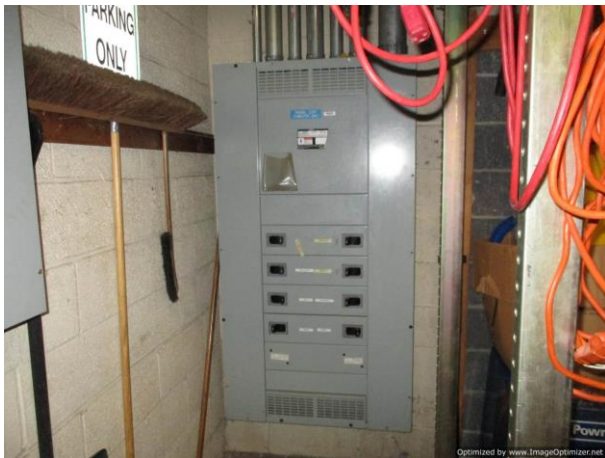
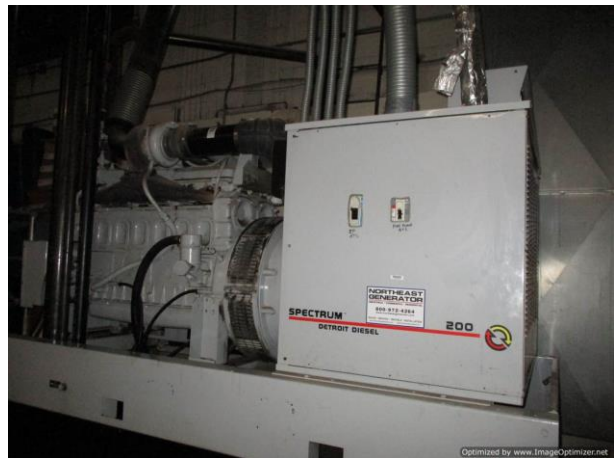
Service to the building is provided by utility company owned transformer bank located in the electrical vault. Secondary service feeders from this bank terminate into a 2000 amp fused disconnect and distribution section with feeder breakers. 208 Y/120 volt power is distributed to panelboards located throughout the building. Branch wiring to lighting and equipment originate from this panelboard. Wiring is old in most of the building except done during recent renovation work. Generator set rated for 200 KW powers emergency/exit lights and a 40 horse power fire pump. Lighting has been converted to LED lamps recently. Classrooms lights are controlled by wall switches and motion sensor.

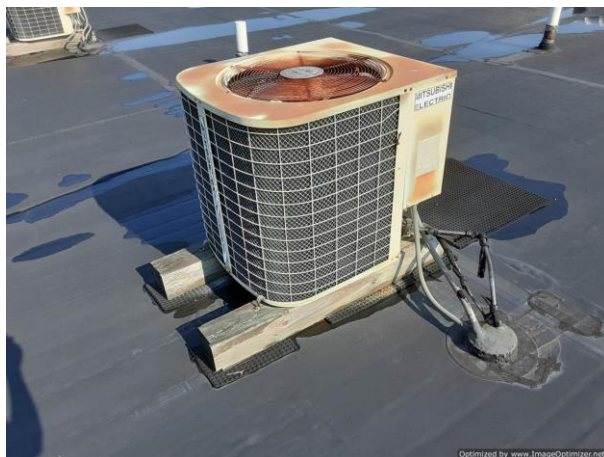
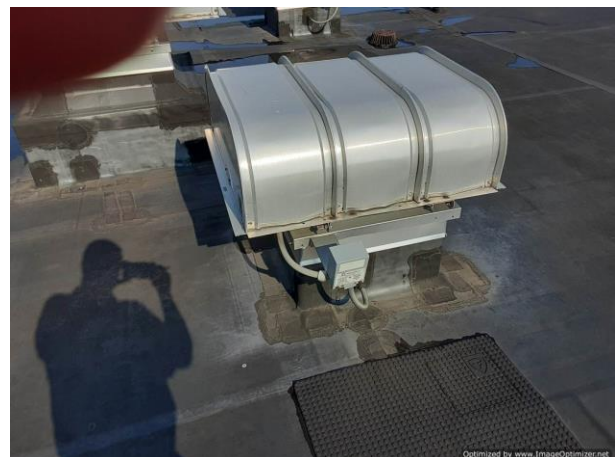
The mechanical system at Rippowam MS does not provide adequate ventilation or air conditioning. Based on existing equipment conditions and an initiative to add air condition building-wide, the District-Wide Summary: 10 Year Forecast Cost Analysis contains an allowance for the wholesale system replacement including demolition of the current system including central plant and distribution. This approach takes into consideration only select capital improvement needs in the Deferred Maintenance & Asset Renewal Report not impacted by system replacement.

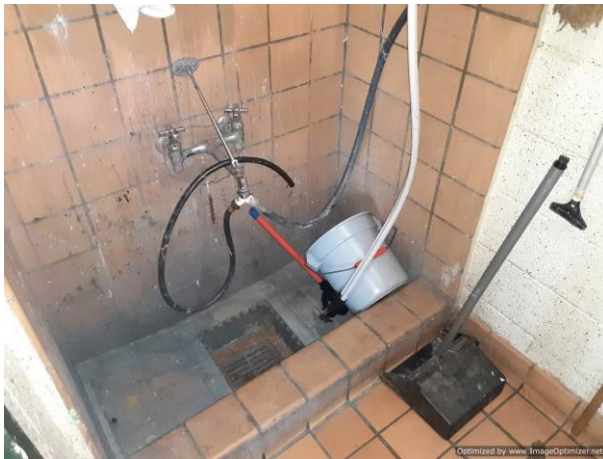
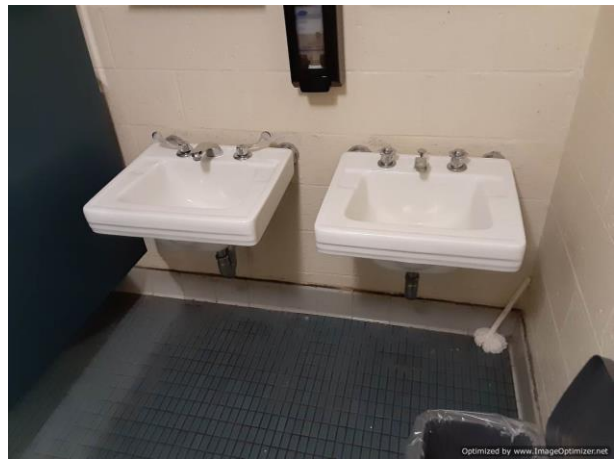
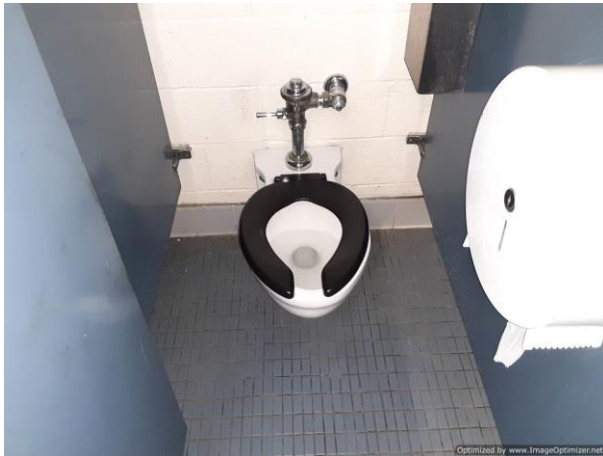
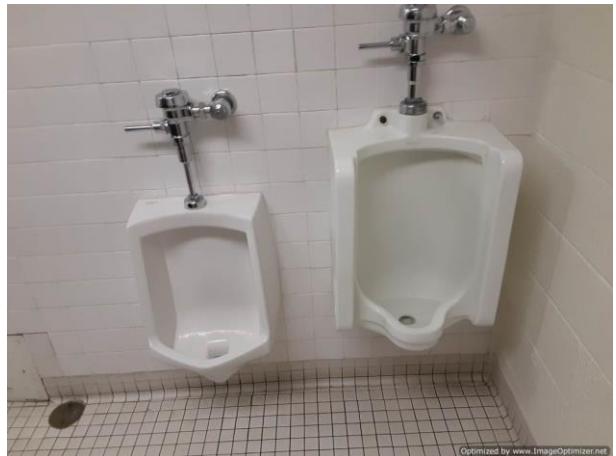
The main building plumbing systems appears to largely be original. Hot water is provided by three hot water heaters and circulators which are being replaced as part of the boiler room project. Fixtures appear to have been replaced sporadically throughout the years on an as needed basis. Water coolers are being replaced with bottle fillers building wide by the district. Fixtures, domestic water and sanitary waste piping should be replaced within the assessment period.

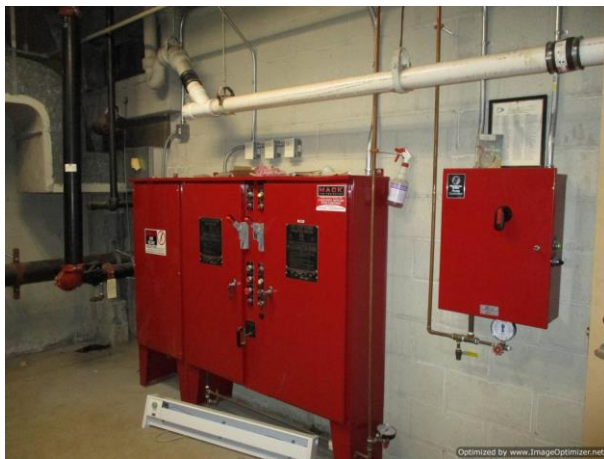
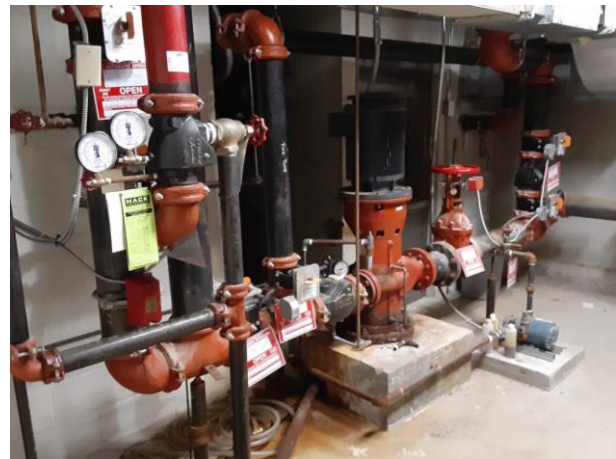
The building sprinkler system was installed in 2002 and is in good condition not requiring replacement in the assessment period. The fire pump, jockey pump and controller should be planned to be replaced within the assessment period.

Fire alarm system was installed in 2006 with devices and main console with voice evacuation system for the building. Building is fully sprinklered with mix of wet system and dry system sprinkler systems. A 40 hp fire pump and jockey pump provides water force required for sprinkler system.
