## Cloonan MS Facility Assessment & Analysis Report

Cloonan Middle  
11 West North Street  
Stamford, Connecticut 06902

StudioJAED  
42 Weybosset Street, Suite 403  
Providence, RI 02903  
401.648.0884

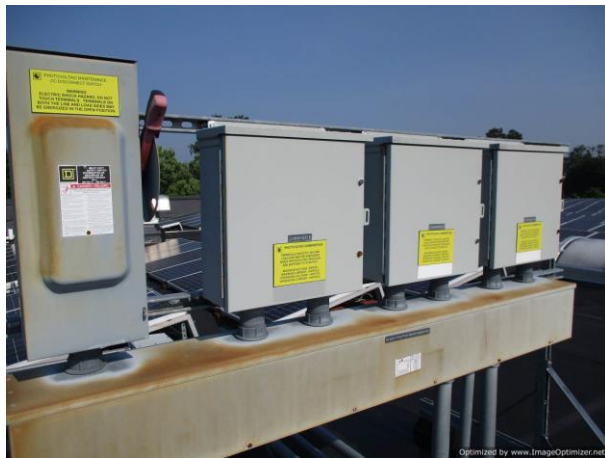
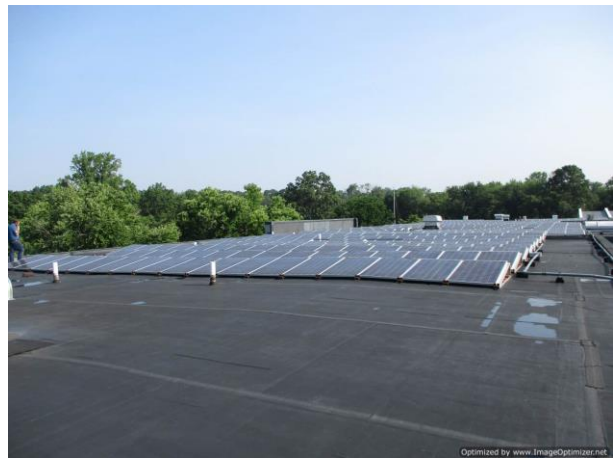
Main building is powered by utility company owned transformer bank located in the transformer room. Service feeder with 480 Y /277 volt power is terminated in 3000 amp fused switch and distribution sections located in the electrical room. Power to all panels originates from this switchboard thru fused disconnects in distribution sections. Equipment and receptacle requiring 208 Y /120 volt power is provided by drytype transformers located throughout the building. Feeder wiring is mostly in either rigid conduit or EMT conduits. Branch circuit wiring is mostly MC Cable or in EMT conduits. Standby generator set rated for 250 KW powers emergency lights and few equipment in the building. Emergency power to life safety loads and normal loads have dedicated Automatic Transfer Switches. Property has roof top mounted photovoltaic panels rated for 202 KW. Power from photovoltaic panels feed into main switchgear. All lighting fixtures except those in gym and auditorium have been replaced with new LED light fixtures.

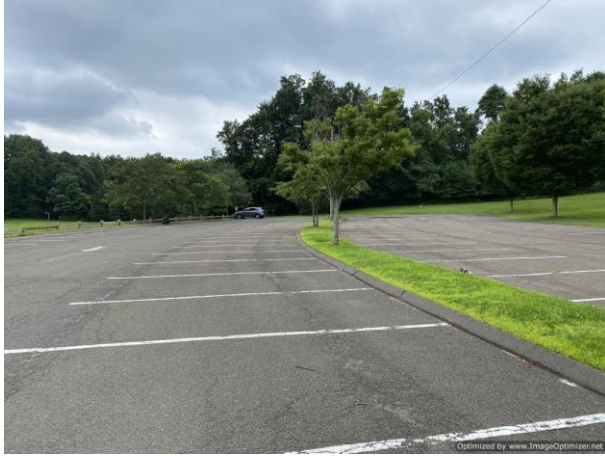
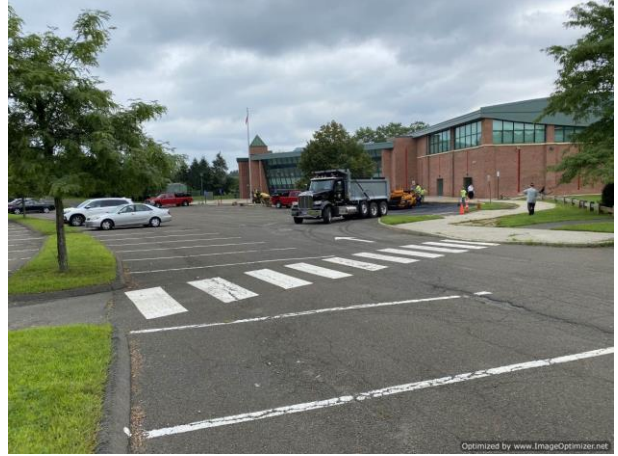
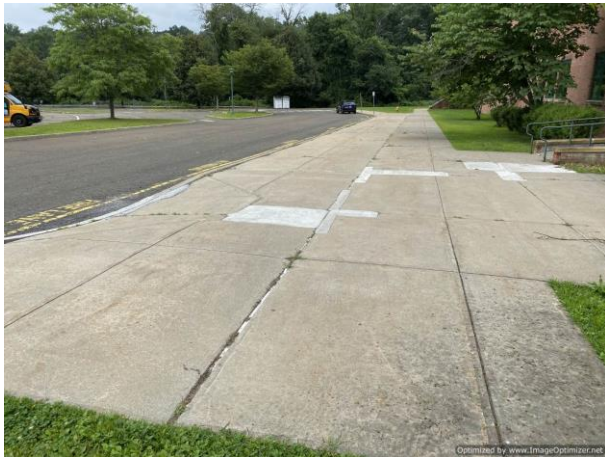
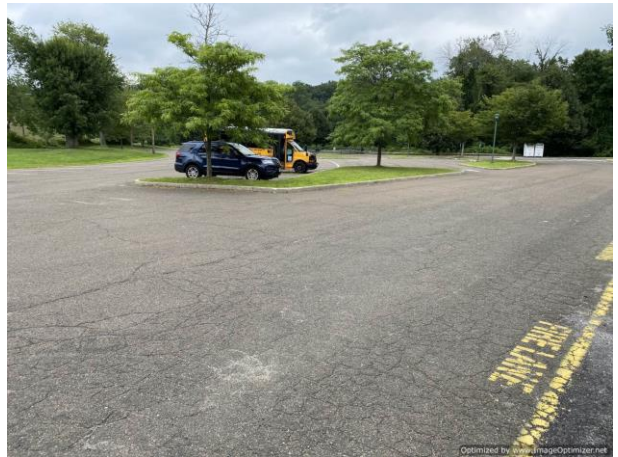
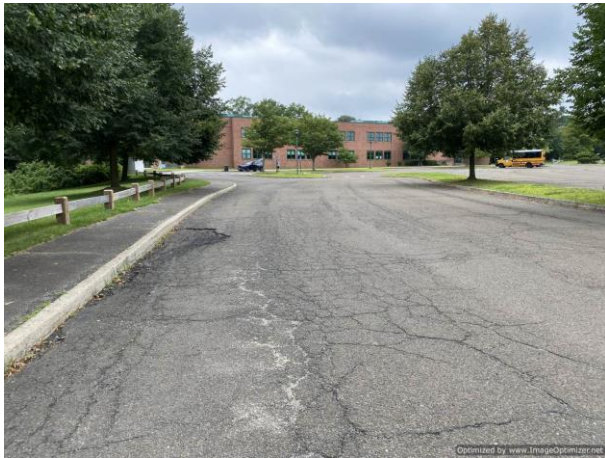
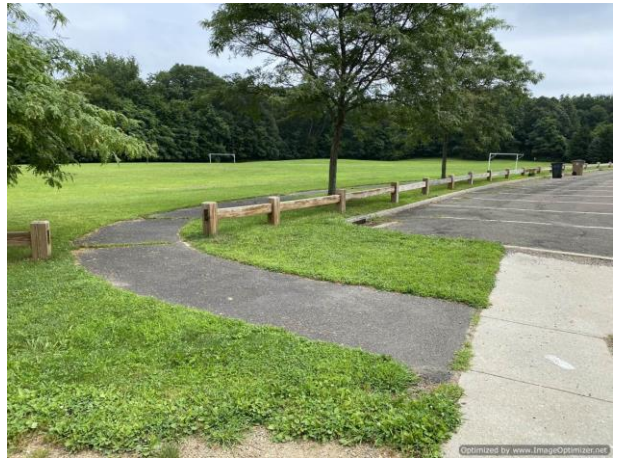
There are approximately 251 spaces in two open lots. The paved parking areas are in poor condition with evidence of cracking and pavement section deterioration. Paved drive isles are in poor condition. The drop off isle is in good condition and new. Curbing on site is fair condition. Sidewalk surfaces are in fair to poor condition. Site lighting is minimal, and a photometric study should be done to determine deficiencies that exist. Fencing is provided along the retaining walls, around the condensing units at the east side of the property, and around the gas meter at the west side of the property. The perimeter fencing is in good condition with isolated sections of damage. Grass play areas/field appear to be in good condition. There is no ADA access to the baseball field. Constructed play areas are not located on site. Storm water from the roofs, landscaped areas, and paved areas flows into on site inlets and catch basins. There is underground piping, which outfalls to a wetlands area located on the property.

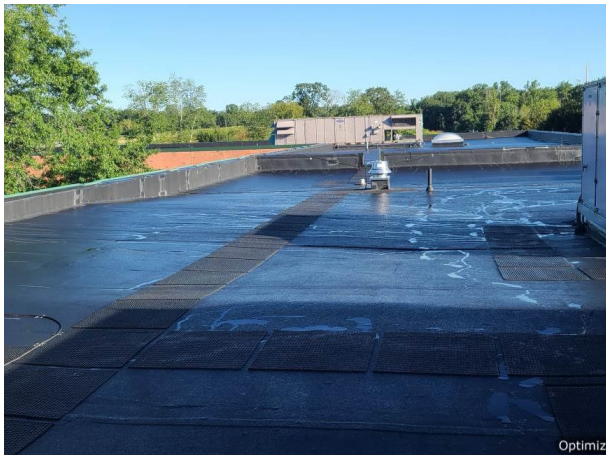
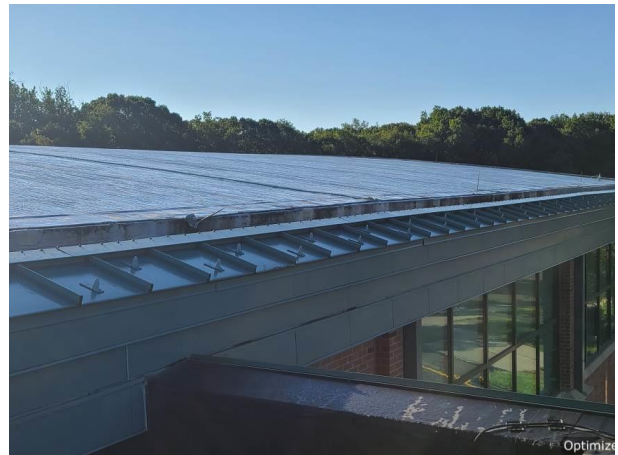
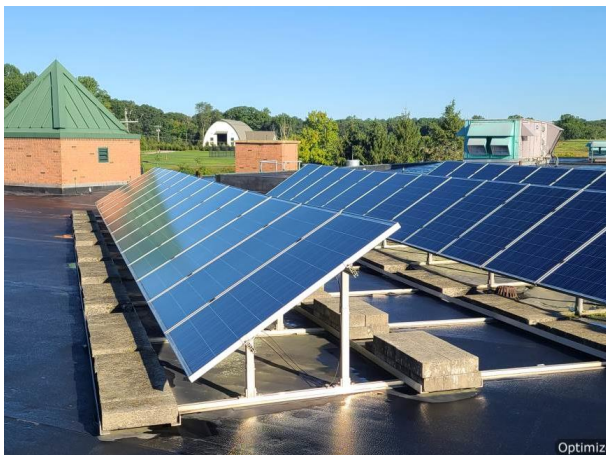
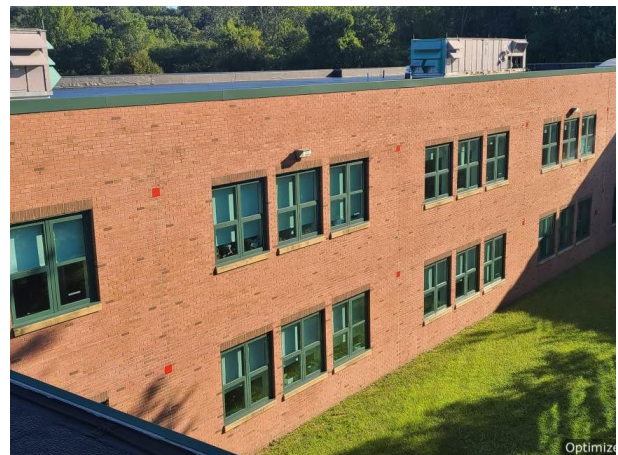
The exterior building envelope is in fair condition. EPDM roofing is recommended to be replaced. Exterior windows are recommended to be recaulked to prevent moisture infiltration. Portions of the exterior façade are in need of repair.

Interior floor finishes include resilient tile, ceramic tile, carpet, wood plank, and painted concrete slab and are in fair condition. Interior wall finishes include painted drywall, painted concrete, painted CMU, painted plaster, and ceramic tile and are in fair condition. Interior ceiling finishes include exposed structure, suspended acoustic tiles, and painted drywall and are in fair condition. All interior doors are worn and approaching the end of their useful life. Classroom and conference room projection equipment should be replaced.

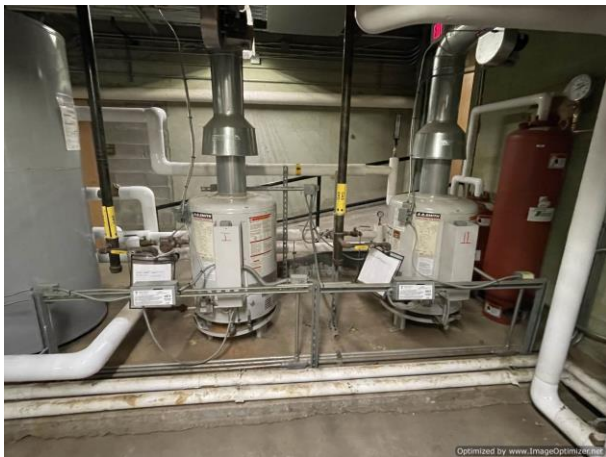
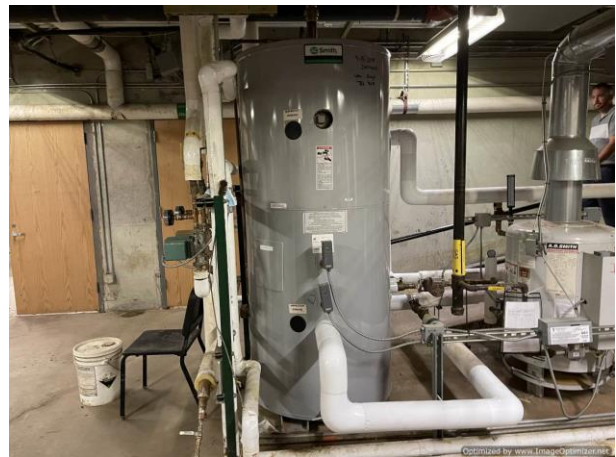
The building plumbing systems are provided by domestic hot water from 2 domestic water boilers, a domestic water storage tank, and hot water re-circulators located in the boiler room. These appear to be circa 2010. The building's plumbing fixtures and piping, etc. appear to be circa 2001.

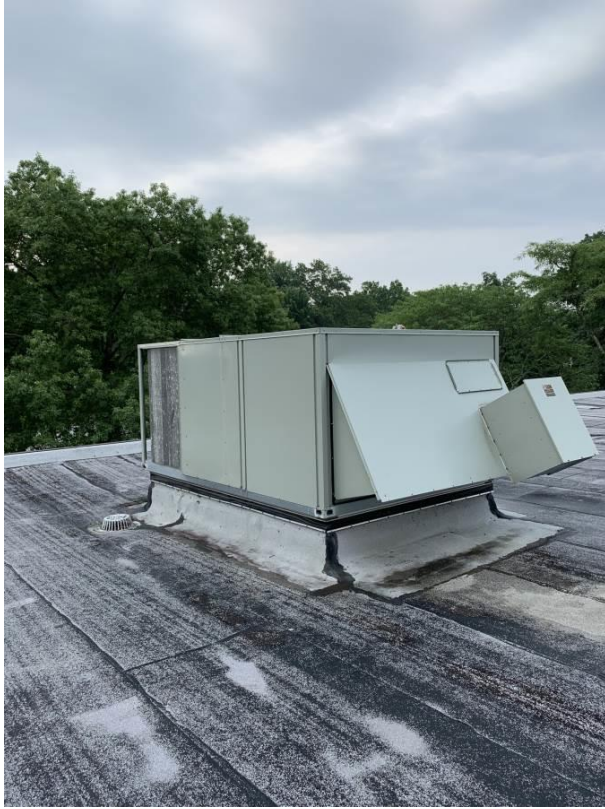
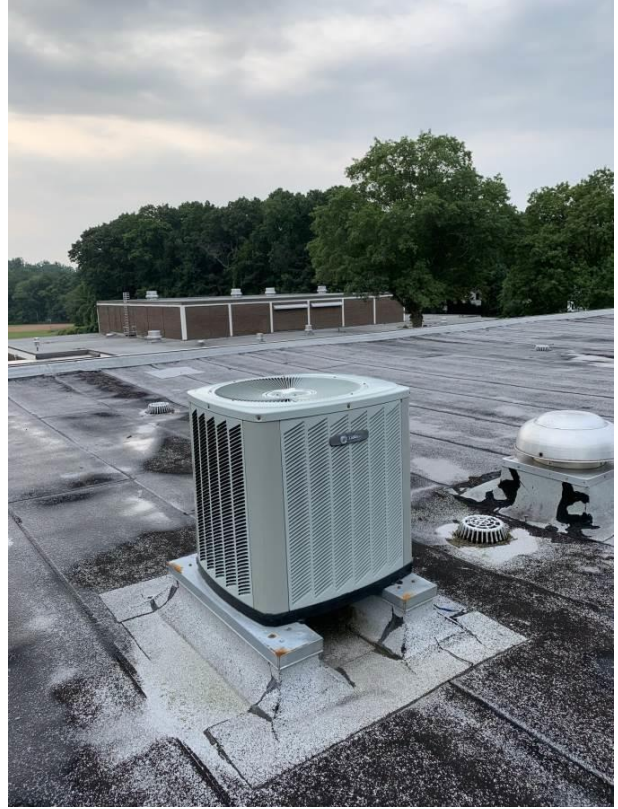
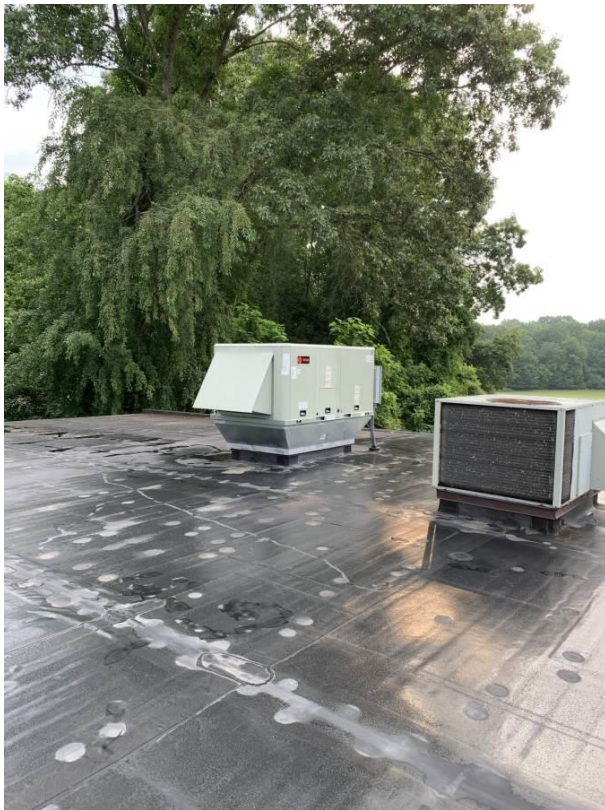
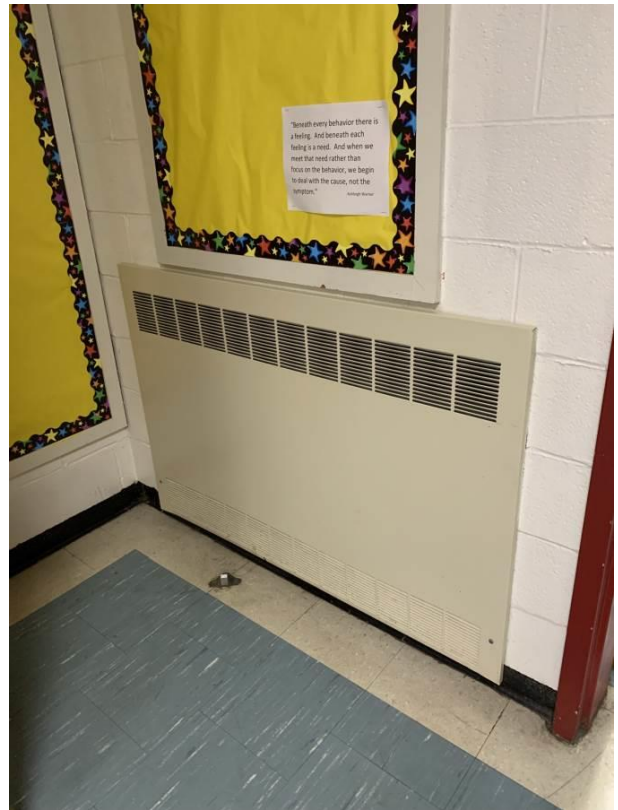
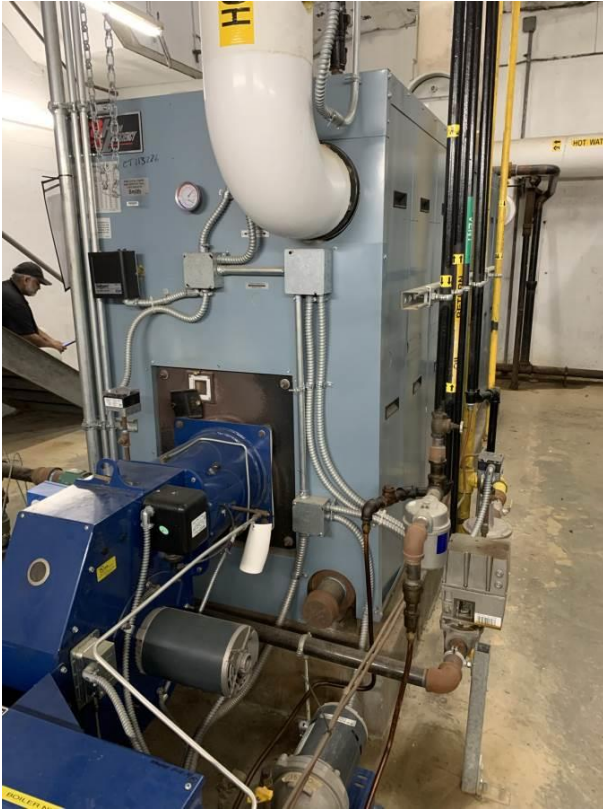
The main building is served by boilers and parts are air conditioned with Package Rooftop A/C & Heat Units. Other major core spaces are heated only and served by Air Handling Units and Supply Air Fans. Classrooms are served by Unit Vents.

The mechanical system at Turn of River MS does not provide adequate ventilation or air conditioning. Based on existing equipment conditions and an initiative to add air condition building-wide, the District-Wide Summary: 10 Year Forecast Cost Analysis contains an allowance for the wholesale system replacement including demolition of the current system including central plant and distribution. This approach takes into consideration only select capital improvement needs in the Deferred Maintenance & Asset Renewal Report not impacted by system replacement.

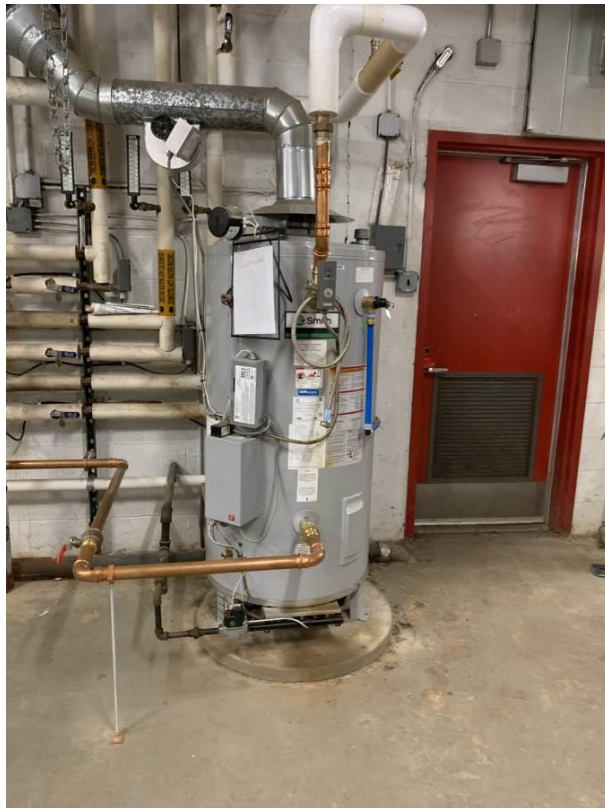
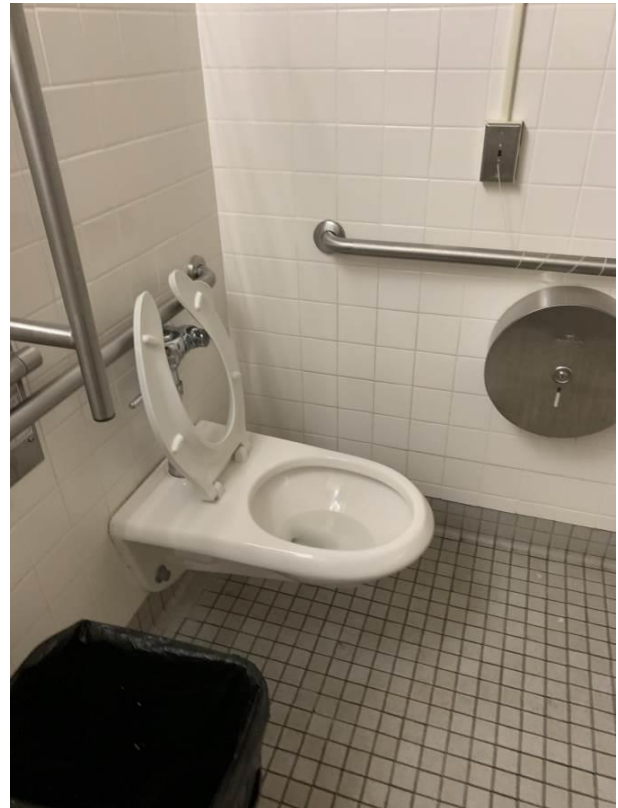
All major plumbing systems other than the newer plumbing fixtures and Domestic Water Heater will need to be replaced within the 10 year study period

There are minimal plumbing systems in the modular classroom buildings. All plumbing within the modular structure would require replacement within the study period. Based on existing conditions, it is the recommendation of this study that the modulares be replaced with a permanent structure, therefore replacement of these HVAC units is not in the report.

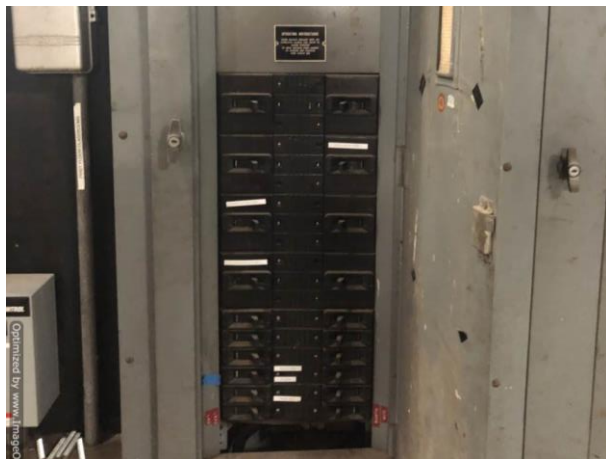
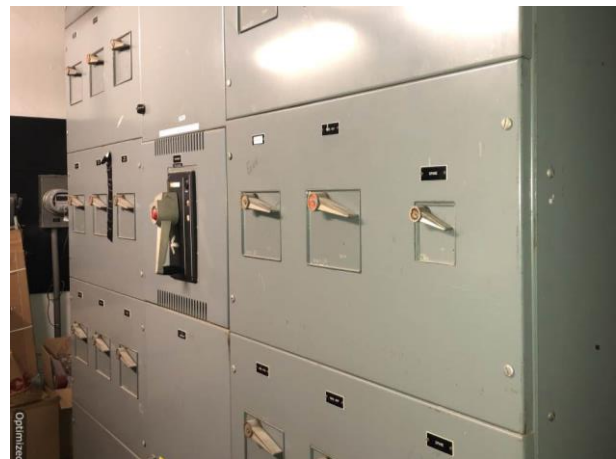
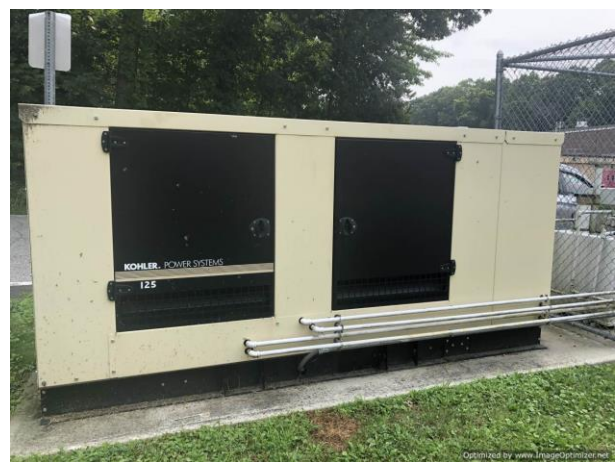
Modular classrooms are powered by Load Centers powered from the main switchgear. Wiring and LED lighting in Modular Classrooms are new with no known deficiency.

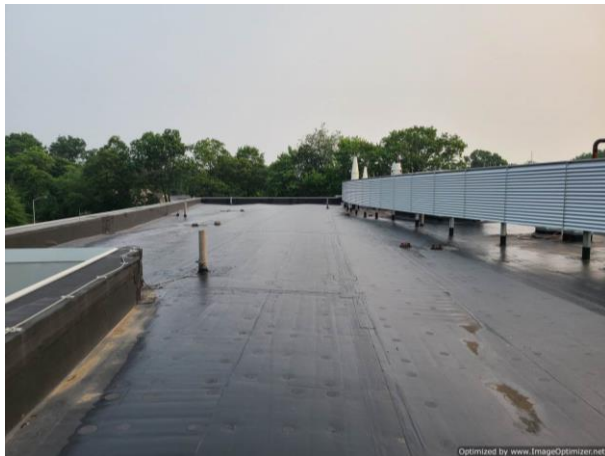
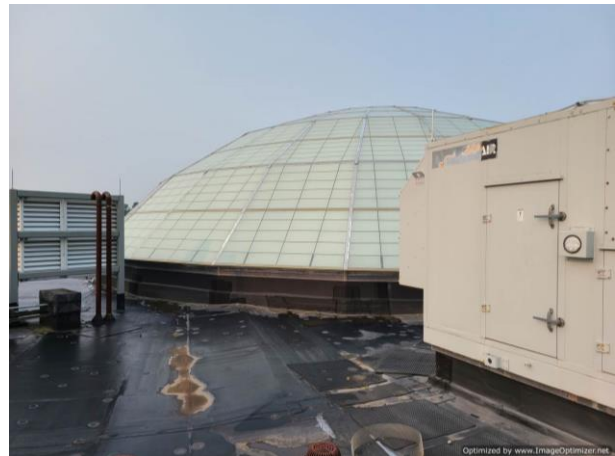
The exterior building envelope is in fair condition. The elastomeric roofing requires replacement. Select translucent panels require remediation and/or replacement. The exterior façade requires sealant to correct moisture infiltration.

Interior floor finishes include resilient tile, ceramic tile, carpet, wood, and concrete slab and are in good condition. Interior wall finishes include painted drywall, painted CMU, painted plaster, decorative panels, formed concrete, and ceramic tile and are in good condition. Interior ceiling finishes include exposed structure, suspended acoustic tiles, drywall, and painted plaster and are in good condition. Casework and countertops are good condition. Classroom and conference room projection equipment should be replaced.

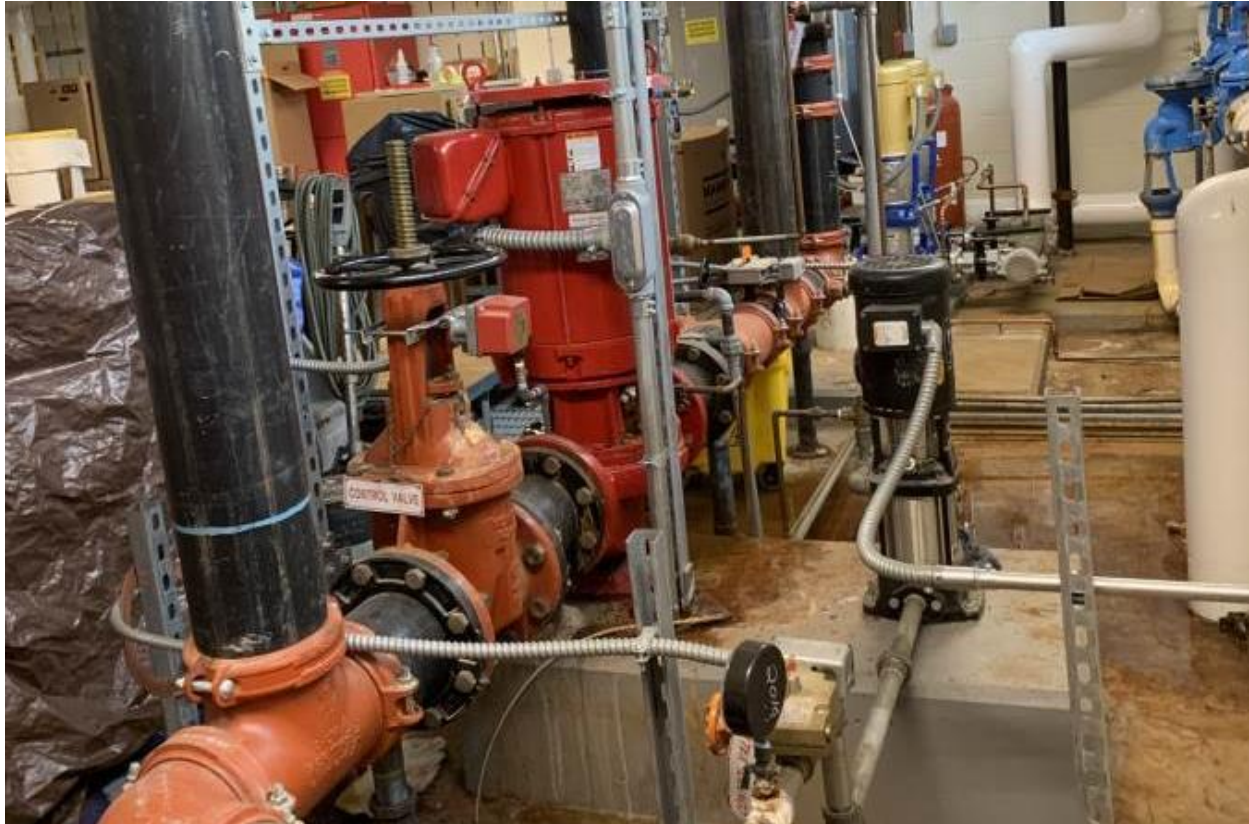
The sprinkler system was installed with the original construction of the building in 2007 and will reach the end of its 30 year useful life in 16 years.

Main building fire alarm system old but functional. Classrooms have audio/visual devices. There is a 480V 400A Water Pump part of the Fire safety system.

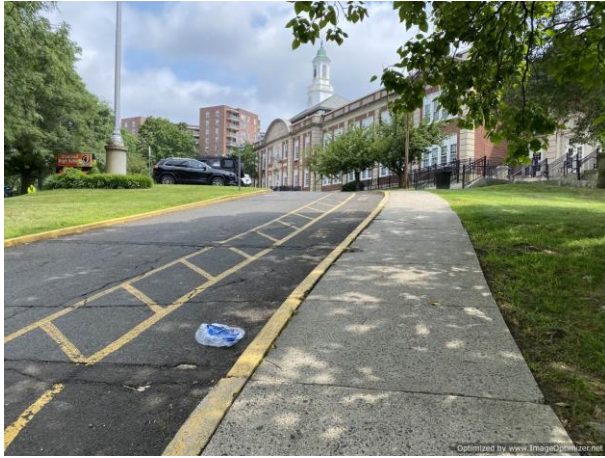
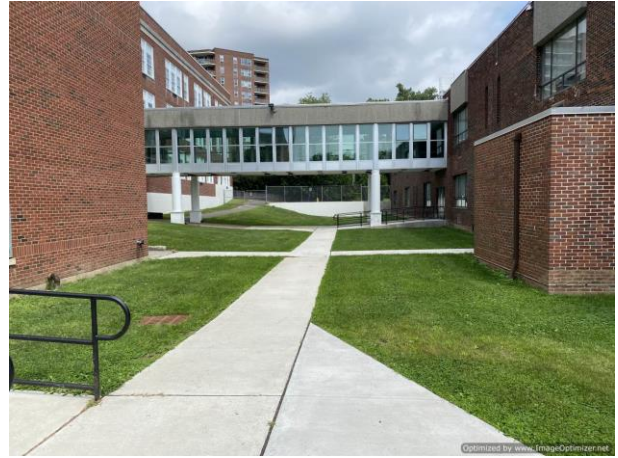
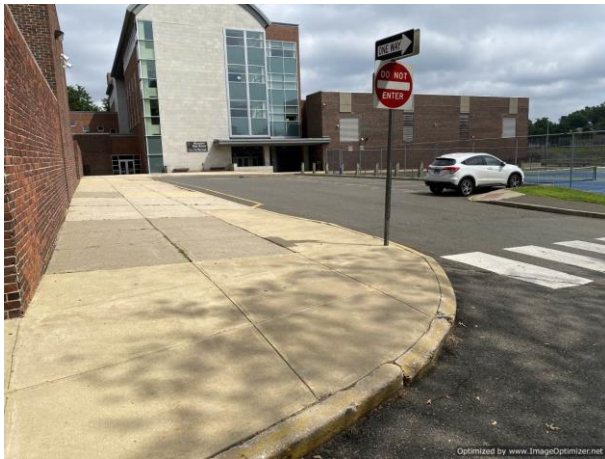
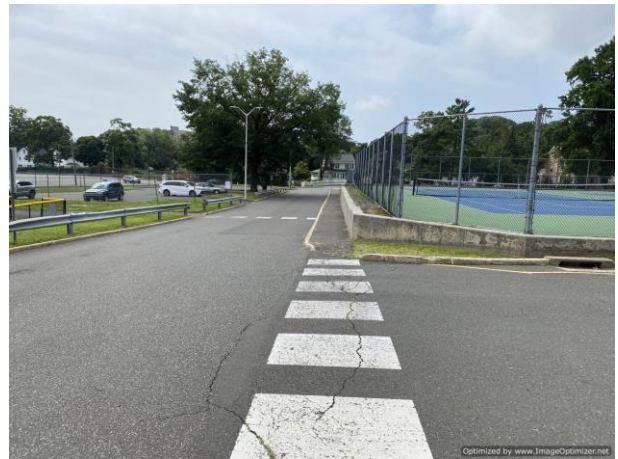
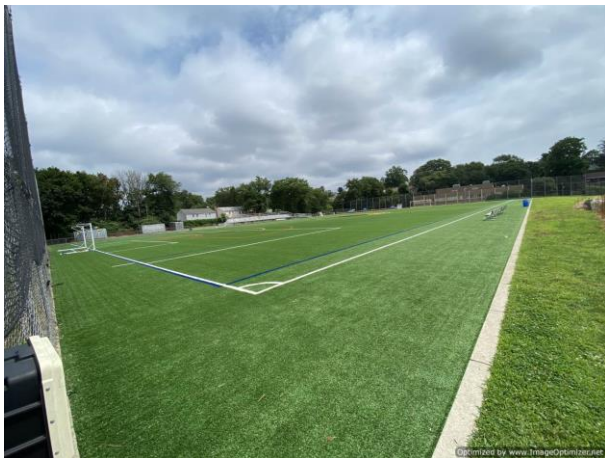
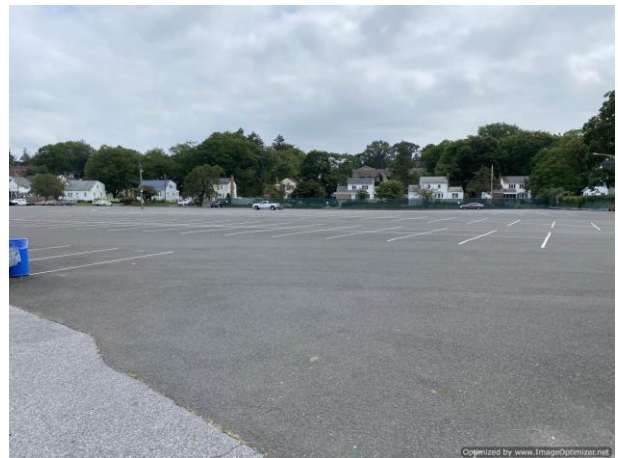
There are approximately 350 spaces in five open lots, one carport under the 9th grade annex. The paved areas are in fair to good condition with evidence of cracking and pavement section deterioration. The paved drive isles are in fair to poor condition. Sidewalk surfaces are in fair condition. Site lighting is minimal and a photometric plan should be done to see where deficiencies exist. Fencing is provided along the north, south, and east property lines and around the tennis courts, baseball fields, soccer field, and east parking lots. The perimeter fencing is in good condition with isolated sections of damage. Grass baseball and softball fields appear to be in good condition. The football field and soccer field are constructed of artificial turf in good condition. Storm water from the roofs, landscaped areas, and paved areas flows into on site inlets and catch basins with underground piping connected to the municipal storm water management system.

Sanitary sewer and the storm water sewer are provided by the Septic System. Domestic water is supplied by Aquarian, electrical service by CL&P, and natural gas is provided by Yankee Gas.

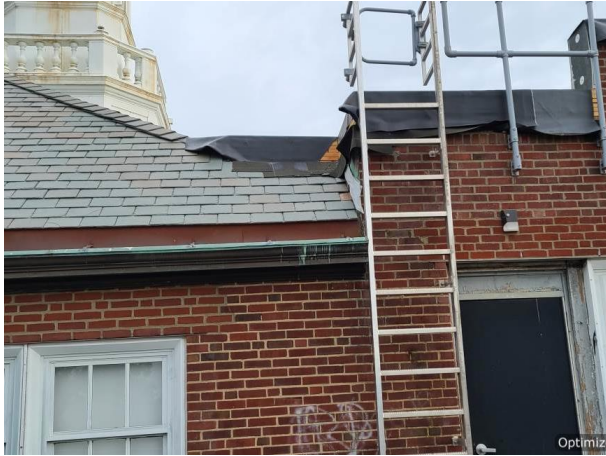
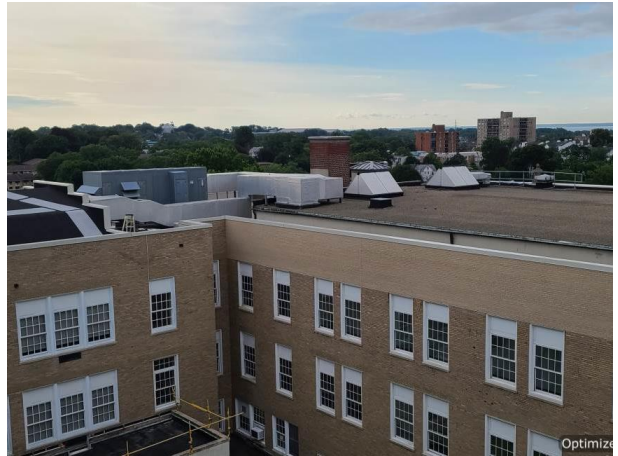
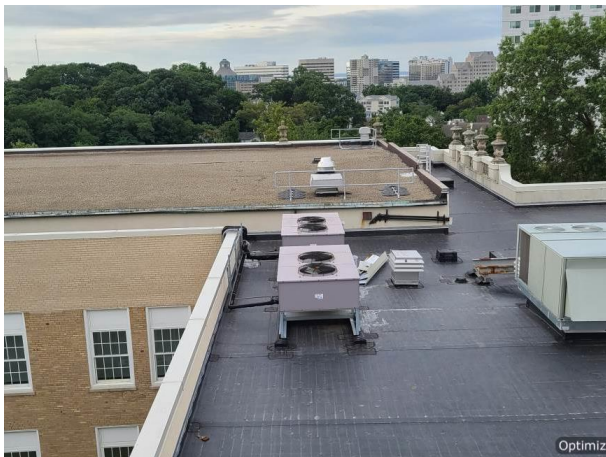
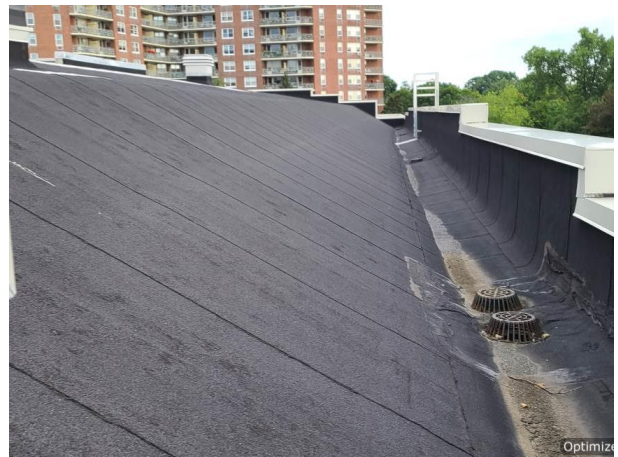
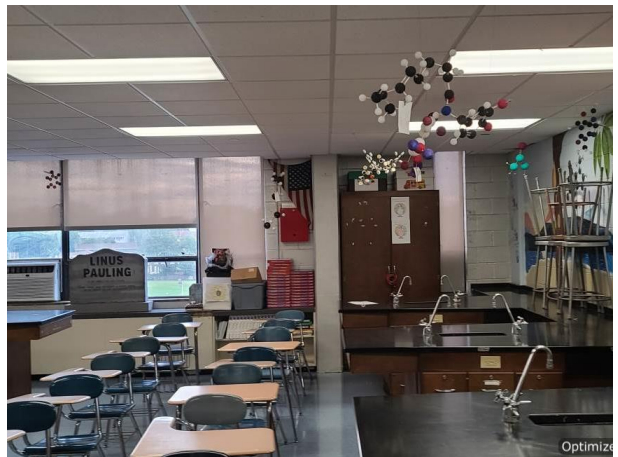
The exterior building envelope is in fair to poor condition with varying roof assemblies and systems. Both the built-up and elastomeric roofing require replacement. Both the aluminum and wood frame windows require remediation and/or replacement. The exterior façade is in need of repair with repointing necessary in the masonry wall areas and the removal of staining.

Interior floor finishes include resilient tile, ceramic tile, carpet, wood, and painted concrete slab and are in good to fair condition. Interior wall finishes include painted drywall, painted CMU, painted plaster, brick veneer, wood panel, painted concrete, brick, acoustical panels, and ceramic tile and are in good to fair condition. Interior ceiling finishes include exposed structure, suspended acoustic tiles, painted and unpainted drywall, and painted plaster and are in good to fair condition. Casework and countertops are in fair to poor condition and in need of replacement. All interior doors are worn and approaching the end of their useful life. Classroom and conference room projection equipment should be replaced.

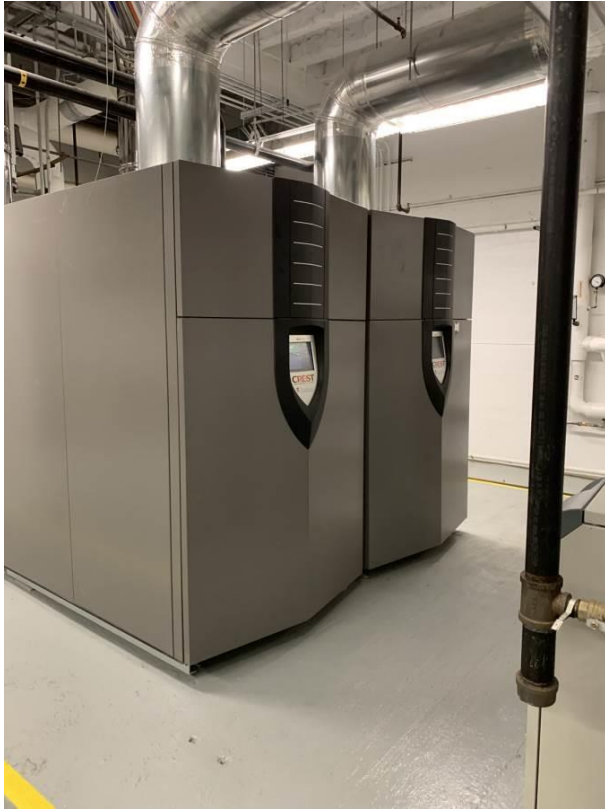
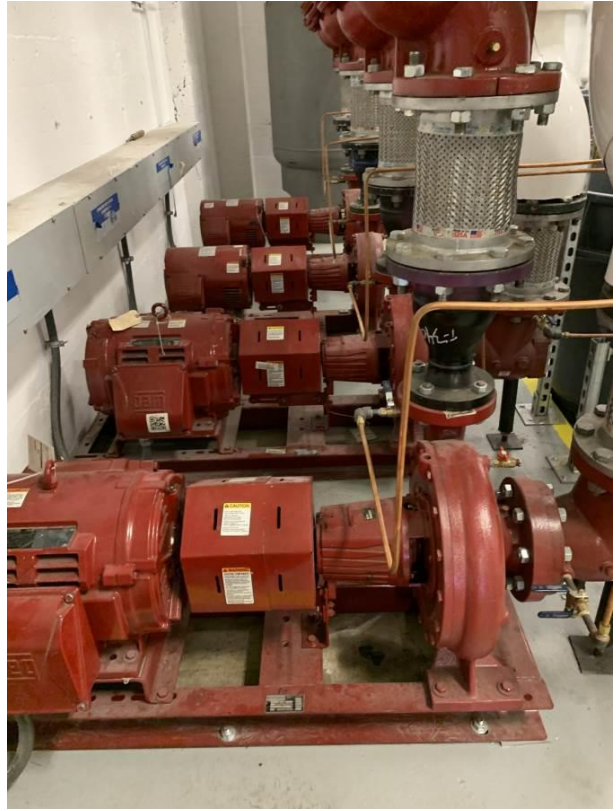
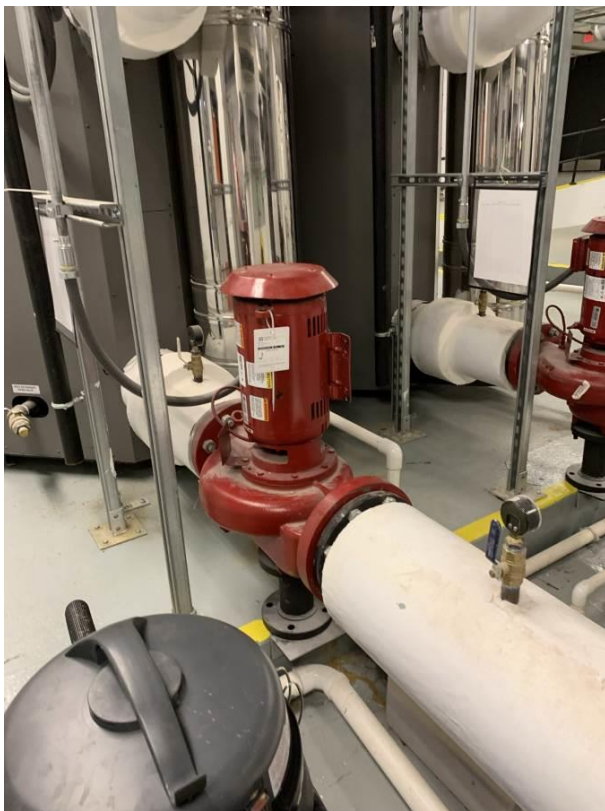
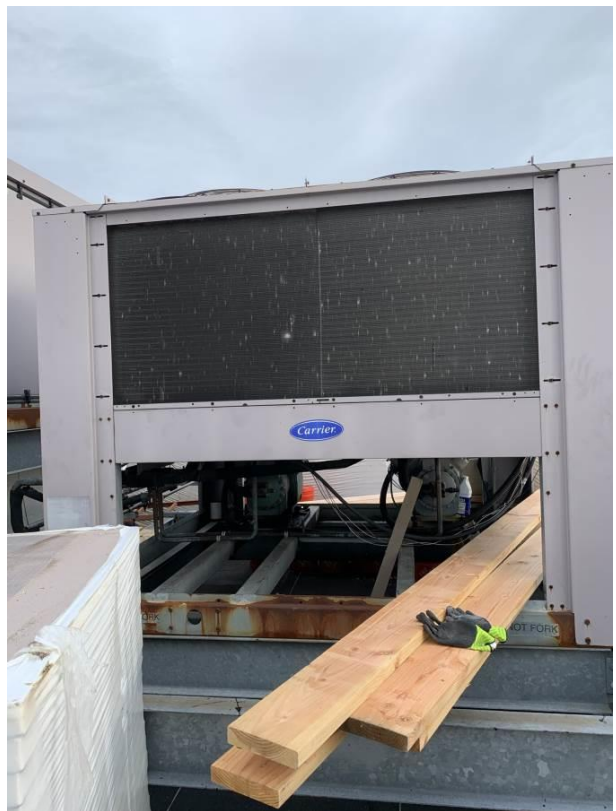
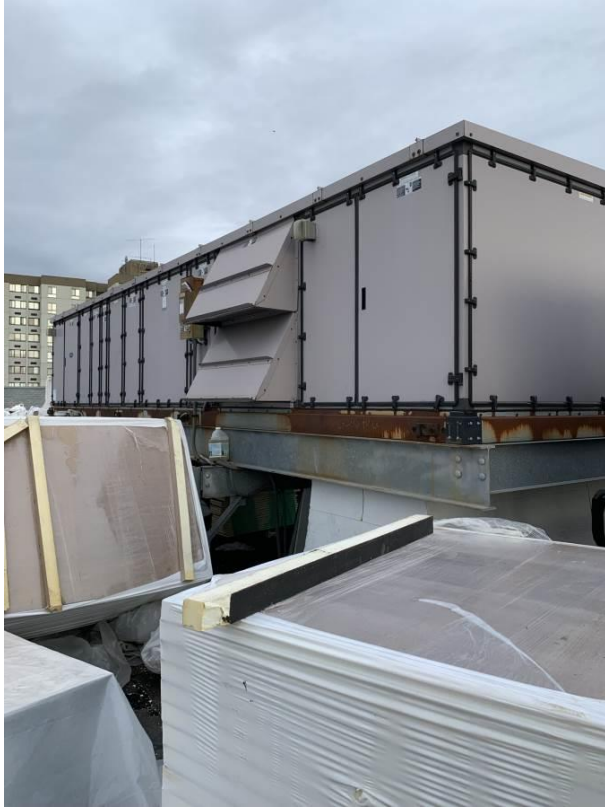
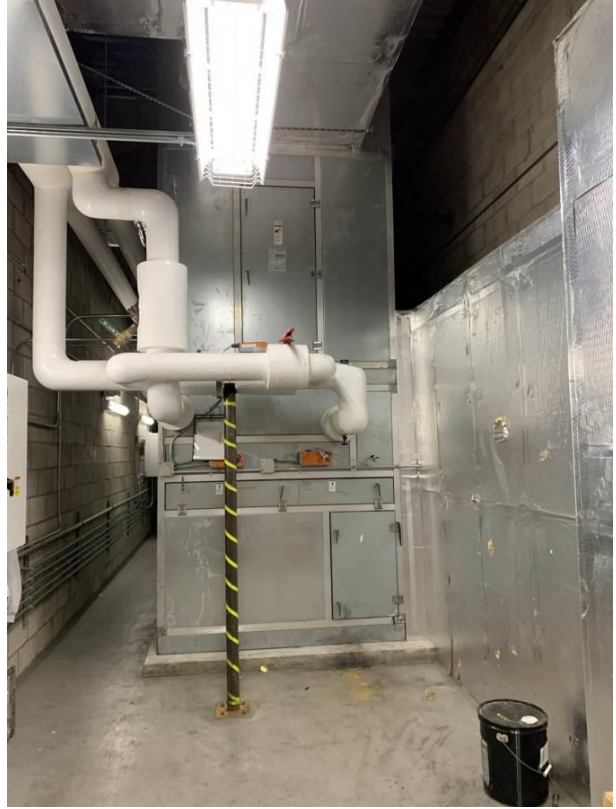
All major mechanical systems and components except for the boilers and hot water pumps will require replacement during the 10 year study period.

The mechanical system at Stamford HS does not provide adequate ventilation or air conditioning. Based on existing equipment conditions and an initiative to add air condition building-wide, the District-Wide Summary: 10 Year Forecast Cost Analysis contains an allowance for the wholesale system replacement including demolition of the current system including central plant and distribution of the original building. This approach takes into consideration only select capital improvement needs in the Deferred Maintenance & Asset Renewal Report not impacted by system replacement. Alternatively, the 1970's addition which is approximately 60,000 gross square feet will only require the capital improvement needs identified in the Deferred Maintenance & Asset Renewal Report.

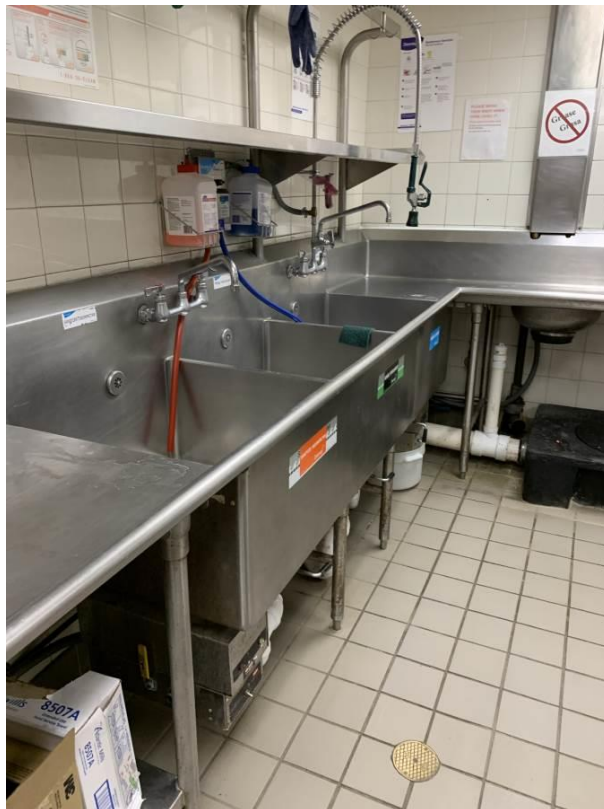
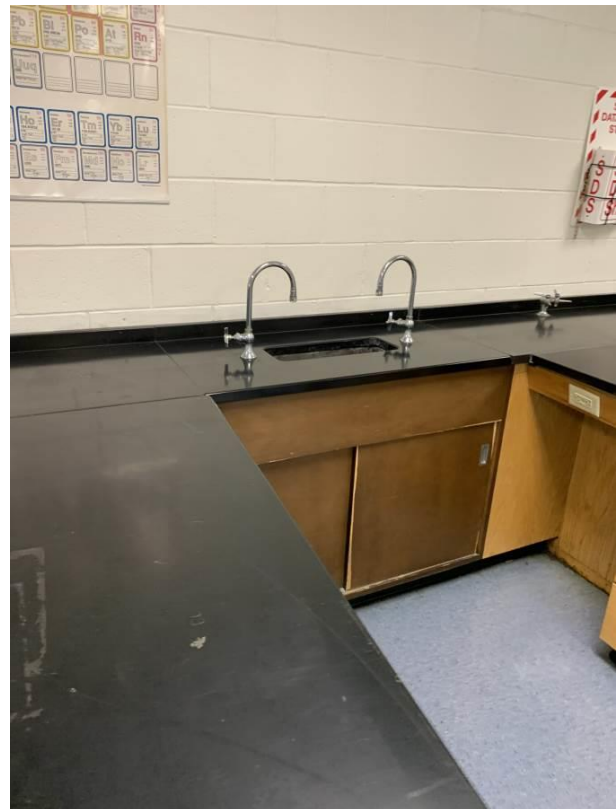
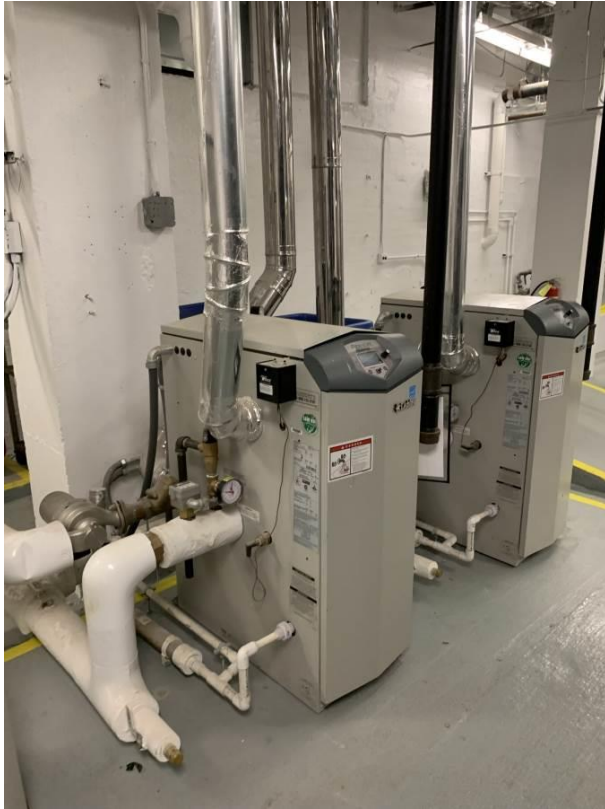
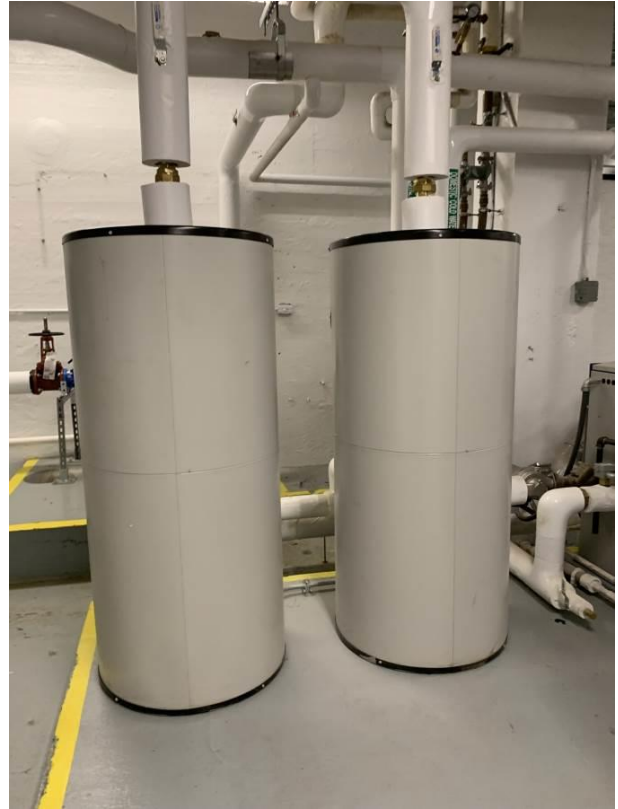
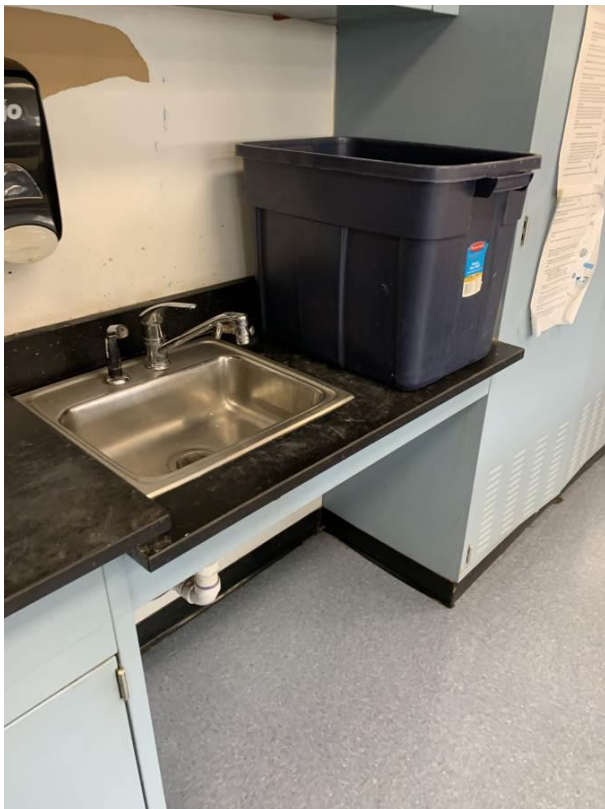
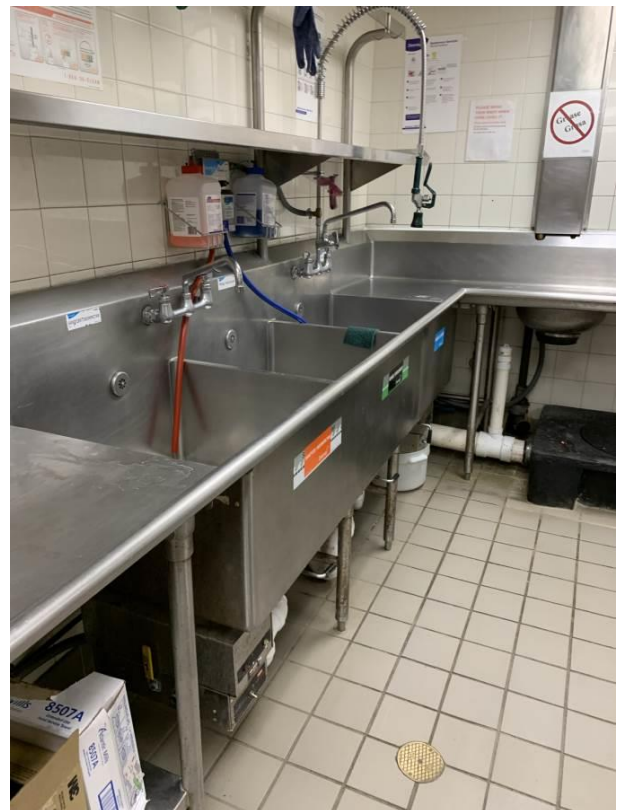
- Domestic hot water boiler and storage tank – 2020
- Domestic hot water heater – 2017
- Domestic water piping system and sanitary piping system – 1975
- Sewage ejector pump, sump pump, lab sinks, lab gas piping and fixtures, eyewash stations, water closets, lavatories, urinals, classroom sinks, locker room showers, electric water coolers, kitchen sinks, mop sinks and utility sinks – 2000
- 2006 addition wing lab sinks, lab gas piping and fixtures, eyewash stations, water closets, lavatories, urinals, classroom sinks, showers, mop sinks and utility sinks – 2006

Most major plumbing systems including domestic and sanitary piping should be replaced in the 10 year study period. The domestic hot water boiler, heater and storage tank and the new laboratory gas piping and fixtures will not need to be replaced within the study period.
