# mahlum

## STUDY AND SURVEY REPORT

MERCER ISLAND SCHOOL DISTRICT | MERCER ISLAND, WASHINGTON

MARCH 2021

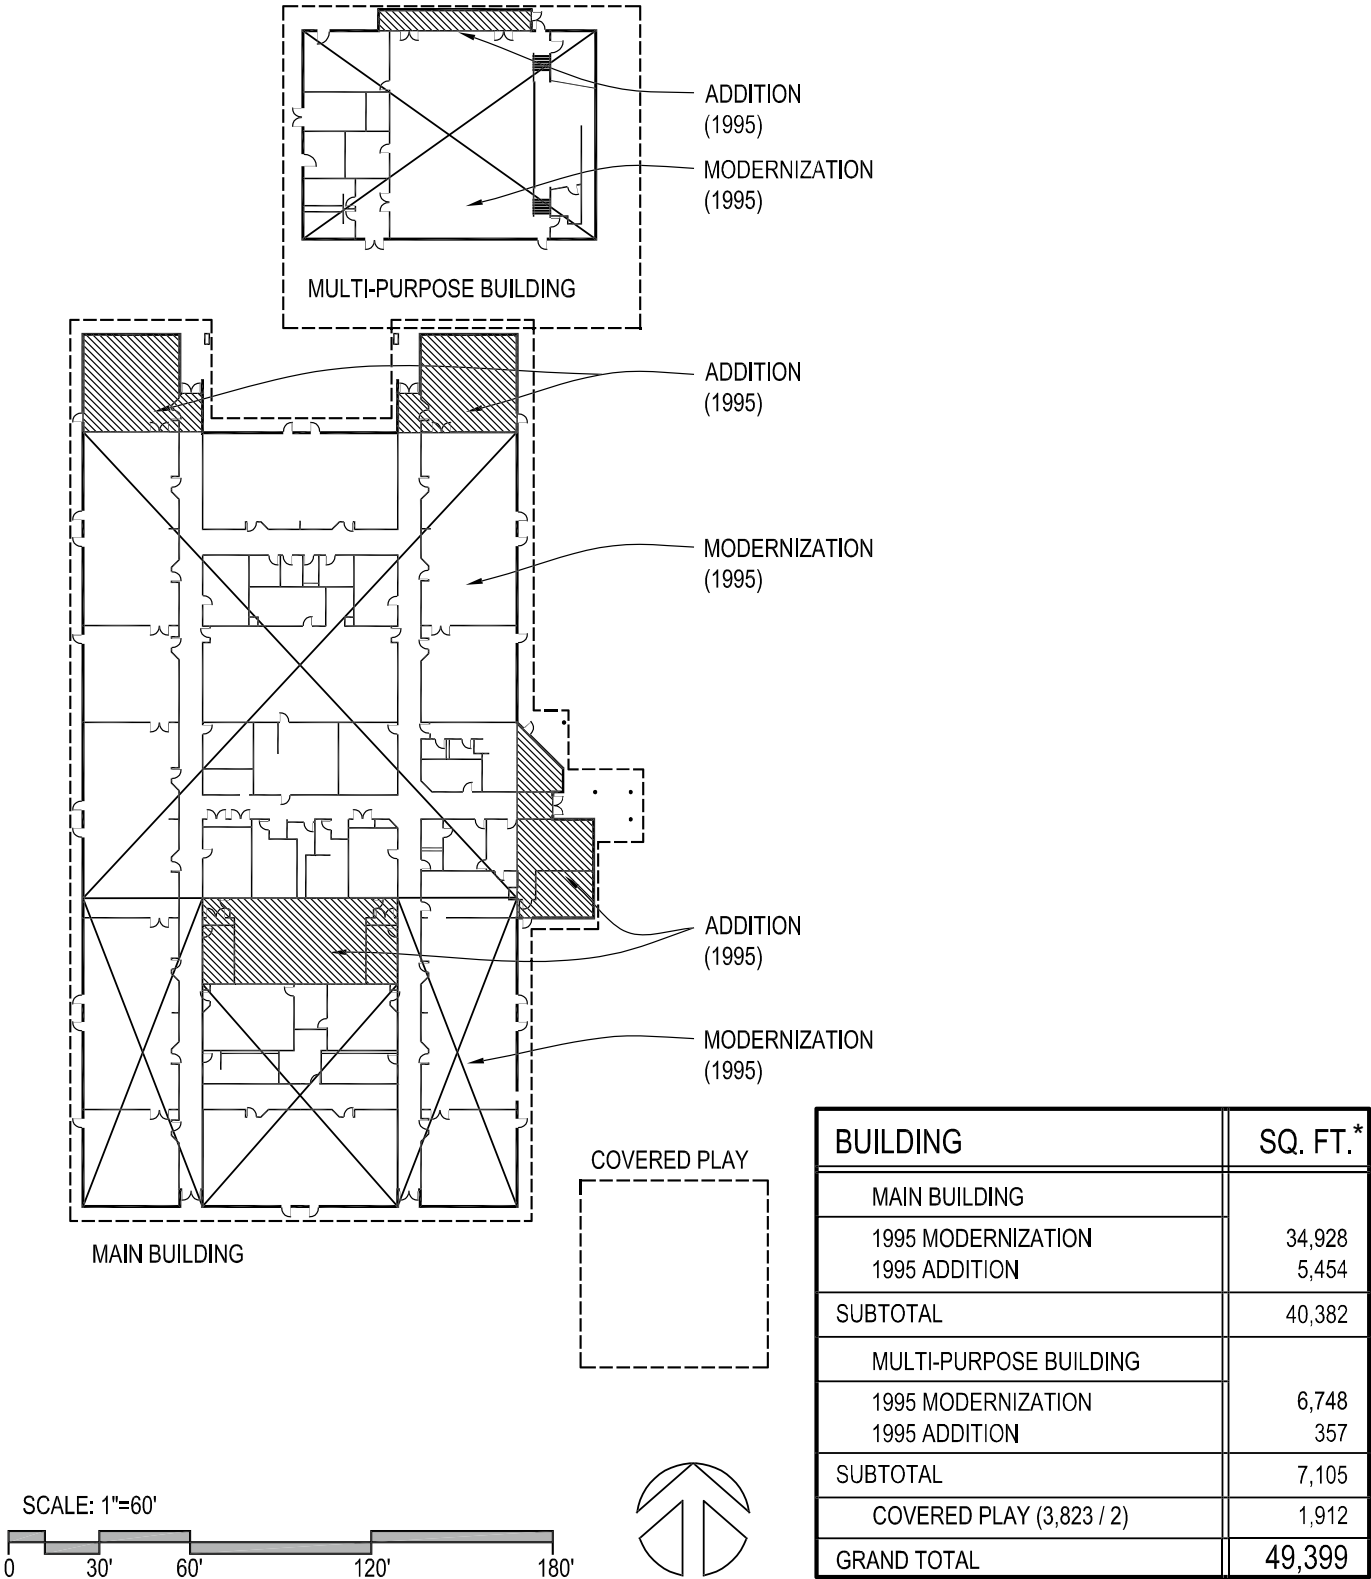
<div>BLRB architects</div> <div>Pacific Plaza 1250 Pacific Ave., Ste. 700 Tacoma, WA, 98402-4308</div> <div>P: 253.627.5599 F: 253.572.5167</div>	Project: MERCER ISLAND SCHOOL DISTRICT STUDY AND SURVEY	Date: JUNE 2018	Reference Sheet No.
	Drawing Title: ISLAND PARK ELEMENTARY SCHOOL 2009 AREA ANALYSIS	Drawn By: JJJ	
		Comm. No. 18.10

\* Building areas are within 1% of recorded area, per as-built drawing takeoffs in accordance with WAC 392-343-019. (Mahlum Architects, 2021)

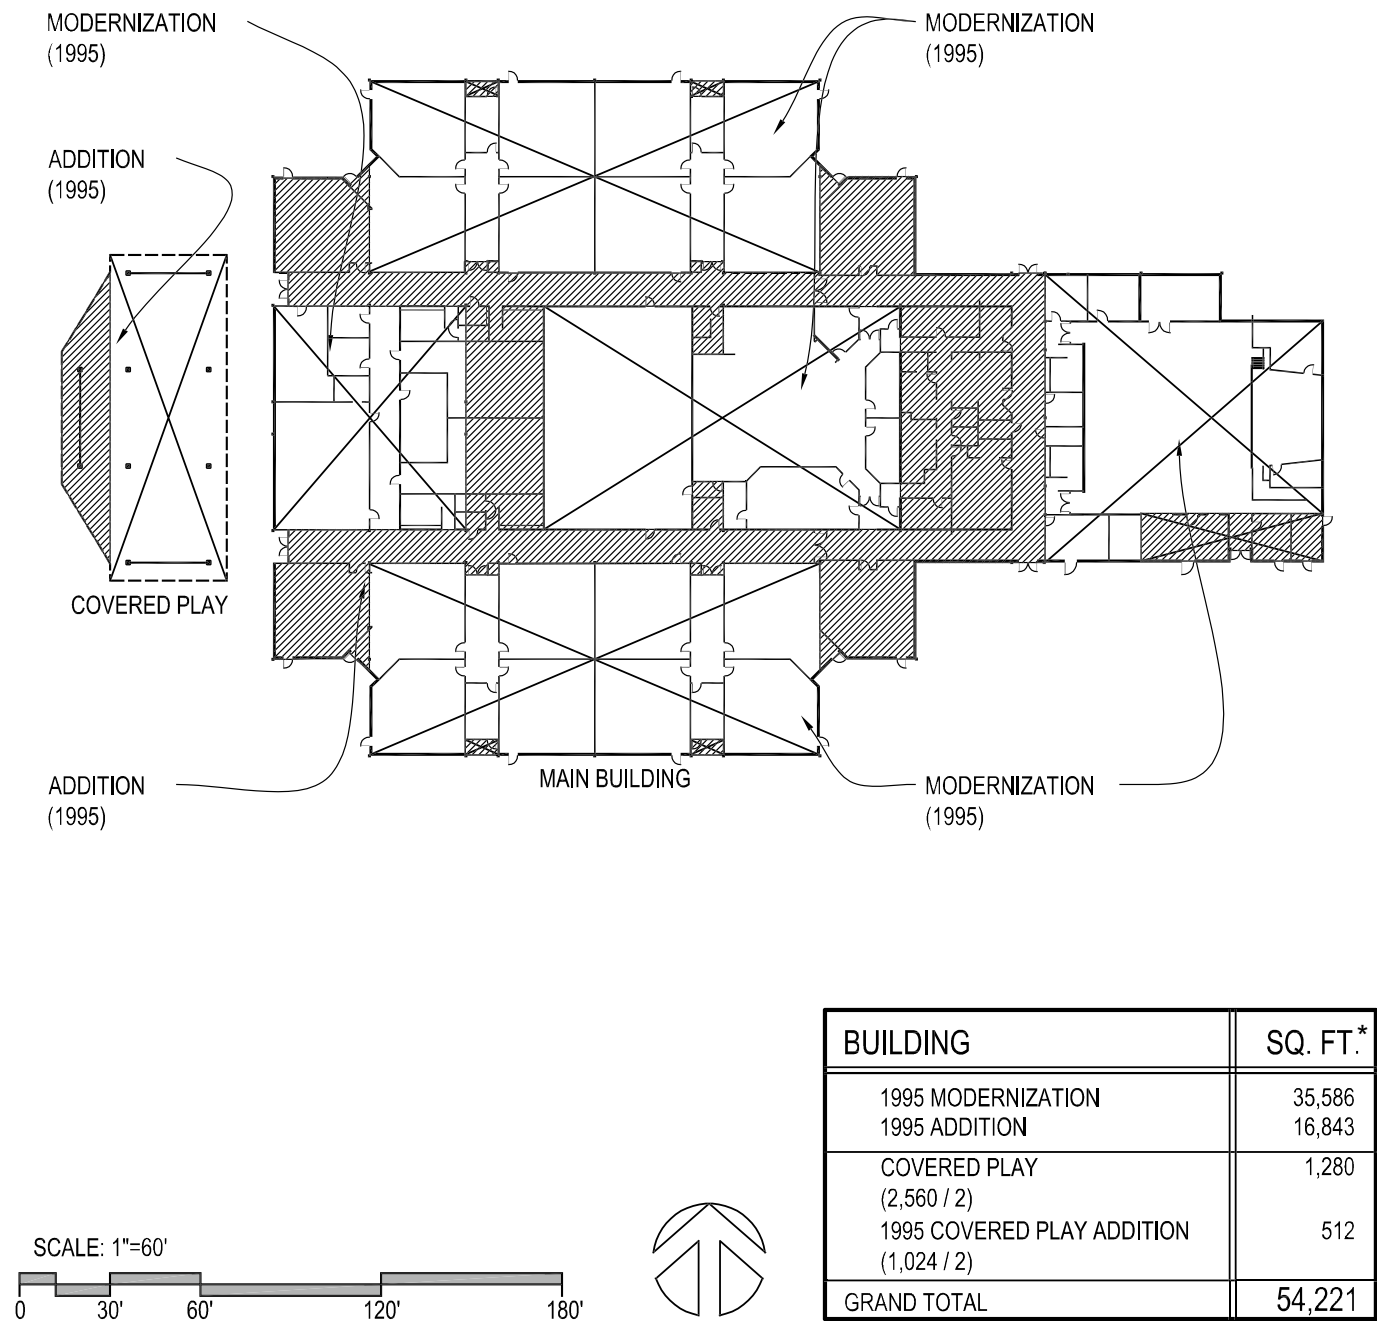
<b>BLRB architects</b>  Pacific Plaza 1250 Pacific Ave., Ste. 700 Tacoma, WA, 98402-4308 P: 253.627.5599 F: 253.572.5167	Project: MERCER ISLAND SCHOOL DISTRICT STUDY AND SURVEY	Date: JUNE 2018	Reference Sheet No.
	Drawing Title: WEST MERCER ELEMENTARY SCHOOL 2009 AREA ANALYSIS	Drawn By: JJJ	
		Comm. No. 18.10

\* Building areas are within 1% of recorded area, per as-built drawing takeoffs in accordance with WAC 392-343-019. (Mahlum Architects, 2021)

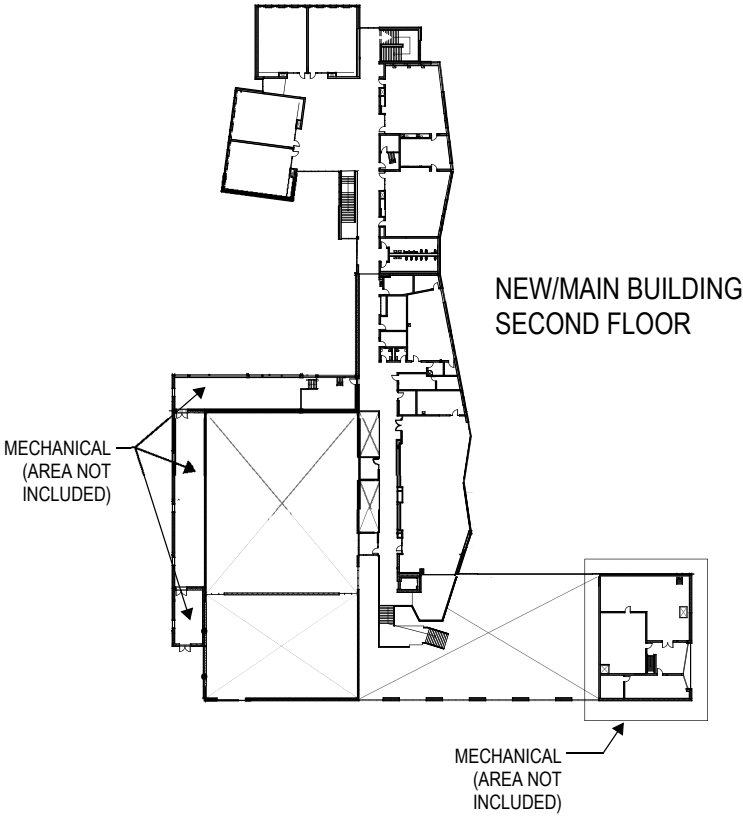
BUILDING	SQ. FT.*
100 / 200 BUILDING	
1994 MODERNIZATION	47,474
1994 ADDITION	16,750
SUBTOTAL	64,224
300 BUILDING	
1994 MODERNIZATION	4,833
2000 ADDITION	10,804
SUBTOTAL	15,637
NEW/MAIN BUILDING	
FIRST FLOOR (2015)	67,989
SECOND FLOOR (2015)	23,676 <sup>1</sup>
SUBTOTAL	91,665
GRAND TOTAL	171,526

<div><div>mahlum</div><div>71 Columbia, Floor 4 Seattle, WA 98104 P: (206) 441-4151</div></div>	Project	MERCER ISLAND SCHOOL DISTRICT STUDY AND SURVEY	Date: MAR 2021	Reference Sheet No. 2
	Drawing Title:	ISLANDER MIDDLE SCHOOL - SECOND FLOOR PLAN	Drawn By: JL	
			Comm. No.

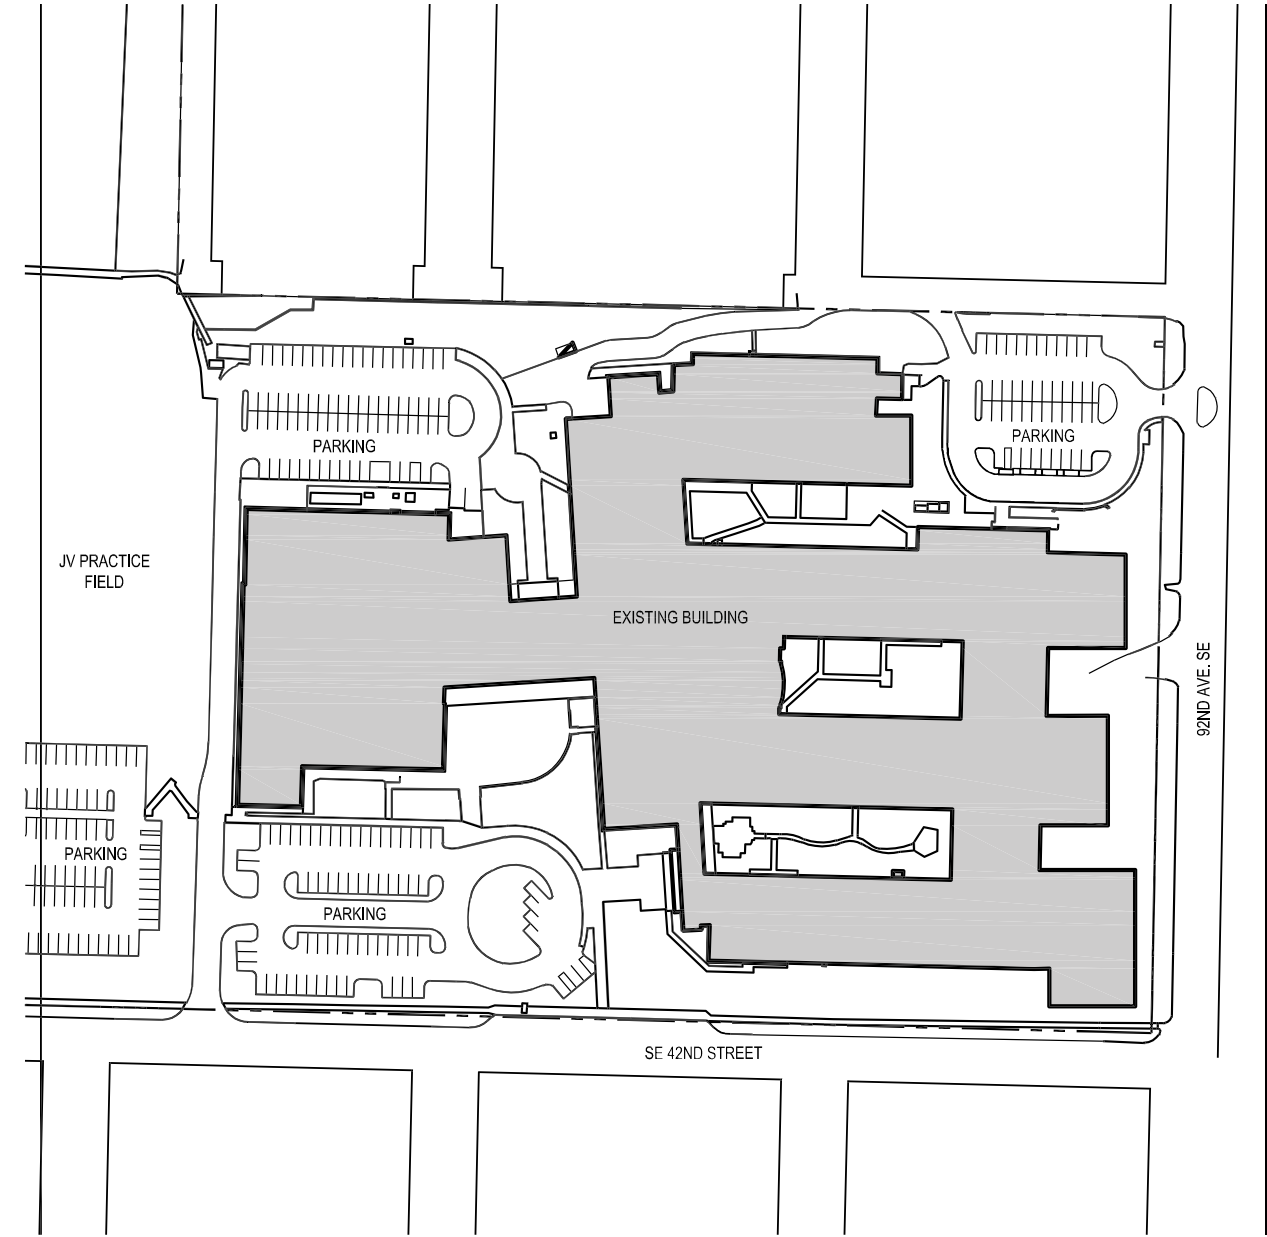
<b>BLRB architects</b>  Pacific Plaza 1250 Pacific Ave., Ste. 700 Tacoma, WA, 98402-4308 P: 253.627.5599 F: 253.572.5167	Project: <b>MERCER ISLAND SCHOOL DISTRICT STUDY AND SURVEY</b>	Date: <b>JUNE 2018</b>	Reference Sheet No.
	Drawing Title: <b>MERCER ISLAND HIGH SCHOOL SITE PLAN</b>	Drawn By: <b>JCH</b>	
		Comm. No. <b>18.10</b>

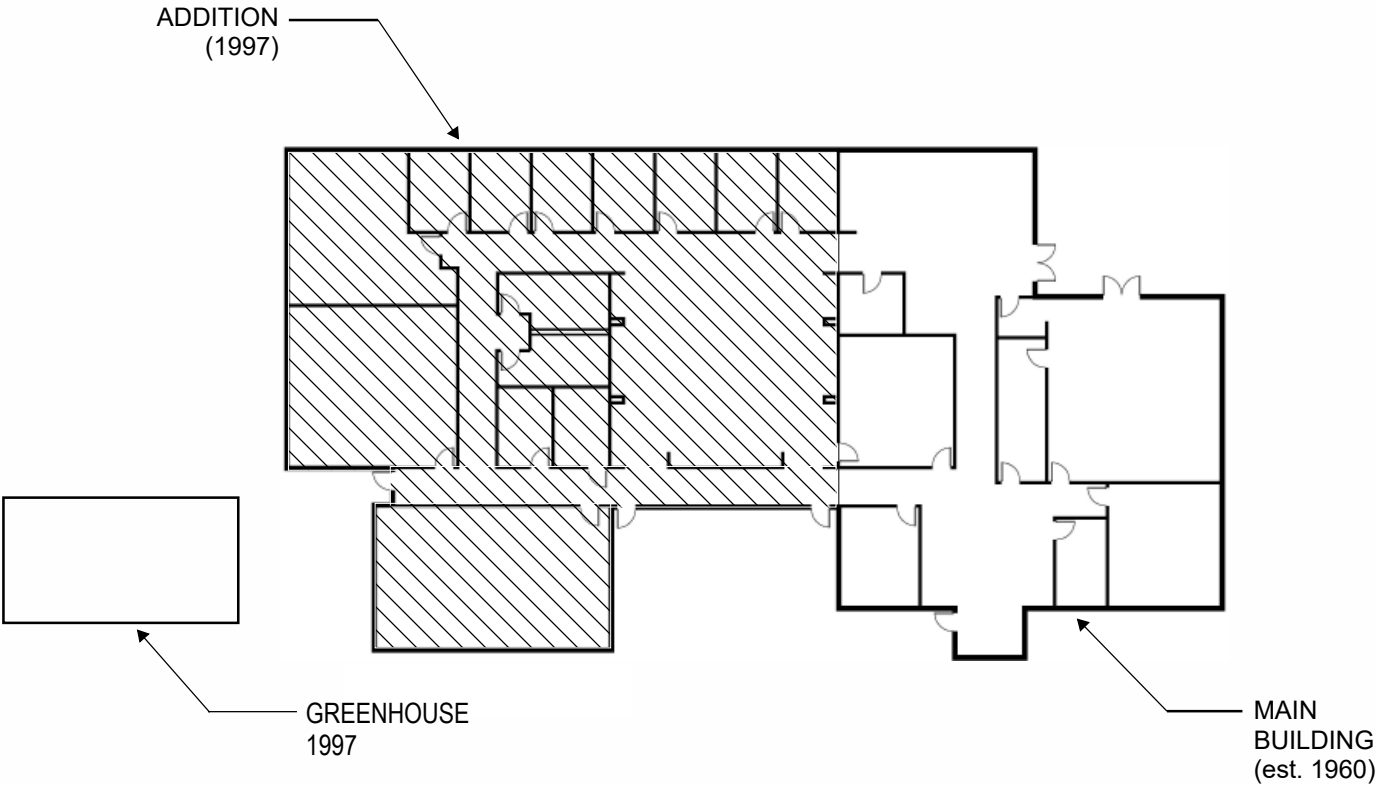
BUILDING	SQ. FT.*
CREST LEARNING CENTER	
MAIN BUILDING	4,017
1997 ADDITION	6,041
GRAND TOTAL	10,058

BUILDING	SQ. FT.*
GREENHOUSE	
MAIN BUILDING	890
GRAND TOTAL	890
