MS4 Annual Report Transmittal Form

For the General Permit to Discharge Stormwater from Small Municipal Separate Storm Sewer Systems (MS4)

This report documents the Town of Putnam efforts to comply with the conditions of the MS4 General Permit to the maximum extent practicable (MEP) from January 1, 2022 to December 31, 2022.

Illicit Discharge Detection and Elimination Investigation
Town of Putnam MS4 Program
February 2023
 Page Name: A1

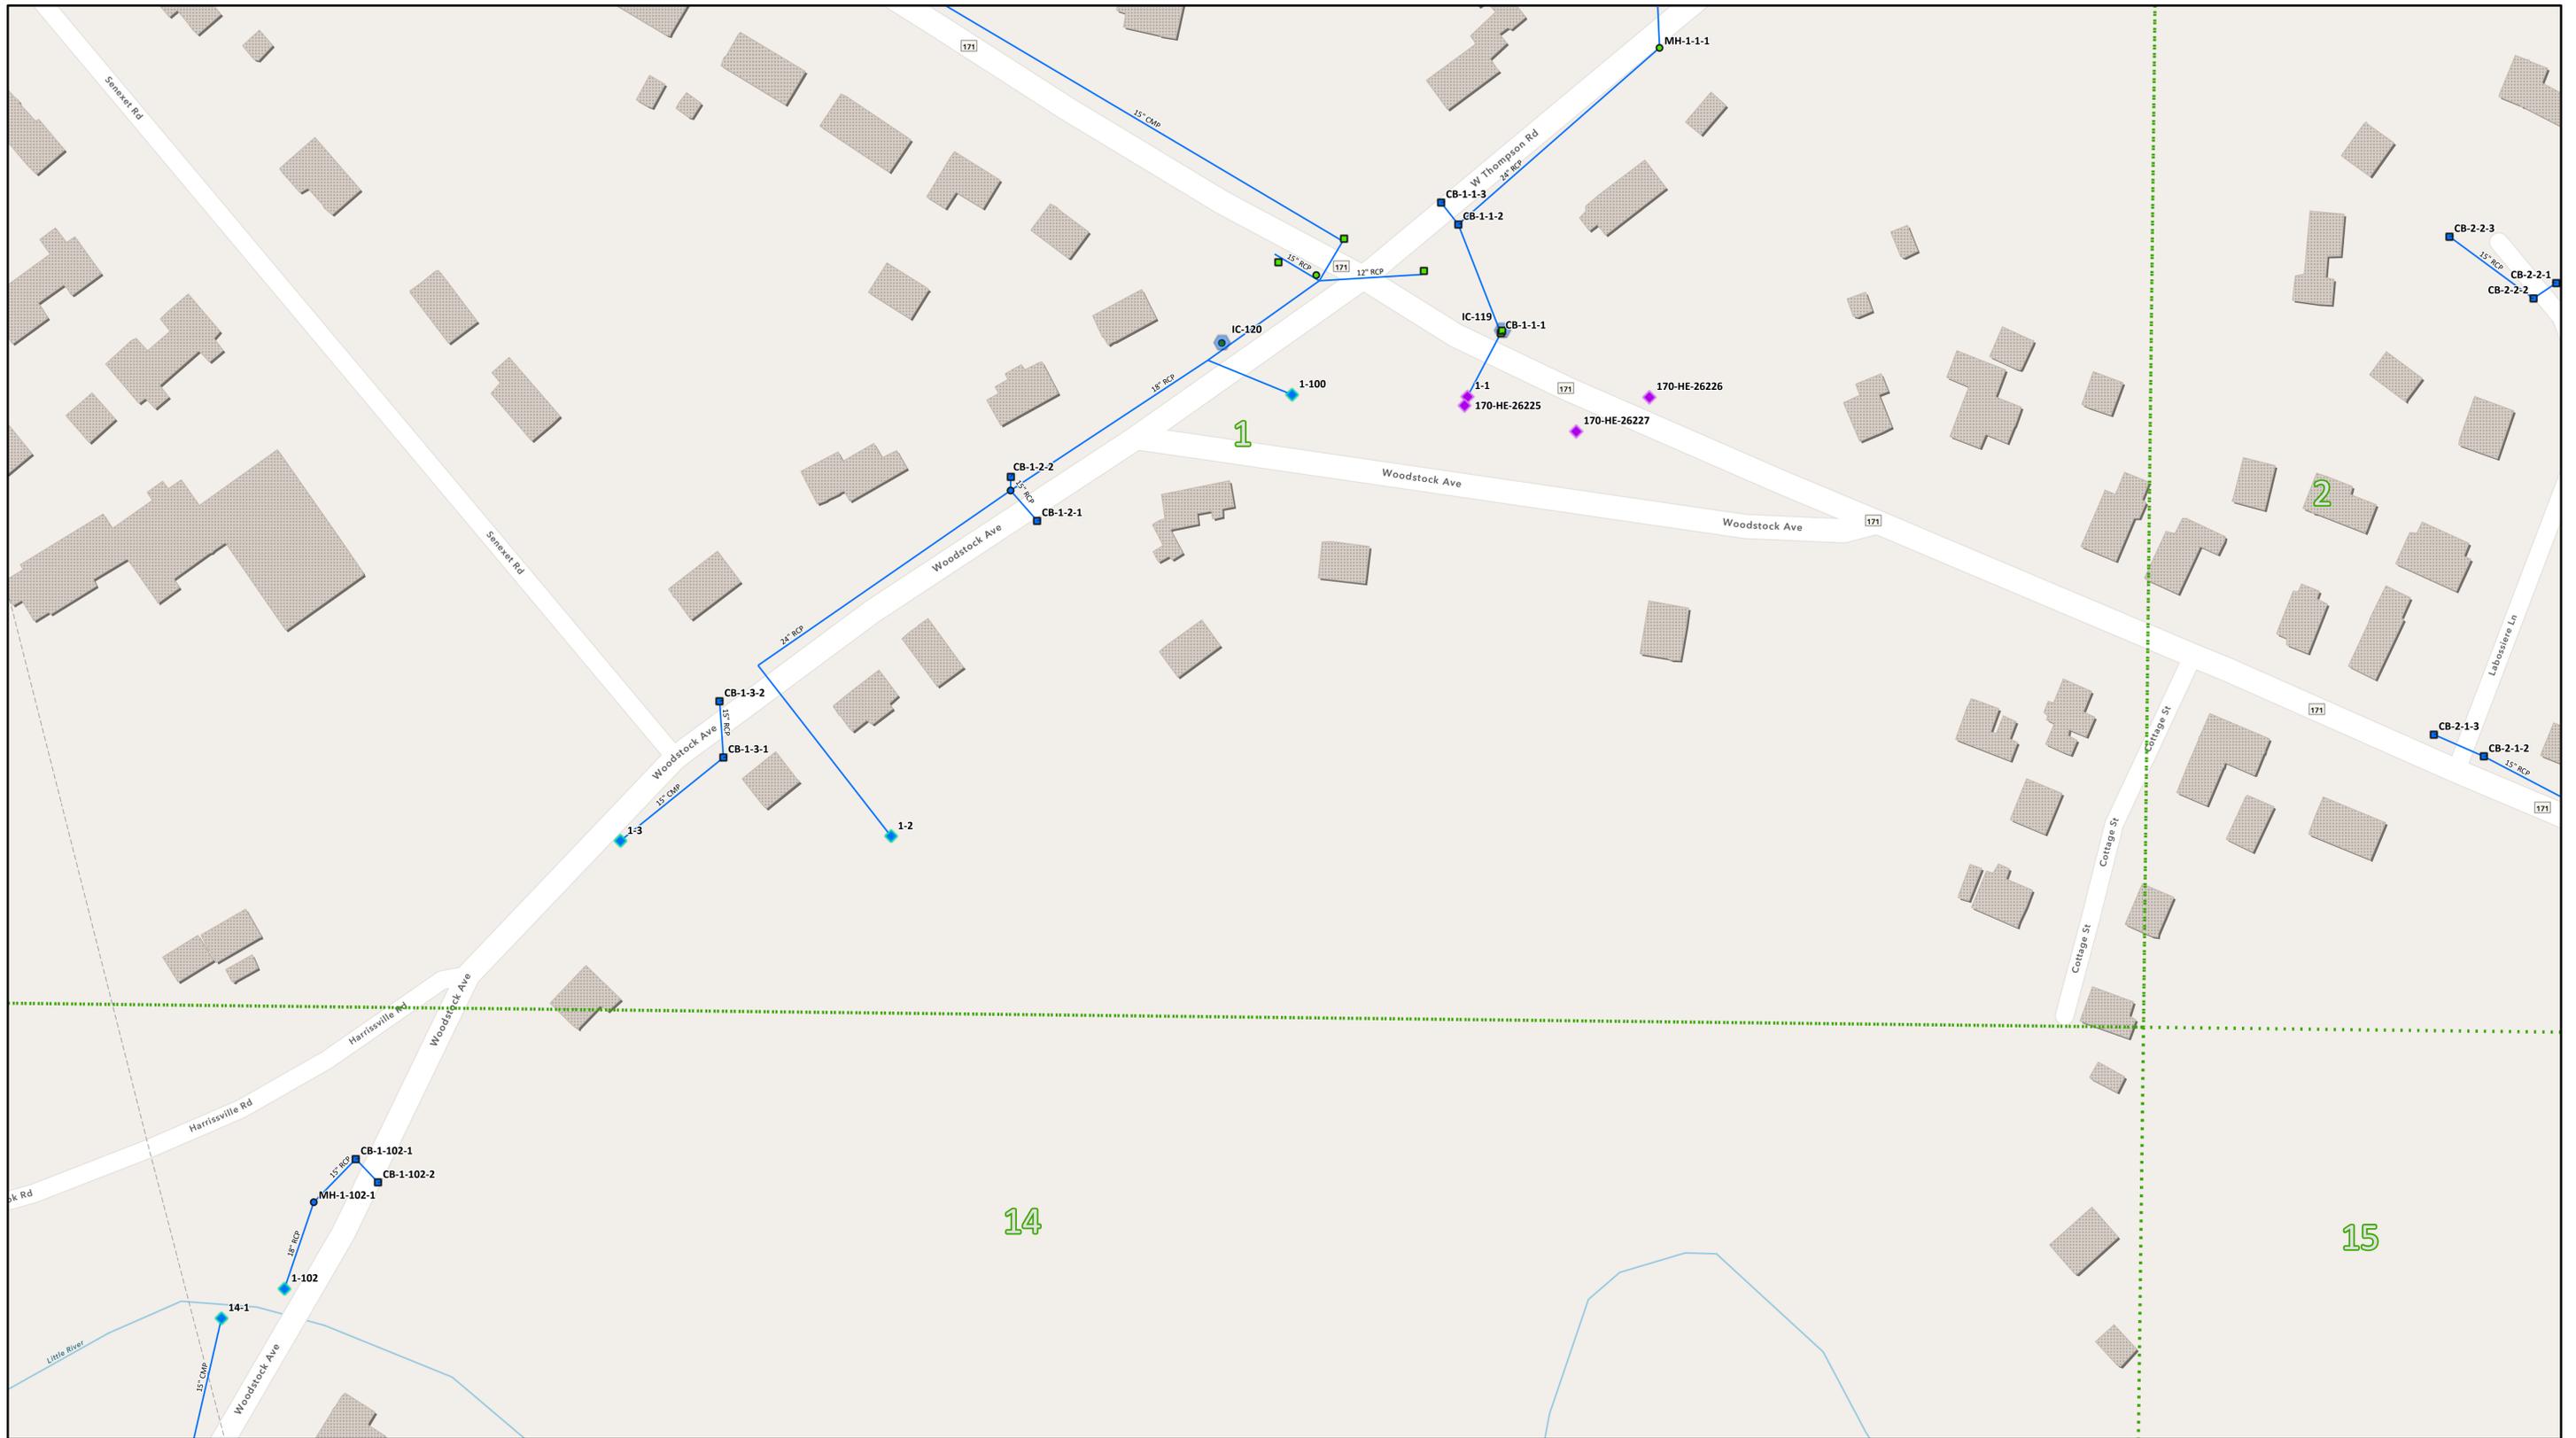
Illicit Discharge Detection and Elimination Investigation
Town of Putnam MS4 Program
February 2023
 Page Name: B1

Legend
 Catch Basin
 ■ City
 ■ State
 Interconnections
 ● Other

Manholes
 ● City
 ● State
 Outfalls
 ◆ City
 ◆ State

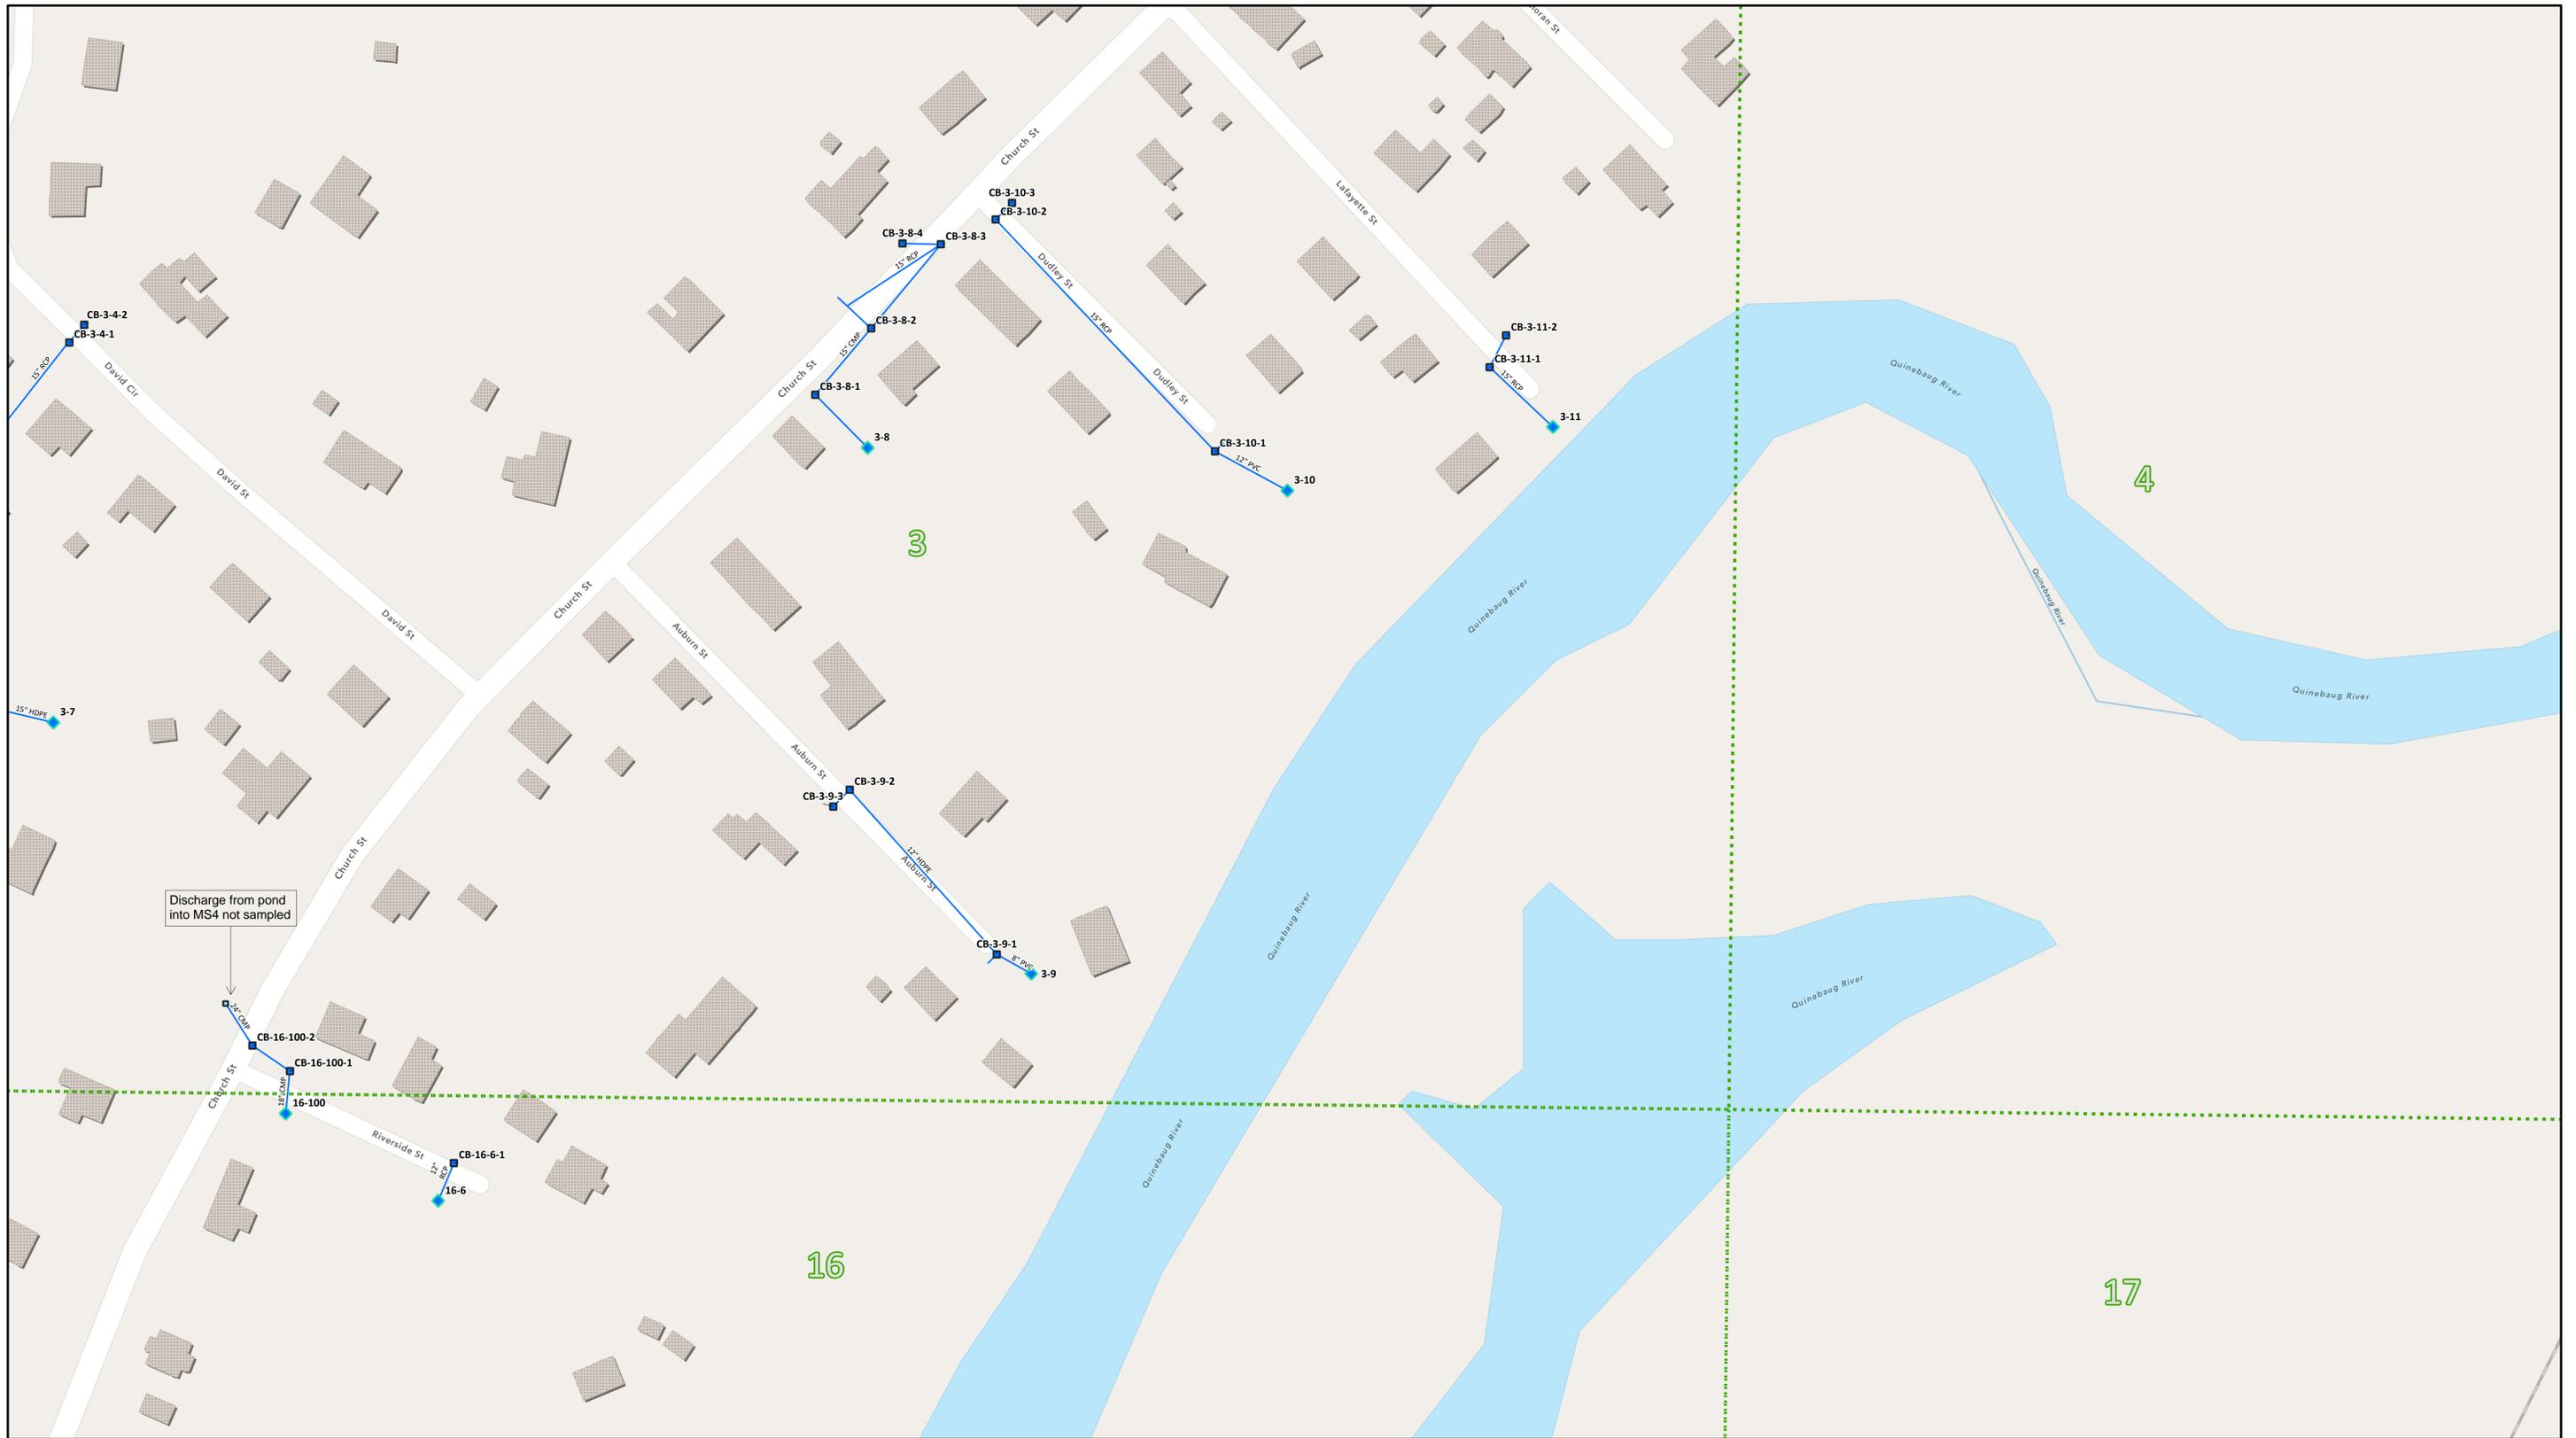
Illicit Discharge Detection and Elimination Investigation
Town of Putnam MS4 Program
February 2023
 Page Name: B4

Discharge from pond into MS4 not sampled

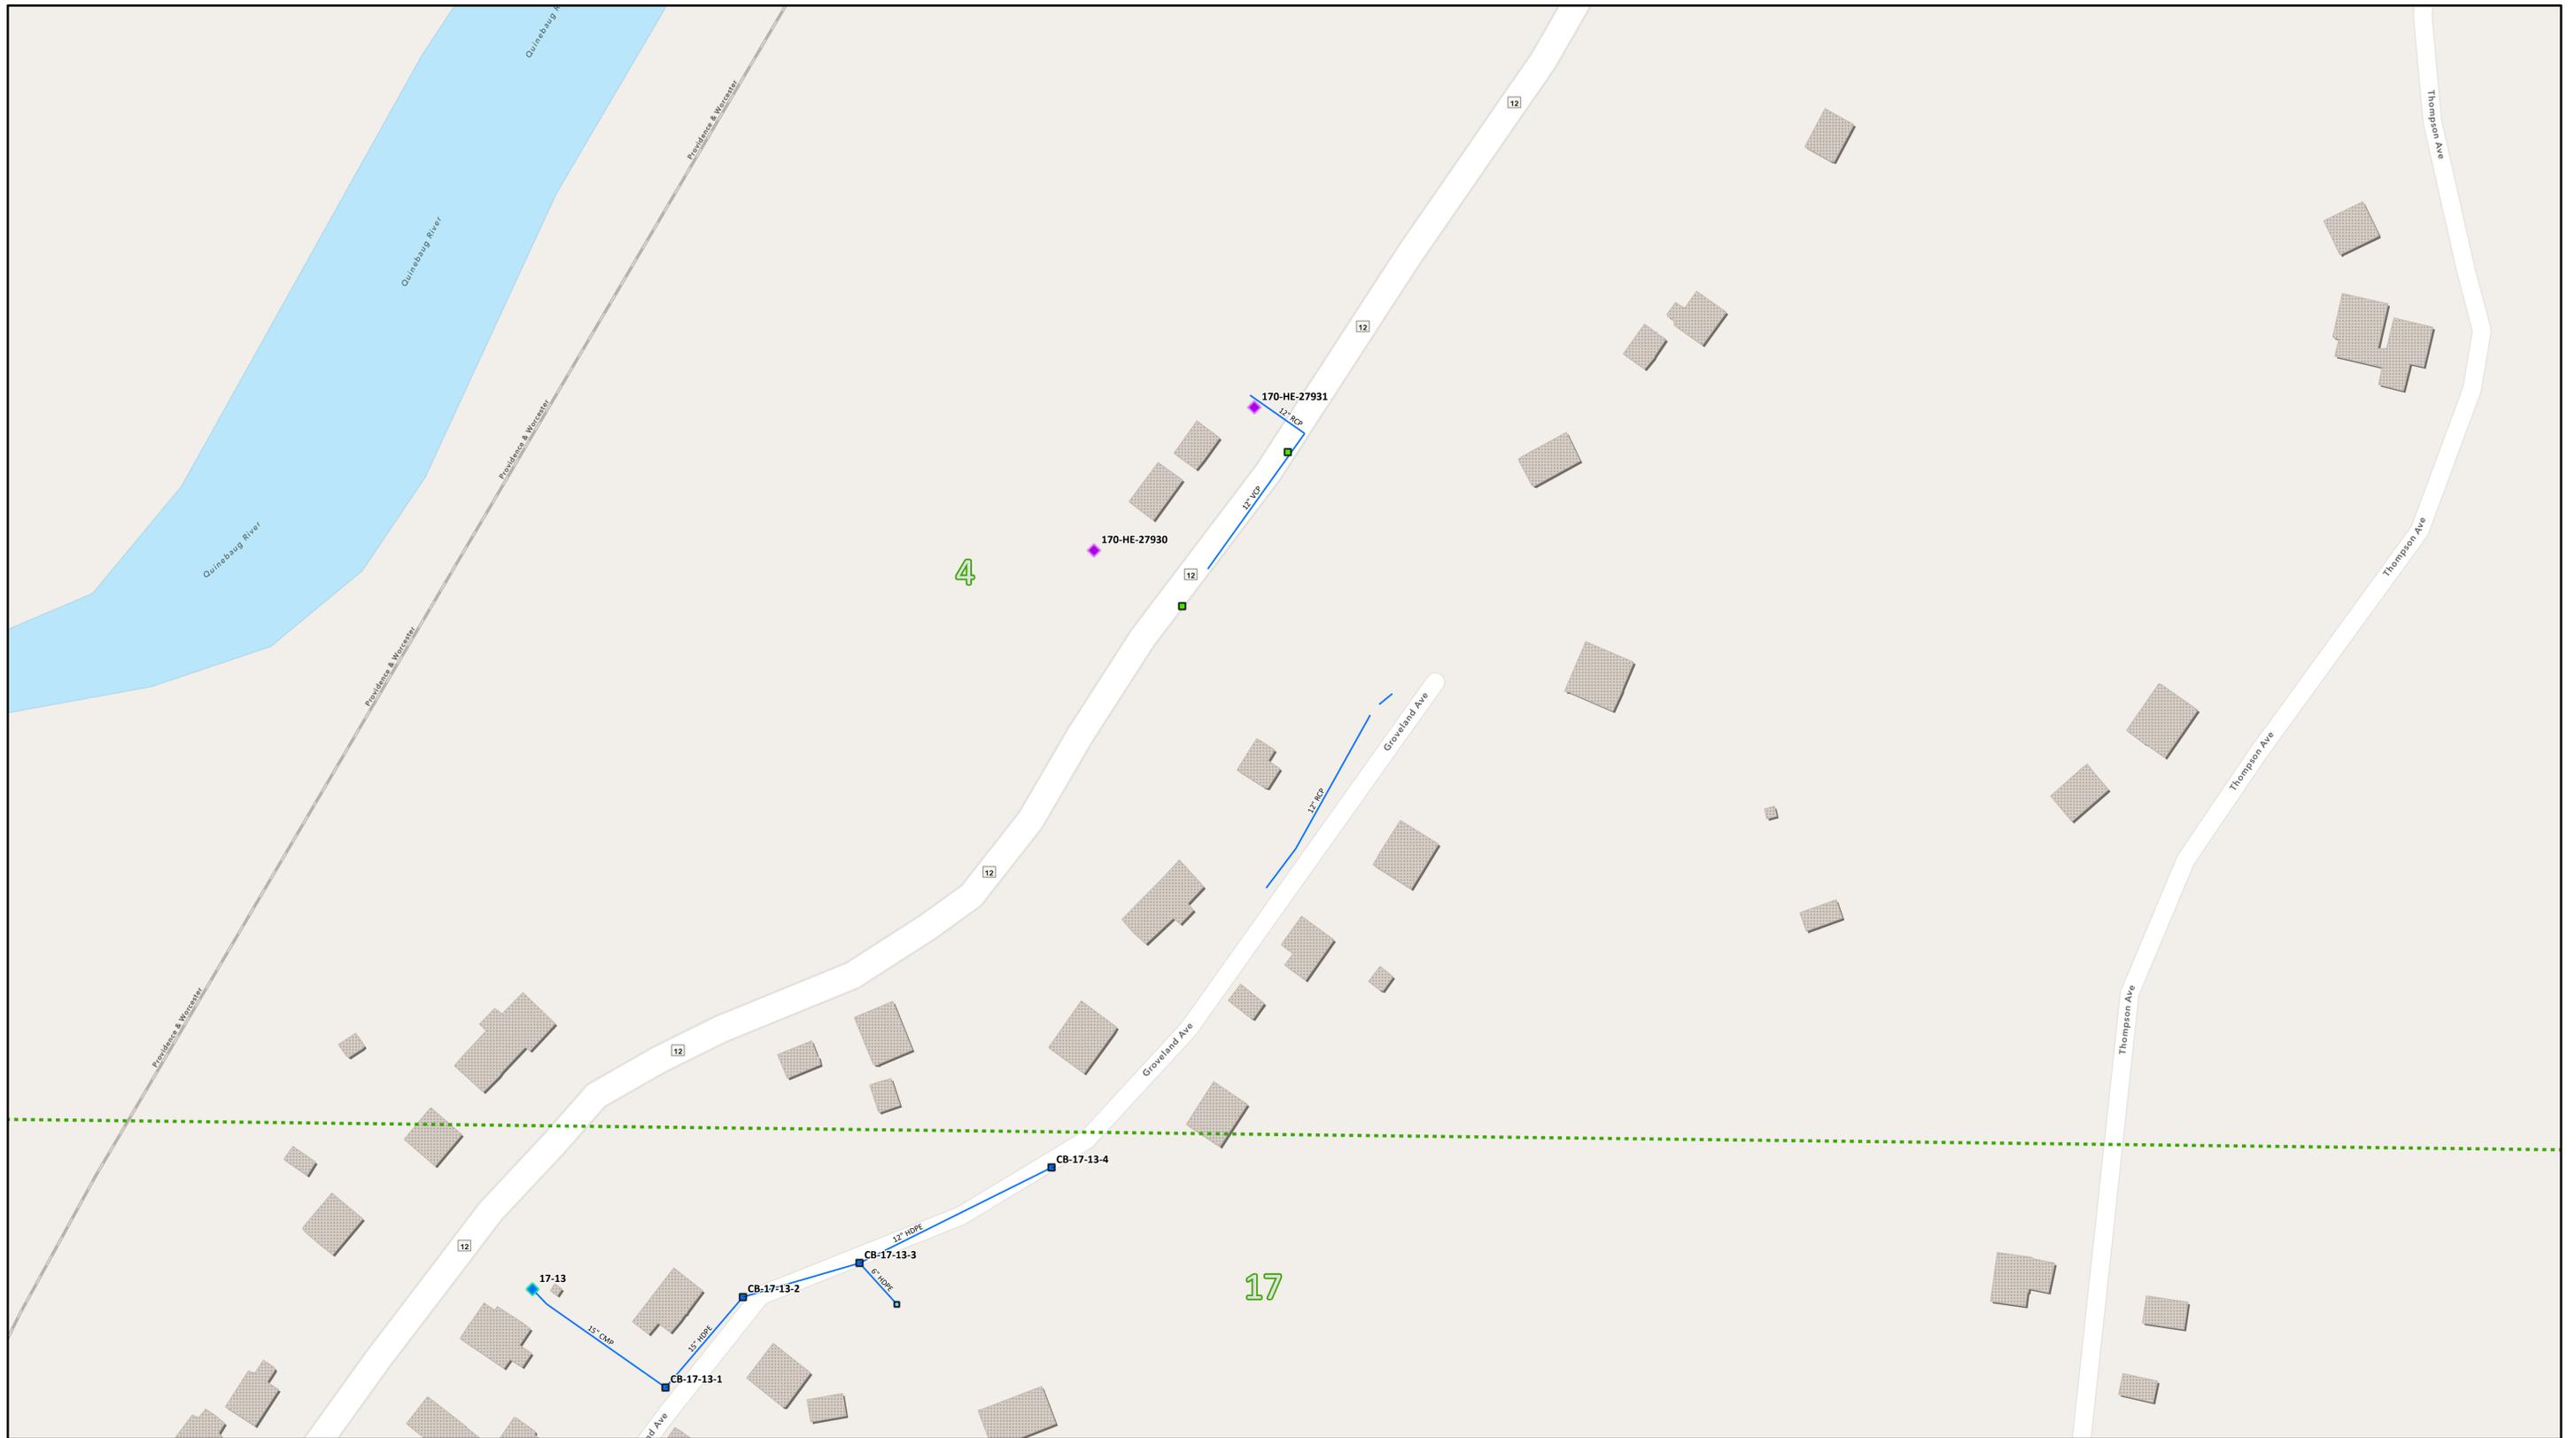
Illicit Discharge Detection and Elimination Investigation
Town of Putnam MS4 Program
February 2023
 Page Name: B5

- Legend**
- Network Structures
 - Catch Basin
 - City
 - State
 - ◆ Outfalls
 - ◆ City
 - ◆ State
 - Gravity Main
 - City
 - Index Map Catchment Plan (March 2018)

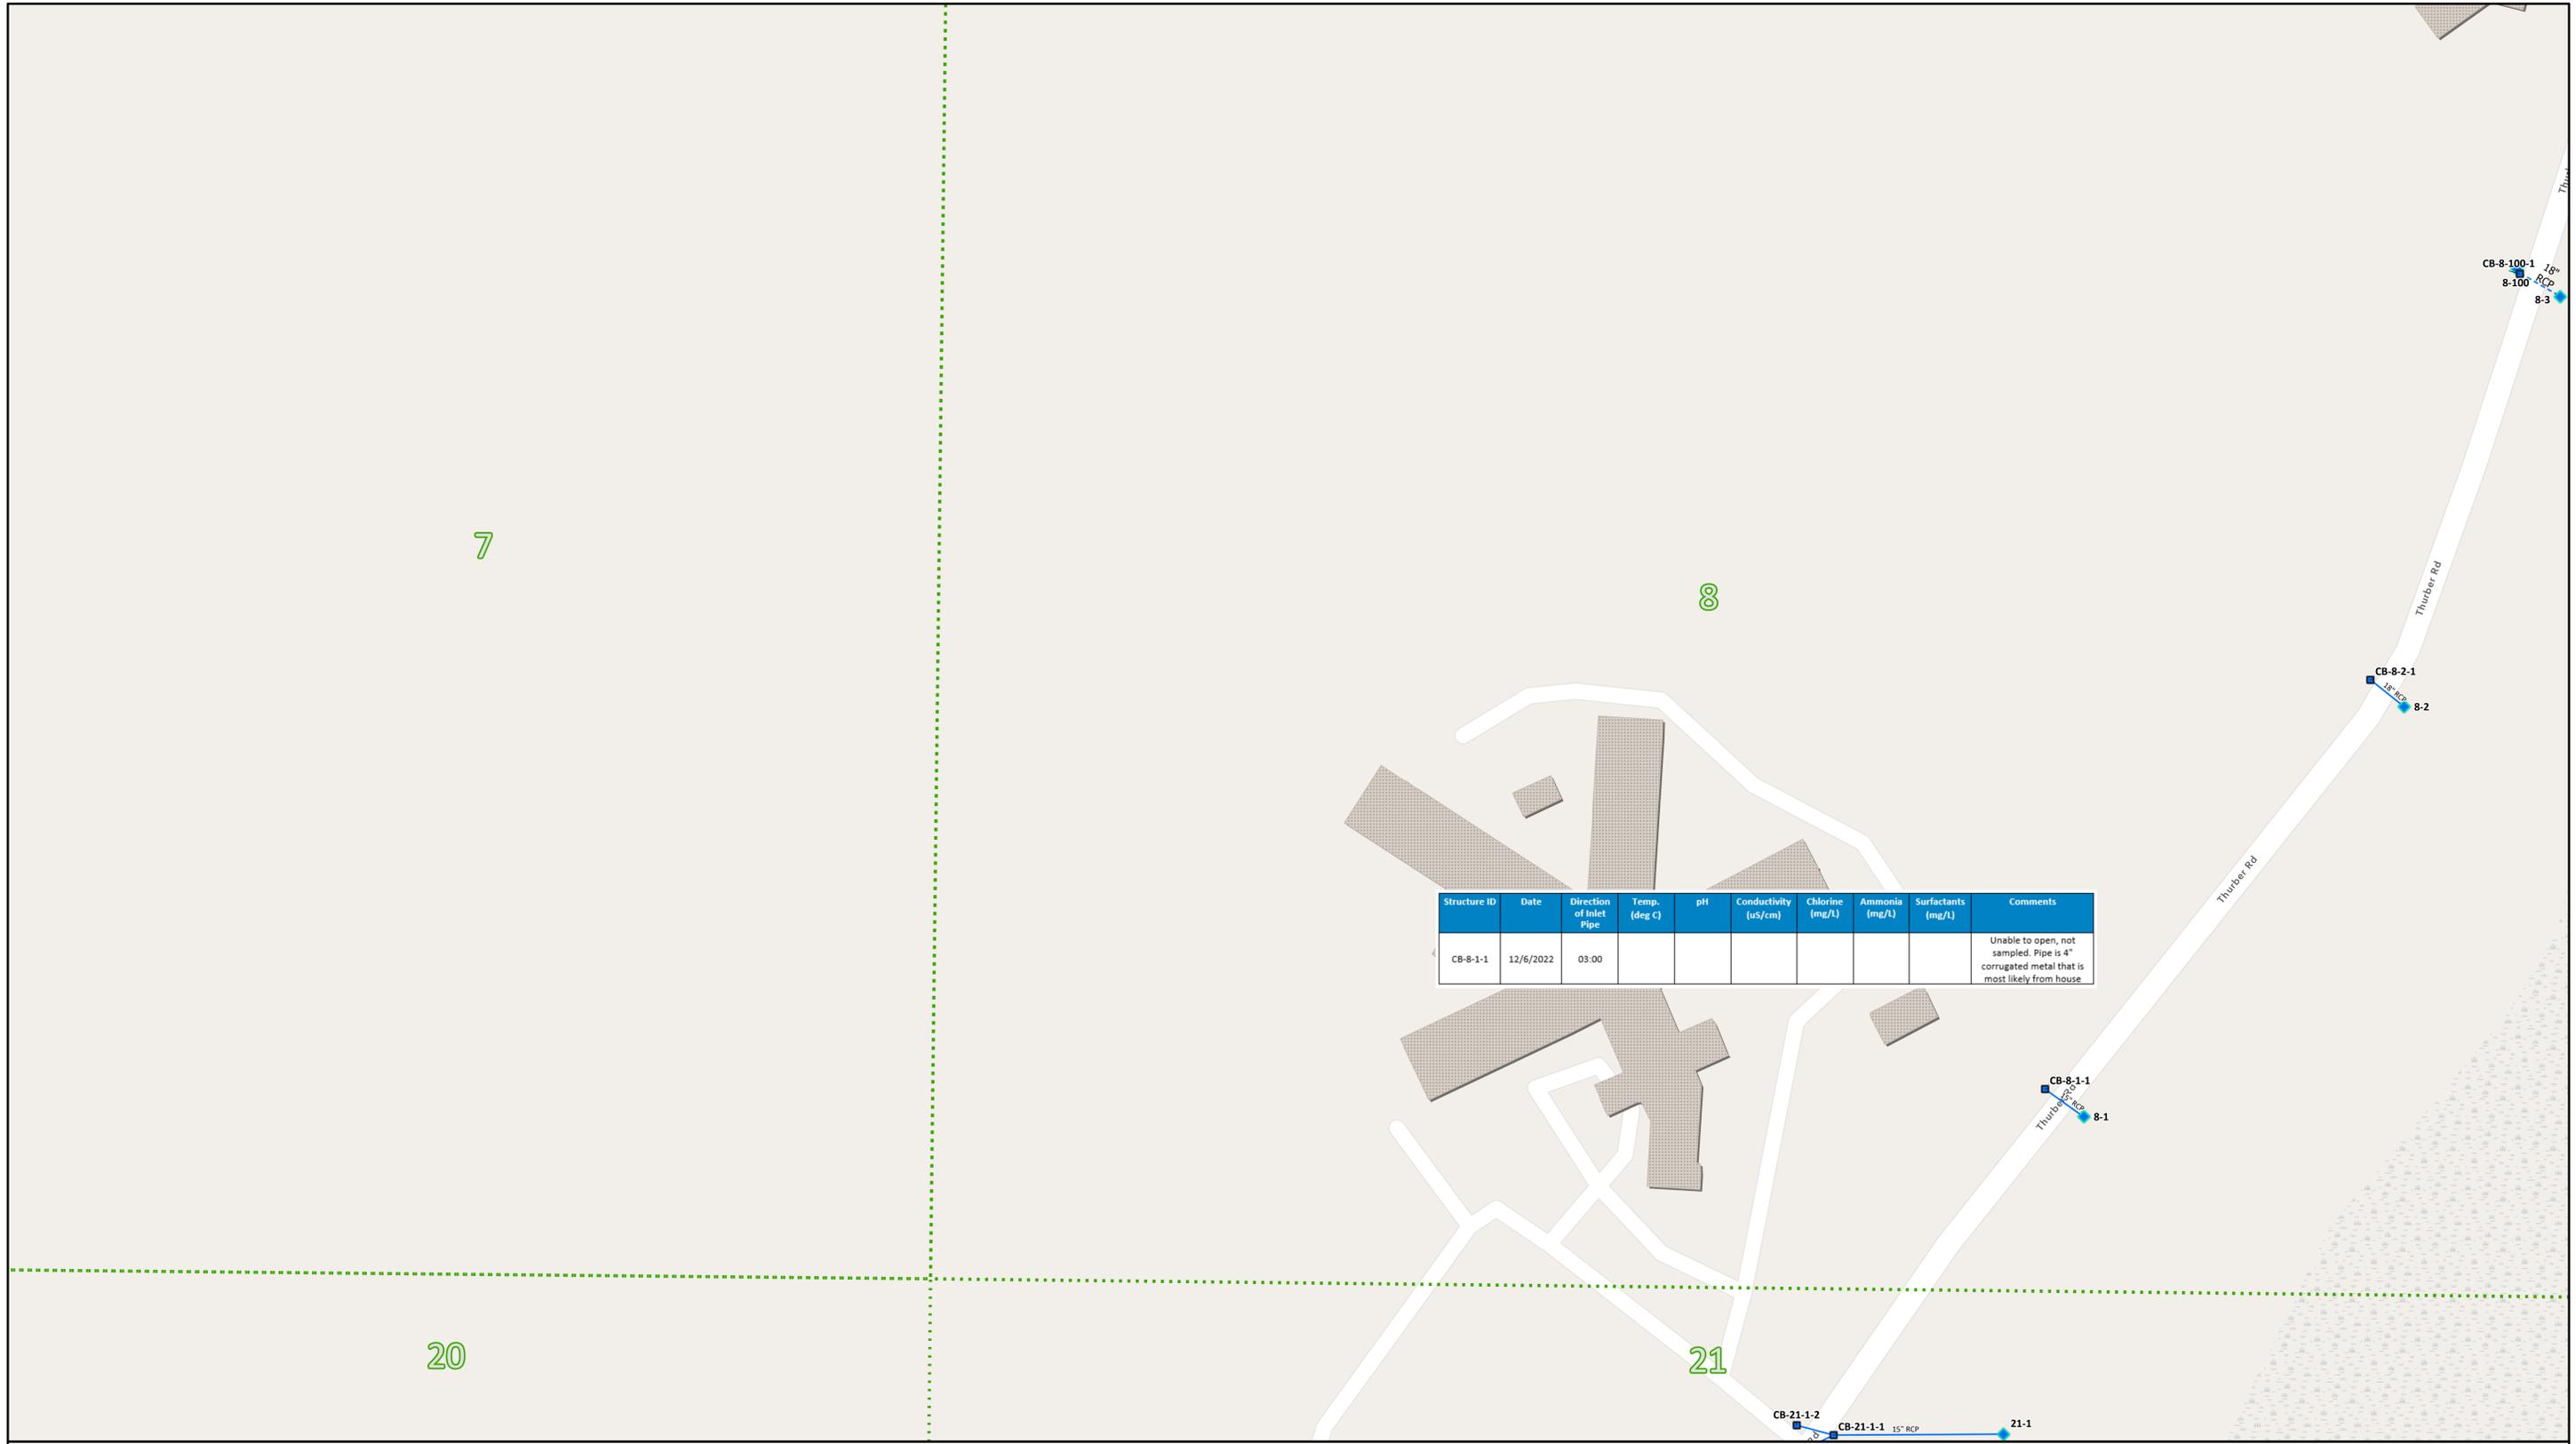
Illicit Discharge Detection and Elimination Investigation
Town of Putnam MS4 Program
February 2023
 Page Name: B10

- Legend**
- Catch Basin
 - City
 - Outfalls
 - City
 - Culvert
 - City
- Gravity Main**
- City
 - Index Map Catchment Plan (March 2018)

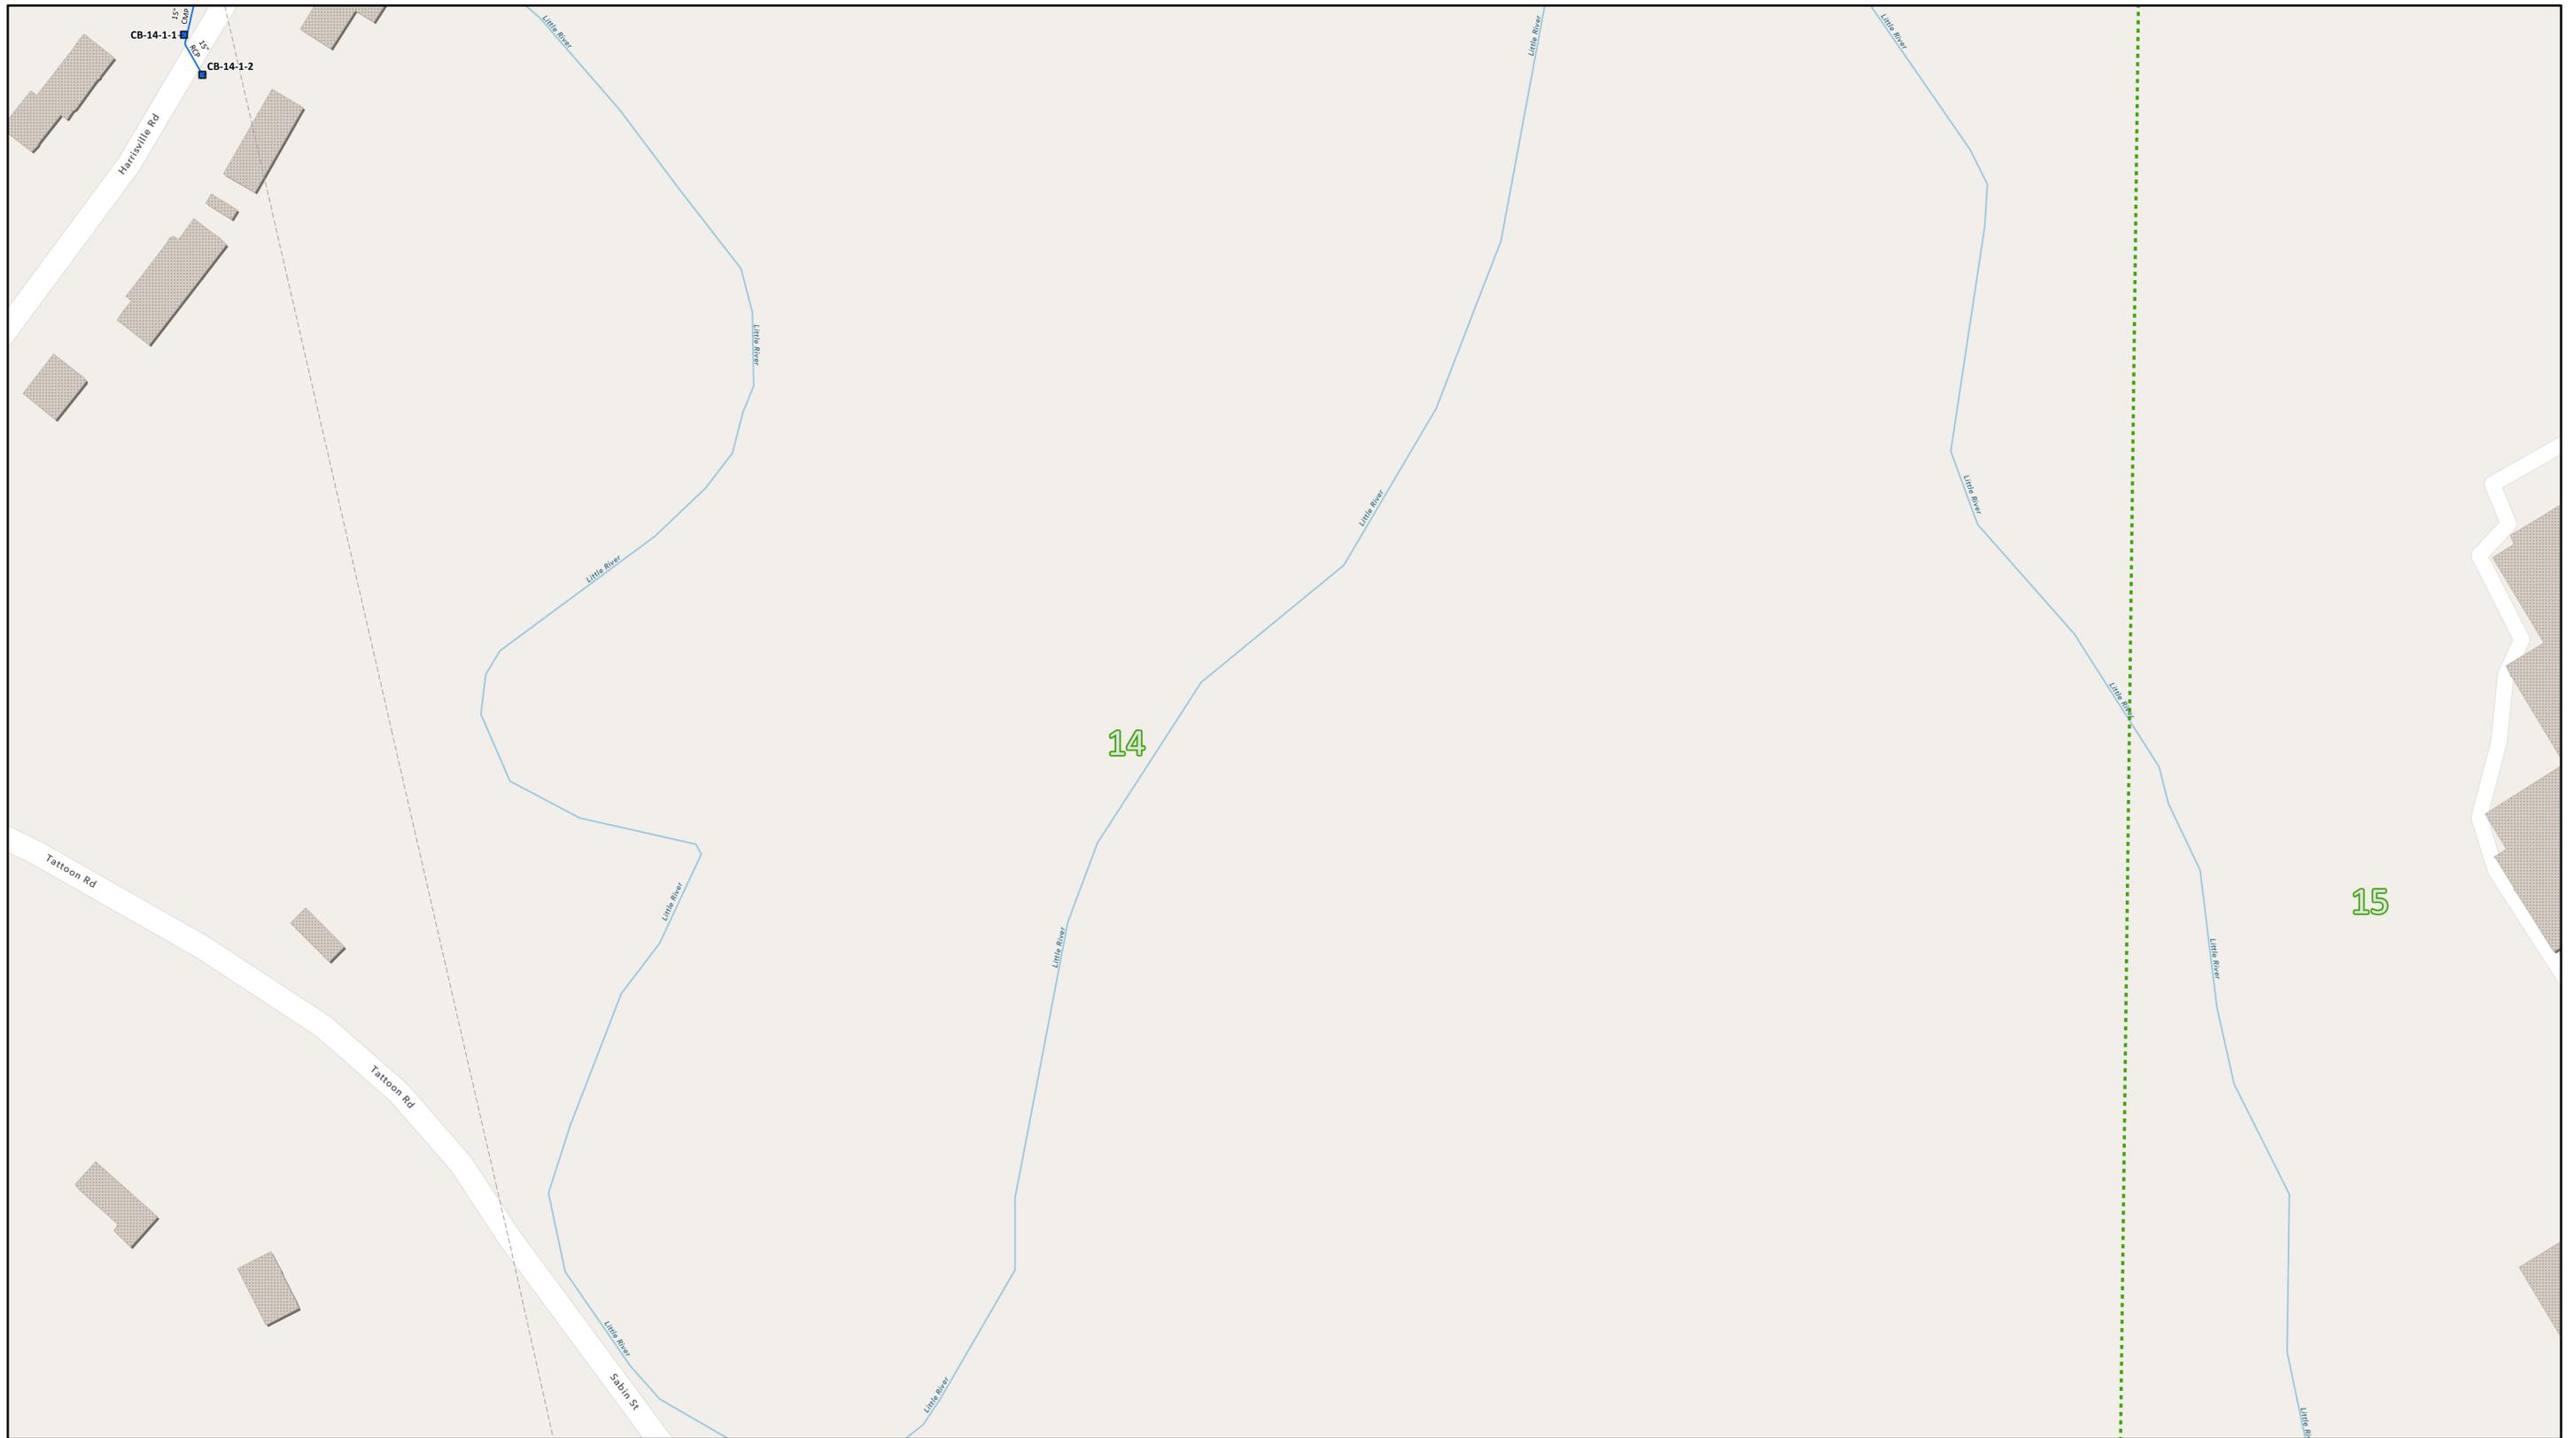
Illicit Discharge Detection and Elimination Investigation
Town of Putnam MS4 Program
February 2023
 Page Name: C1

CB-14-1-1
CB-14-1-2

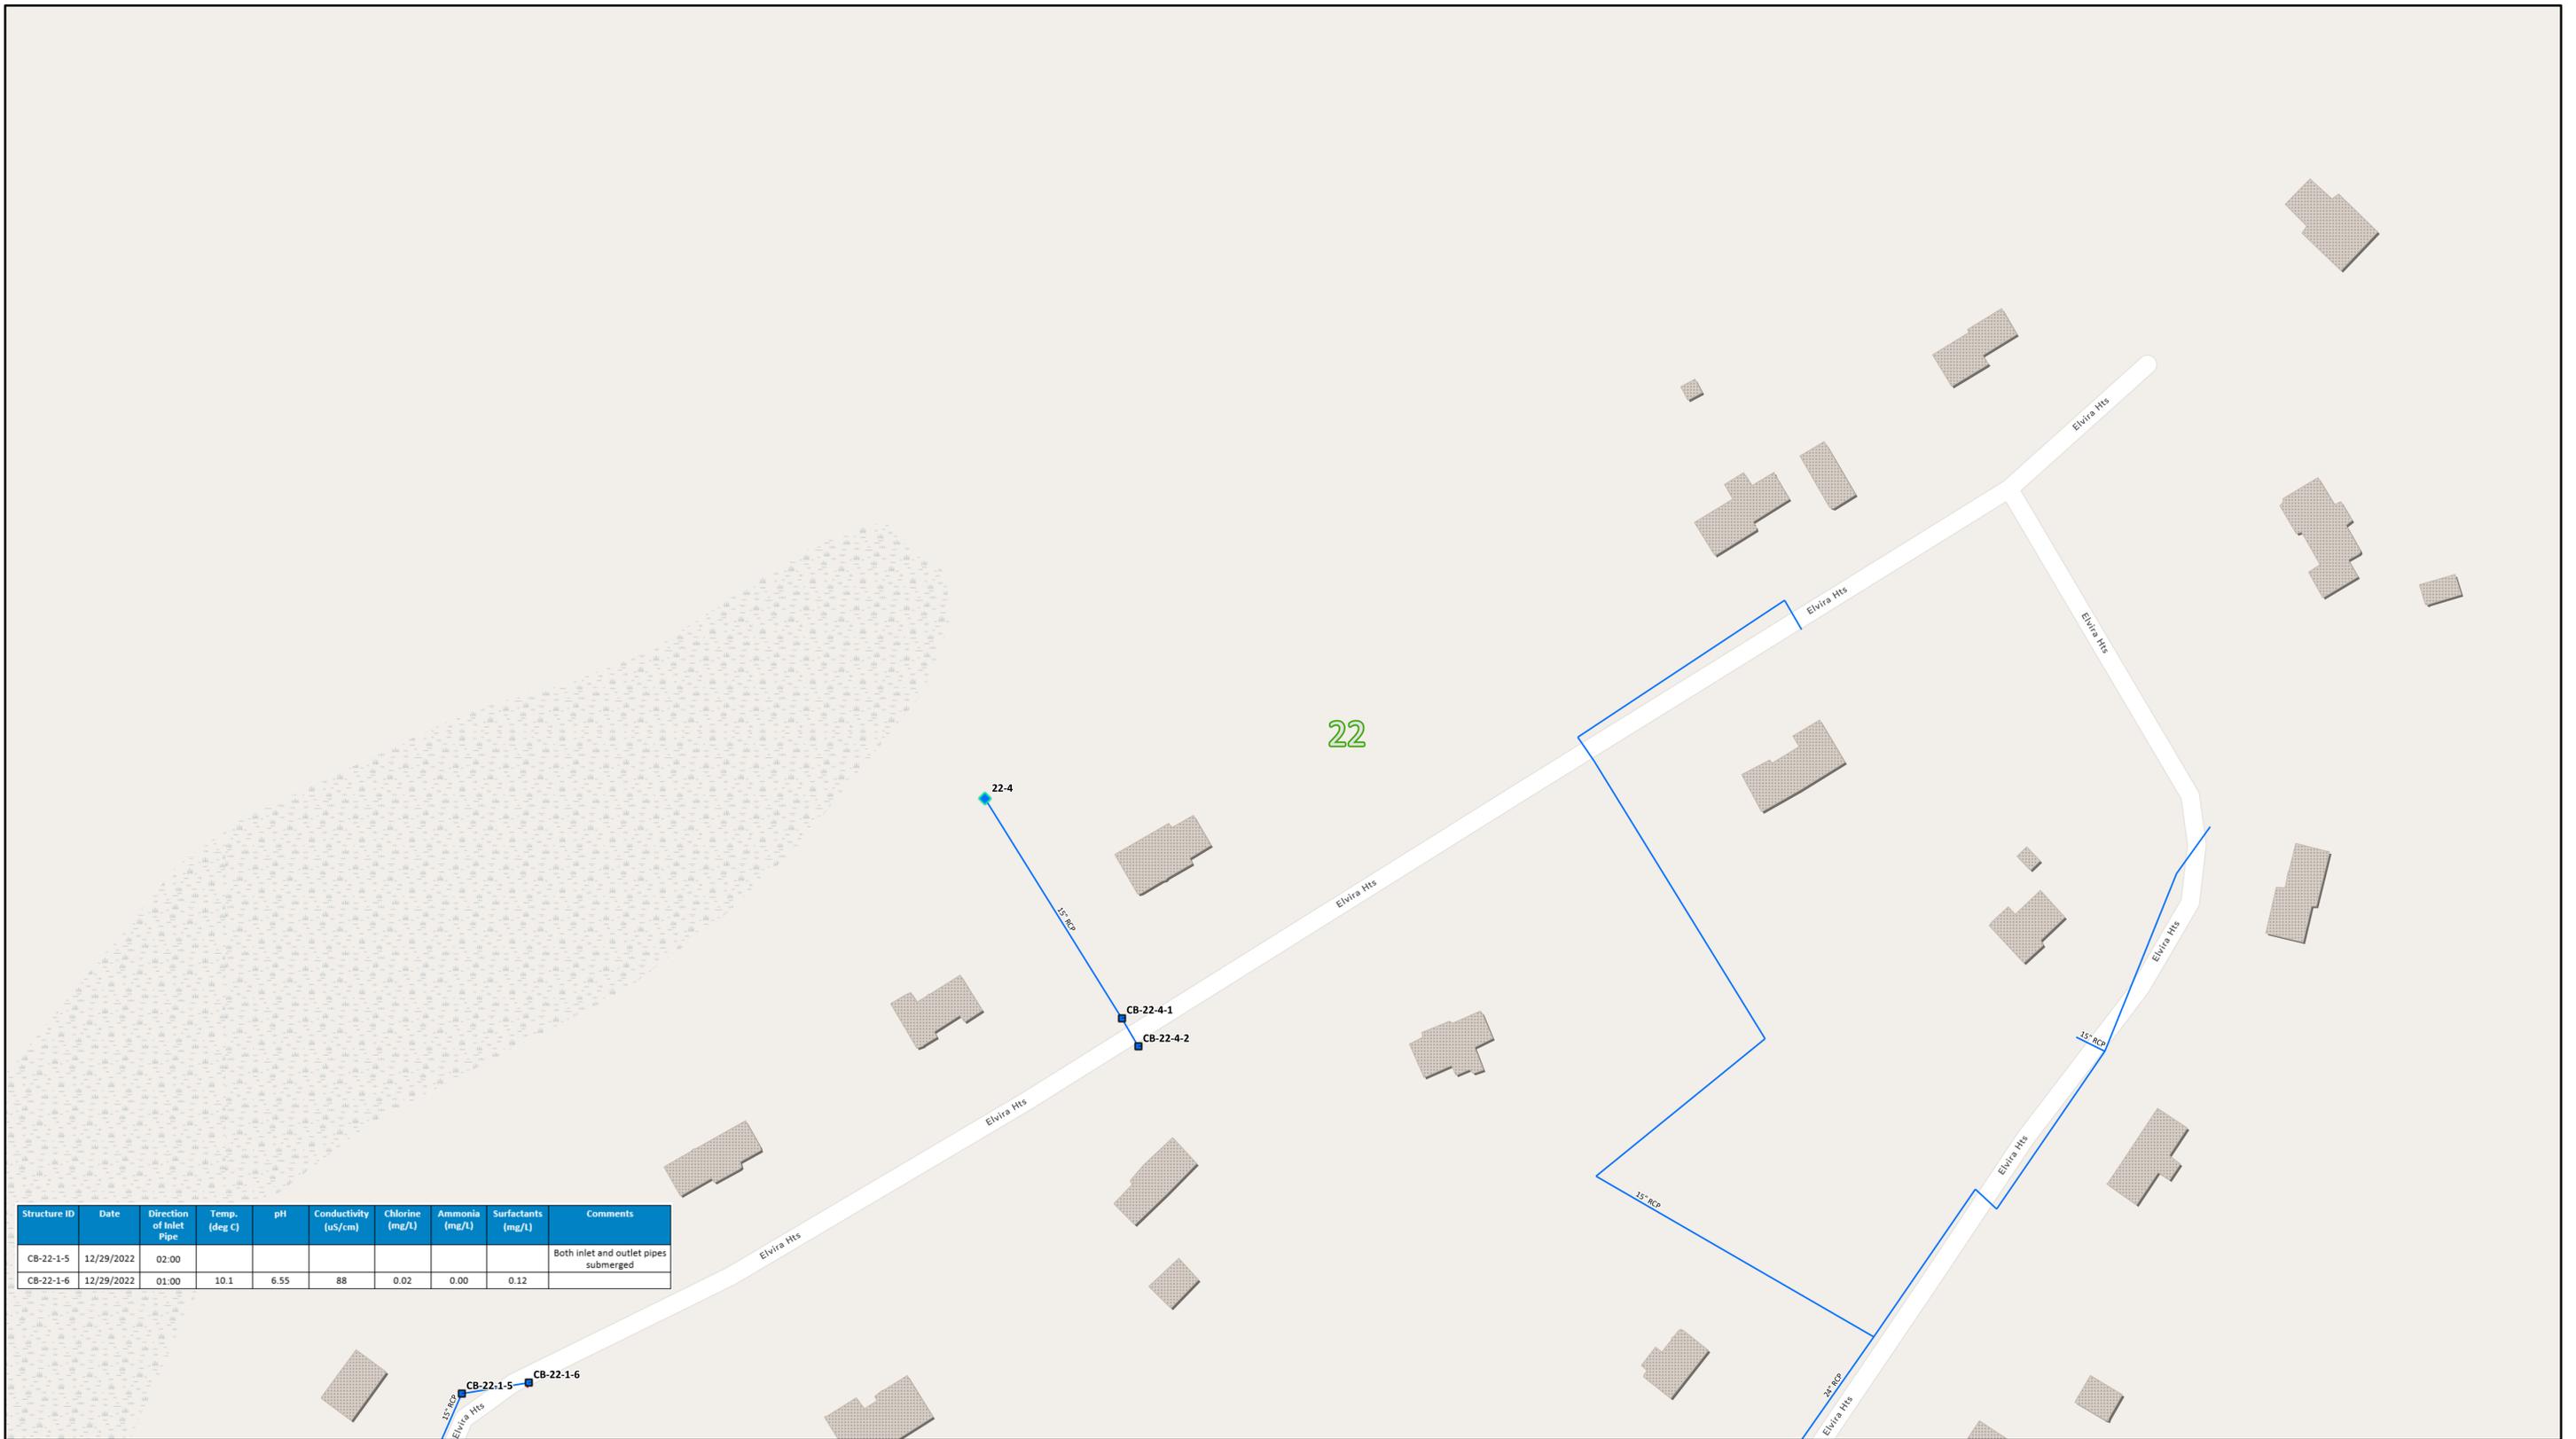
Illicit Discharge Detection and Elimination Investigation
Town of Putnam MS4 Program
February 2023

| Structure ID | Date | Direction of Inlet Pipe | Temp. (deg C) | pH | Conductivity (uS/cm) | Chlorine (mg/L) | Ammonia (mg/L) | Surfactants (mg/L) | Comments |
| CB-22-1-5 | 12/29/2022 | 02:00 | | | | | | | Both inlet and outlet pipes submerged |
