MS4 Annual Report Transmittal Form

For the General Permit to Discharge Stormwater from Small Municipal Separate Storm Sewer Systems (MS4)

This report documents the Town of Putnam efforts to comply with the conditions of the MS4 General Permit to the maximum extent practicable (MEP) from January 1, 2022 to December 31, 2022.

Illicit Discharge Detection and Elimination Investigation
Town of Putnam MS4 Program
February 2023
 Page Name: A1

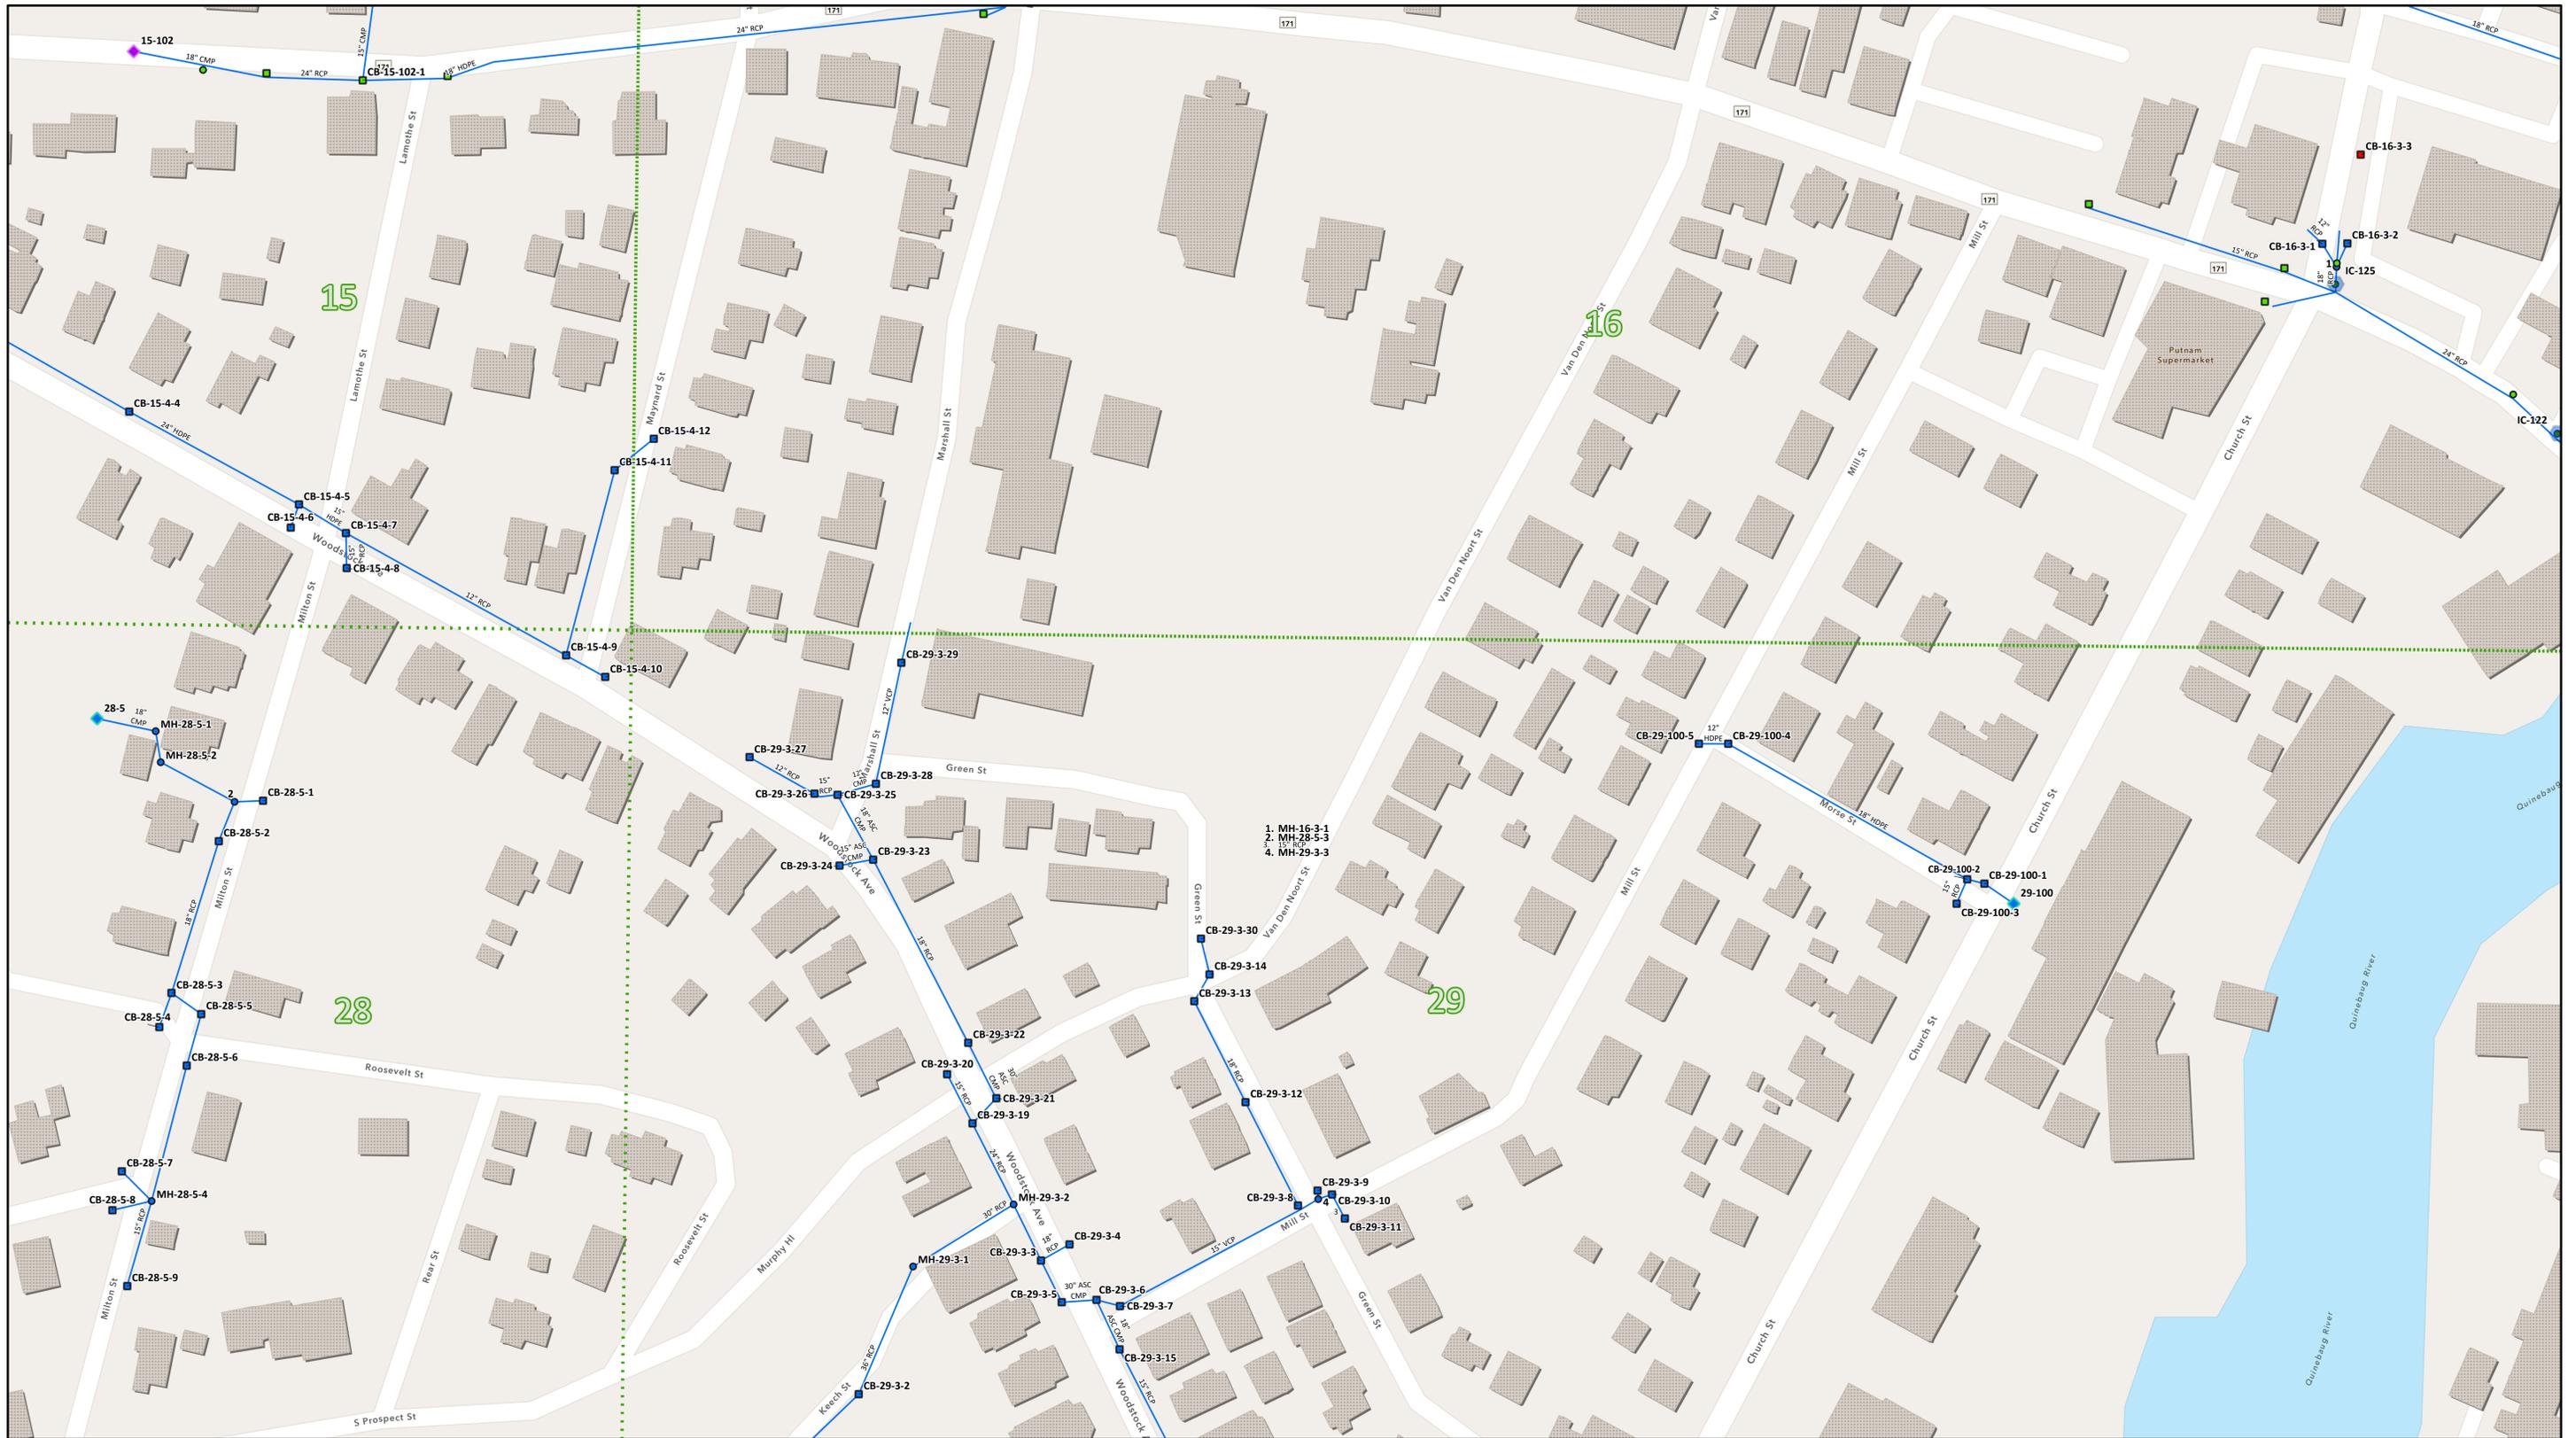
Illicit Discharge Detection and Elimination Investigation
Town of Putnam MS4 Program
February 2023
 Page Name: D2

- 1. MH-16-3-1
- 2. MH-28-5-3
- 3. MH-29-3-3
- 4. MH-29-3-3

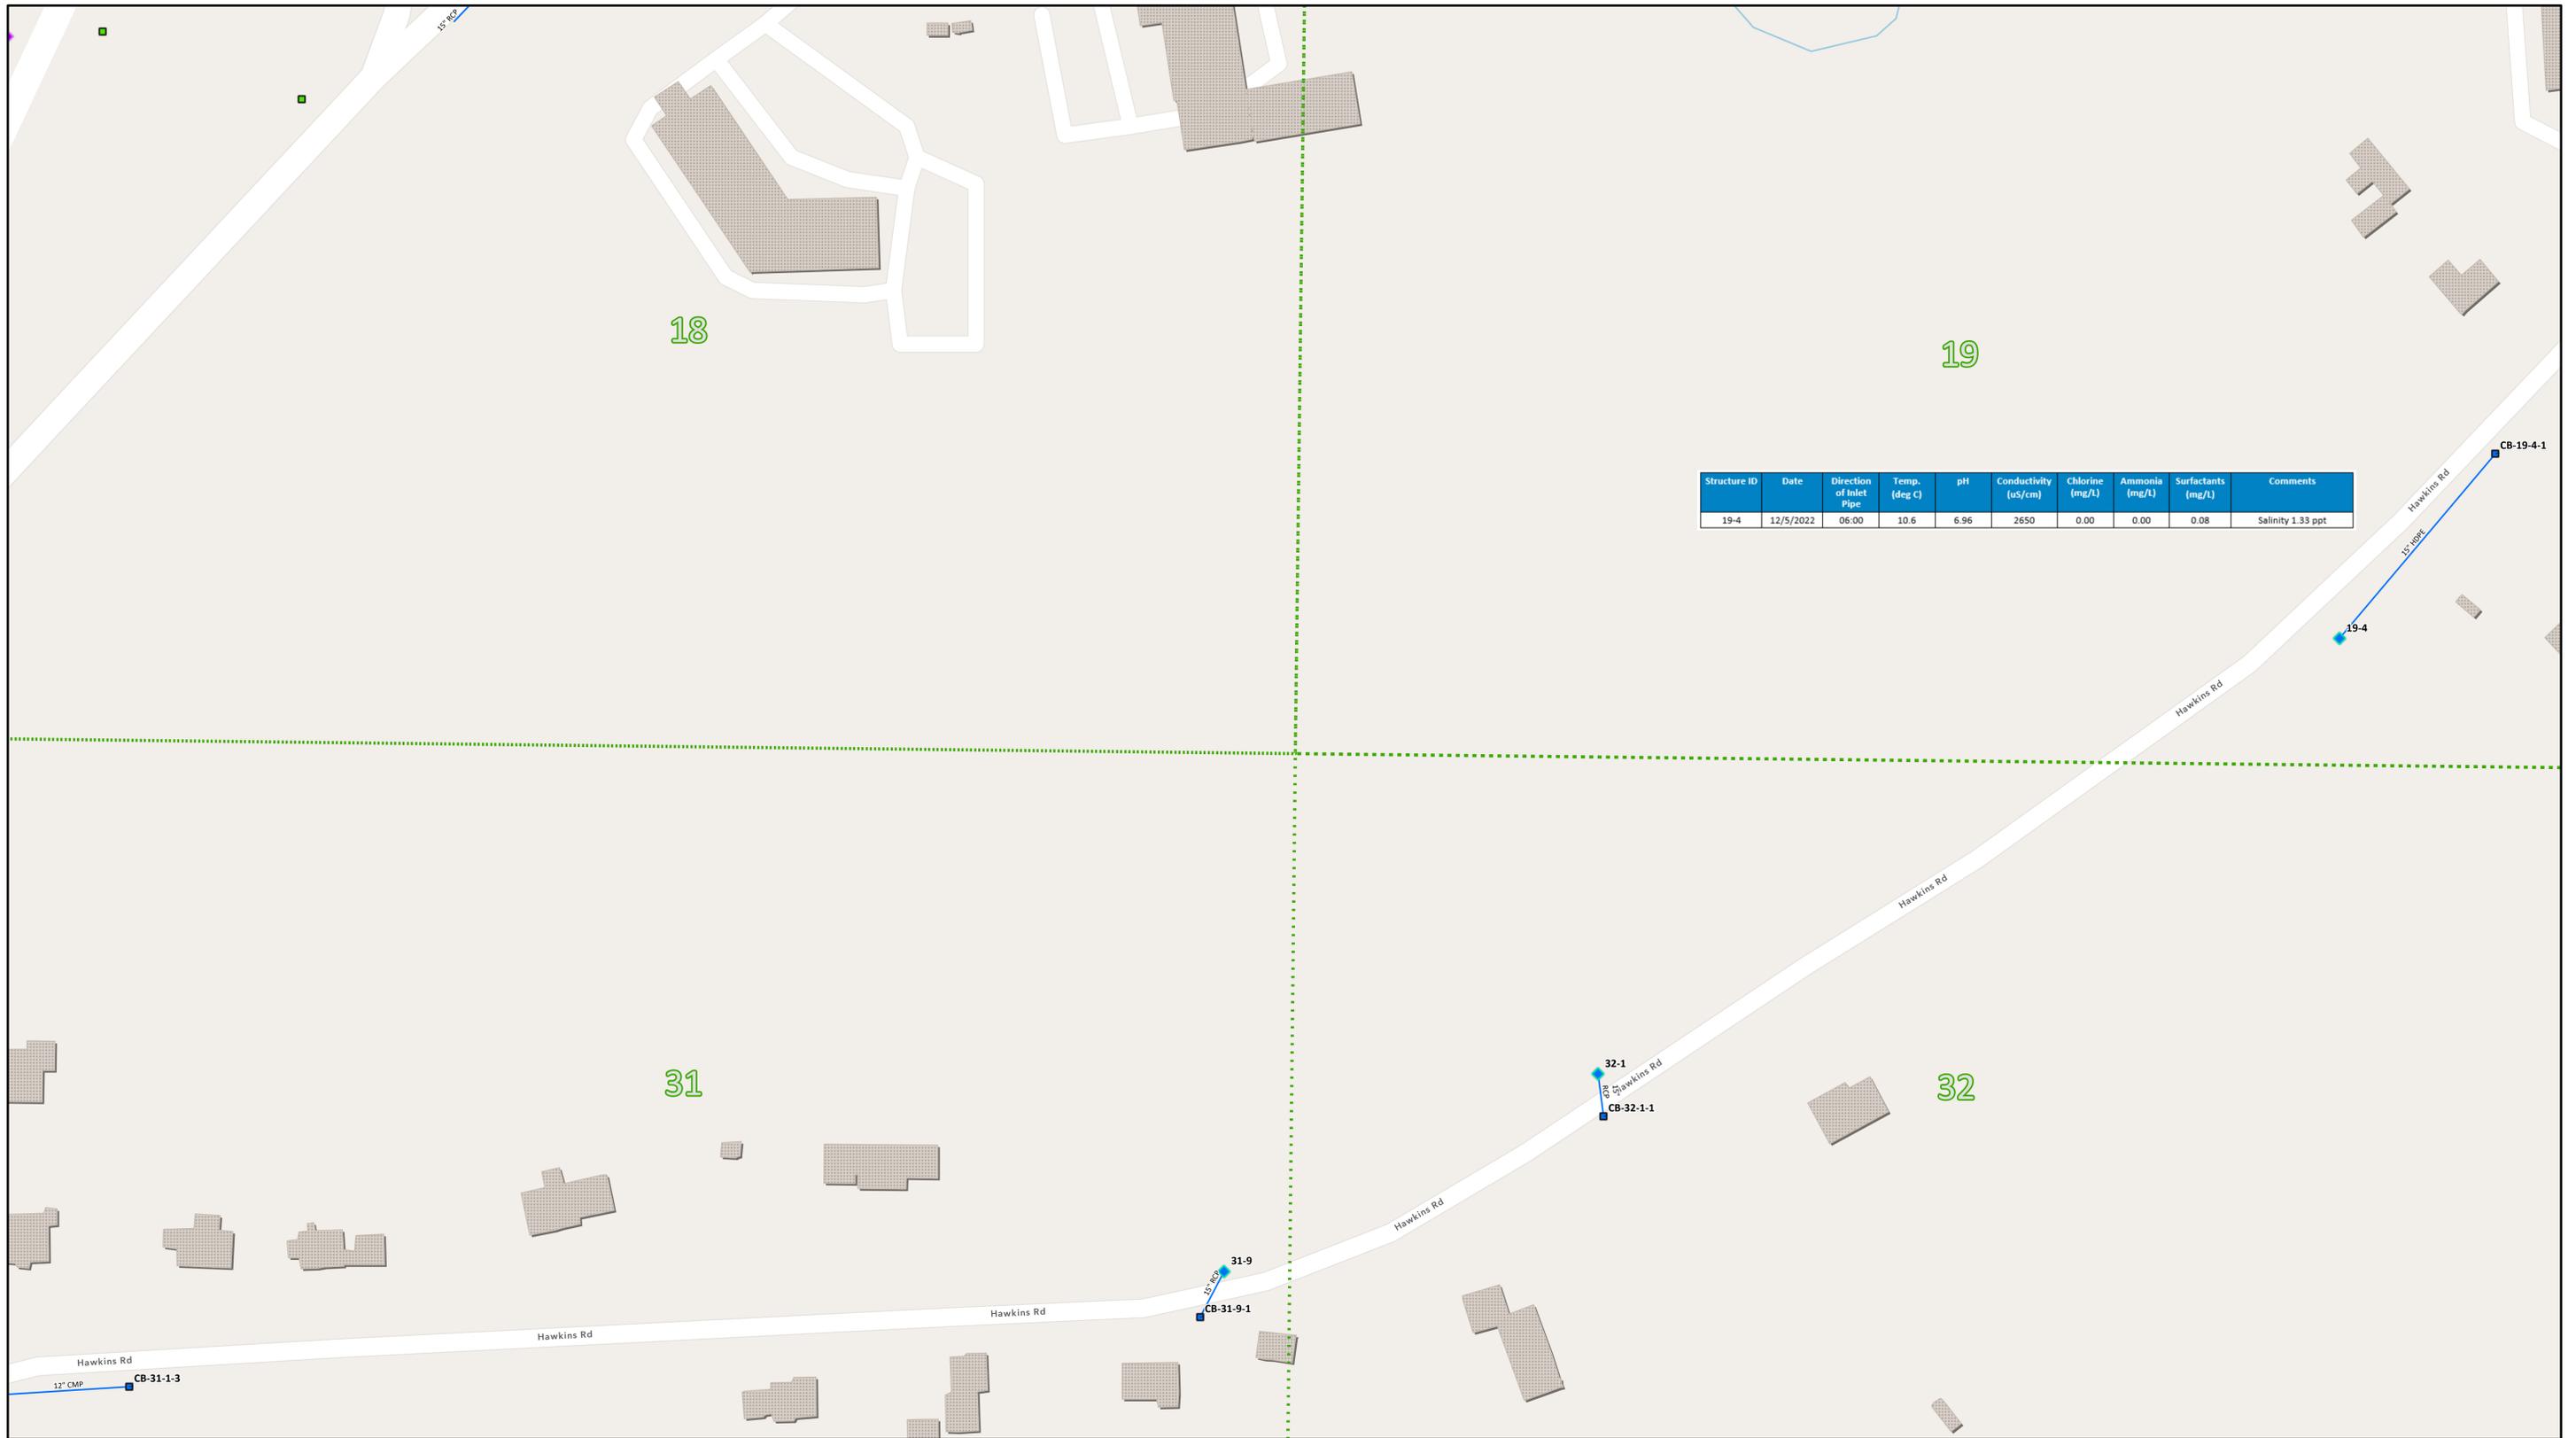
Page Name: D6

| Structure ID | Date | Direction of Inlet Pipe | Temp. (deg C) | pH | Conductivity (uS/cm) | Chlorine (mg/L) | Ammonia (mg/L) | Surfactants (mg/L) | Comments |
| 19-4 | 12/5/2022 | 06:00 | 10.6 | 6.96 | 2650 | 0.00 | 0.00 | 0.08 | Salinity 1.33 ppt |

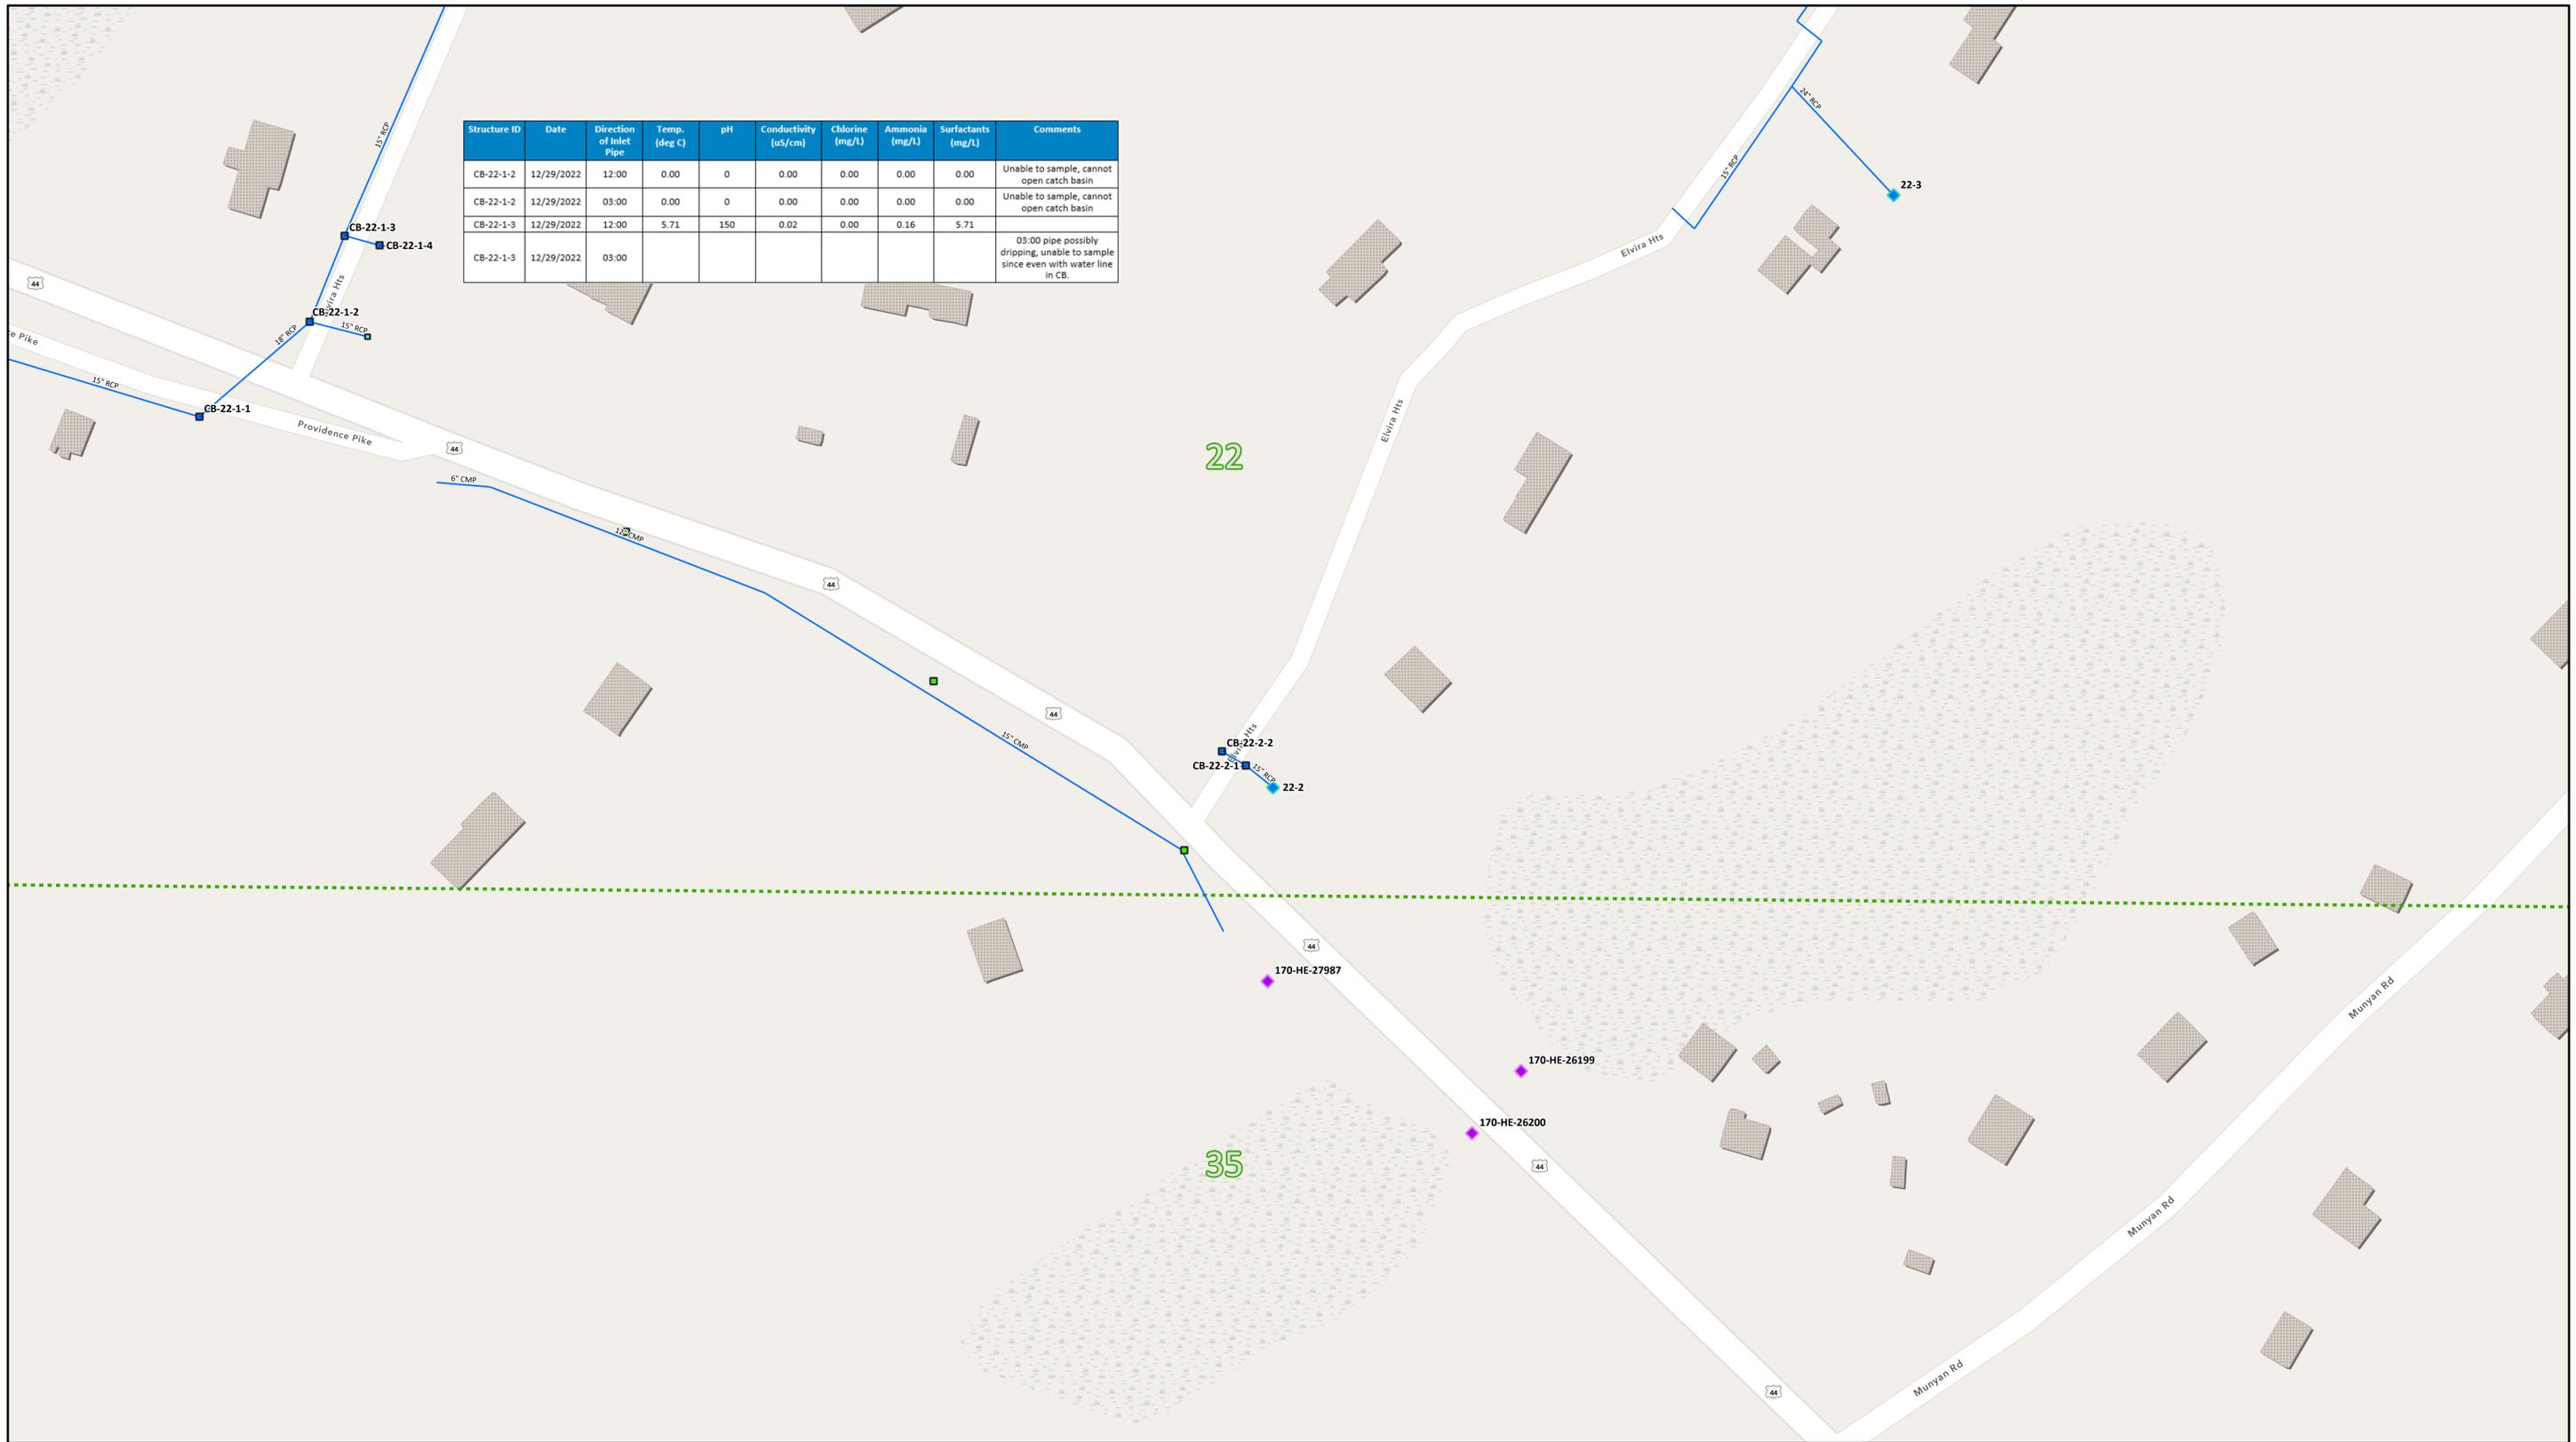
| Structure ID | Date | Direction of Inlet Pipe | Temp. (deg C) | pH | Conductivity (uS/cm) | Chlorine (mg/L) | Ammonia (mg/L) | Surfactants (mg/L) | Comments |
| CB-22-1-2 | 12/29/2022 | 12:00 | 0.00 | 0 | 0.00 | 0.00 | 0.00 | 0.00 | Unable to sample, cannot open catch basin |
| CB-22-1-3 | 12/29/2022 | 12:00 | 5.71 | 150 | 0.02 | 0.00 | 0.16 | 5.71 | |
| CB-22-1-3 | 12/29/2022 | 09:00 | | | | | | | 03:00 pipe possibly dripping, unable to sample since even with water line in CB. |

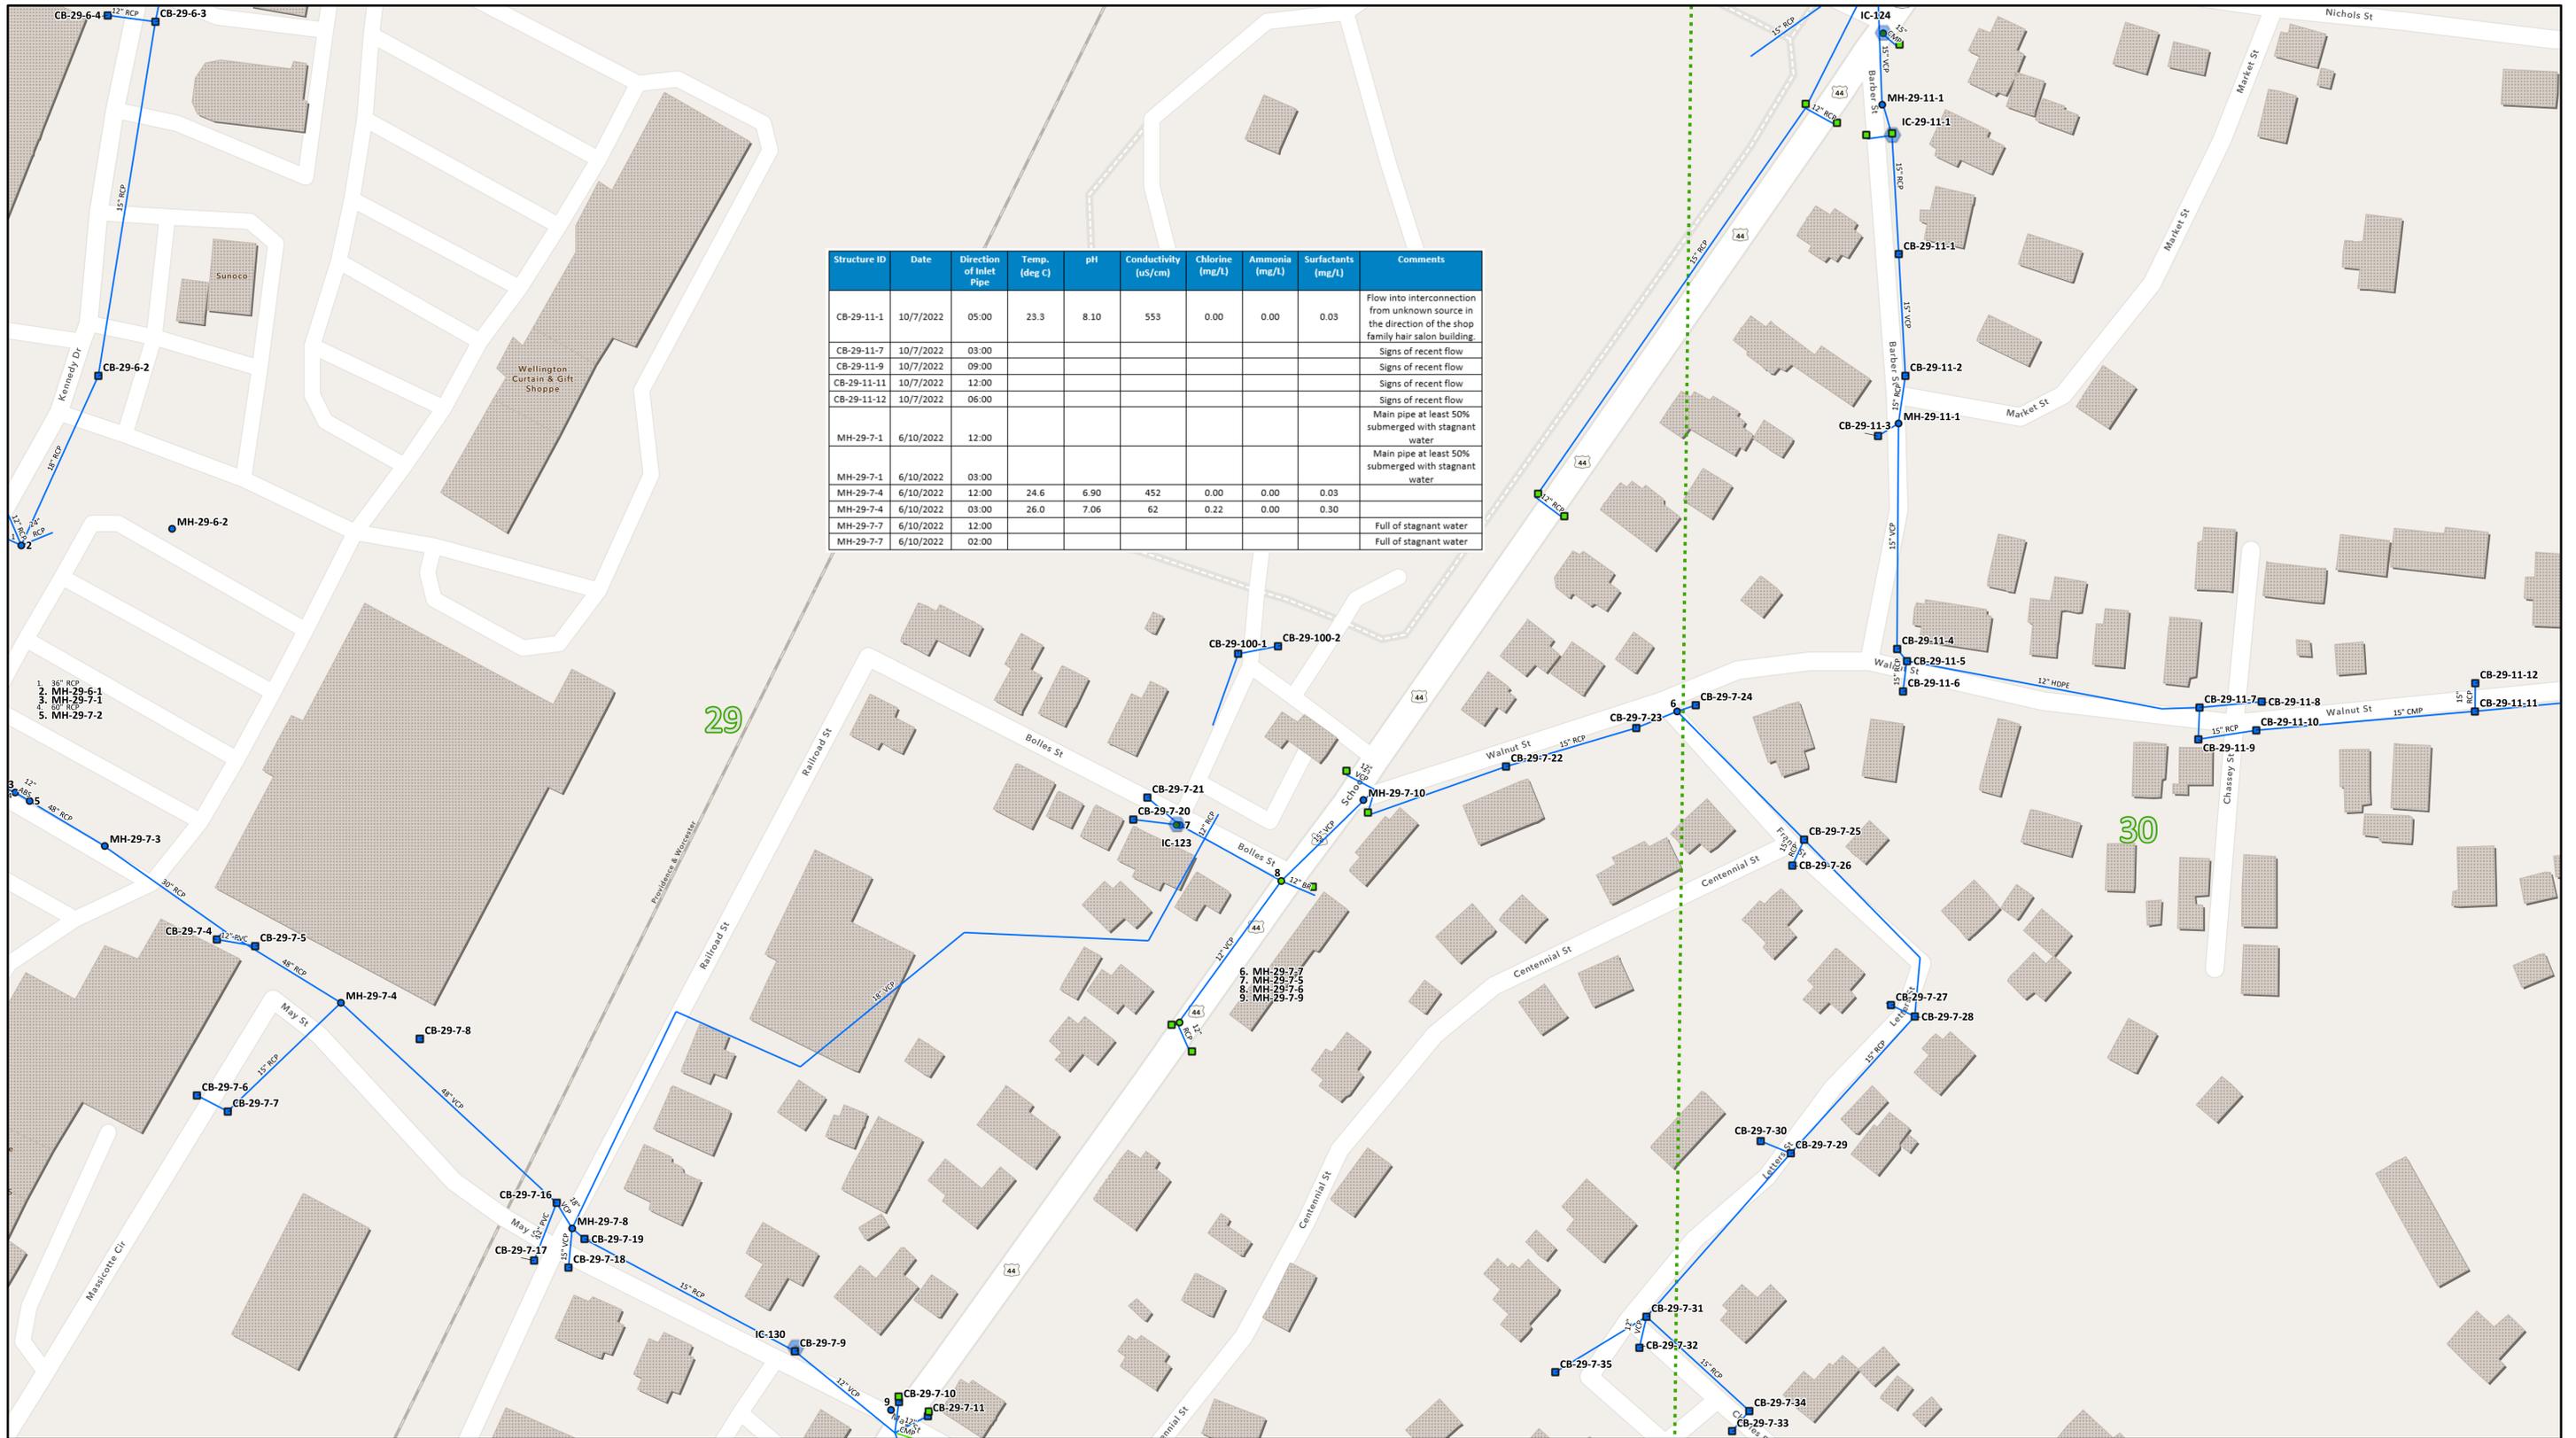
| Structure ID | Date | Direction of Inlet Pipe | Temp. (deg C) | pH | Conductivity (us/cm) | Chlorine (mg/L) | Ammonia (mg/L) | Surfactants (mg/L) | Comments |
| CB-29-11-1 | 10/7/2022 | 05:00 | 23.3 | 8.10 | 553 | 0.00 | 0.00 | 0.03 | Flow into interconnection from unknown source in the direction of the shop family hair salon building. |
| MH-29-7-1 | 6/10/2022 | 12:00 | | | | | | | Main pipe at least 50% submerged with stagnant water |
| MH-29-7-4 | 6/10/2022 | 12:00 | 24.6 | 6.90 | 452 | 0.00 | 0.00 | 0.03 | |

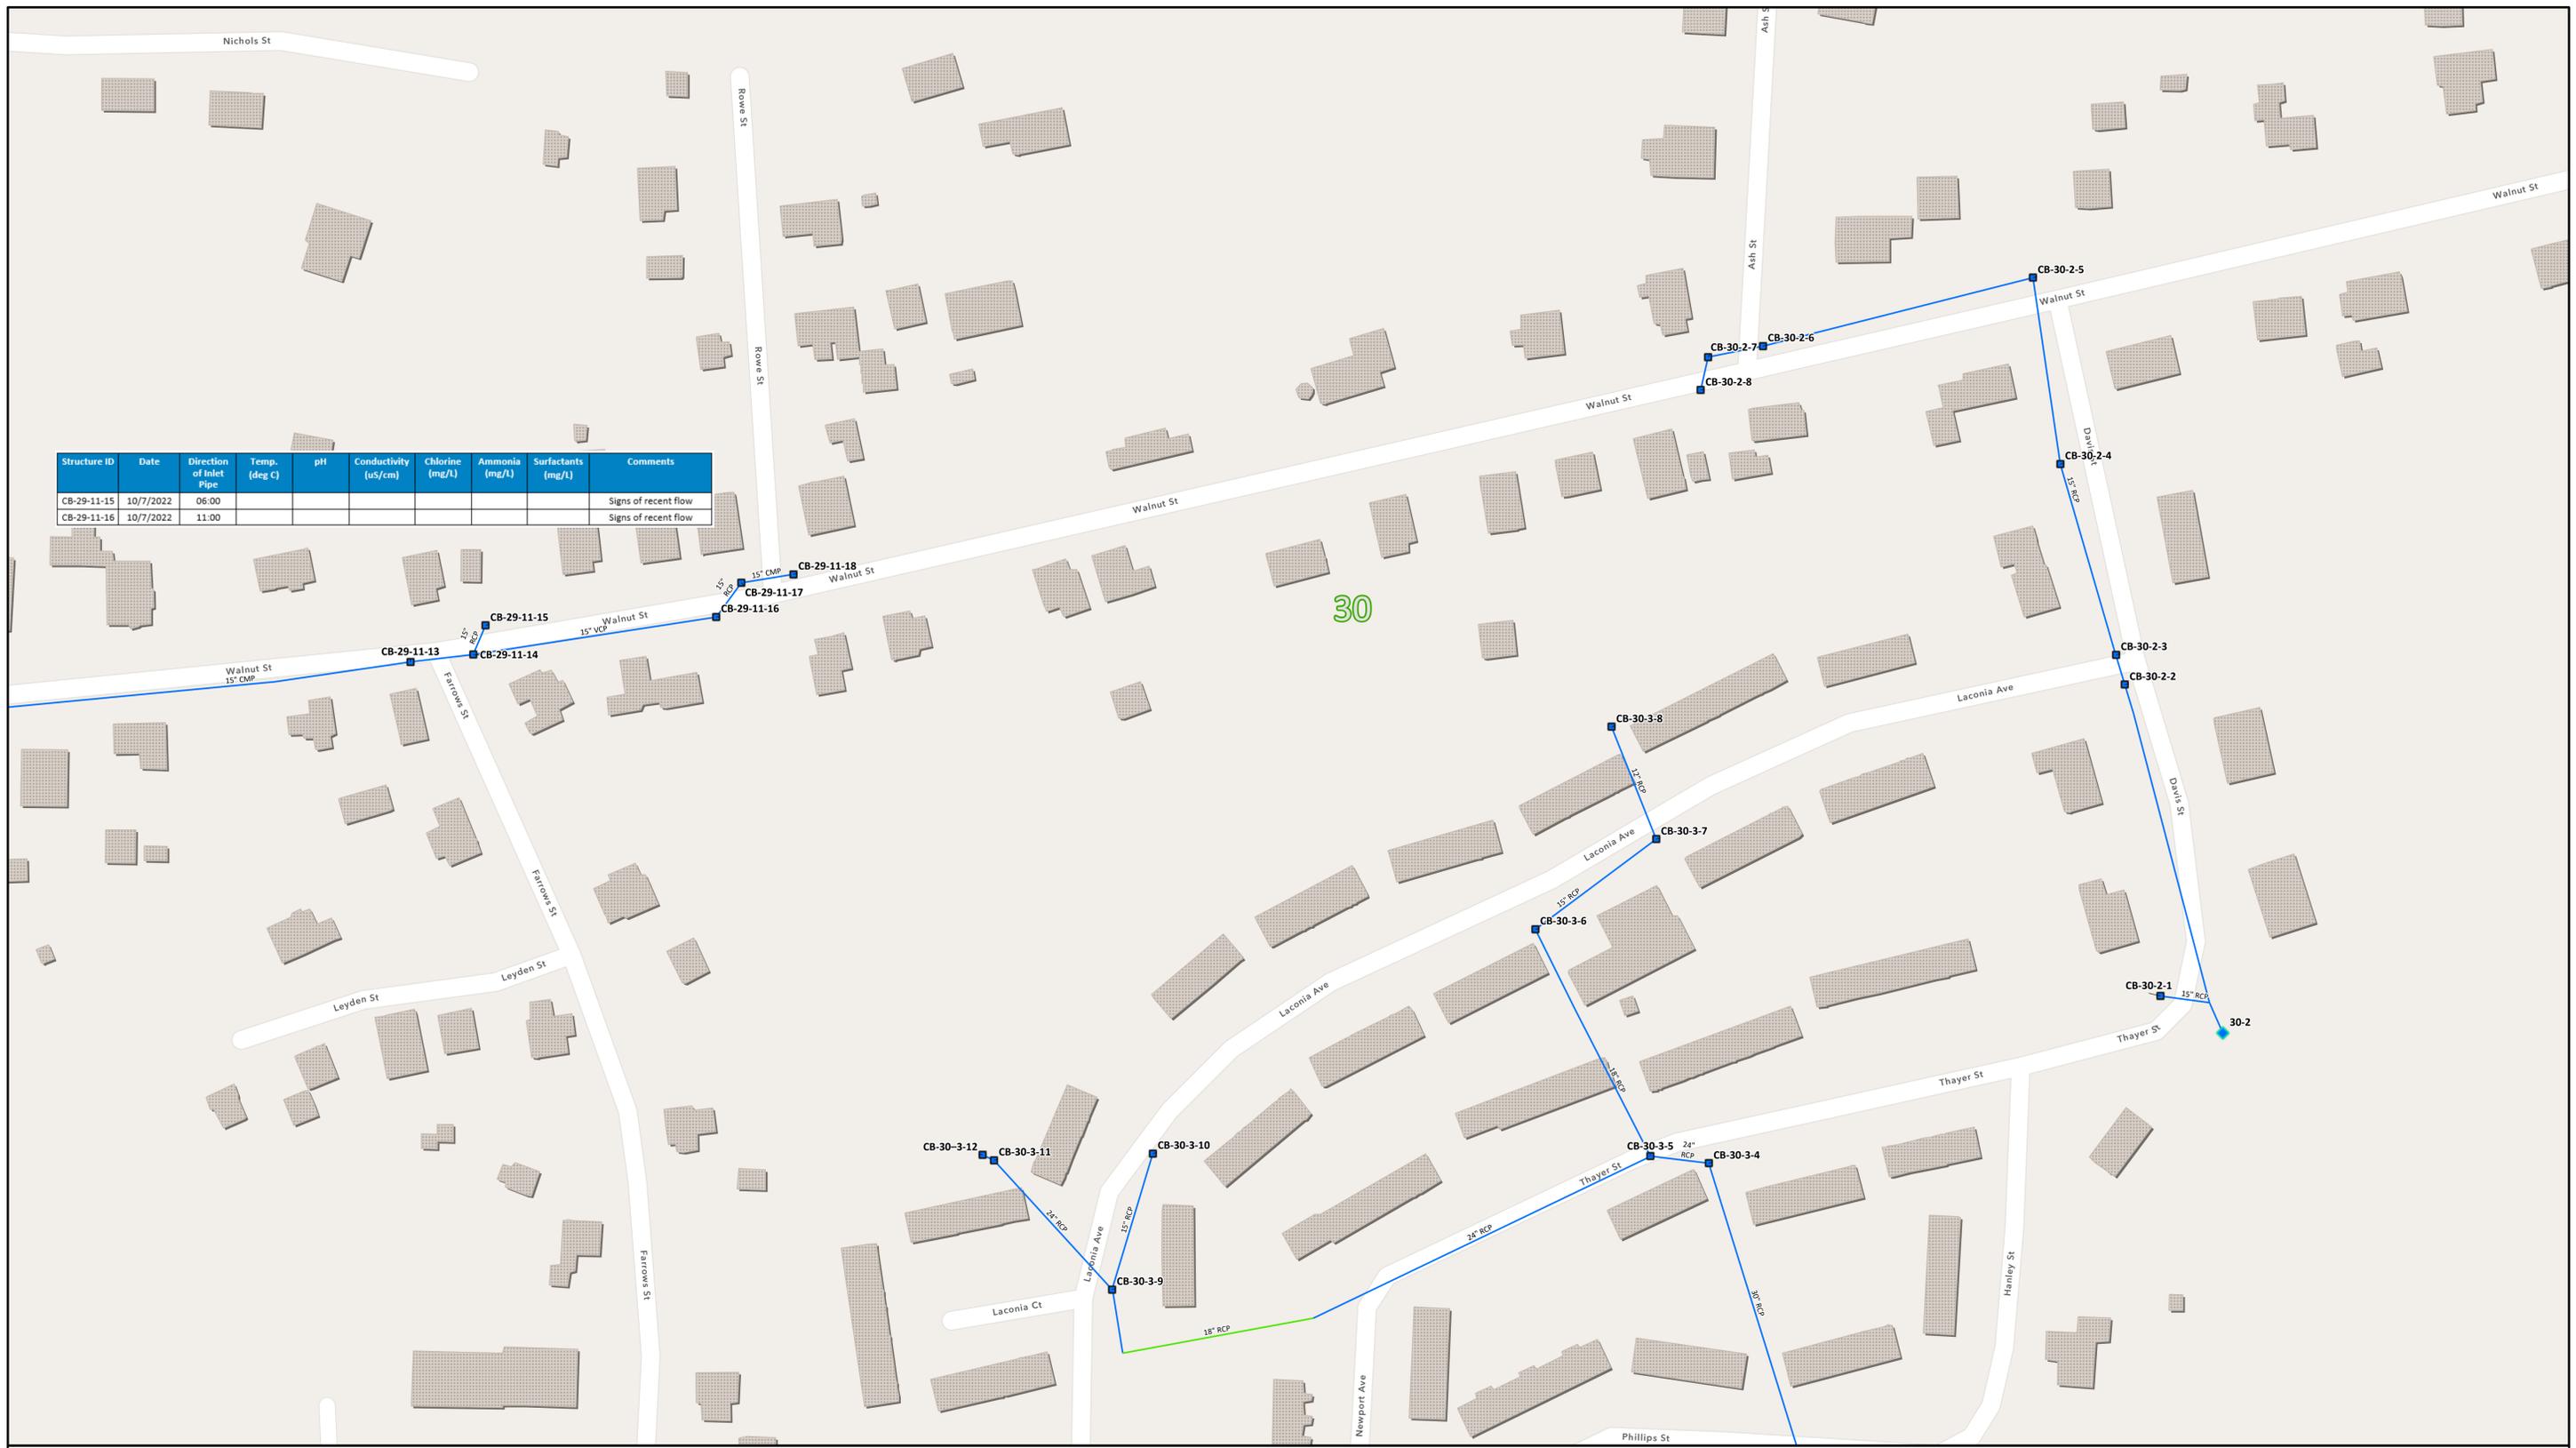
Illicit Discharge Detection and Elimination Investigation
Town of Putnam MS4 Program
February 2023
 Page Name: E4

| Structure ID | Date | Direction of Inlet Pipe | Temp. (deg C) | pH | Conductivity (uS/cm) | Chlorine (mg/L) | Ammonia (mg/L) | Surfactants (mg/L) | Comments |
| CB-29-11-15 | 10/7/2022 | 06:00 | | | | | | | Signs of recent flow |
| CB-29-11-16 | 10/7/2022 | 11:00 | | | | | | | Signs of recent flow |

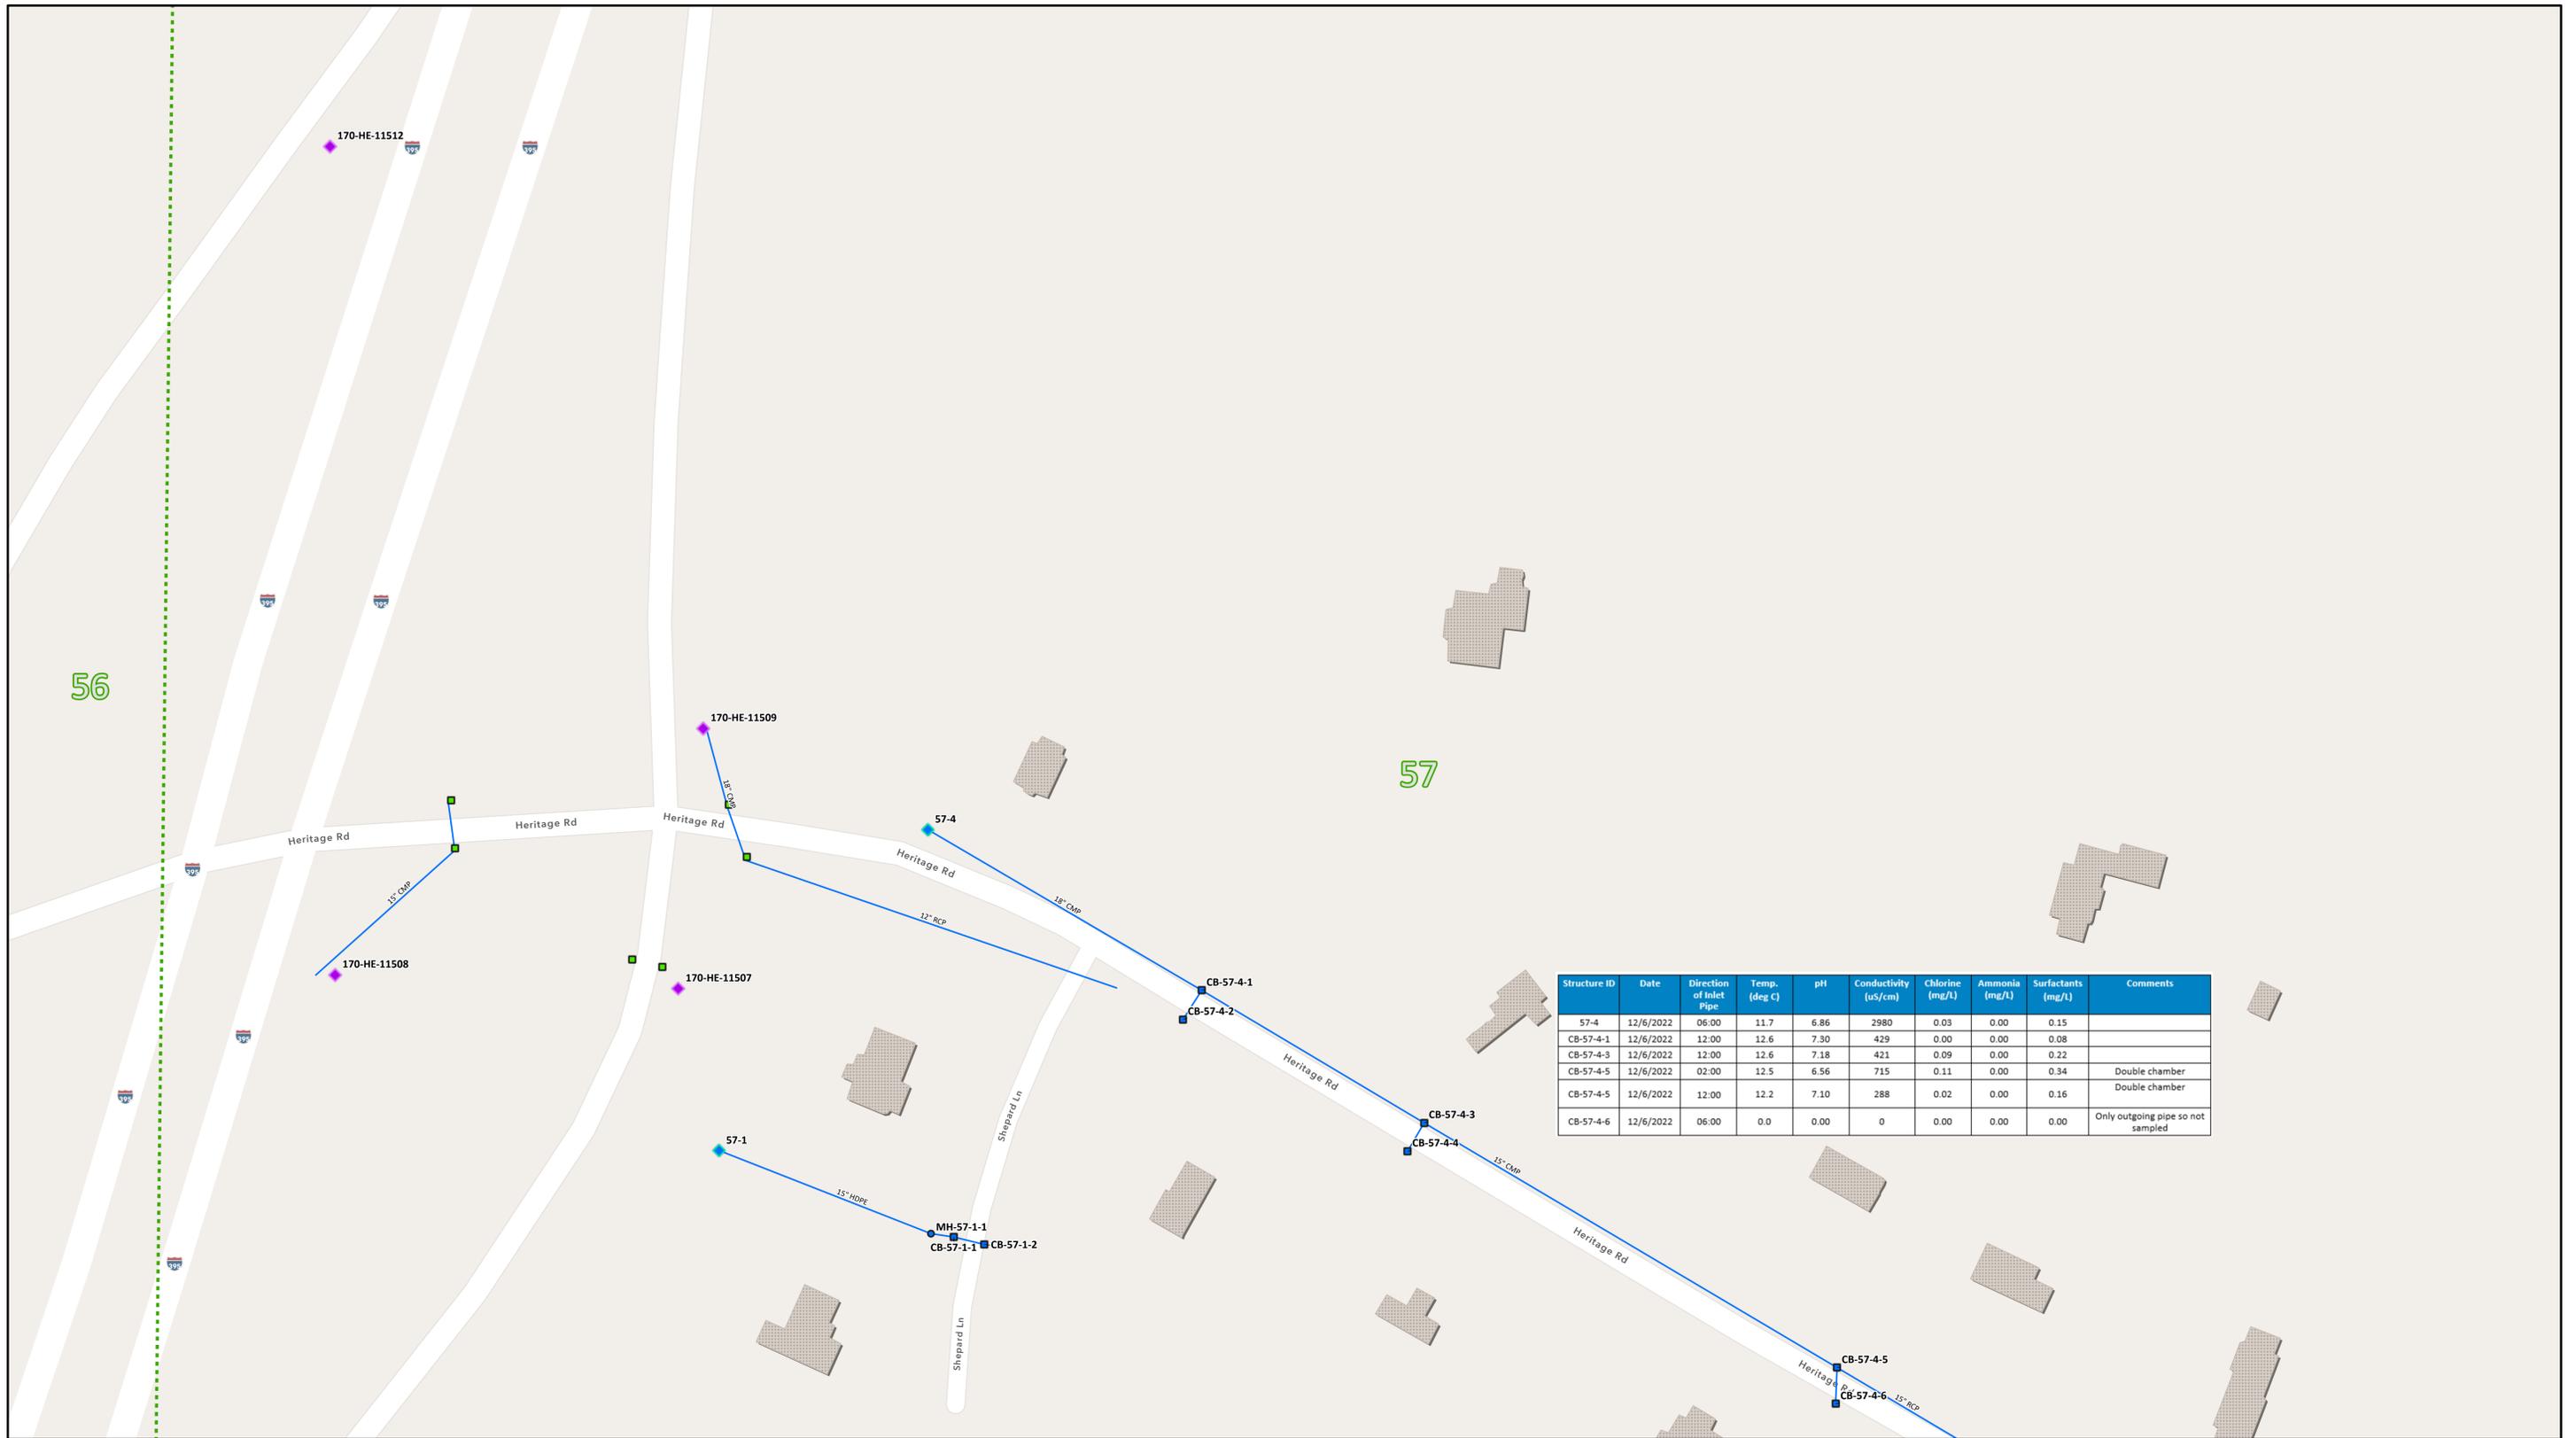
Page Name: H5

| Structure ID | Date | Direction of Inlet Pipe | Temp. (deg C) | pH | Conductivity (uS/cm) | Chlorine (mg/L) | Ammonia (mg/L) | Surfactants (mg/L) | Comments |
| 57-4 | 12/6/2022 | 06:00 | 11.7 | 6.86 | 2980 | 0.03 | 0.00 | 0.15 | |

| Outfall ID | IDDE Concern(s) | Comments | Recommendations |
|---|---|---|--|
| 57-4 | Chlorine | Outfall and upstream structures sampled. Soap suds observed. | CCTV along Heritage Road |
