MS4 Annual Report Transmittal Form

For the General Permit to Discharge Stormwater from Small Municipal Separate Storm Sewer Systems (MS4)

This report documents the Town of Putnam efforts to comply with the conditions of the MS4 General Permit to the maximum extent practicable (MEP) from January 1, 2022 to December 31, 2022.

Illicit Discharge Detection and Elimination Investigation
Town of Putnam MS4 Program
February 2023
 Page Name: A1

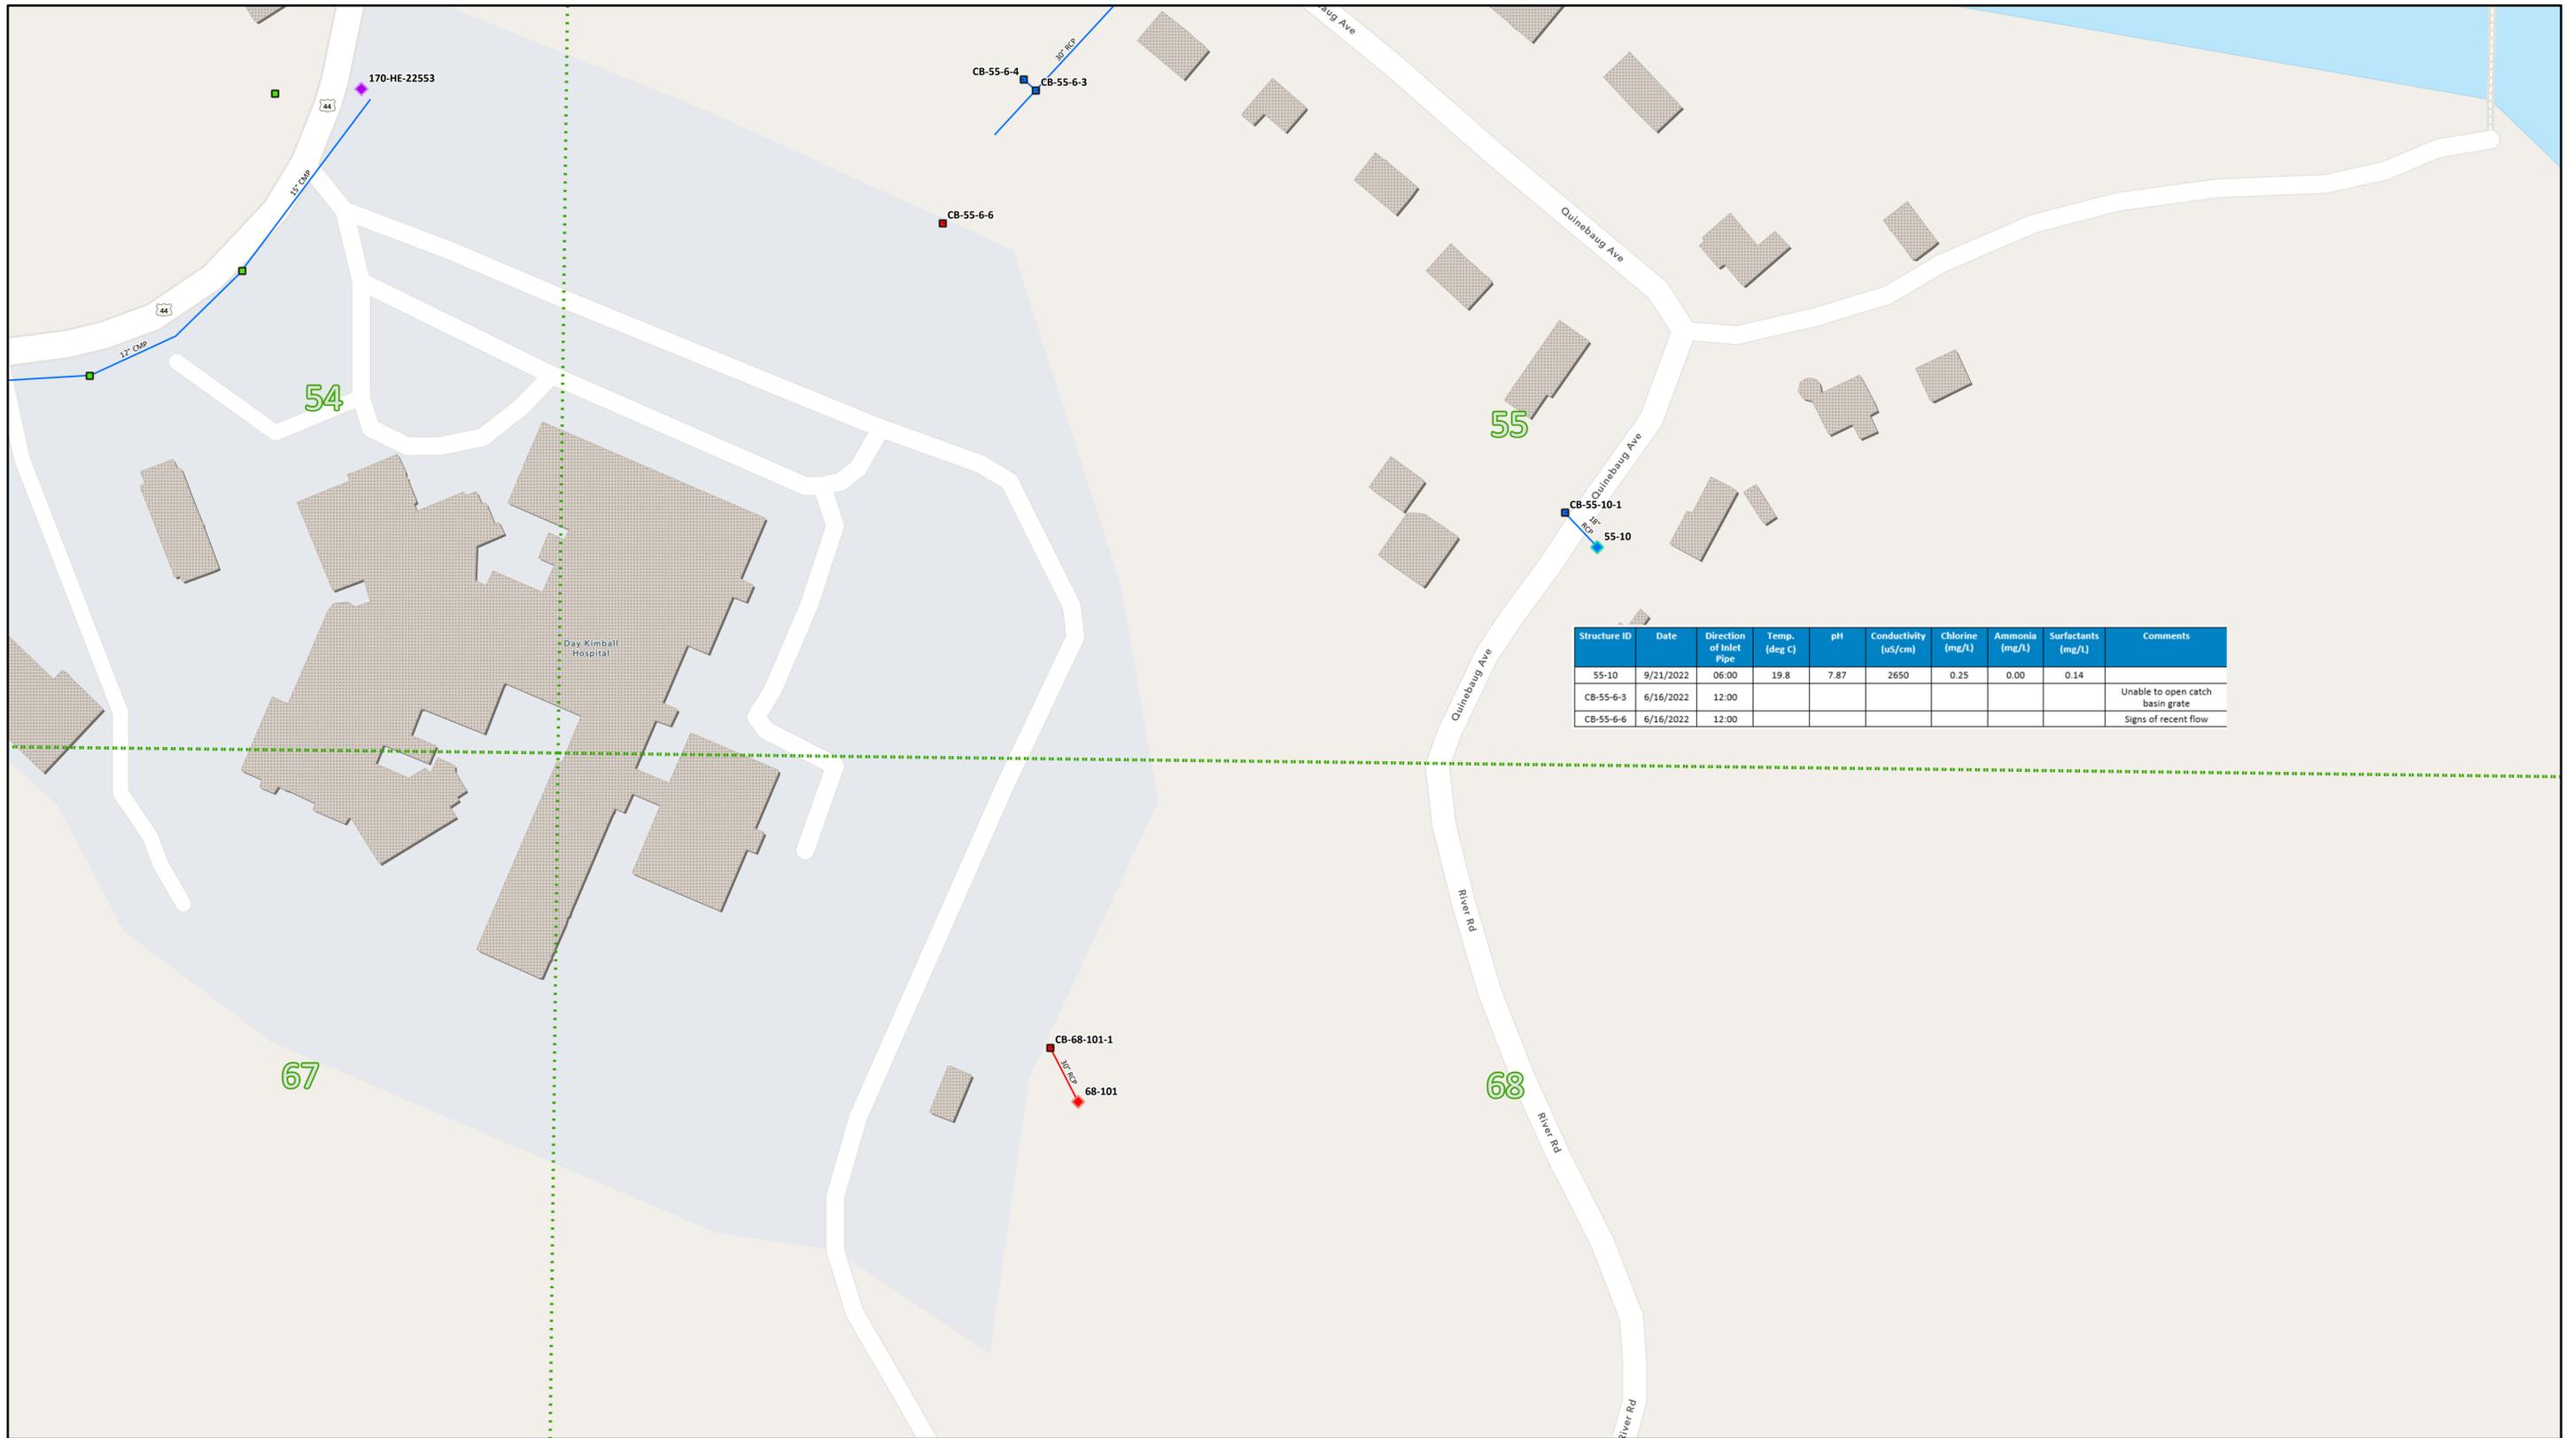
Illicit Discharge Detection and Elimination Investigation
Town of Putnam MS4 Program
February 2023

| Structure ID | Date | Direction of Inlet Pipe | Temp. (deg C) | pH | Conductivity (uS/cm) | Chlorine (mg/L) | Ammonia (mg/L) | Surfactants (mg/L) | Comments |
| 55-10 | 9/21/2022 | 06:00 | 19.8 | 7.87 | 2650 | 0.25 | 0.00 | 0.14 | |
| CB-55-6-3 | 6/16/2022 | 12:00 | | | | | | | Unable to open catch basin grate |
| CB-55-6-6 | 6/16/2022 | 12:00 | | | | | | | Signs of recent flow |

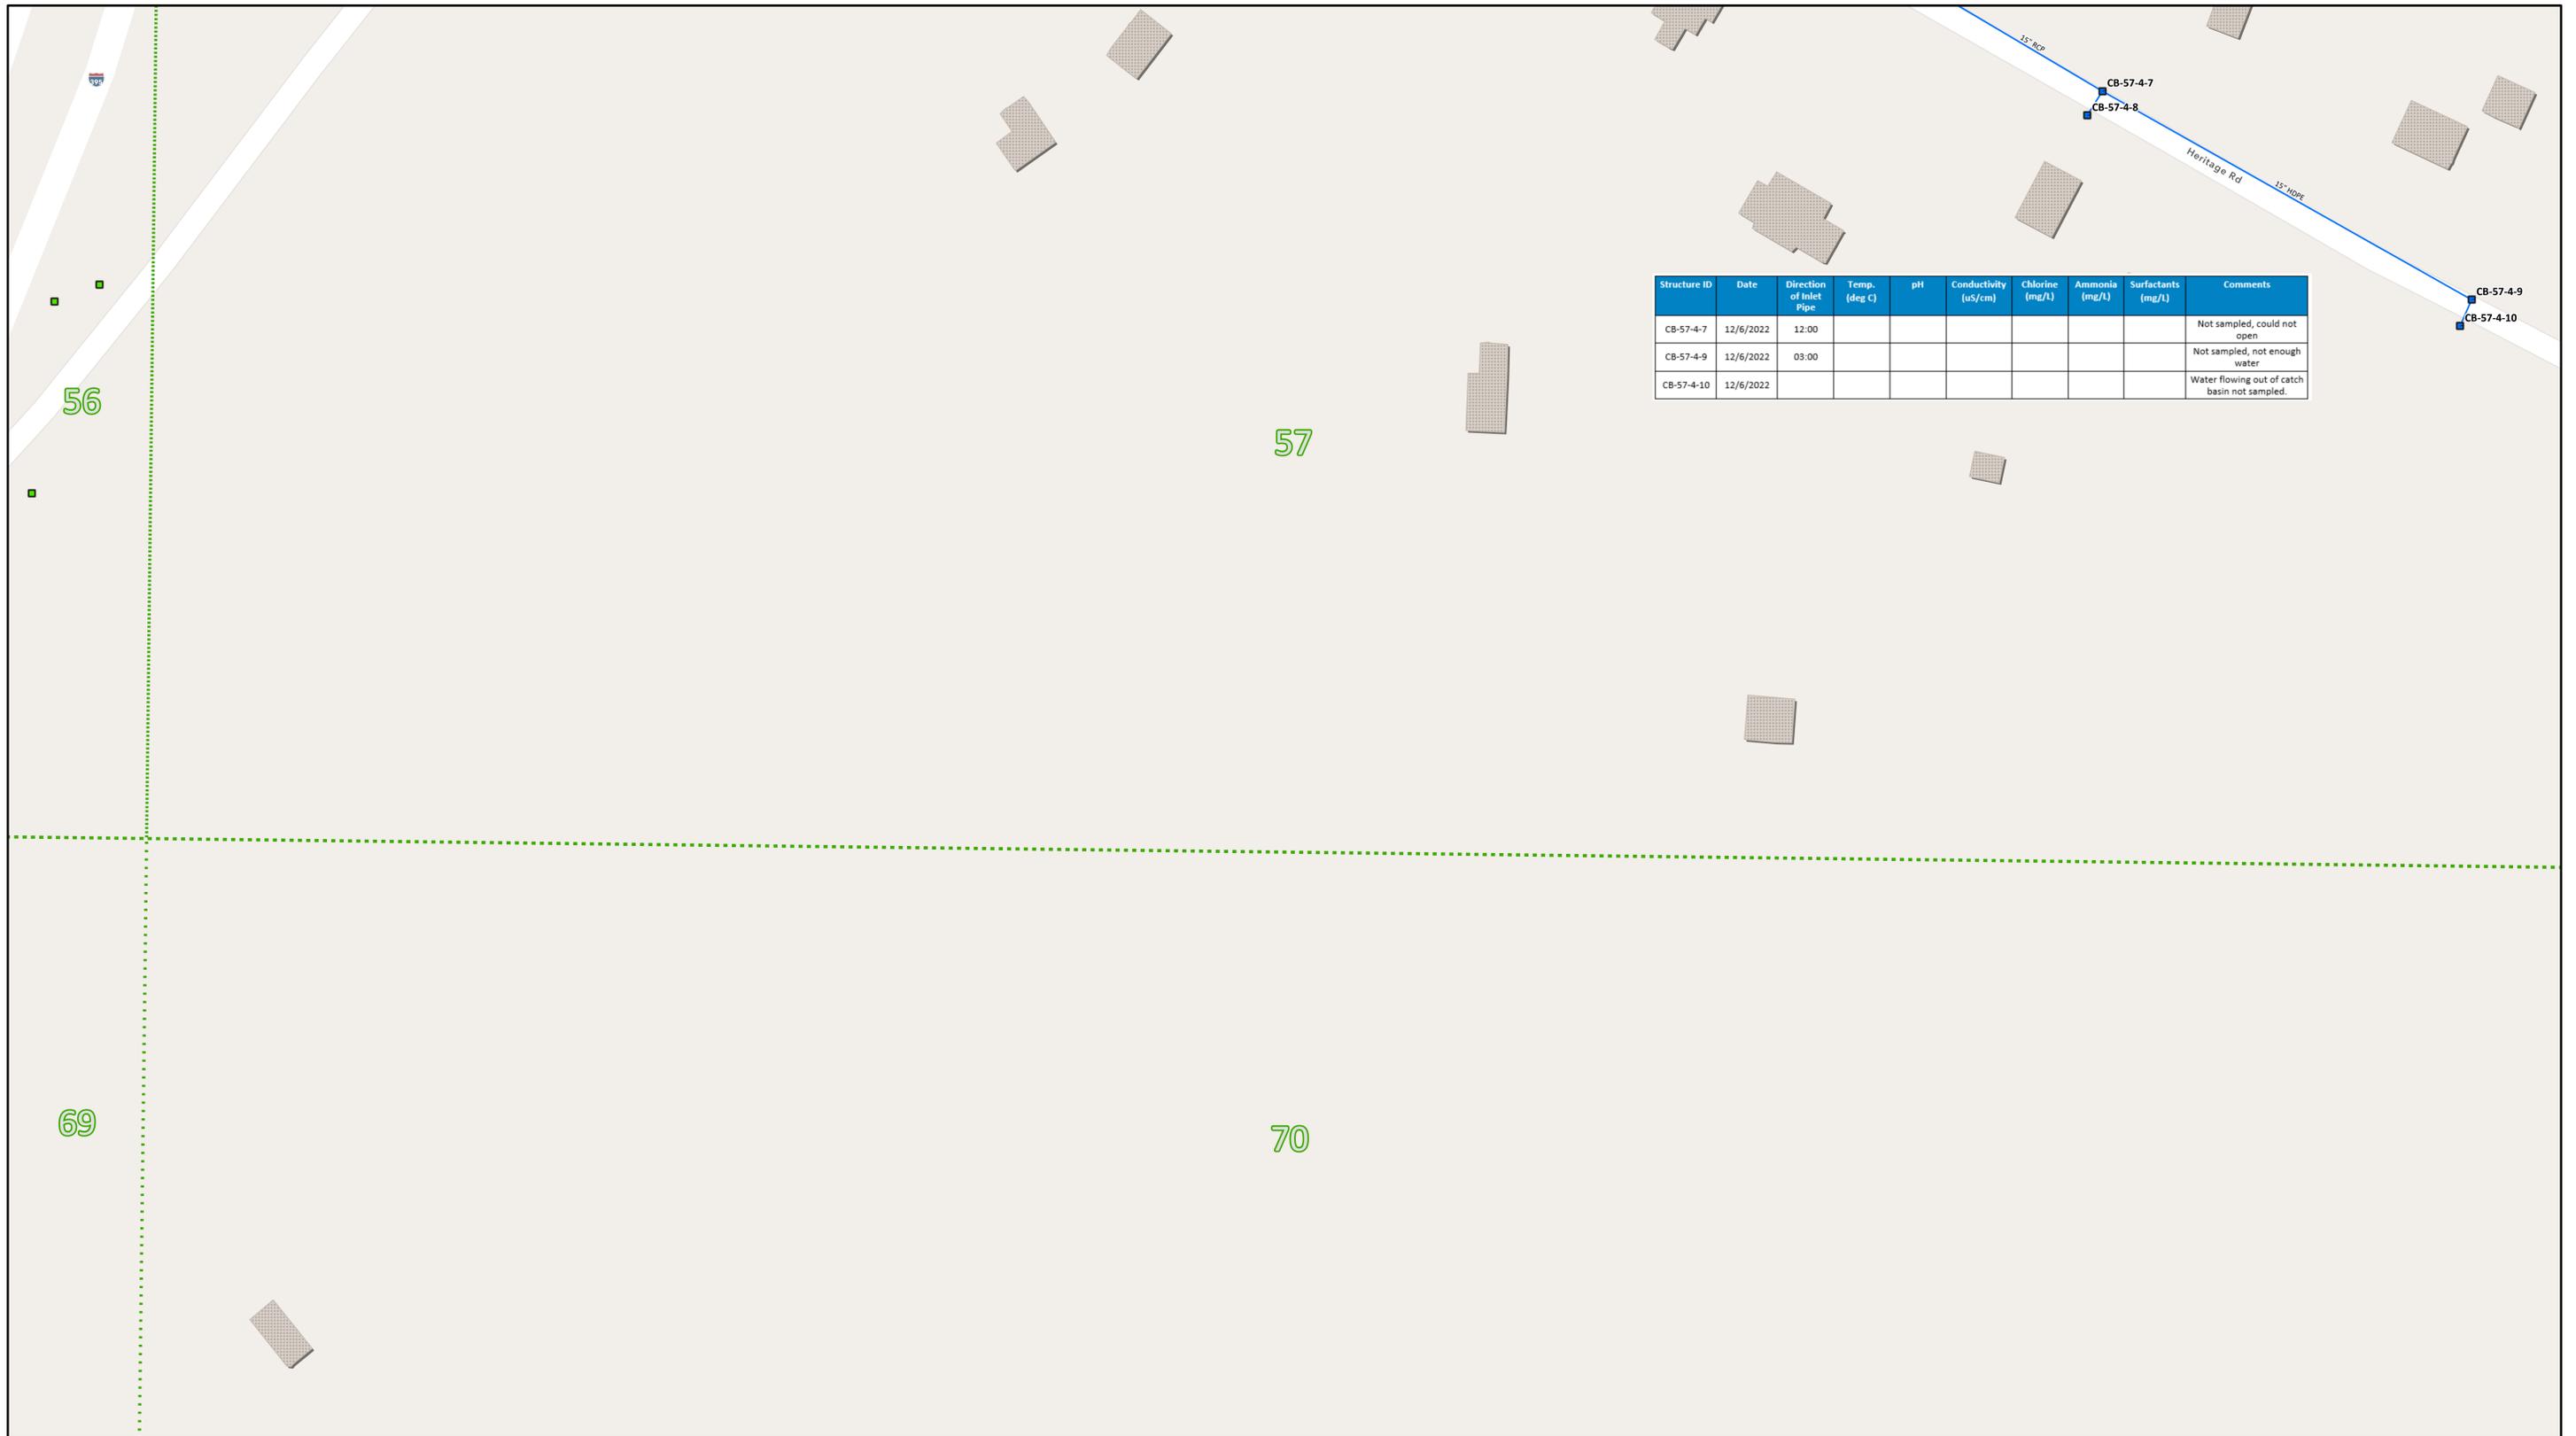
Illicit Discharge Detection and Elimination Investigation
Town of Putnam MS4 Program
February 2023

| Structure ID | Date | Direction of Inlet Pipe | Temp. (deg C) | pH | Conductivity (uS/cm) | Chlorine (mg/L) | Ammonia (mg/L) | Surfactants (mg/L) | Comments |
| CB-57-4-7 | 12/6/2022 | 12:00 | | | | | | | Not sampled, could not open |

| Outfall ID | IDDE Concern(s) | Comments | Recommendations |
|---|---|---|--|
| 57-4 | Chlorine | Outfall and upstream structures sampled. Soap suds observed. | CCTV along Heritage Road |

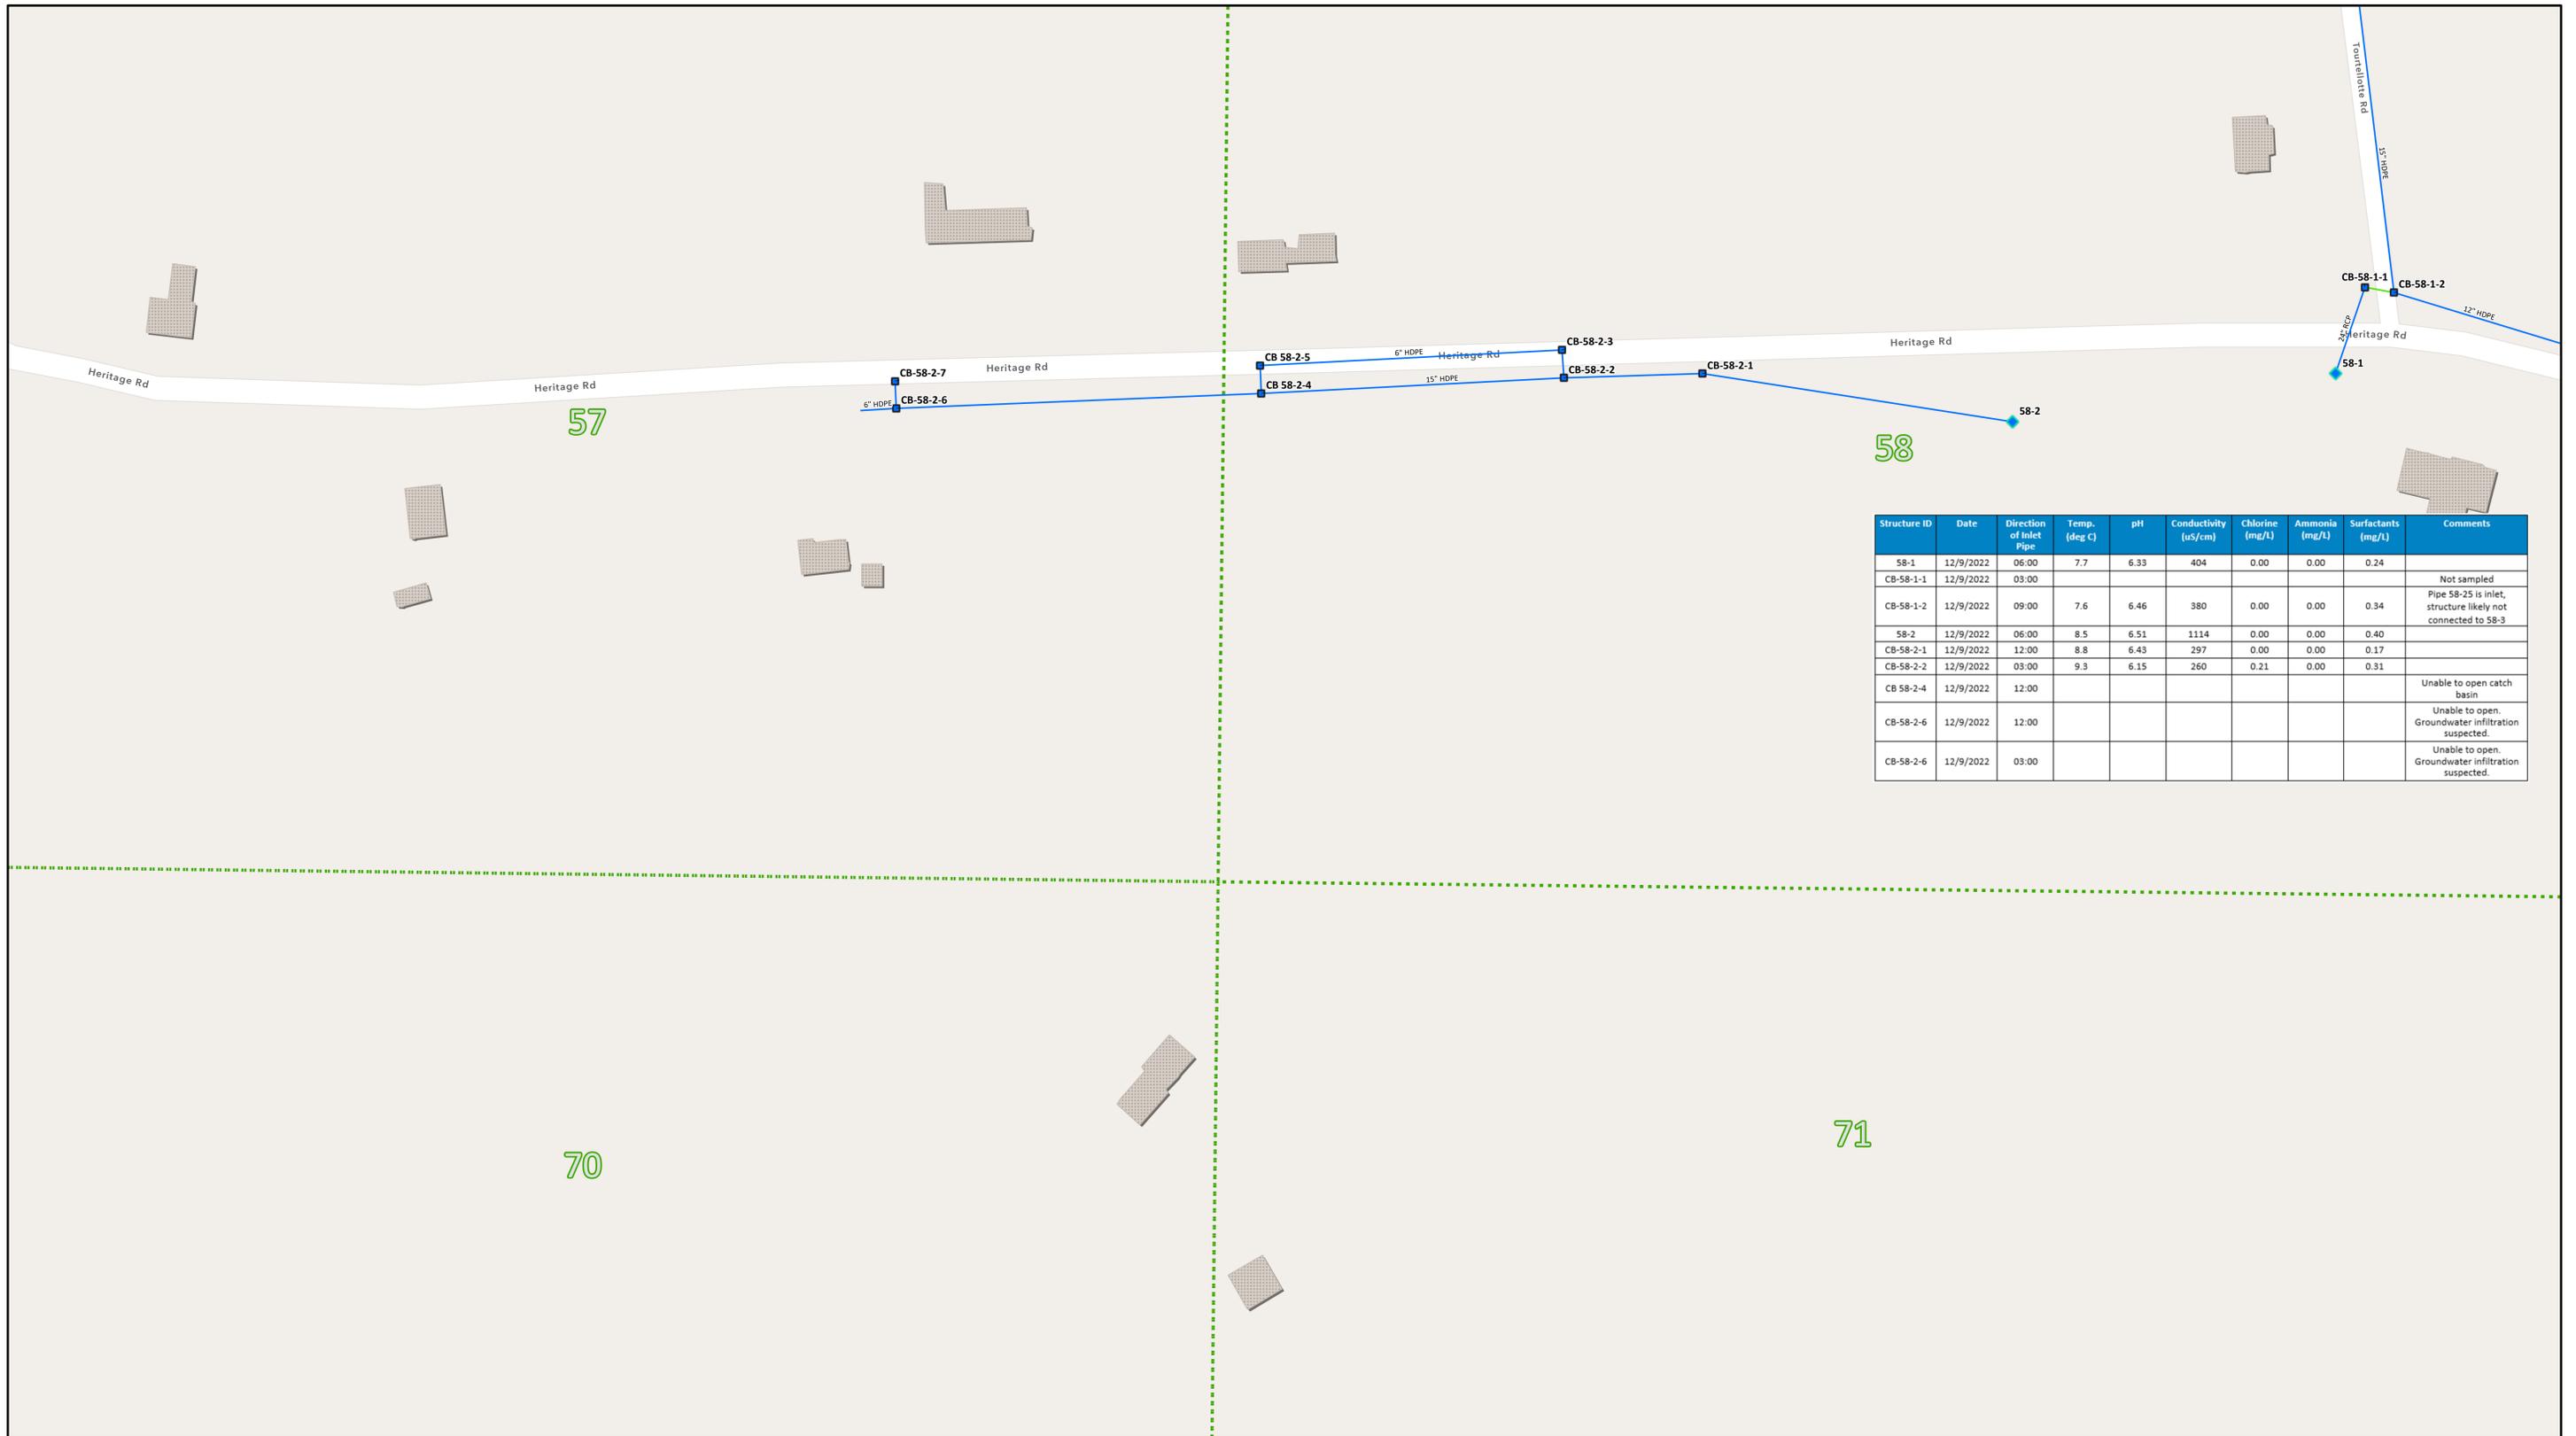
Illicit Discharge Detection and Elimination Investigation
Town of Putnam MS4 Program
February 2023
 Page Name: I6

| Structure ID | Date | Direction of Inlet Pipe | Temp. (deg C) | pH | Conductivity (us/cm) | Chlorine (mg/L) | Ammonia (mg/L) | Surfactants (mg/L) | Comments |
| 58-1 | 12/9/2022 | 06:00 | 7.7 | 6.33 | 404 | 0.00 | 0.00 | 0.24 | |
| CB-58-2-6 | 12/9/2022 | 12:00 | | | | | | | Unable to open. Groundwater infiltration suspected. |
| CB-58-2-6 | 12/9/2022 | 03:00 | | | | | | | Unable to open. Groundwater infiltration suspected. |

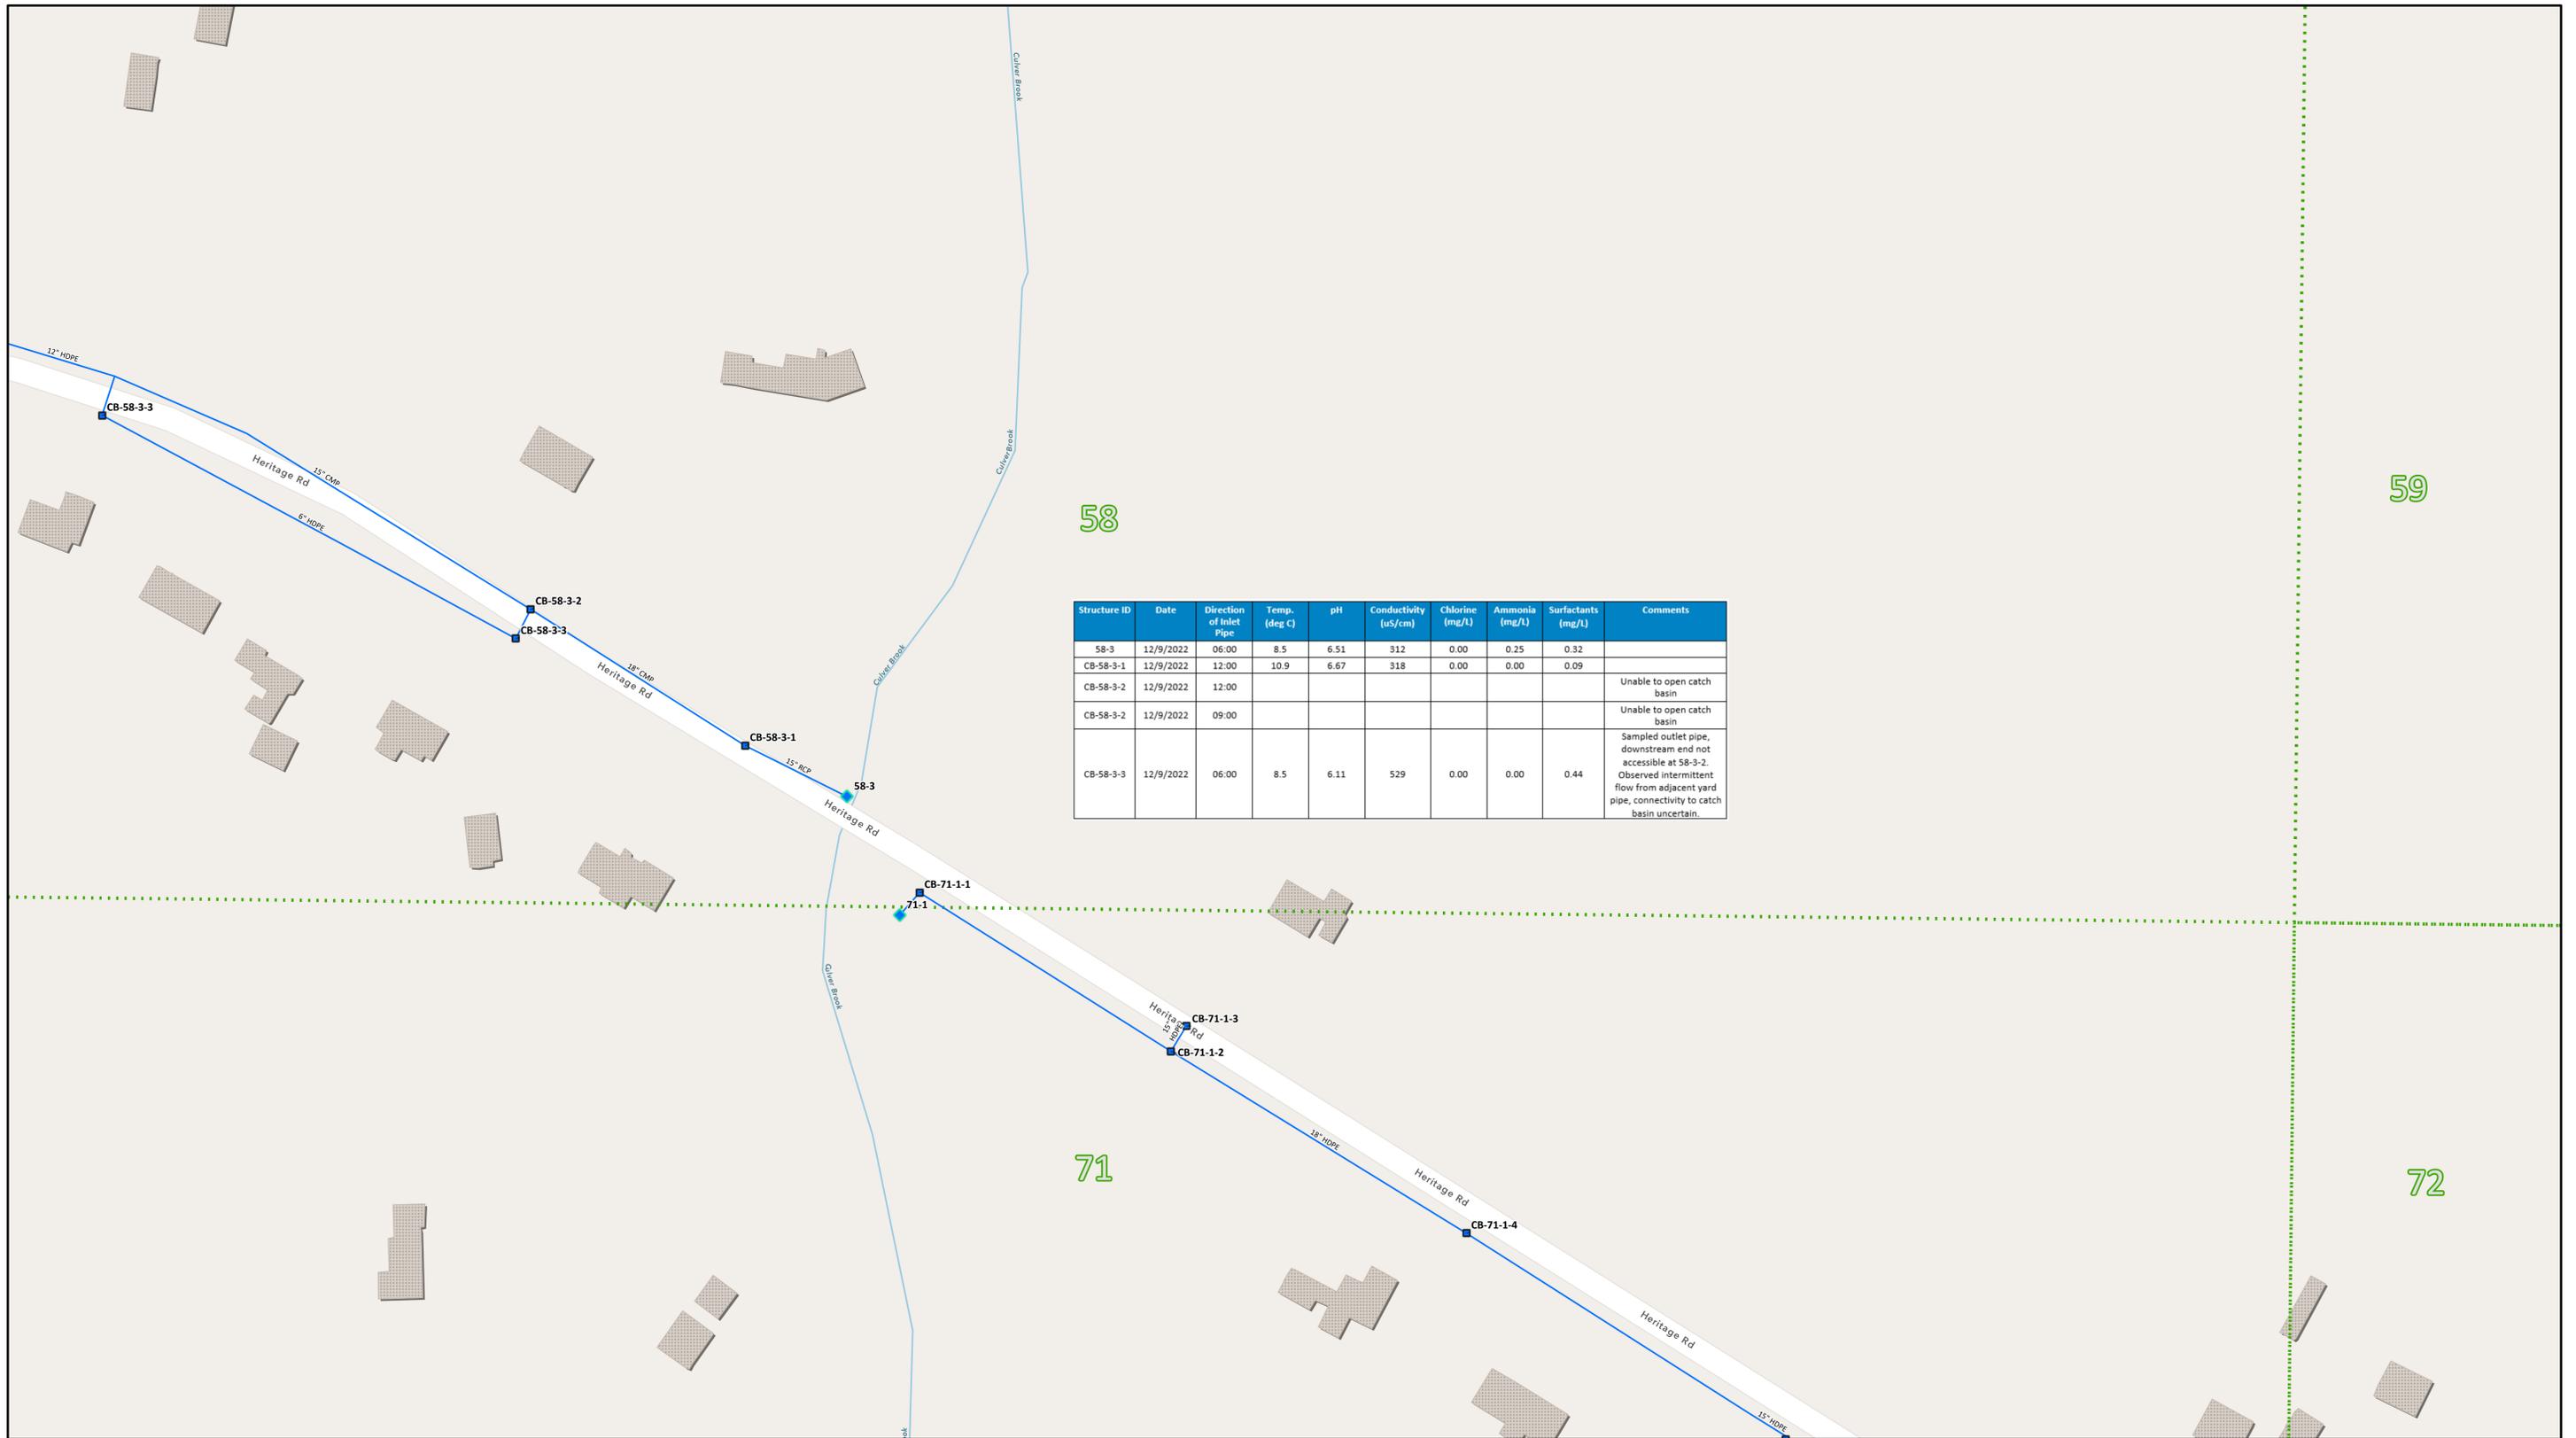
Illicit Discharge Detection and Elimination Investigation
Town of Putnam MS4 Program
February 2023
 Page Name: 17

| Structure ID | Date | Direction of Inlet Pipe | Temp. (deg C) | pH | Conductivity (uS/cm) | Chlorine (mg/L) | Ammonia (mg/L) | Surfactants (mg/L) | Comments |
|---|---|---|---|---|---|---|---|---|--|
| CB-58-3-3 | 12/9/2022 | 06:00 | 8.5 | 6.11 | 529 | 0.00 | 0.00 | 0.44 | Sampled outlet pipe, downstream end not accessible at 58-3-2. Observed intermittent flow from adjacent yard pipe, connectivity to catch basin uncertain. |

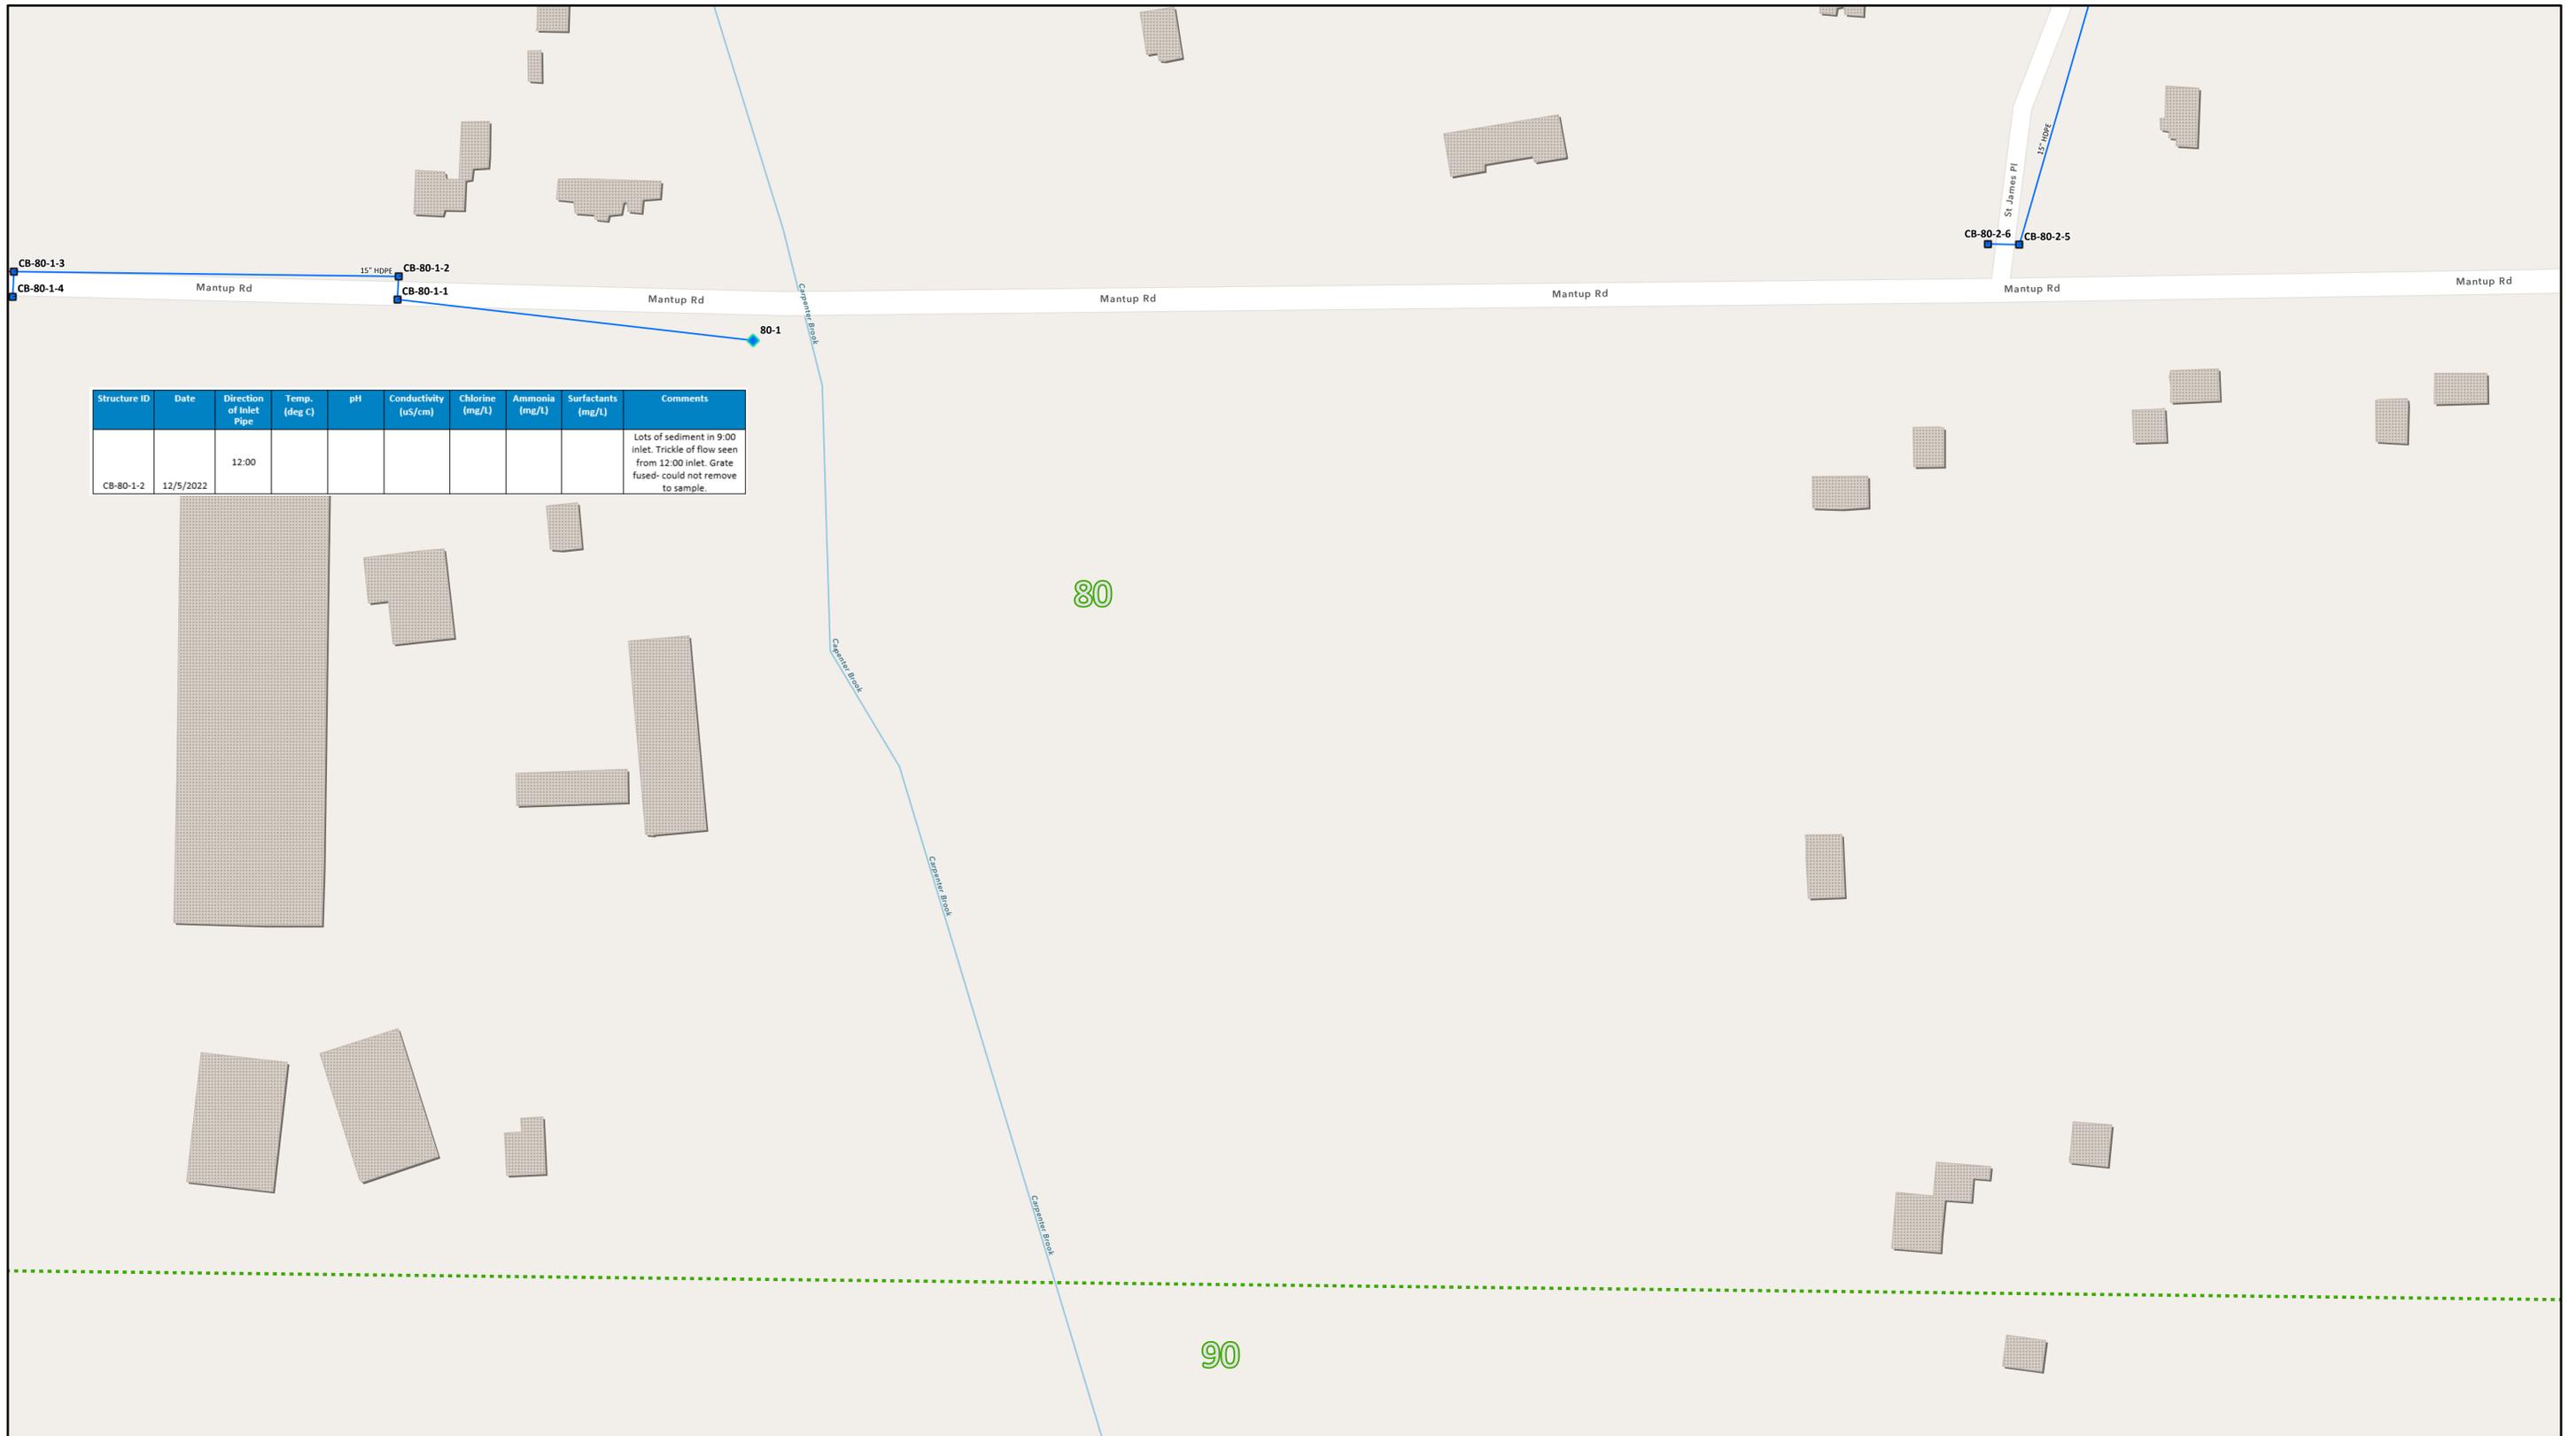
Page Name: L1

| Structure ID | Date | Direction of Inlet Pipe | Temp. (deg C) | pH | Conductivity (uS/cm) | Chlorine (mg/L) | Ammonia (mg/L) | Surfactants (mg/L) | Comments |
| CB-80-1-2 | 12/5/2022 | 12:00 | | | | | | | Lots of sediment in 9:00 inlet. Trickle of flow seen from 12:00 inlet. Grate fused- could not remove to sample. |

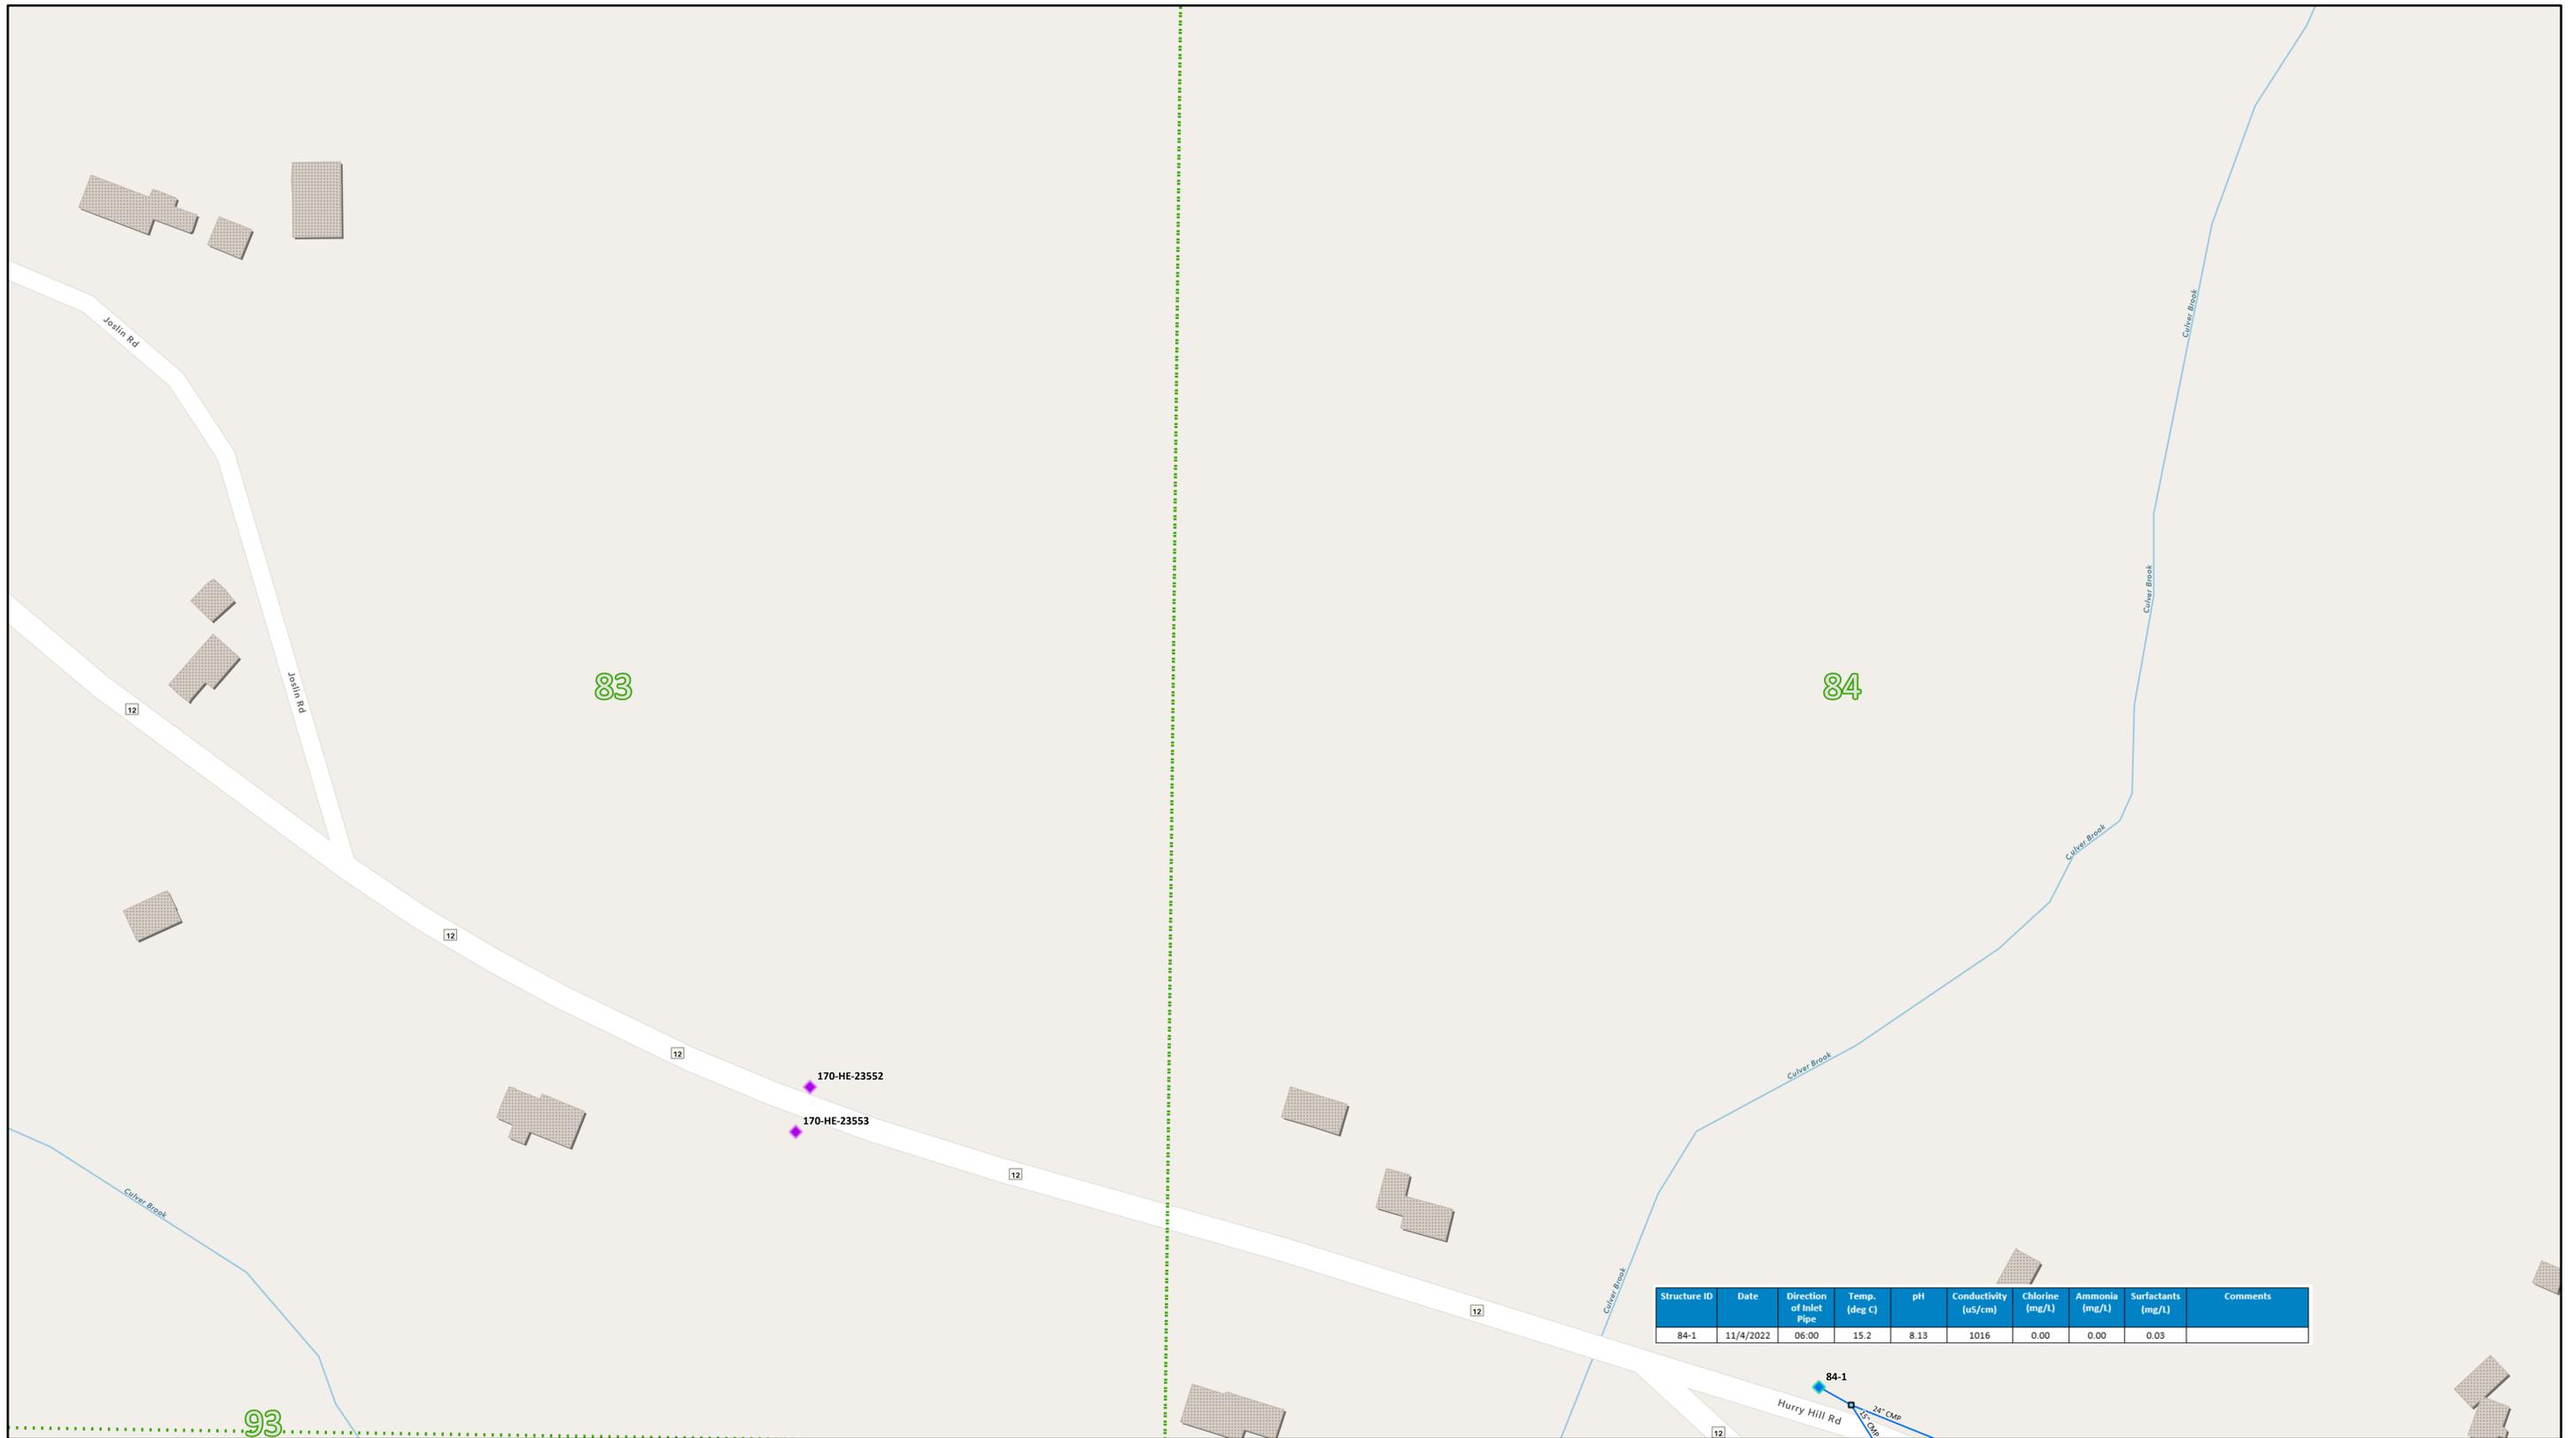
| Structure ID | Date | Direction of Inlet Pipe | Temp. (deg C) | pH | Conductivity (uS/cm) | Chlorine (mg/L) | Ammonia (mg/L) | Surfactants (mg/L) | Comments |
| 84-1 | 11/4/2022 | 06:00 | 15.2 | 8.13 | 1016 | 0.00 | 0.00 | 0.03 | |
