MS4 Annual Report Transmittal Form

For the General Permit to Discharge Stormwater from Small Municipal Separate Storm Sewer Systems (MS4)

This report documents the Town of Putnam efforts to comply with the conditions of the MS4 General Permit to the maximum extent practicable (MEP) from January 1, 2022 to December 31, 2022.

Illicit Discharge Detection and Elimination Investigation
Town of Putnam MS4 Program
February 2023
 Page Name: A1

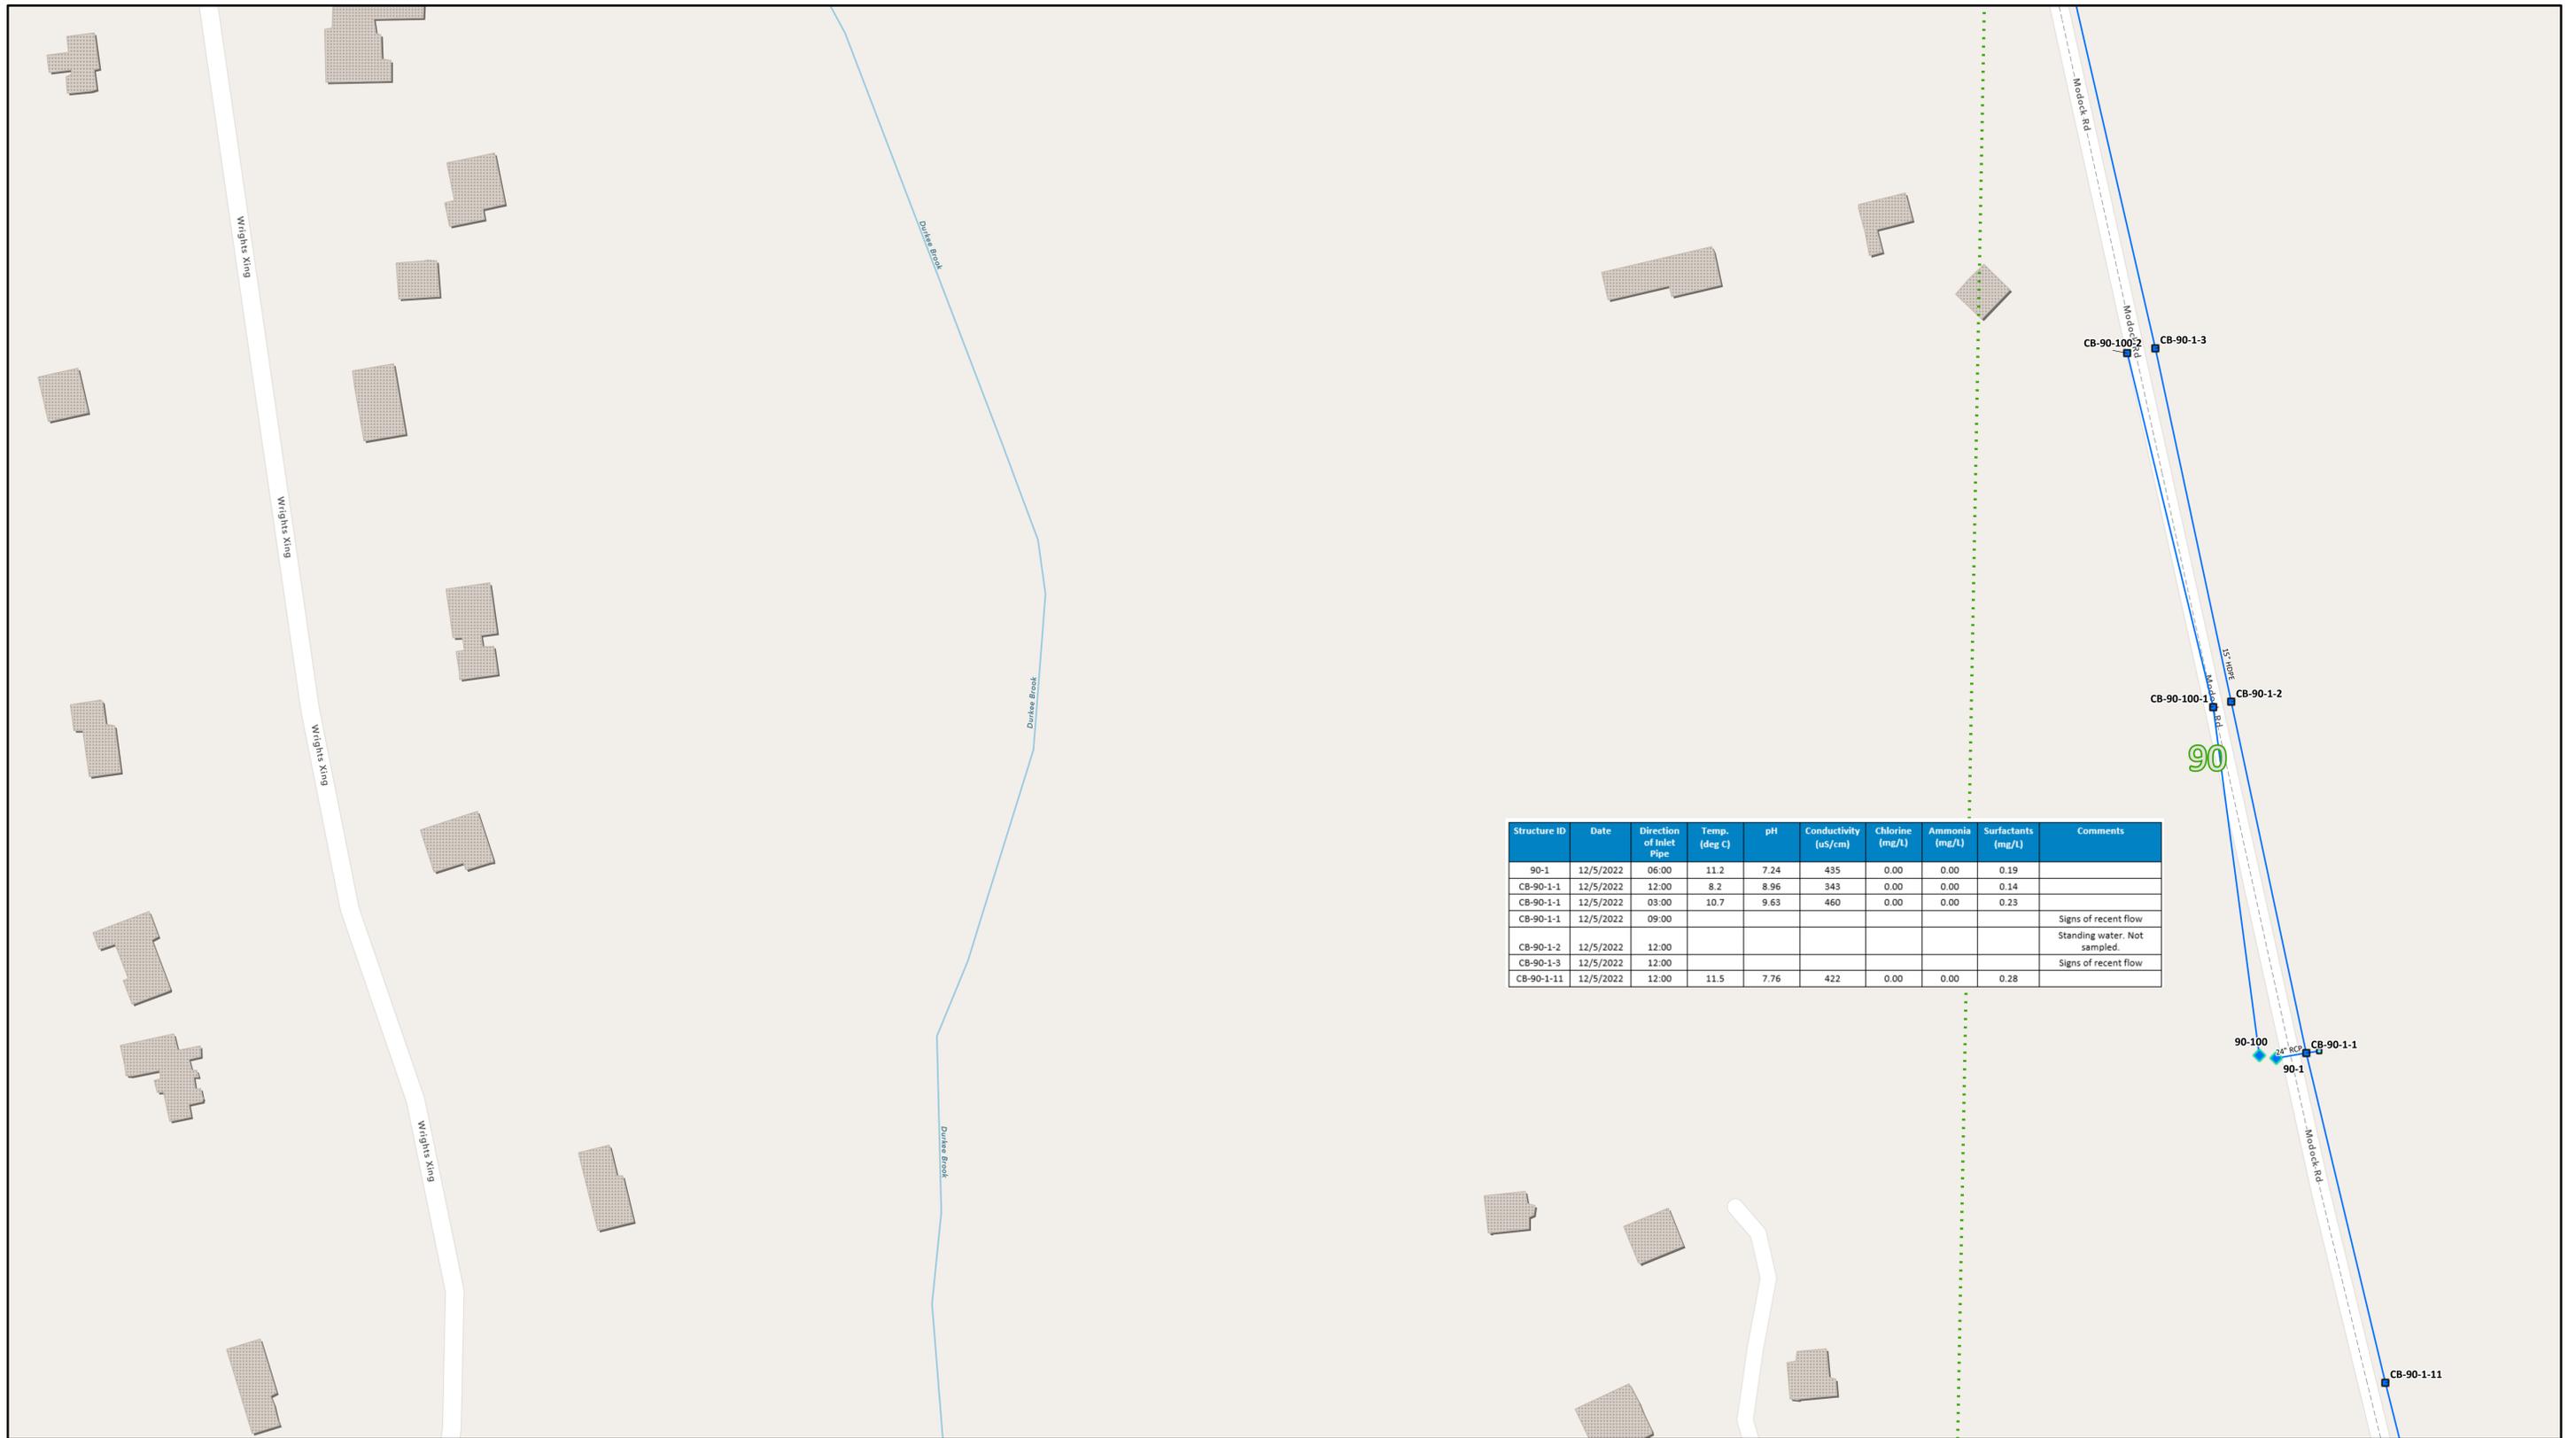
Illicit Discharge Detection and Elimination Investigation
Town of Putnam MS4 Program
February 2023
 Page Name: L9

| Structure ID | Date | Direction of Inlet Pipe | Temp. (deg C) | pH | Conductivity (uS/cm) | Chlorine (mg/L) | Ammonia (mg/L) | Surfactants (mg/L) | Comments |
| 90-1 | 12/5/2022 | 06:00 | 11.2 | 7.24 | 435 | 0.00 | 0.00 | 0.19 | |

| Outfall ID | IDDE Concern(s) | Comments | Recommendations |
|---|---|---|--|
| 90-1 | Surfactants | Significant sediment build-up observed in this system, both north of outfall (no flow) and south (sampled). | CCTV and cleaning along Modock Road |

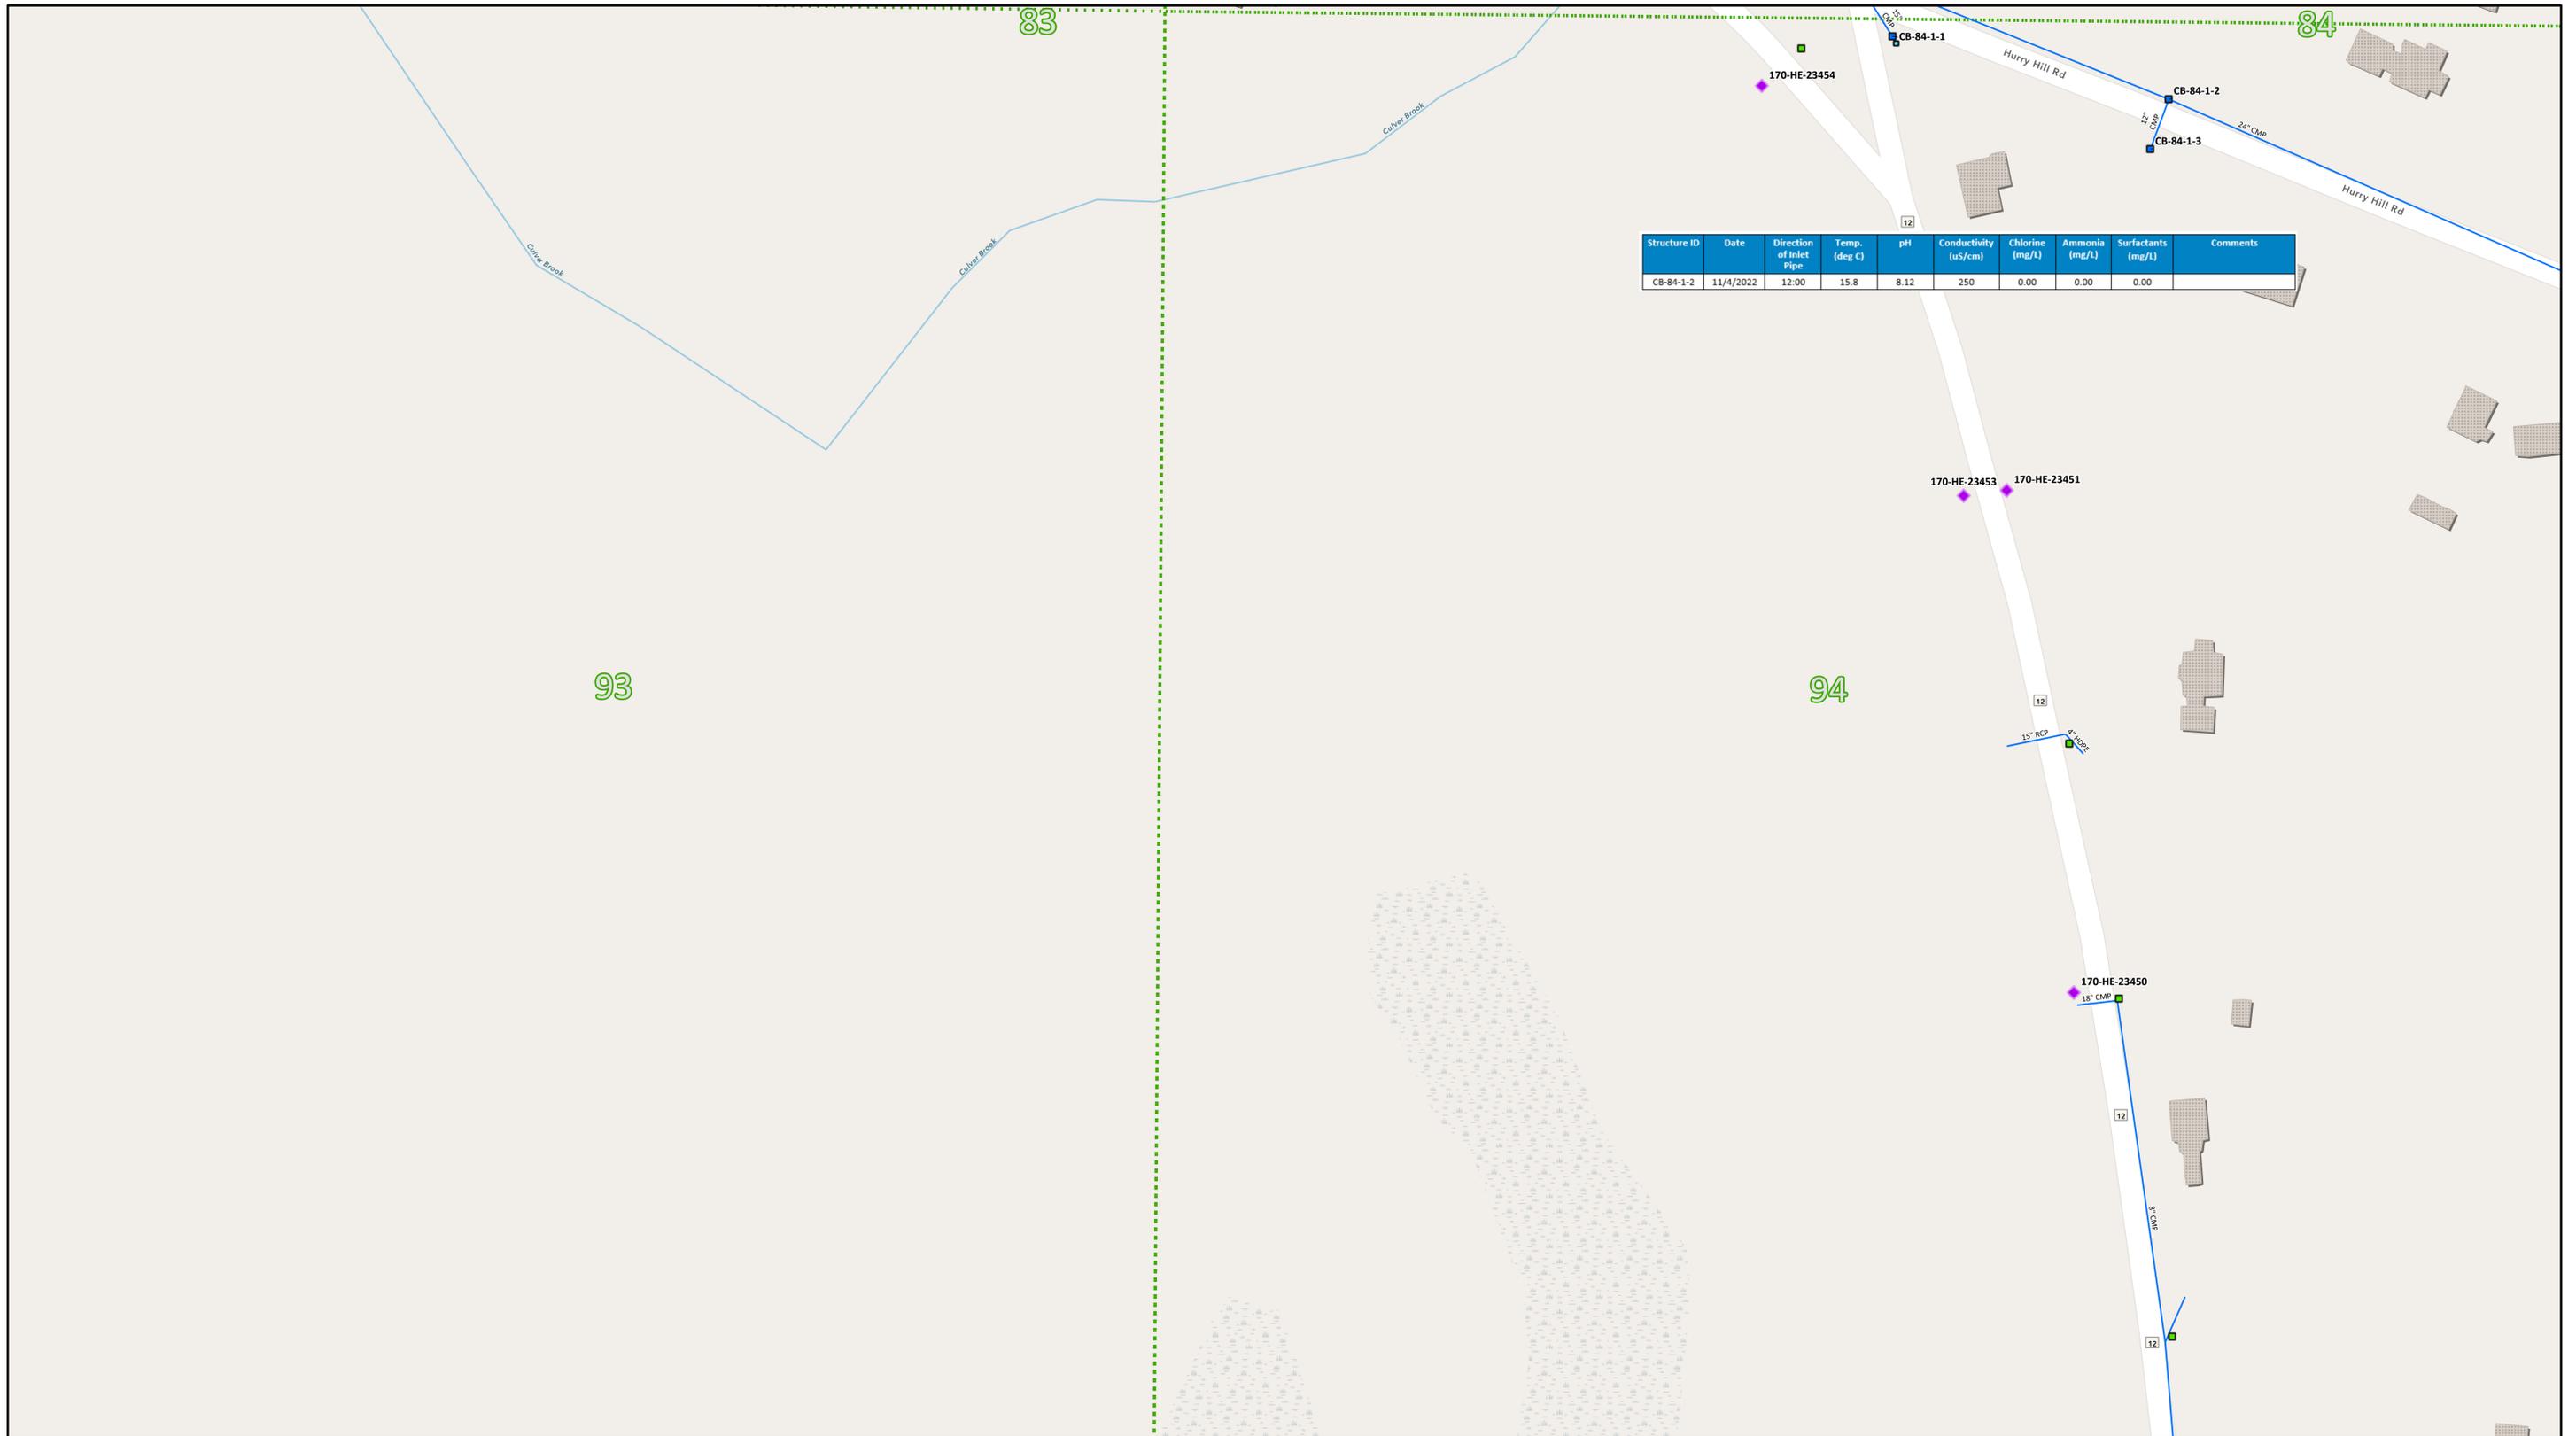
| Structure ID | Date | Direction of Inlet Pipe | Temp. (deg C) | pH | Conductivity (uS/cm) | Chlorine (mg/L) | Ammonia (mg/L) | Surfactants (mg/L) | Comments |
| CB-84-1-2 | 11/4/2022 | 12:00 | 15.8 | 8.12 | 250 | 0.00 | 0.00 | 0.00 | |

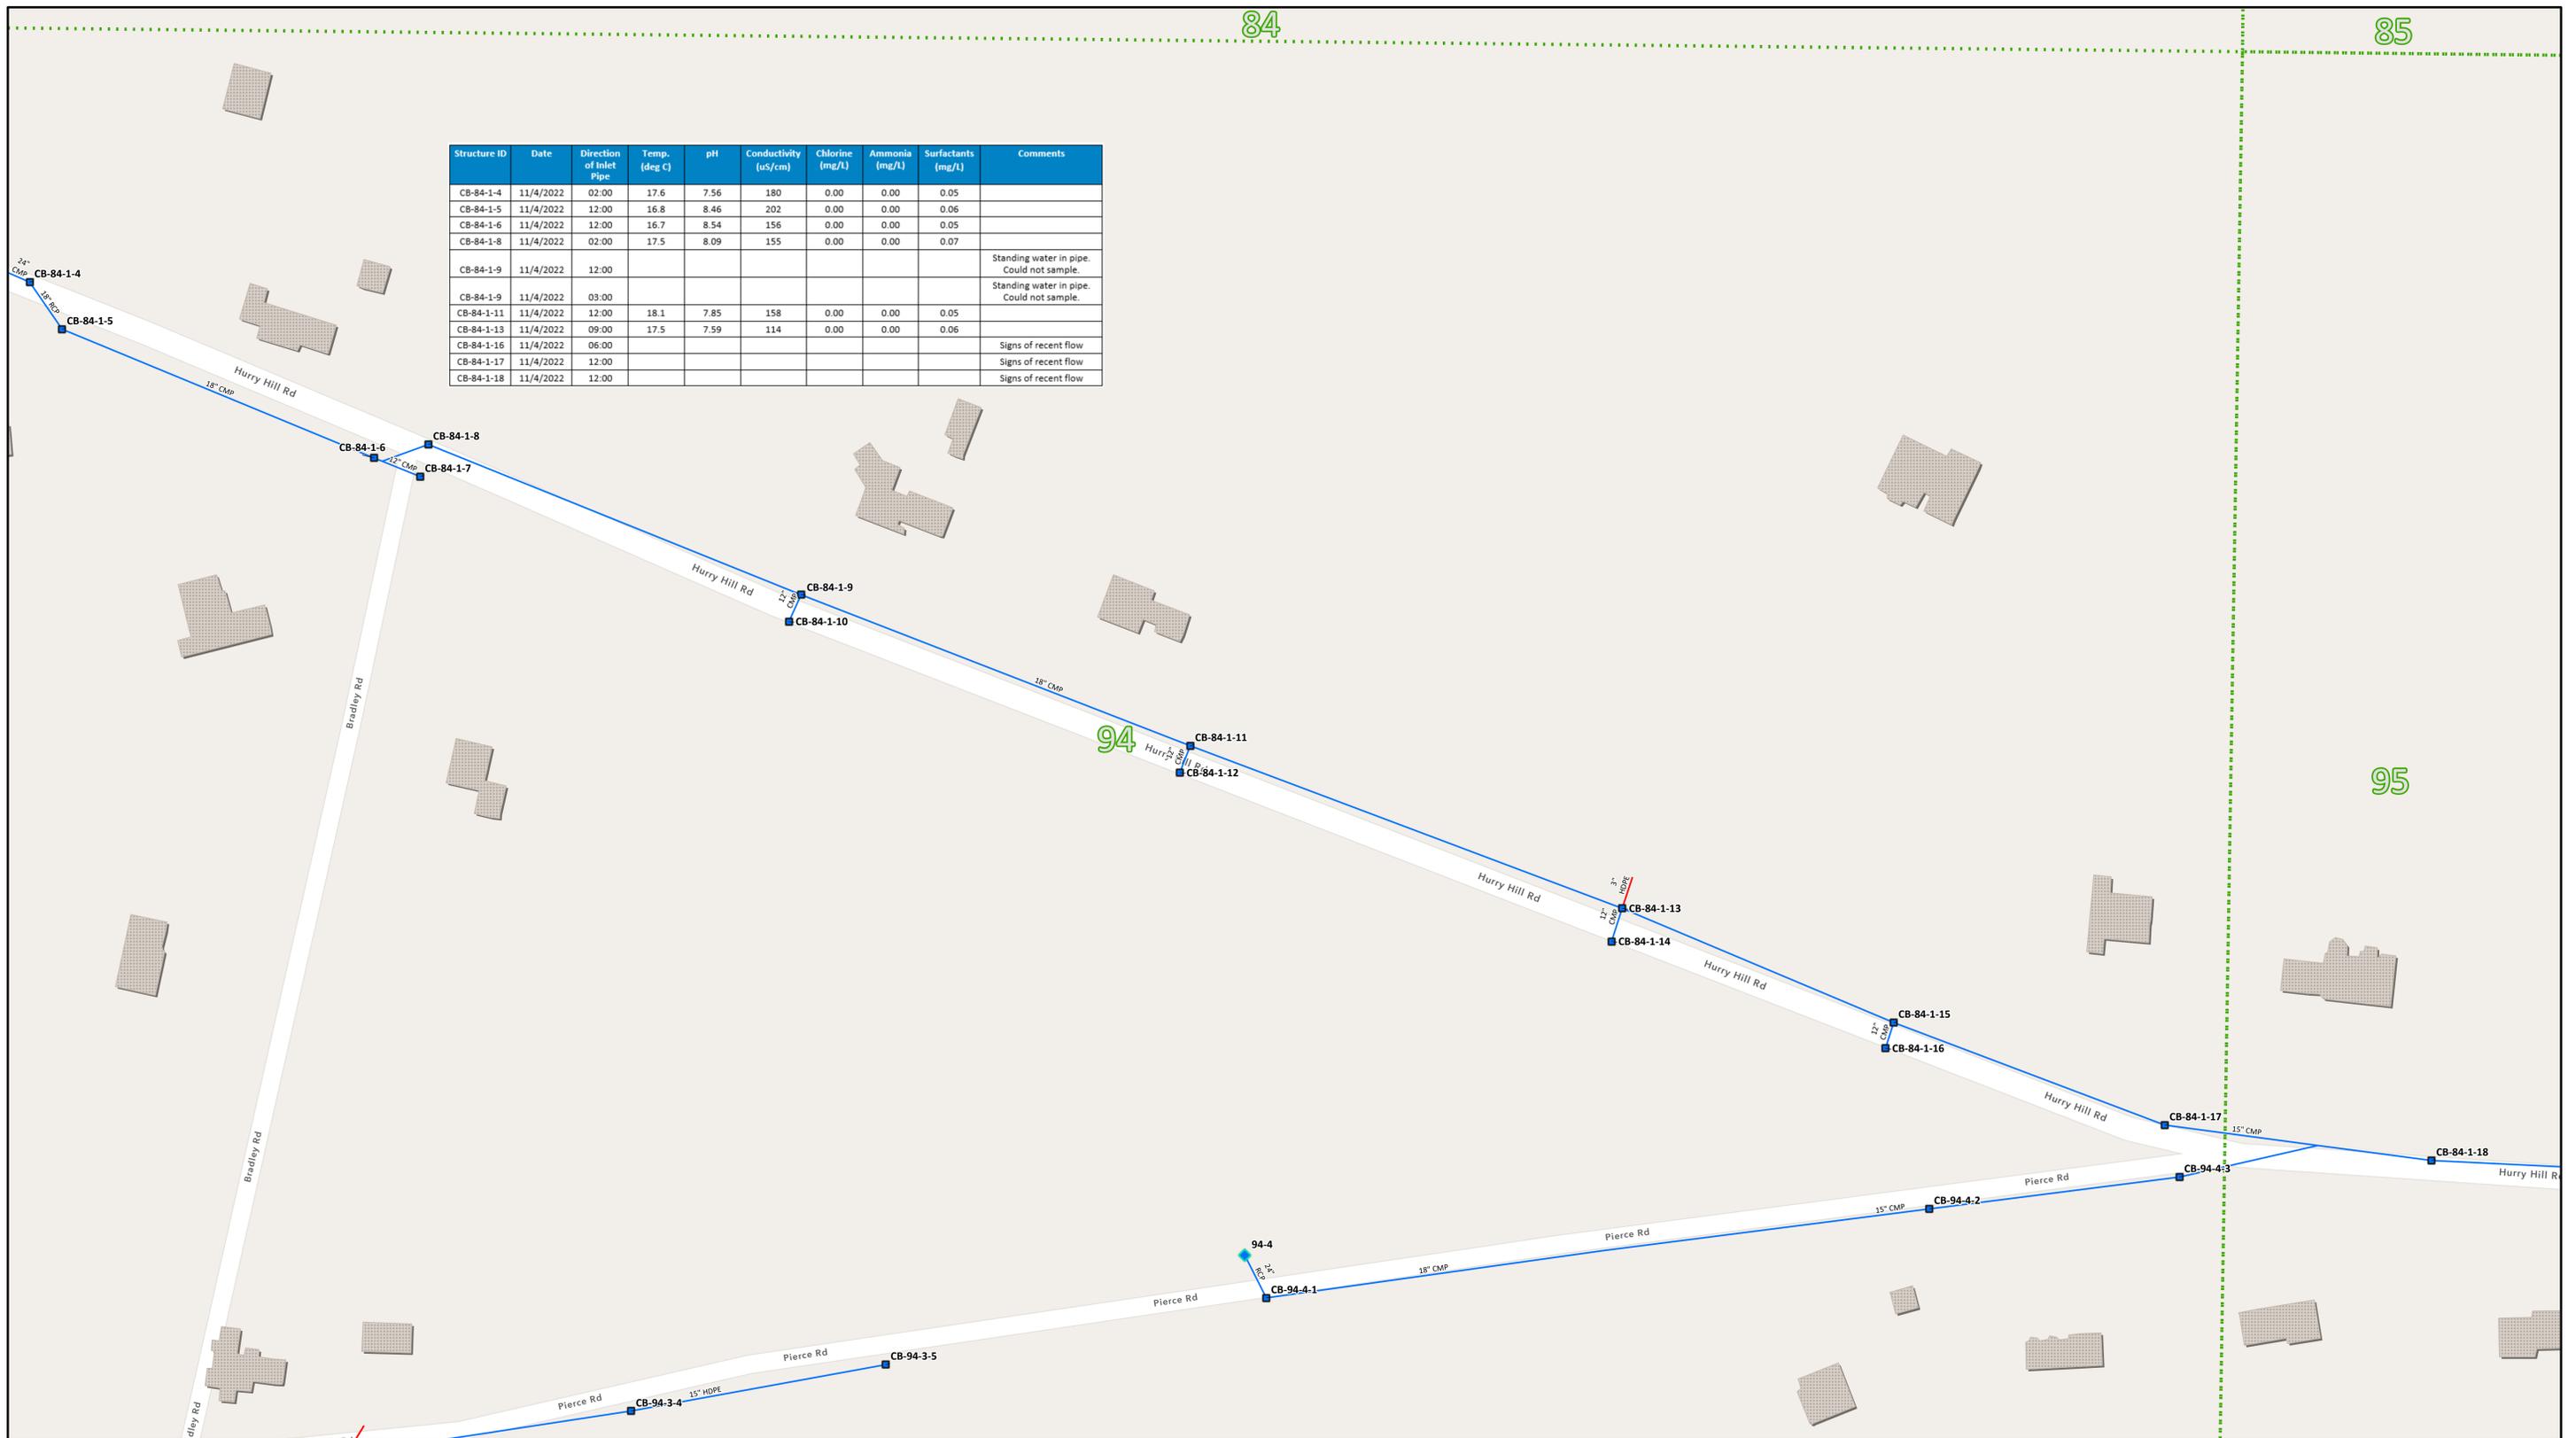
Illicit Discharge Detection and Elimination Investigation
Town of Putnam MS4 Program
February 2023
 Page Name: M7

| Structure ID | Date | Direction of Inlet Pipe | Temp. (deg C) | pH | Conductivity (uS/cm) | Chlorine (mg/L) | Ammonia (mg/L) | Surfactants (mg/L) | Comments |
| CB-84-1-17 | 11/4/2022 | 12:00 | | | | | | | Signs of recent flow |
| CB-84-1-18 | 11/4/2022 | 12:00 | | | | | | | Signs of recent flow |

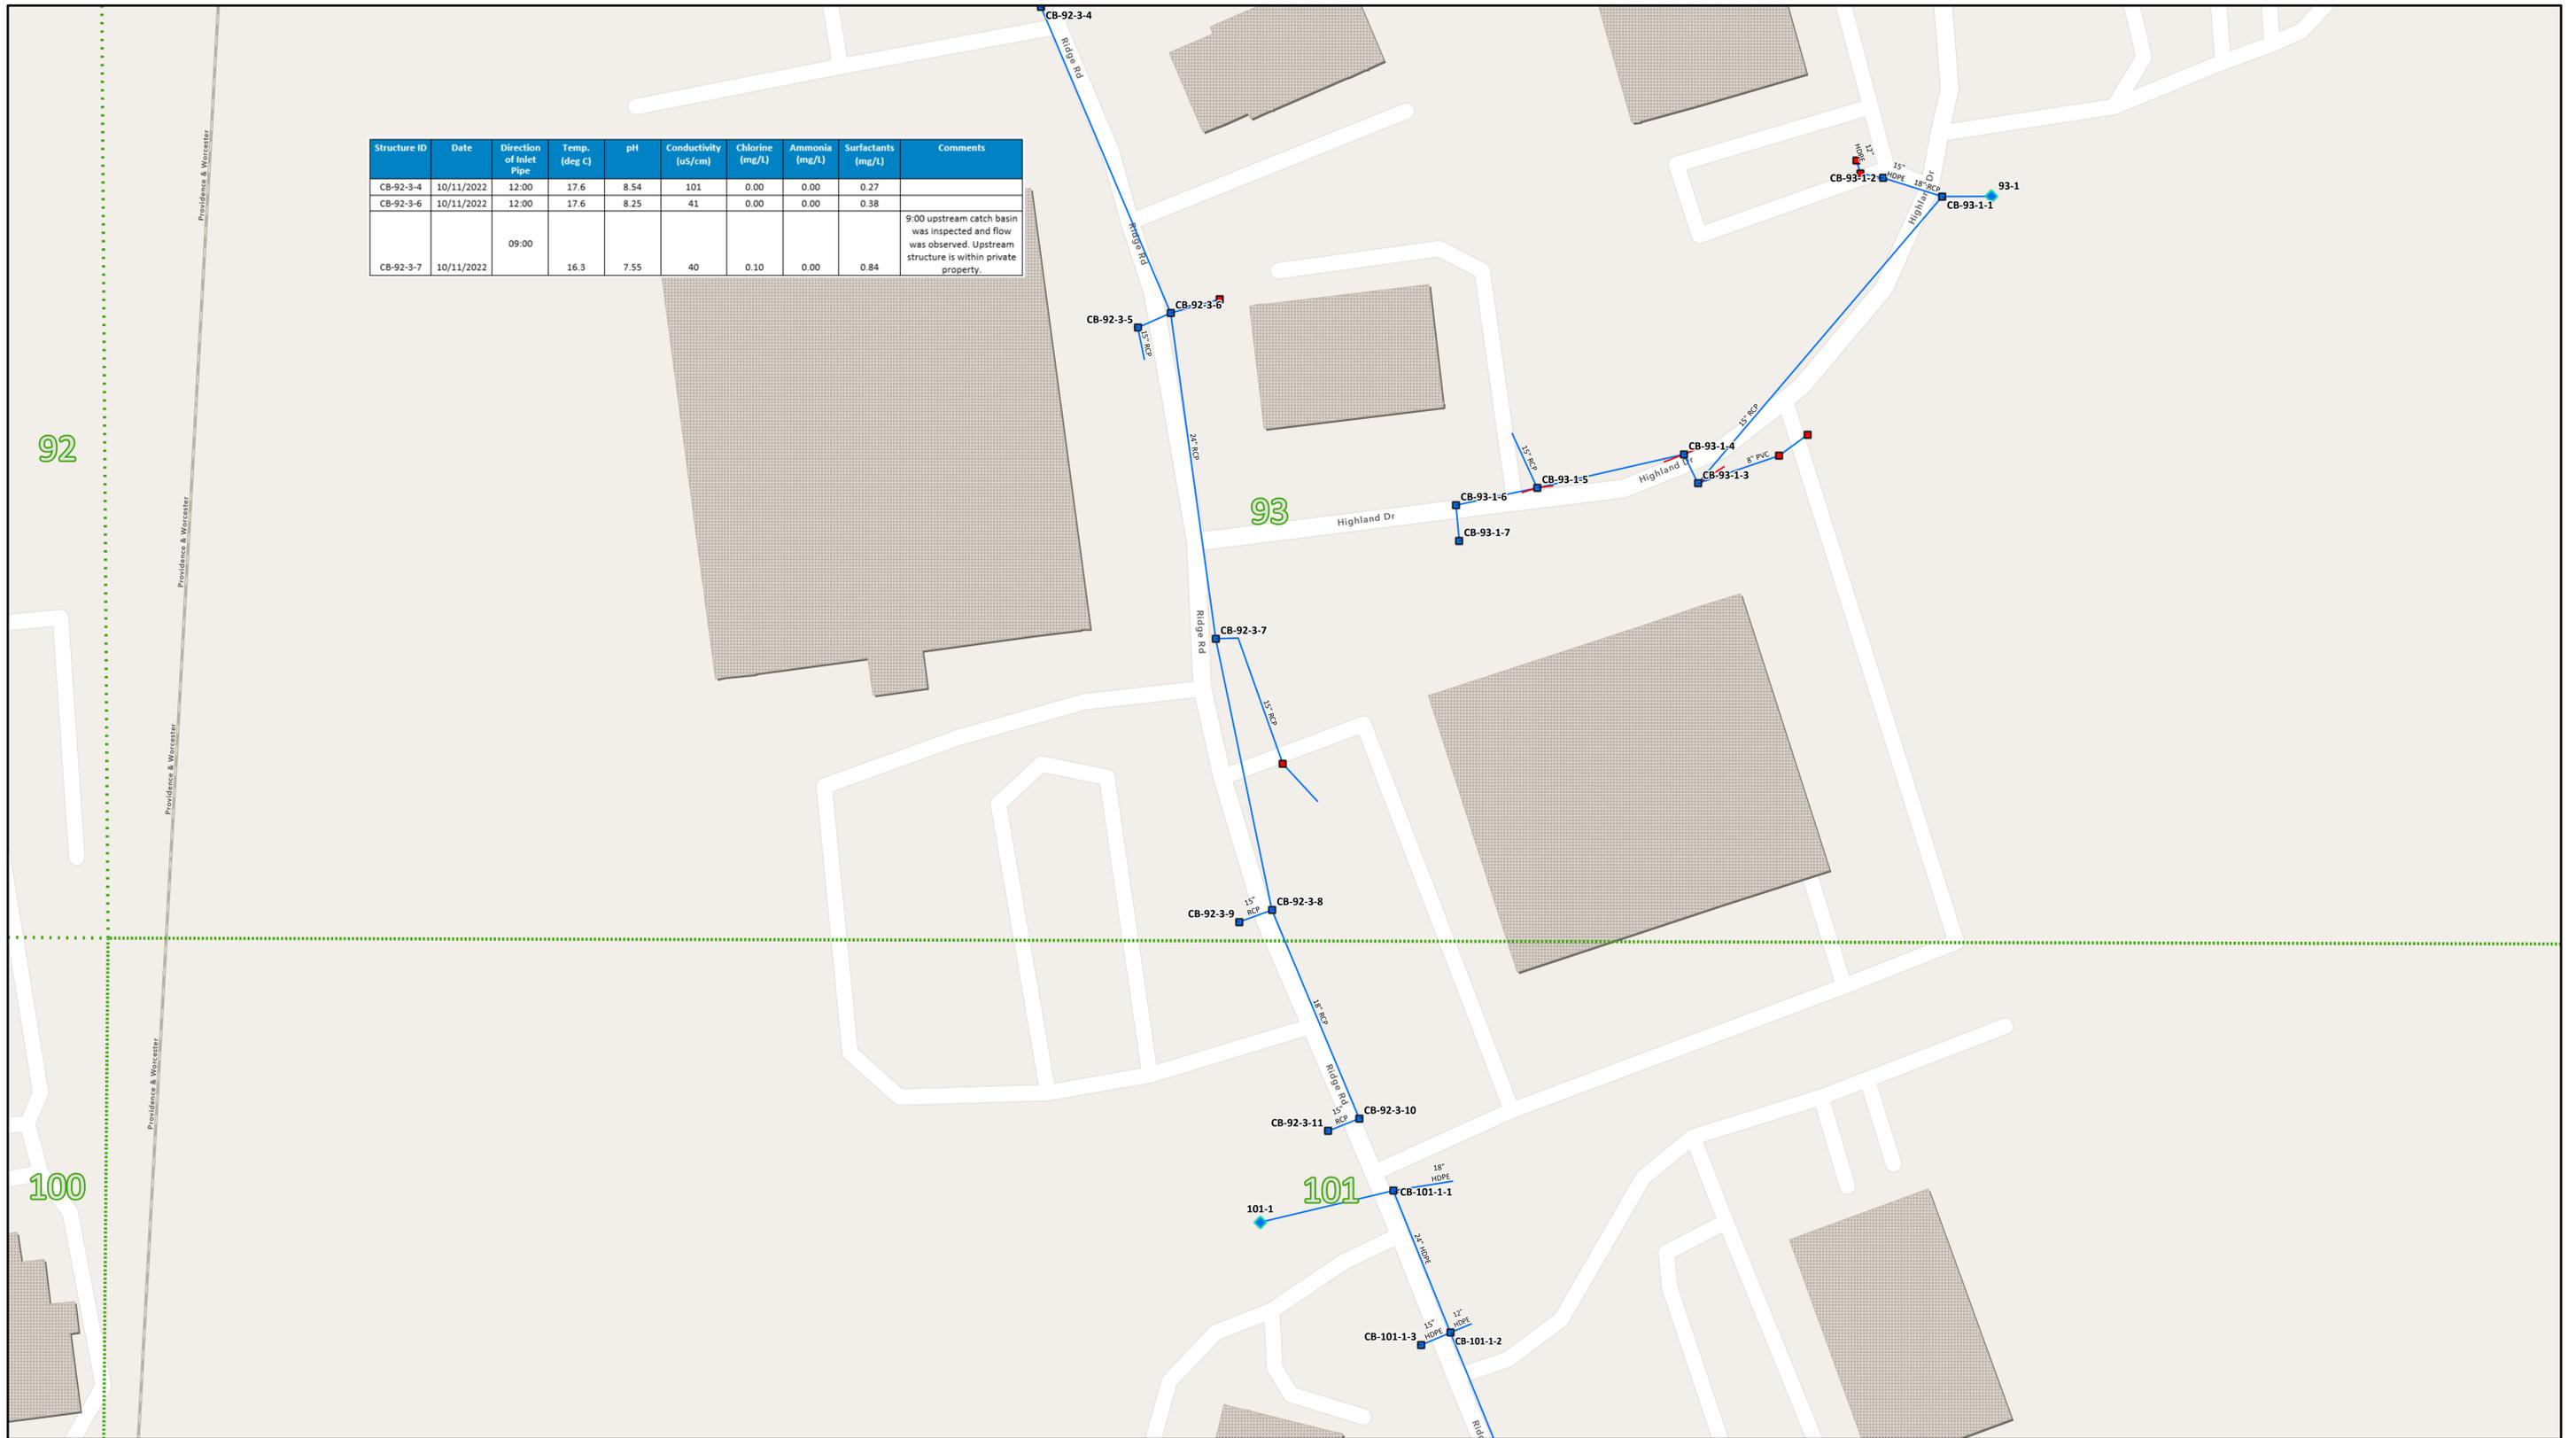
| Structure ID | Date | Direction of Inlet Pipe | Temp. (deg C) | pH | Conductivity (uS/cm) | Chlorine (mg/L) | Ammonia (mg/L) | Surfactants (mg/L) | Comments |
|---|---|---|---|---|---|---|---|---|---|
| CB-92-3-6 | 10/11/2022 | 12:00 | 17.6 | 8.25 | 41 | 0.00 | 0.00 | 0.38 | |
| CB-92-3-7 | 10/11/2022 | 09:00 | 16.3 | 7.55 | 40 | 0.10 | 0.00 | 0.84 | 9:00 upstream catch basin was inspected and flow was observed. Upstream structure is within private property. |

| Outfall ID | IDDE Concern(s) | Comments | Recommendations |
|---|---|---|--|
| 92-3 | Chlorine, Surfactants | Flow originates from private MS4 interconnection. Soap suds observed. | Dye test property adjacent to CB-92-3-7. |

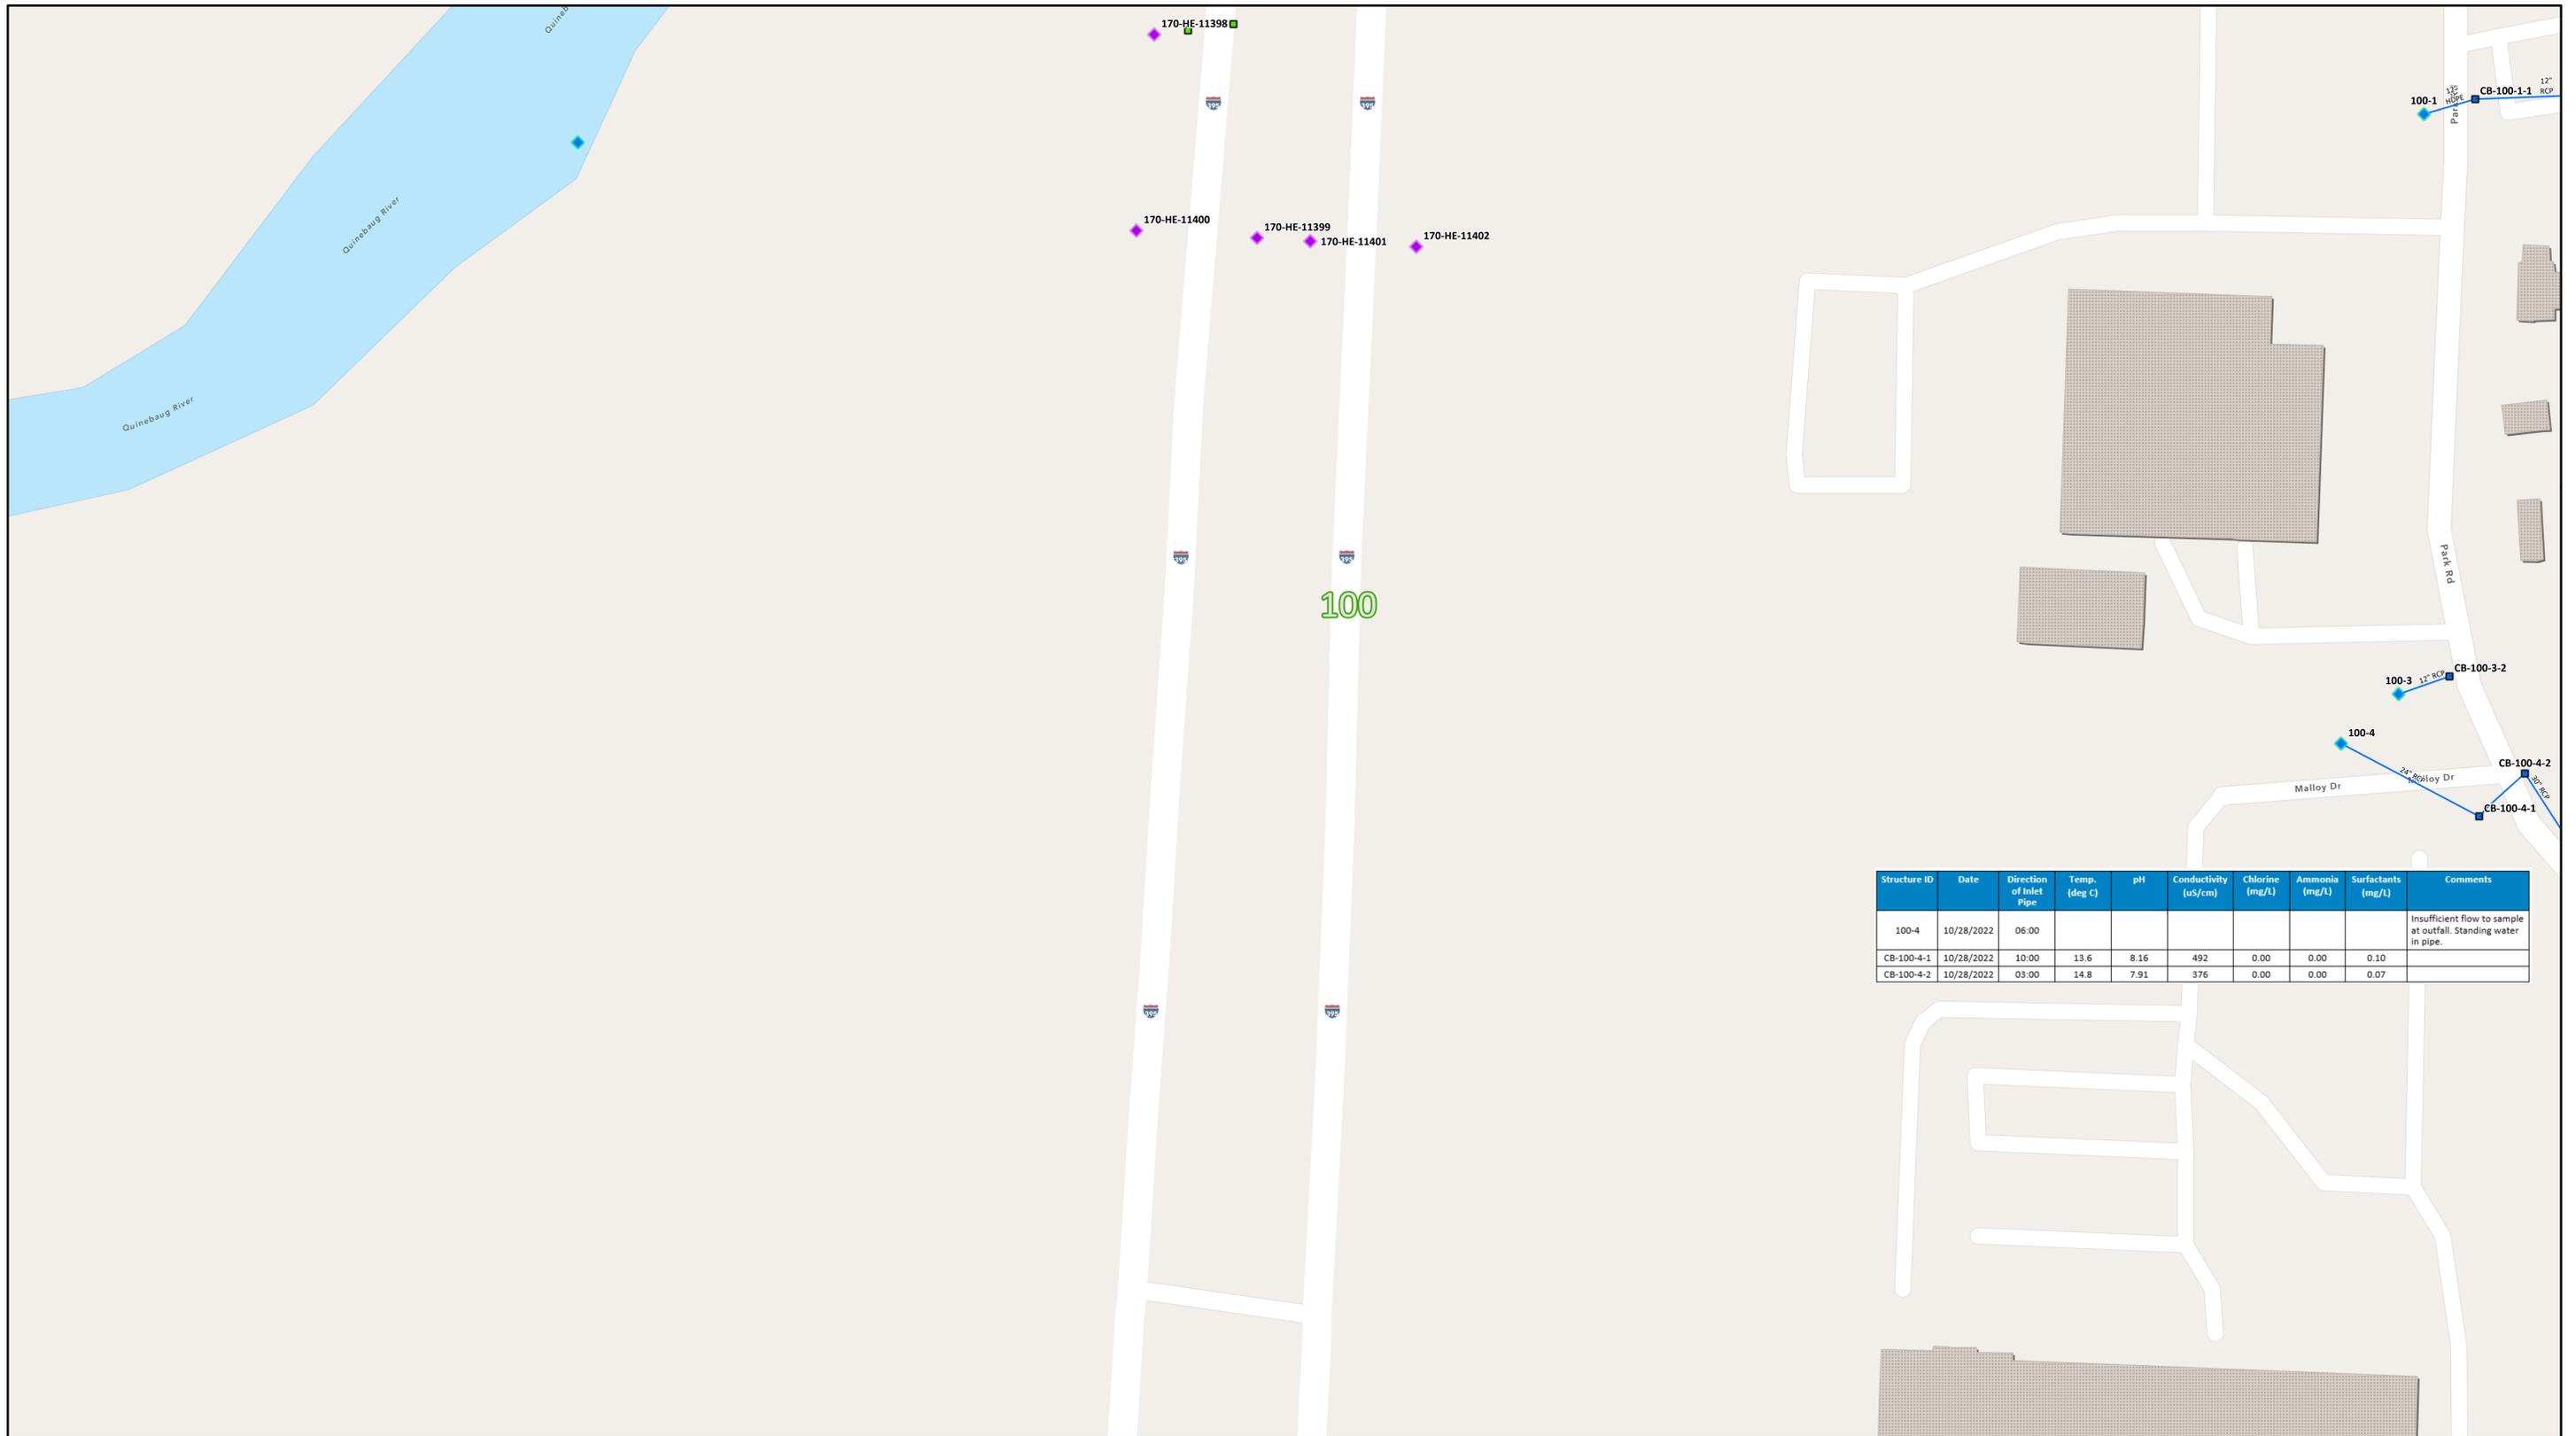
Illicit Discharge Detection and Elimination Investigation
Town of Putnam MS4 Program
February 2023
 Page Name: O2

| Structure ID | Date | Direction of Inlet Pipe | Temp. (deg C) | pH | Conductivity (us/cm) | Chlorine (mg/L) | Ammonia (mg/L) | Surfactants (mg/L) | Comments |
| 100-4 | 10/28/2022 | 06:00 | | | | | | | Insufficient flow to sample at outfall. Standing water in pipe. |

| Outfall ID | IDDE Concern(s) | Comments | Recommendations |
|---|---|---|--|
| 100-4 | No exceedances | Intermittent flow observed through private connection to CB-100-4-10 but unable to sample. | No further follow-up recommended. |

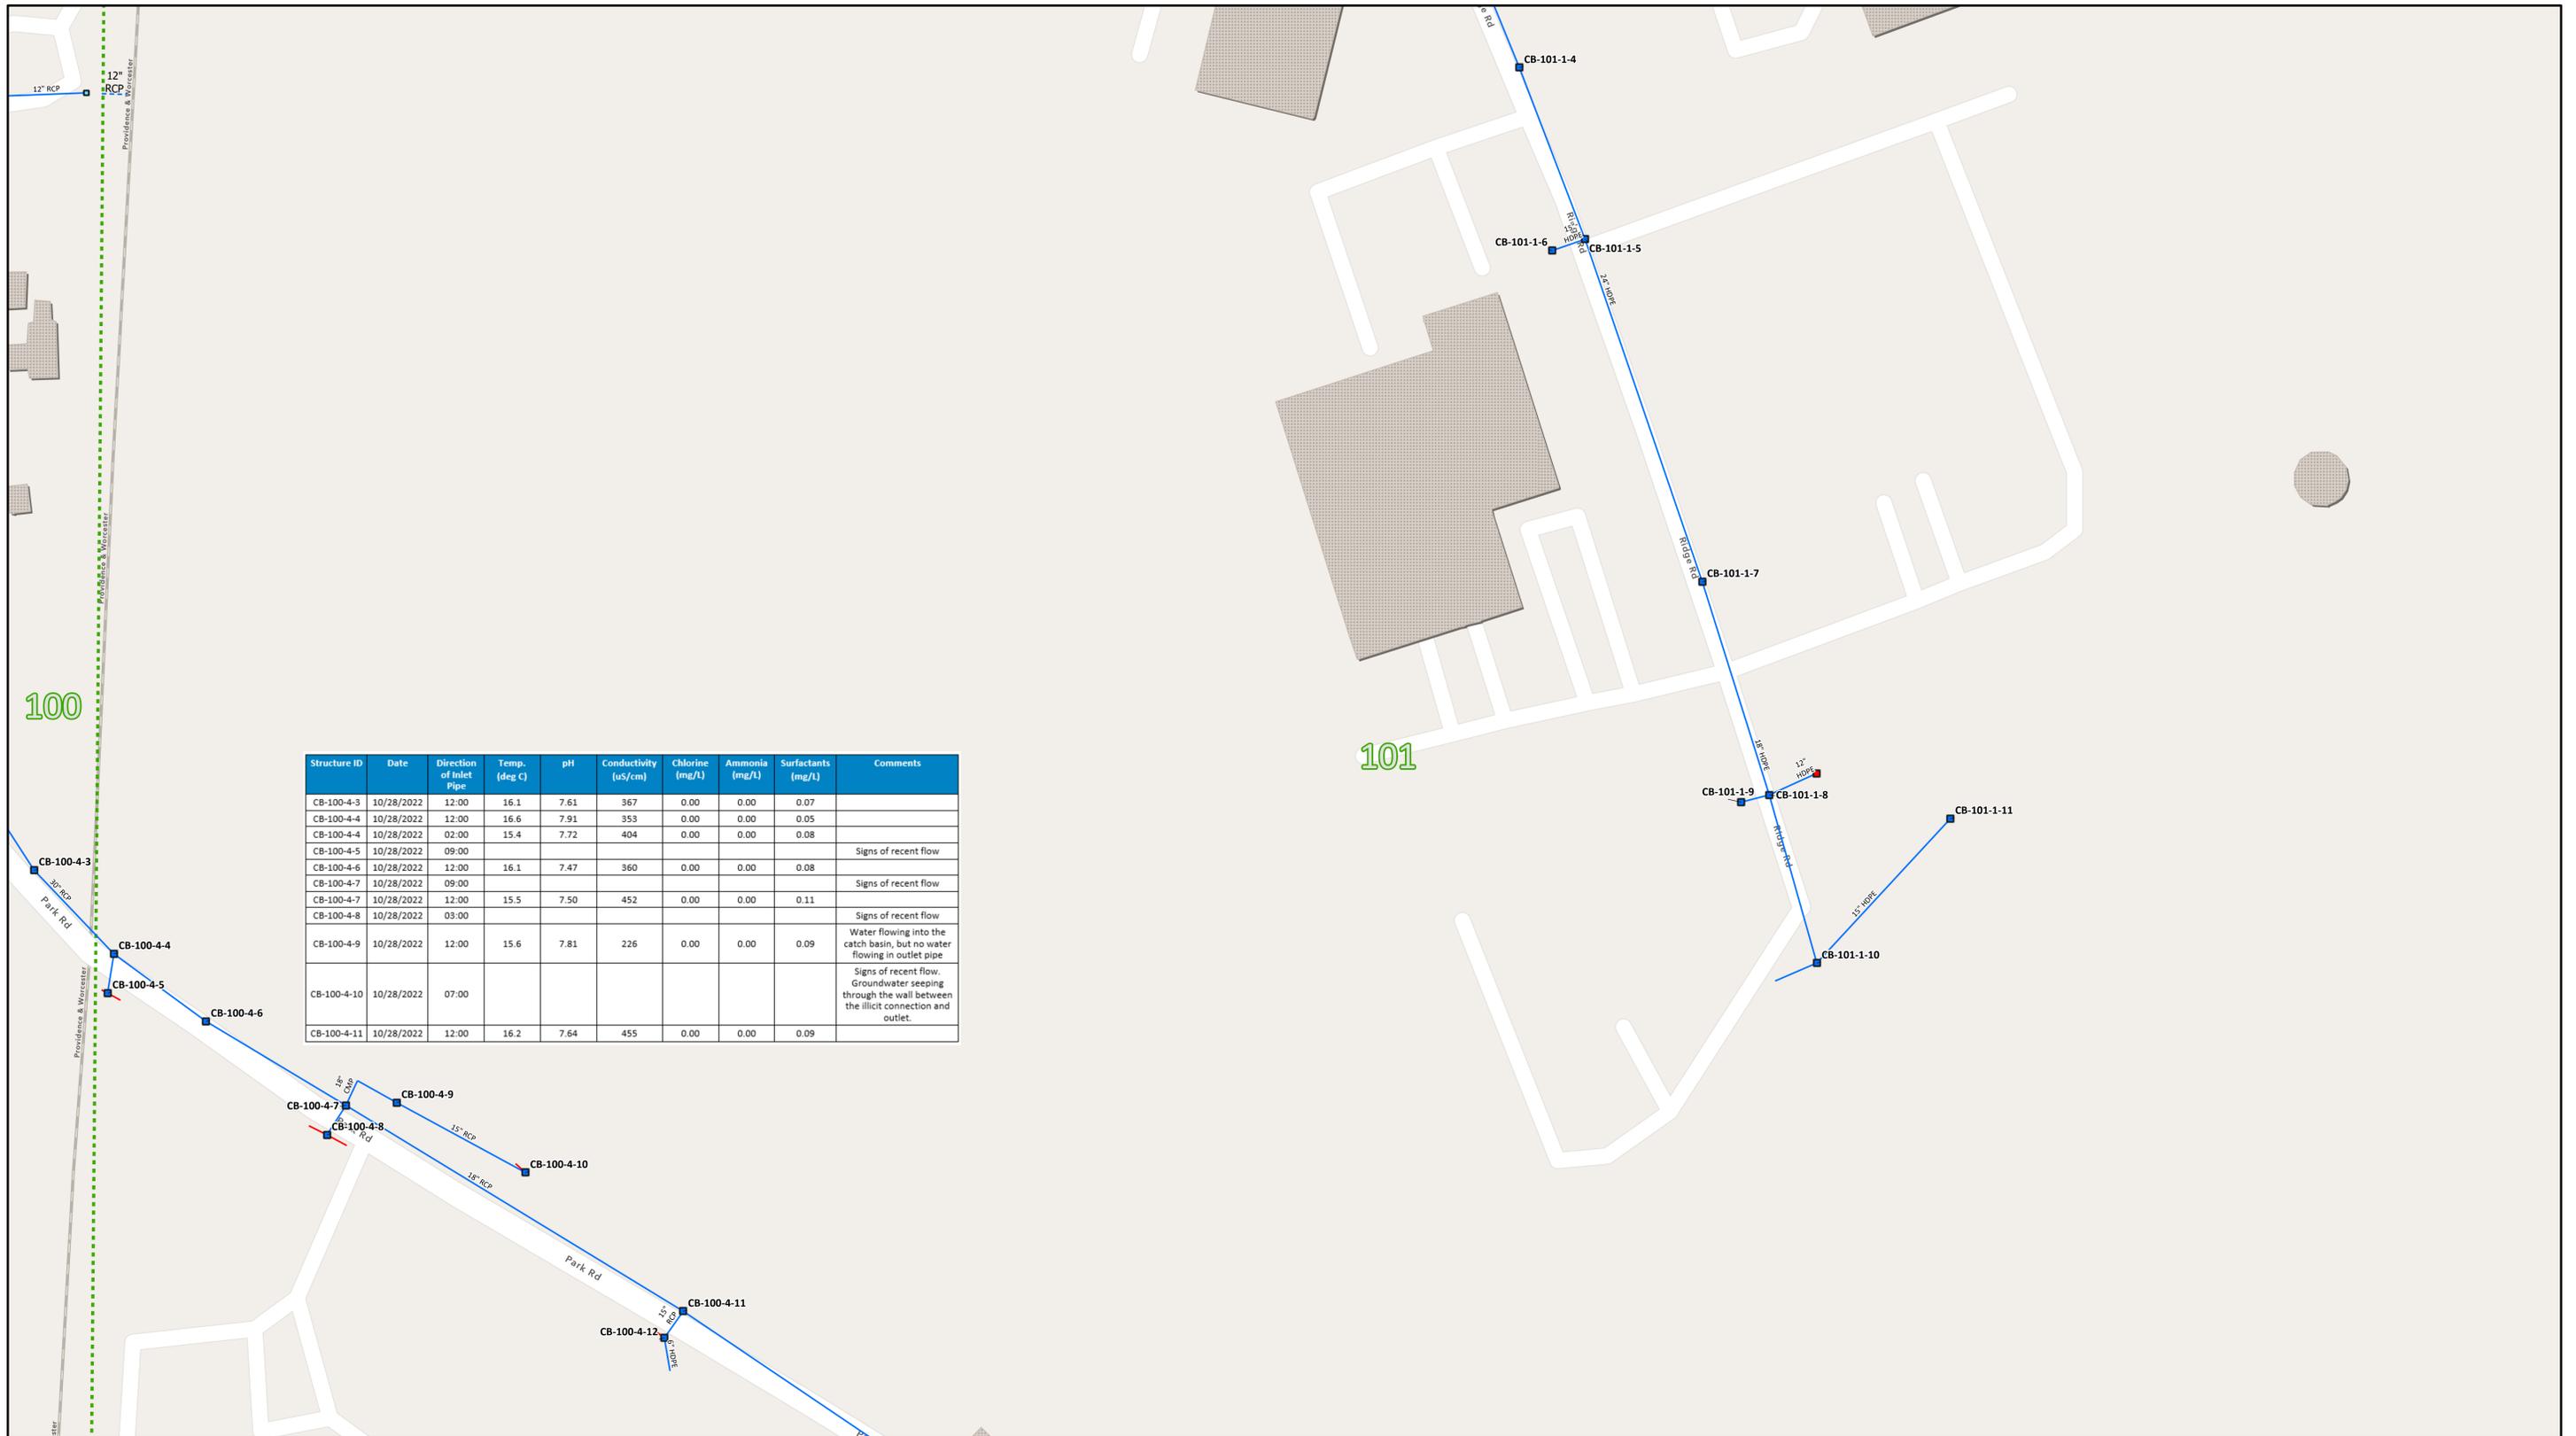
Page Name: O5

| Structure ID | Date | Direction of Inlet Pipe | Temp. (deg C) | pH | Conductivity (uS/cm) | Chlorine (mg/L) | Ammonia (mg/L) | Surfactants (mg/L) | Comments |
| CB-100-4-3 | 10/28/2022 | 12:00 | 16.1 | 7.61 | 367 | 0.00 | 0.00 | 0.07 | |
