MS4 Annual Report Transmittal Form

For the General Permit to Discharge Stormwater from Small Municipal Separate Storm Sewer Systems (MS4)

This report documents the Town of Putnam efforts to comply with the conditions of the MS4 General Permit to the maximum extent practicable (MEP) from January 1, 2022 to December 31, 2022.

Illicit Discharge Detection and Elimination Investigation
Town of Putnam MS4 Program
February 2023
 Page Name: A1

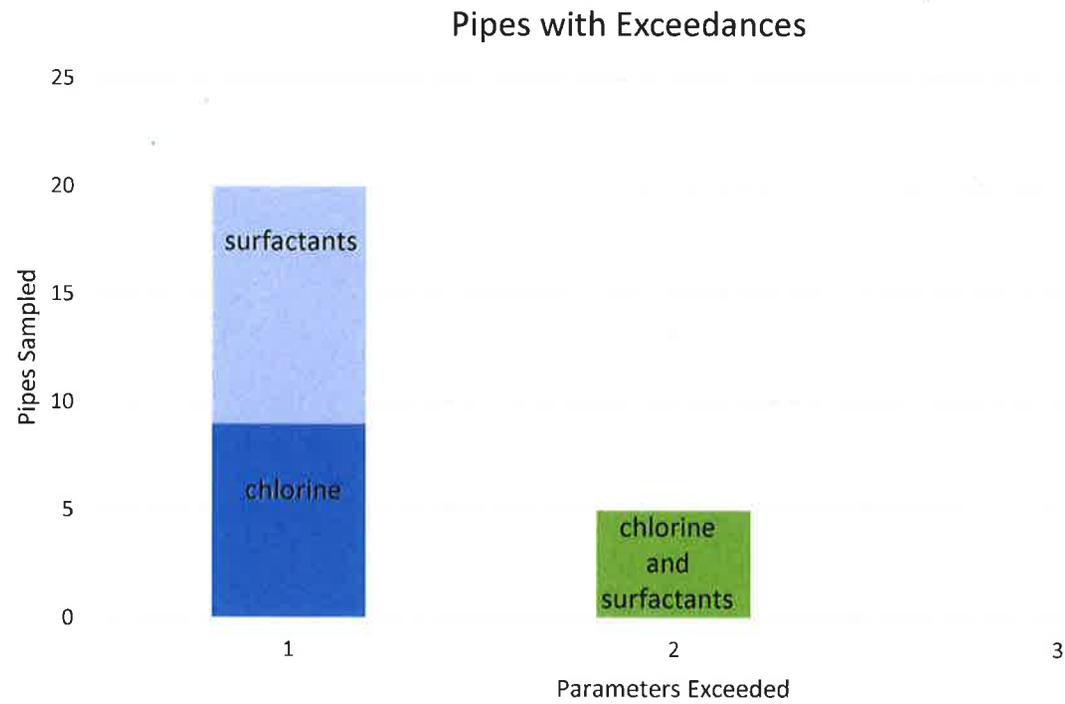
Figure 1 Sampled Pipes with Exceedances

Attachment A provides a detailed figure with inspection data for each outfall investigation.

Within the 22 systems, 56 pipes were sampled, and 25 pipes exceeded at least one water quality threshold, with 20 having one parameter with an exceedance and 5 having two parameters with exceedances. **Figure 1** (attached) shows pipes sampled by number of parameters exceeded. Of 56 sampled pipes, none of the pipes sampled had exceedances for all three field tests.
