FEASIBILITY STUDY UPDATE

CHESTER COUNTY, PA

GREENWOOD ELEMENTARY SCHOOL NEW GARDEN ELEMENTARY SCHOOL

MAY 2, 2022

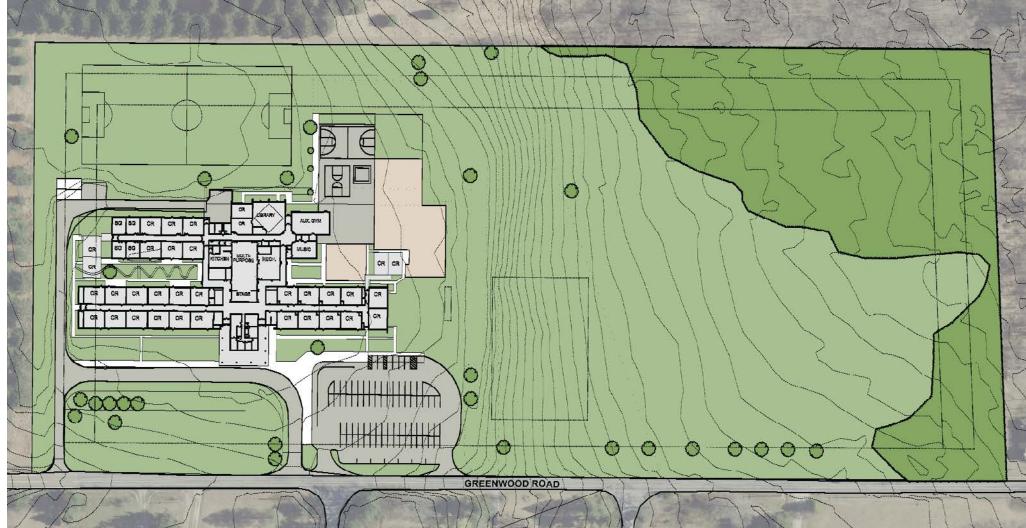
Existing Greenwood site plan

A steep drop off occurs across the center of the site, creating a natural divide between developed and undeveloped land. This divide limits the area to position a new building to the north end of the site, as it is recommended to avoid building on the southern end of the site due to proximity to wetlands. The project can take advantage of this sloped area to create a two-story classroom wing (similar to Bancroft Elementary School).

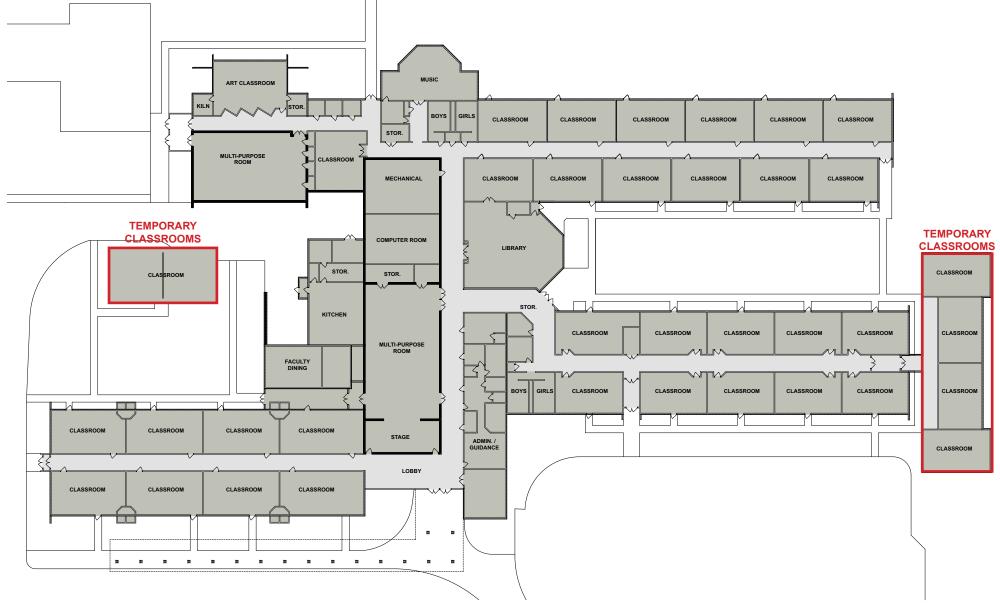
Existing New Garden floor plan

The circulation within the building lacks clear, visual connections to the northeast and southwest wings. Visual connection creates a safer school environment.

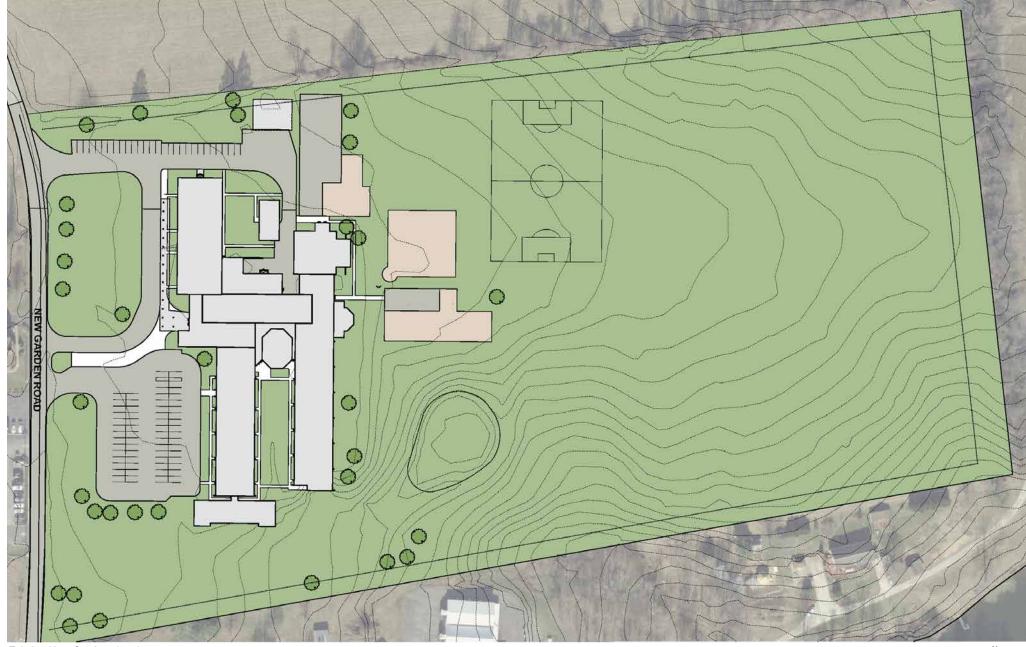
Existing New Garden site plan

The site is clear and mostly available for development and the only obstacle is the existing detention basin. The site slopes down to the south and the north-east. The slope can be utilized to create a twostory classroom wing (similar to Bancroft Elementary School).

New Garden utilizes a storm water detention basin. Further investigation will be required if the existing basin is expanded or retrofitted, including infiltration testing.

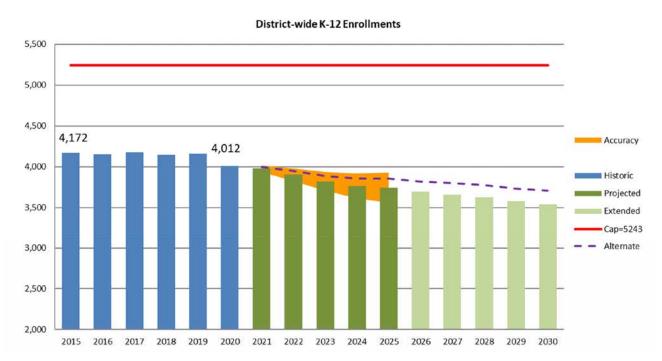
The 2020 enrollment is 160 students (3.8%) less than the 2015 enrollments at the beginning of the historic period having decreased to 4,012 students. That is the equivalent of 12 students per grade or about 1/2 classroom per grade decrease in the historic period.

Enrollments are projected to decrease by an additional 269 students to 3,743 students (-6.8%) in year 2025 at the end of the 5-year projection. 70 students (about 5 per grade) have been added to the 5-year projection from new multi-family housing

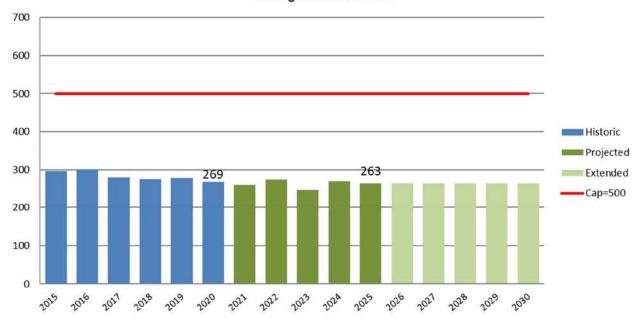
Kindergarten Enrollments

Kindergarten enrollments that have been decreasing in the historical period, by 27 students, will decrease by 6 students in the 5-year projected period. Five Kindergarten students from new housing are added to the projection period.

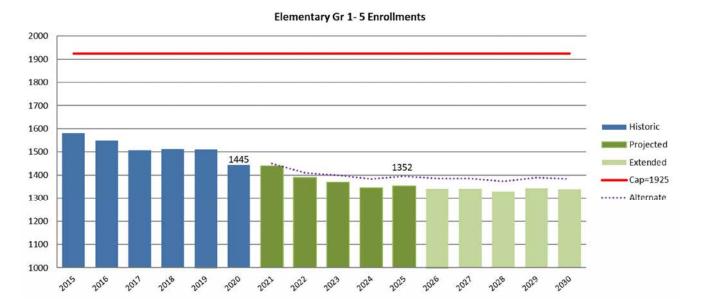
Enrollment Projections Elementary Projection

In the historic period enrollments decreased 136 students to a total of 1,445 Grade 1-5 students.

In the projection period enrollments will continue to decrease by 93 students to a new low of 1,352 students at the end of the projection period in year 2023-24. The alternate projection is for 1,396 students. 32 students from new housing were added to the Grade 1-5 projection.

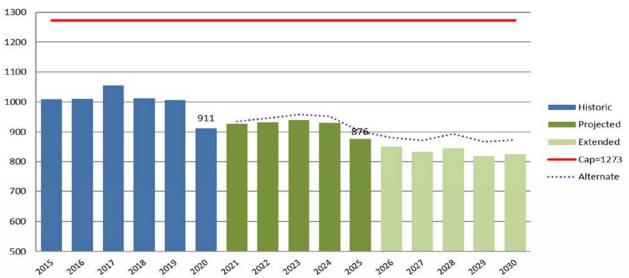
Enrollment Projections Middle School Projection

In the historic period enrollments decreased 280 students to a total of 911 students.

In the projection period enrollments will continue to decrease by an additional 35 students to a low of 876 students at the end of the projection period in year 2025-26. 16 students have been added to these grade Levels. The alternate projection is for 900 students.

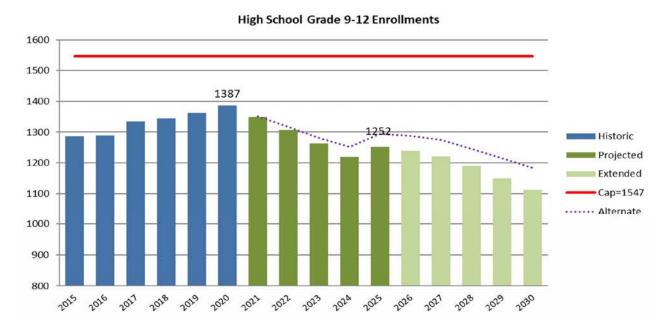
In the historic period enrollments increased 101 students to a total of 1,387 students.

In the projection period enrollments will begin to decrease by 136 students to a low of 1,252 students at the end of the projection period in year 2025-26. The alternate projection is for 1,294 students. 22 students from new housing have been added at the high school level.

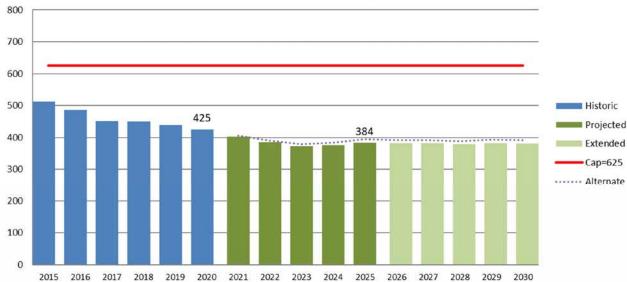
Enrollment Projections Bancroft Elementary School

Enrollments which decreased 87 in the historic period, will decrease by 41 in the projection period to a new low of 384 students in year 2025-26. Five students from new housing are added to the Bancroft projection.

Sections increase from a current 22 classrooms to a projection period high of 20 classrooms.

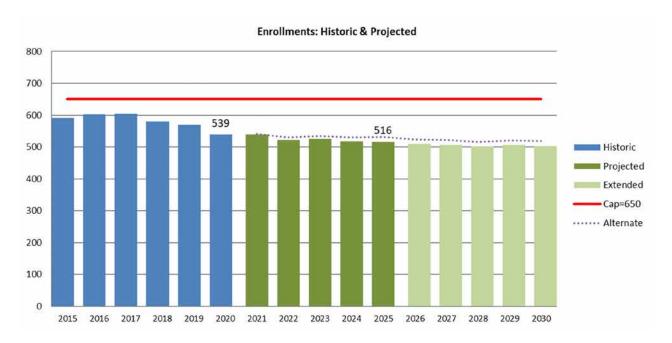
Enrollment Projections
Greenwood Elementary School

Enrollments which decreased 53 in the historic period, will decrease by 23 in the projection period to a low of 516 students in year 2025-26. 32 students from new housing are added to the Greenwood projection

Sections stabilize at the current 25.

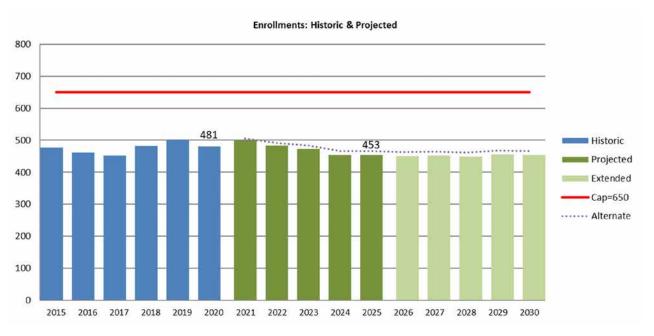
Enrollment Projections
New Garden Elementary School

Enrollments which increased 4 in the historic period, will decrease by 28 in the projection period to a low of 453 students in year 2025-26. No students from new housing are added to the New Garden projection.

Sections decrease from the current 25 to 23.
