Building 1: (1st and 2nd Grades)
 Year Const.: 1962
 Renovations: Various Years
 Square Footage: 26,400 Single Story
 Total: 26,400

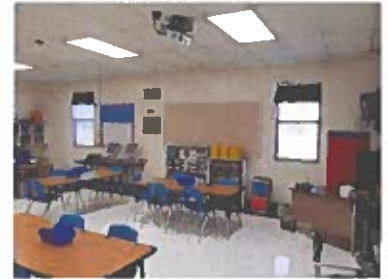
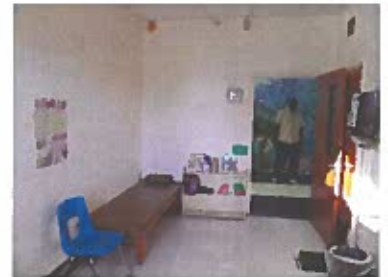
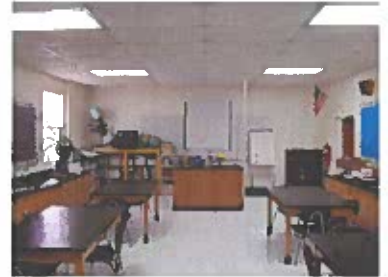
Footings: Spread
 Structure: Wooden Trusses on Load Bearing Masonry
 Exterior Walls: Load Bearing CMU/Brick Veneer
 Fenestration: Aluminum Double Hung and fixed Storefront and EFIS infill
 Exterior Doors: Hollow Metal Frames and Hollow Metal Doors
 Roof System: Metal Retrofit
 Finishes: Average to Good. Floors-VCT Corridors and Classrooms; Acoustic ceilings; and Painted CMU walls
 Plumbing Systems: Copper Supply/Cast Iron Waste
 Mechanical Systems:
 Classrooms: Wall Hung Bard Units
 Office: Wall Hung Bard Units
 Electrical System: 277/480V System
 Fire Alarm: Needs Replacement
 Emergency Lighting: Wall Mounted Battery Backup
