**Darlington County School District**  
Darlington, South Carolina  
September 12, 2012

## **Lamar Area Schools - Building Evaluations**

**School Name:** Spaulding Middle  
**Principal:** Mr. Derrick Glover  
**Grade Levels:** 6<sup>th</sup> – 8<sup>th</sup> Grades  
**Site Size:** Approximately 15 Acres  
**Student Population:** 274 (Approximate Student Population)  
**Staff Size:** 33 (Approximate Staff Size)

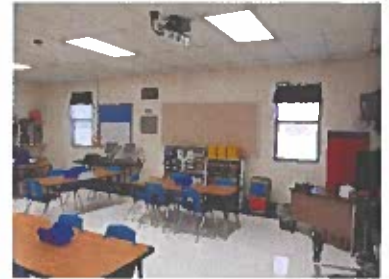
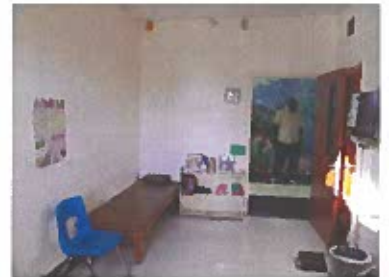
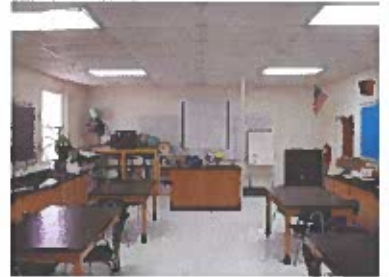
Footings: Spread  
 Structure: Wooden Trusses on Load Bearing Masonry  
 Exterior Walls: Load Bearing CMU/Brick Veneer  
 Fenestration: Aluminum Double Hung and fixed Storefront and EFIS infill  
 Exterior Doors: Hollow Metal Frames and Hollow Metal Doors  
 Roof System: Metal Retrofit  
 Finishes: Average to Good. Floors-VCT Corridors and Classrooms; Acoustic ceilings; and Painted CMU walls  
 Plumbing Systems: Copper Supply/Cast Iron Waste  
 Mechanical Systems:  
 Classrooms: Wall Hung Bard Units  
 Office: Wall Hung Bard Units  
 Electrical System: 277/480V System  
 Fire Alarm: Needs Replacement  
 Emergency Lighting: Wall Mounted Battery Backup

Utilities: City of Lamar  
 Occupancy: Educational Type "E"  
 Construction Type: III B Unprotected/Un-sprinkled  
 Area Allowed: 14,500 sf  
 Maximum Stories: Two (2) Stories  
 Occupant Load:  
 Fire Rated Assemblies:  
 Fire Barriers: Corridors Not Rated 1 hr. req.  
 Wood Trusses: Not Rated  
 Roof/Ceiling: Not Rated 1 hr. req.  
 Fire Walls: Not Required  
 Toilets:  
 Toilet Counts: Appear to be adequate  
 ADA Accessibility: Appear to be compliant
