**Darlington County School District**  
Darlington, South Carolina  
August 8, 2012

## **Darlington Area Schools - Building Evaluations**

**School Name:** St. John's Elementary      Observed By: Creed/Carter  
**Principal:** Ms. Jean Taylor  
**Grade Levels:** 3K – 5th  
**Site Size:** Approximately 12 Acres  
**Student Population:** 667 (Approximate Student Population)  
**Staff Size:** 86 (Approximate Staff Size)

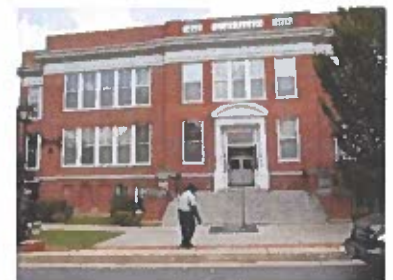
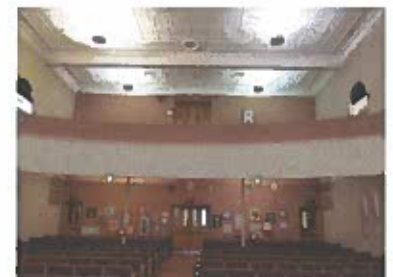
Footings:	Spread
Structure:	Wood Frame with wood veneer
Exterior Walls:	Brick Veneer/cast stone
Fenestration:	Aluminum Double Hung and fixed Storefront
Exterior Doors:	Hollow Metal Frames and Aluminum Storefront
Elevated Floor:	Wood frame
Roof System:	4-Ply Built-up Roof on wood
Finishes:	Hard wood quarry tile floors. Some walls glazed block
Plumbing Systems	Copper Supply/Cast Iron Waste
Mechanical Systems:	
First Floor:	
Second Floor:	
Other:	
Electrical System:	240/480V System
Fire Alarm:	Recently upgraded

Emergency Lights: Wall mounted battery backup

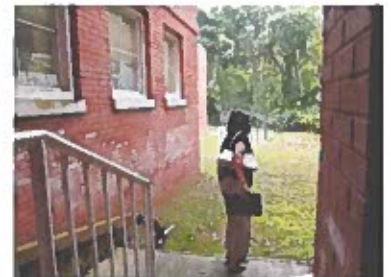
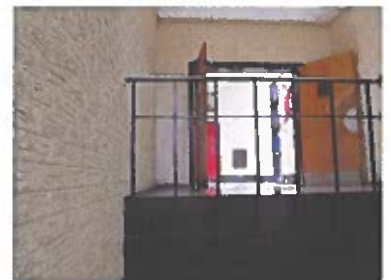
Footings:	Spread
Structure:	Wood Frame
Exterior Walls:	Brick Veneer / cast stone
Fenestration:	Aluminum Double Hung and fixed Storefront
Exterior Doors:	Hollow Metal Frames and Aluminum Storefront
Elevated Floor:	Wood Joist
Roof System:	4-Ply Built-up Roof on wood decking
Finishes:	Floors QT Corridors/VCT Classrooms; acoustic ceilings; and Painted CMU walls, some glazed block walls. Carpet in Media
Plumbing Systems	Copper Supply/Cast Iron Waste
<b>Mechanical Systems:</b>	
First Floor:	
Second Floor:	
Other:	
Electrical System:	240/480V System

Fire Alarm: Recently upgraded  
Emergency Lighting: Wall mounted battery backup

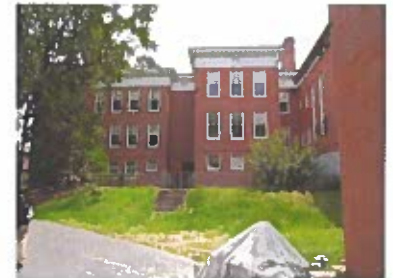
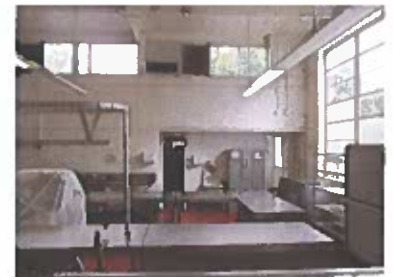
Footings:	Spread
Structure:	Masonry Load bearing
Exterior Walls:	CMU/Brick Veneer
Fenestration:	Aluminum Double Hung and fixed Storefront
Exterior Doors:	Hollow Metal Frames and Aluminum Storefront
Elevated Floor:	Composite Slab on Steel Frame
Roof System:	Standing seam metal roof
Finishes:	Average. Floors QT Corridors/VCT Classrooms; acoustic. ceilings; and Painted CMU walls, VCT cafeteria Copper Supply/Cast Iron Waste
Plumbing Systems	
Mechanical Systems:	
First Floor:	
Second Floor:	
Other:	
Electrical System:	240/480V System
Fire Alarm:	Recently upgraded

Emergency Lighting: Wall mounted battery backup

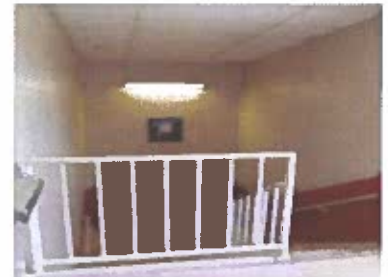
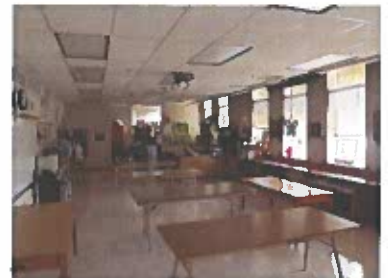
Footings:	Spread
Structure:	Steel Bar Joist on Load Bearing Masonry
Exterior Walls:	Load Bearing CMU/Brick Veneer
Fenestration:	Aluminum Double Hung and fixed Storefront
Exterior Doors:	Hollow Metal Frames and Aluminum Storefront
Roof System:	Standing Seam Metal Roof
Finishes:	Average to poor. Floors-VCT and hardwoods/tile
Plumbing Systems	Copper Supply/Cast Iron Waste
Mechanical Systems:	
Gym and Lobby:	No A/C, electric heat
Electrical System:	277/480V System
Fire Alarm:	
Emergency Lighting:
