Darlington County School District

Hartsville Area Schools - Building Evaluations

School Name: Washington Street Elementary Observed By: Cannon/Carter
Principal: Ms. Valerie Sawyer
Grade Levels: 1st – 3rd Grades and Special Needs
Site Size: Approximately 11 Acres
Student Population: 360 (Approximate Student Population)
Staff Size: 40 (Approximate Staff Size)

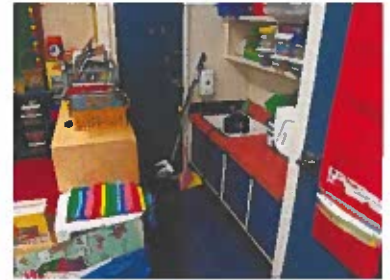
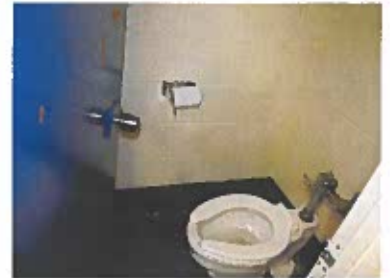
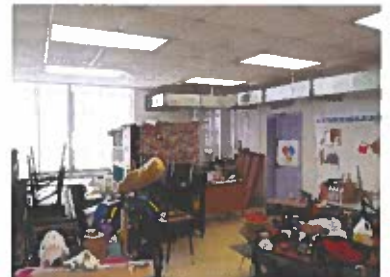
Building 1: (1st and 2nd Grades)
 Year Const.: 1962
 Renovations: Various Years
 Square Footage: 27,000 Single Story
 Total: 27,000 27,000

Footings: Spread
Structure: Steel Bar Joist on Load Bearing Masonry
Exterior Walls: Load Bearing CMU/Brick Veneer
Fenestration: Aluminum Double Hung and fixed Storefront
Exterior Doors: Hollow Metal Frames and Aluminum Storefront
Roof System: Metal Retrofit
Finishes: Average to Good. Floors-VCT Corridors and Classrooms; Acoustic ceilings; and Painted CMU walls
Plumbing Systems
Mechanical Systems:
 Classrooms: Wall Hung Bard Units
 Office: Wall Hung Bard Units
Electrical System: 277/480V System
Fire Alarm: Recently upgraded
Emergency Lighting: Wall Mounted Battery Backup

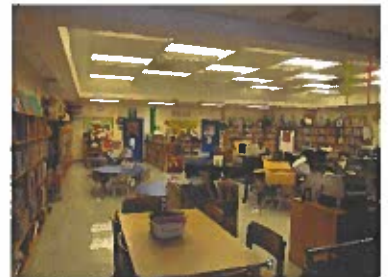
Building 2: (Media Center/3rd Grade/Fine Arts)
 Year Const.: 1987
 Renovations: Various Years
 Square Footage: 18,500 Single Story
 Total: 18,500 18,500

Footings: Spread
 Structure: Steel Bar Joist on Load Bearing Masonry
 Exterior Walls: Load Bearing CMU/Brick Veneer
 Fenestration: Aluminum Double Hung and fixed Storefront
 Exterior Doors: Hollow Metal Frames and Aluminum Storefront
 Roof System: Metal Retrofit
 Finishes: Average to Good. Floors-VCT
 Corridors and Classrooms; Acoustic ceilings; and Painted CMU walls
 Plumbing Systems: Copper Supply/Cast Iron Waste
 Mechanical Systems:
 Classrooms: Wall Hung Bard Units
 Office: Wall Hung Bard Units
 Electrical System: 277/480V System
 Fire Alarm: Recently upgraded
 Emergency Lighting: Wall Mounted Battery Backup
