Seismic Evaluation For:

MEDFORD SCHOOL DISTRICT 549C

Jackson County, Oregon

April, 2022

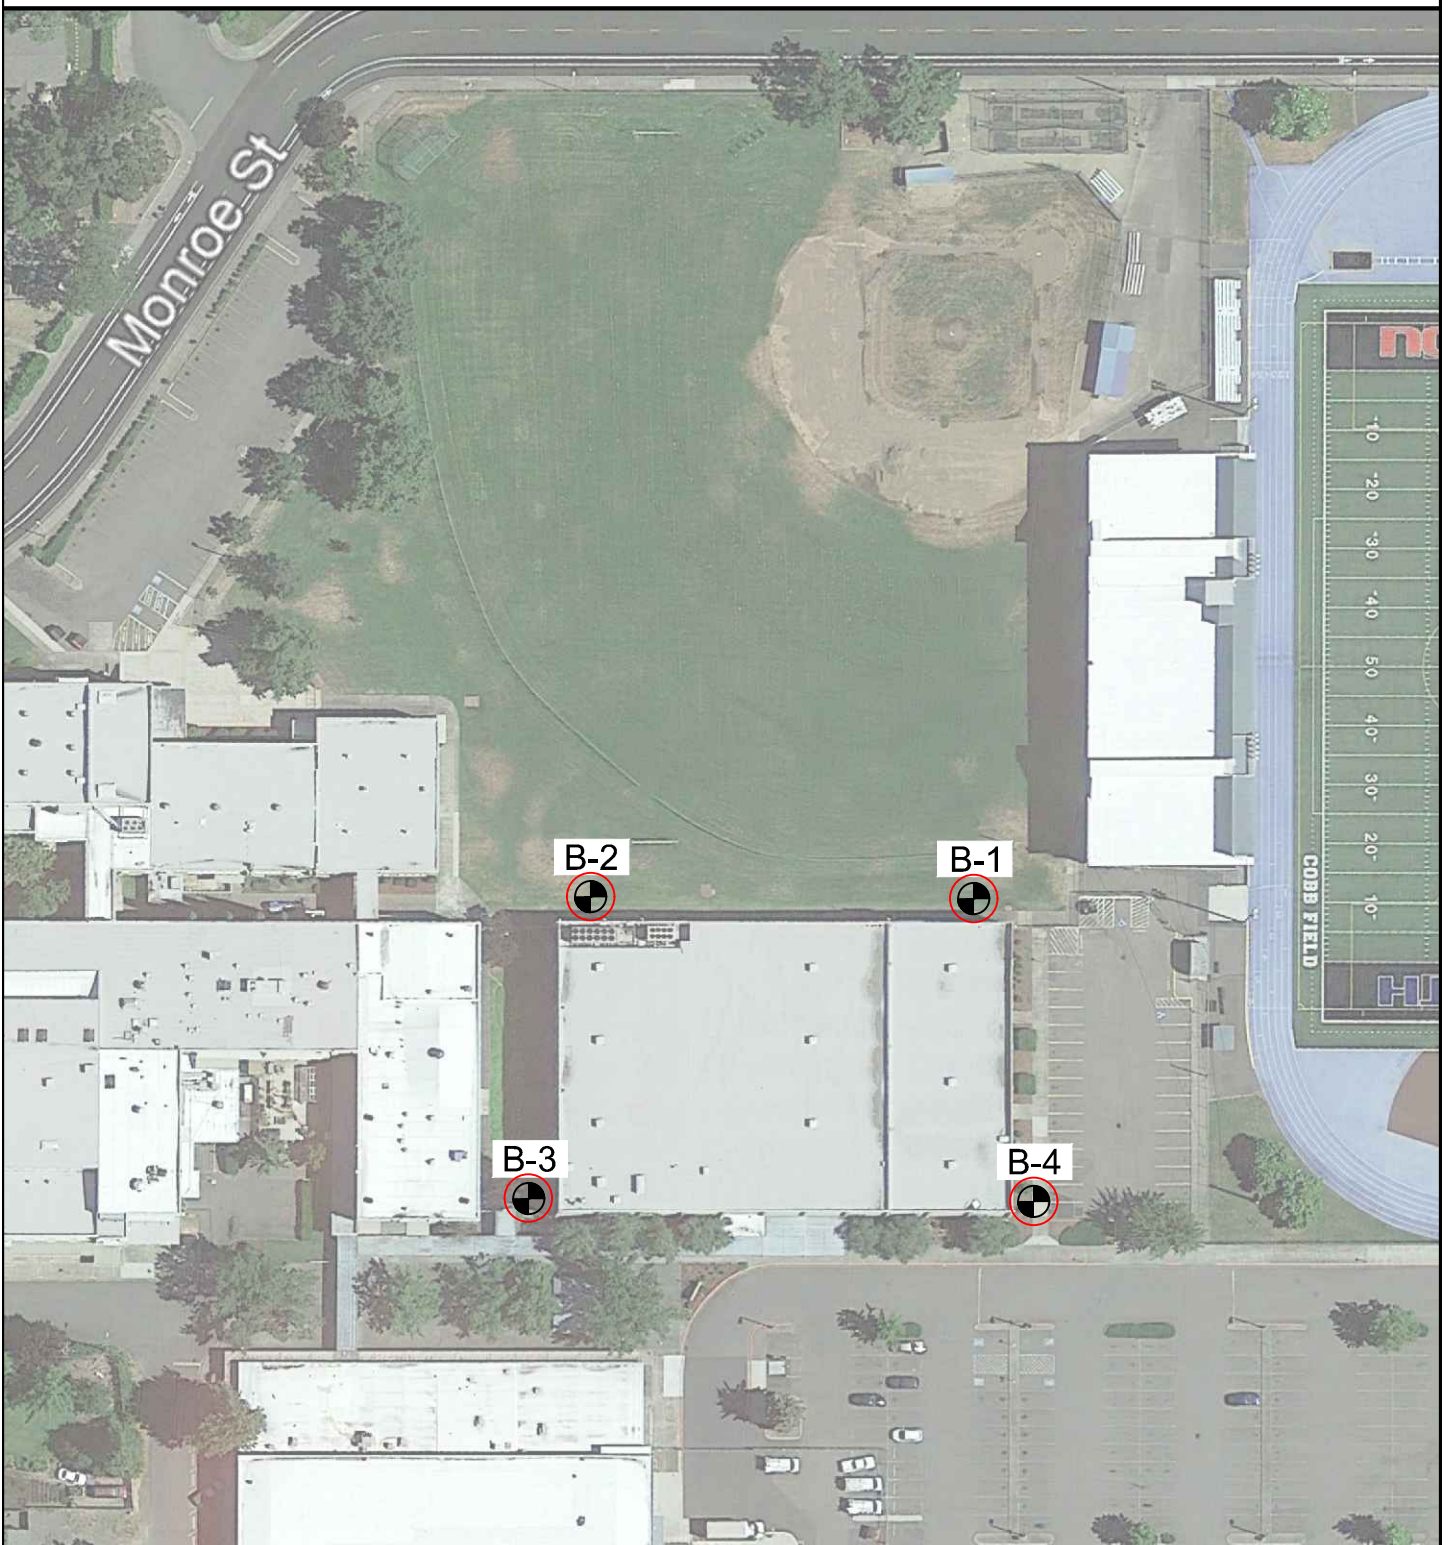
FIGURE:
2

SITE PLAN WITH
BORING LOCATIONS
MSDEC GYMNASIUM
MEDFORD, OREGON
