Alameda Unified School District

Facilities Master Plan

May 27, 2014

QUATTROCCHI KWOK
ARCHITECTS

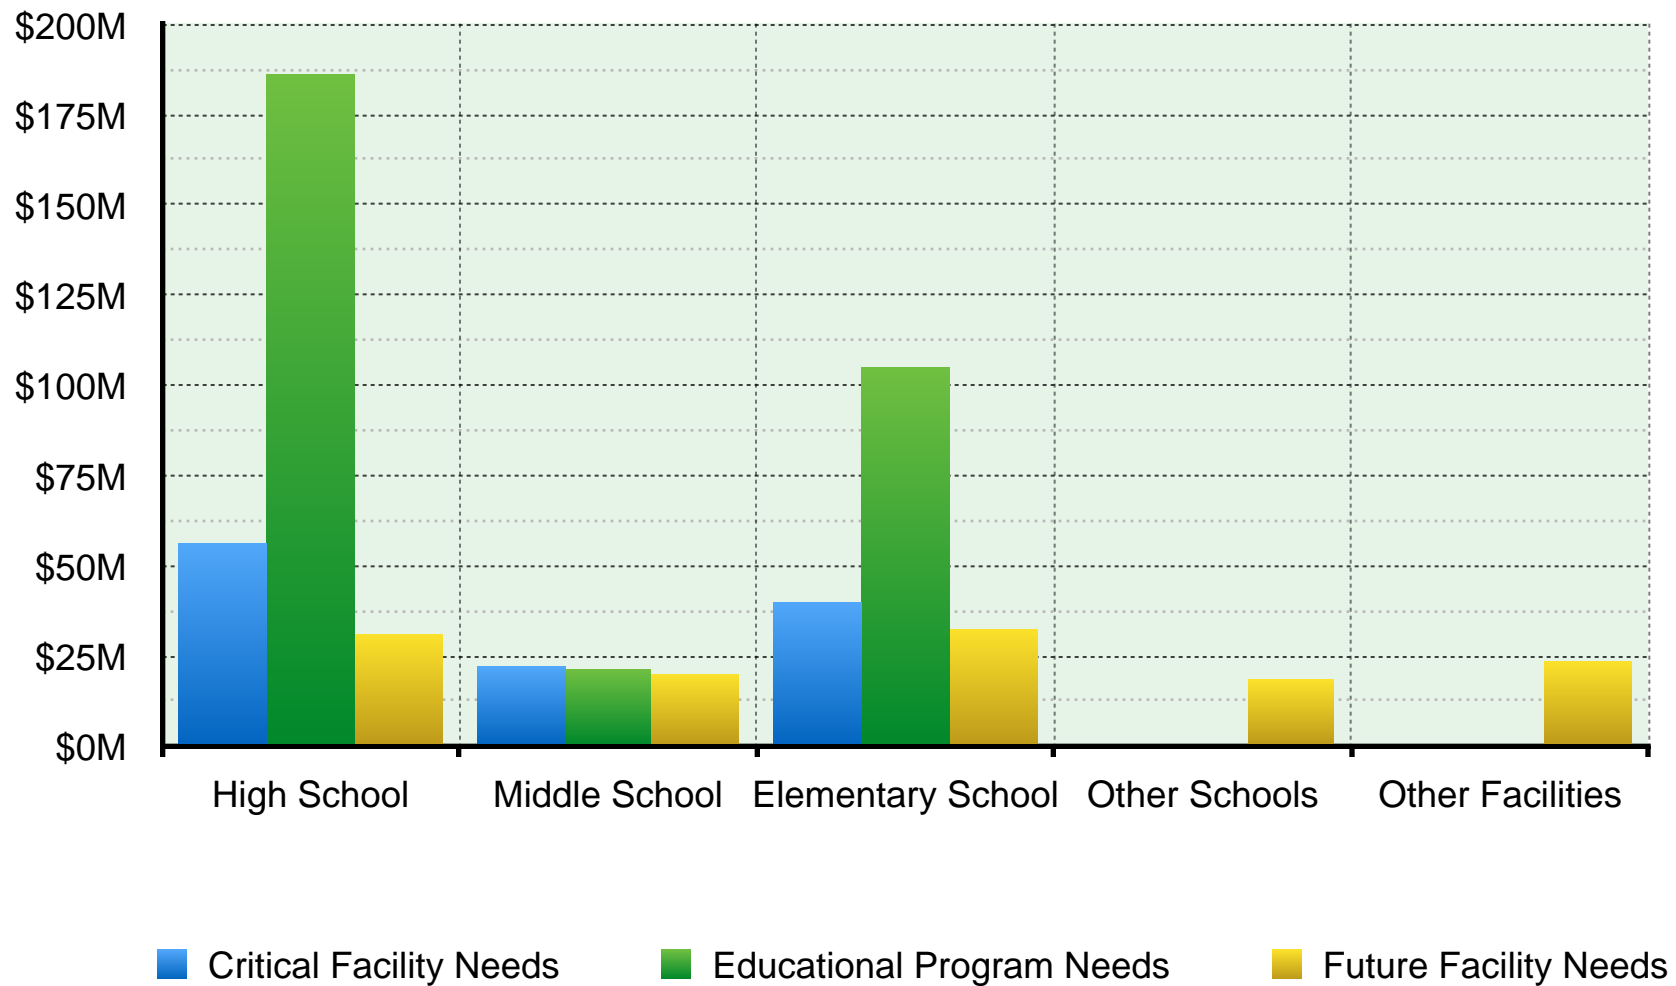
Facilities Master Plan Summary - Costs by School

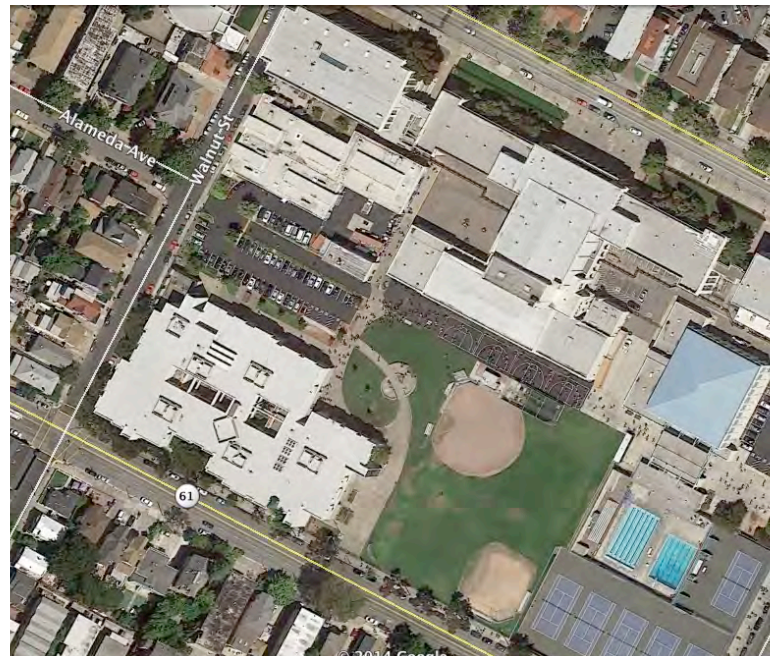
Facilities Assessment Needs - Auditorium (1924)

- Exterior cement plaster is cracking.
- Fire escape steel stair deterioration requires repair or replacement.
- Replace heating, lighting, fire sprinkler, and alarm systems.
- Accessible audience seating at balcony
- Stage and dressing room accessibility
- Boiler system with radiators is obsolete and needs to be replaced.

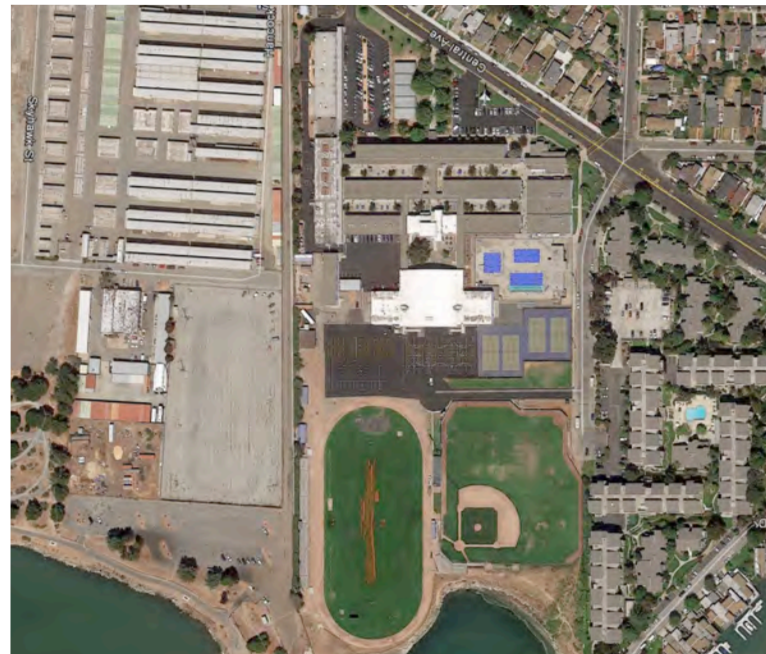
Encinal High School - Existing Conditions Summary

Facilities Assessment Needs

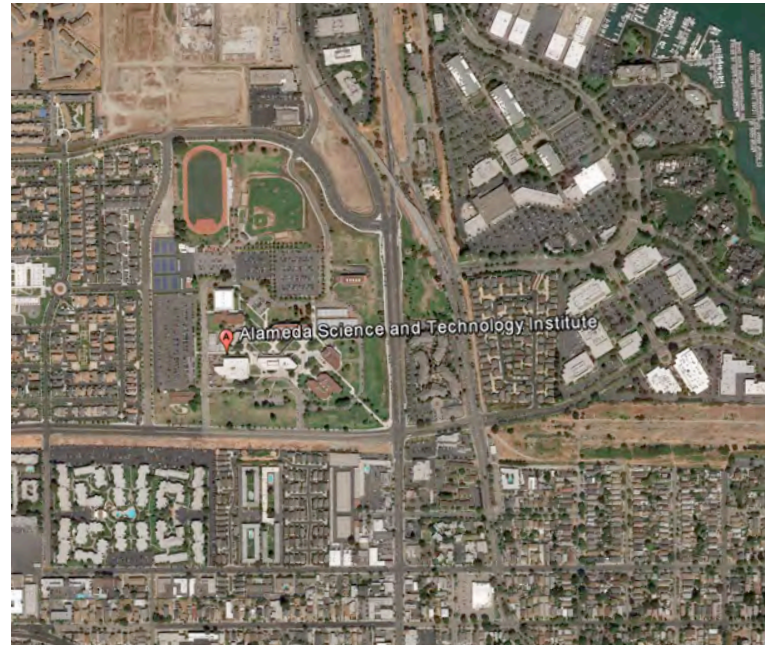
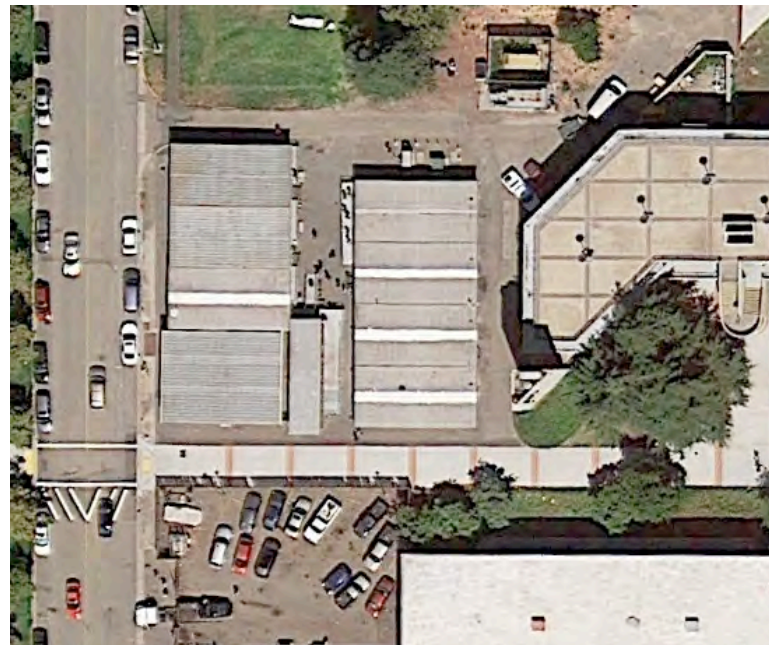
Alameda Science and Technology Institute - Existing Conditions Summary (from 2012 Assessment)

Facilities Assessment Needs

- Accessibility to some key areas is lacking.
- Portable buildings are congested with ramp system.
- Phone and public address systems are inadequate.

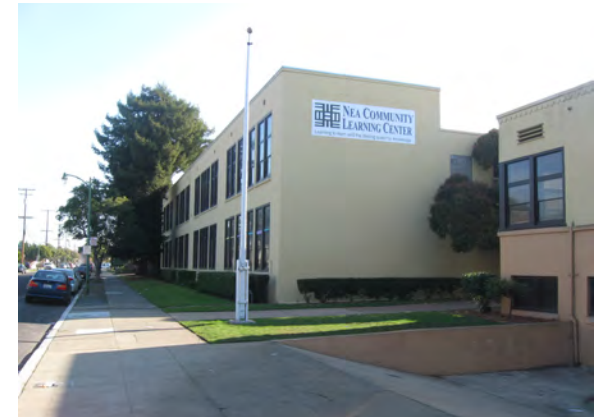
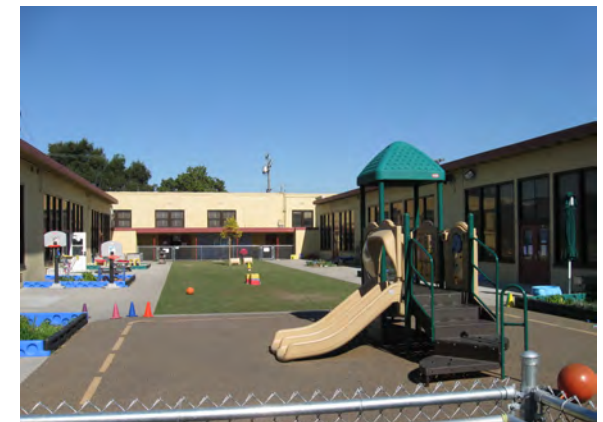
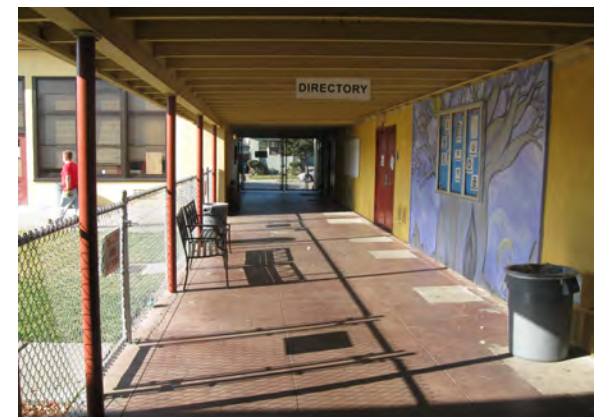
WCDC/Island High School - Master Plan Summary

Safety and Security	Repair and extend perimeter fencing, provide inner fencing at WCDC, improve site lighting, provide dedicated and clearly marked primary entrances for each school, reposition administration with physical and visual connection to primary site entrance and improve parking and vehicular circulation.

Facilities Infrastructure	Provide new administration and classroom building for Island High School, expand WCDC administration space to provide meeting and conference rooms, add toilet rooms to each WCDC classroom.

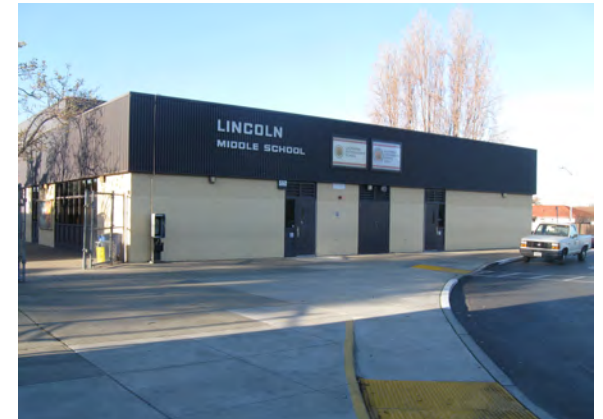
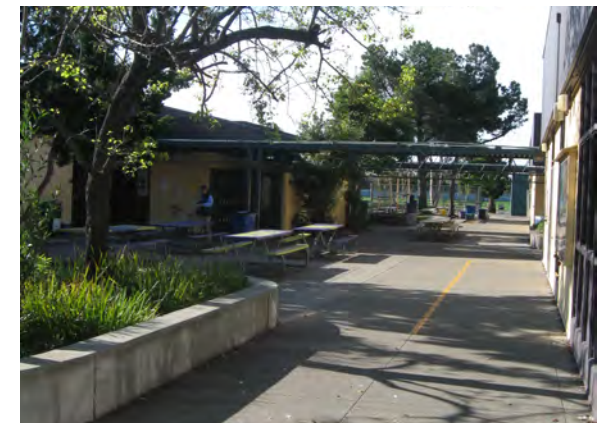
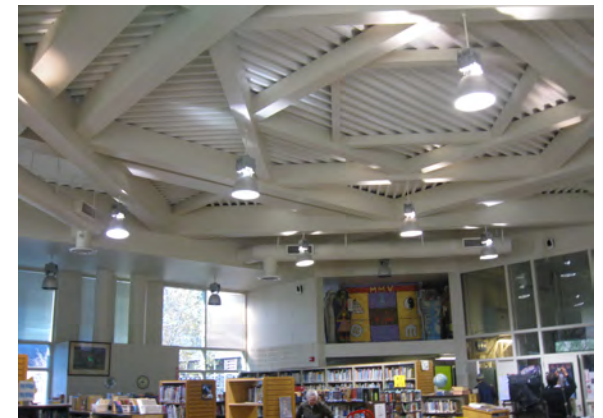
Lincoln Middle School - Master Plan Summary

Accessibility	Renew damaged and heaved paving and striping at walkways and play yard, improve restroom, adjust exterior path of travel slopes, drop-off, parking and doors and provide way-finding signage.

Science, Technology, Engineering, Art, Mathematics	New appropriately-sized science lab to replace undersized space, outdoor art space.

Facilities Infrastructure	Provide new classrooms and gymnasium, modernized multi-purpose room and music classroom, replace mechanical systems, provide a campus energy-management system.

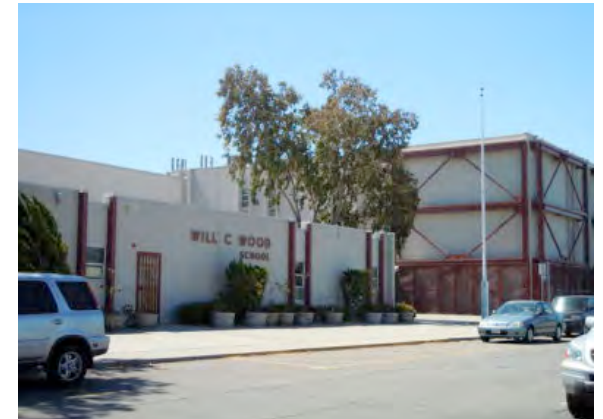
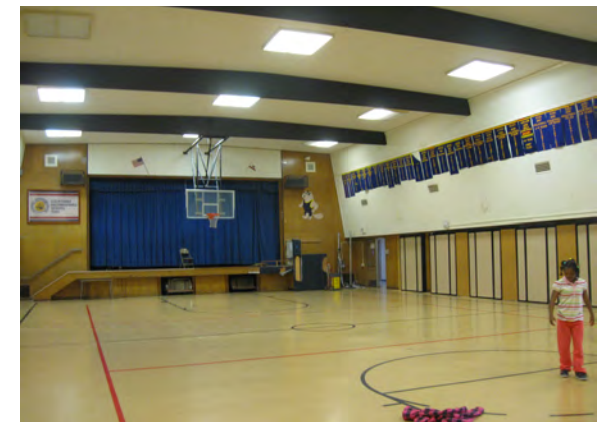
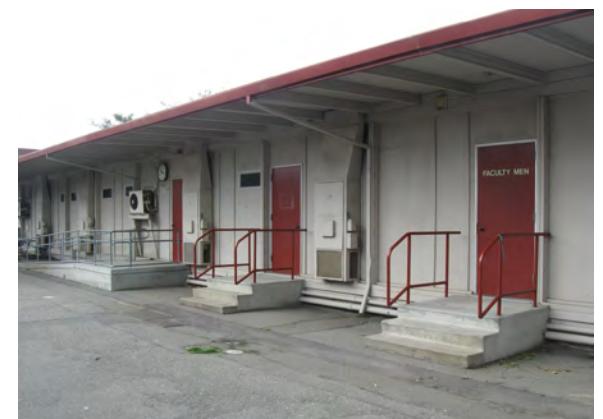
Wood Middle School - Master Plan Summary

Facilities Infrastructure	Provide a campus energy-management system, replace existing heating system, provide gym and locker room facility, provide more meeting and breakout space.

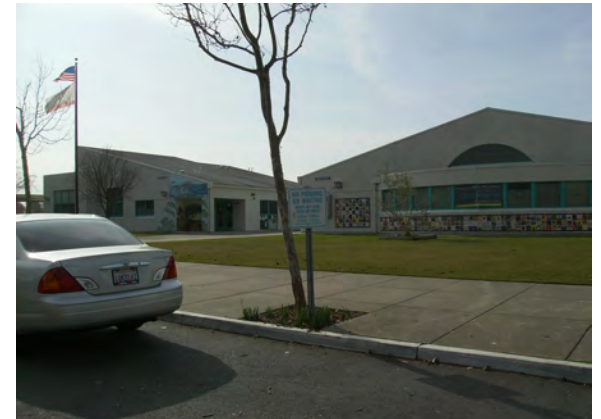
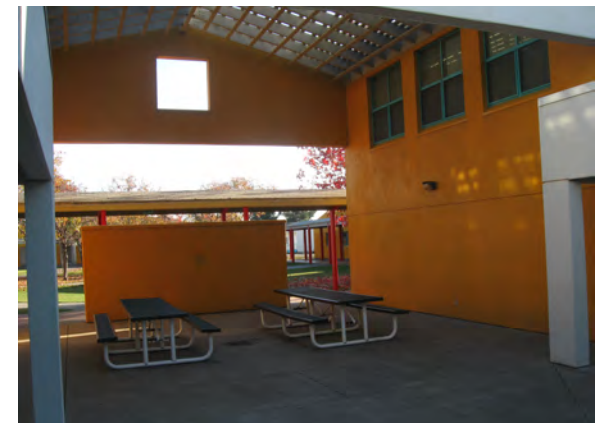
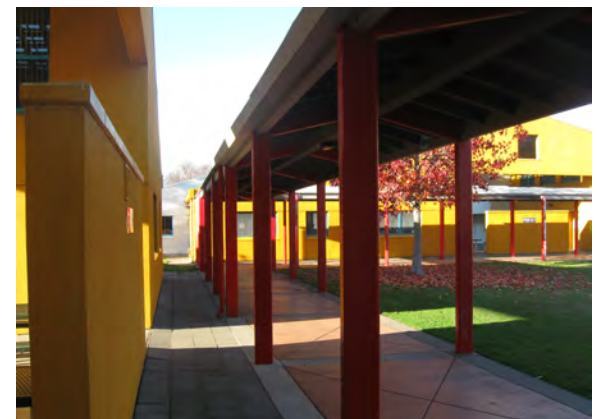
Bay Farm Elementary School - Master Plan Summary

Facilities Infrastructure	Provide a campus energy-management system, replace existing original heating system equipment, and improve site drainage, provide more meeting and breakout space.

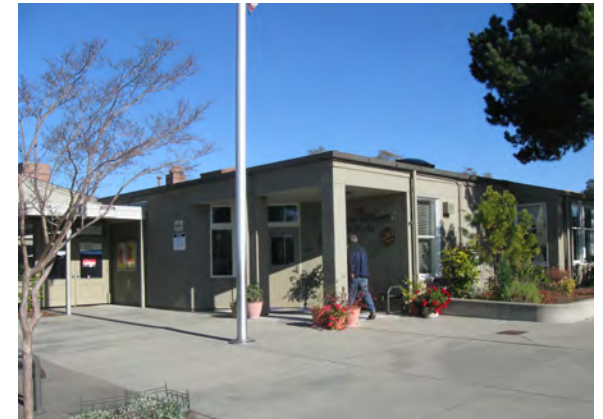
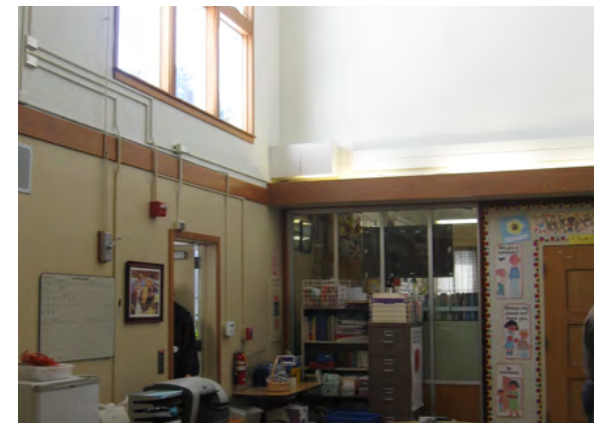
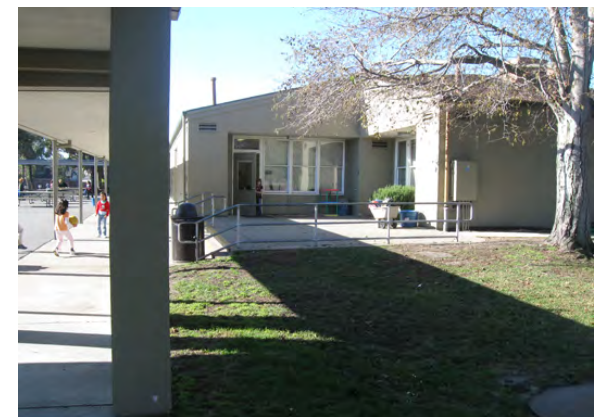
Amelia Earhart Elementary School - Master Plan Summary

Facilities Infrastructure	New administration, multi-purpose and classroom structures, new play field, campus energy-management system.

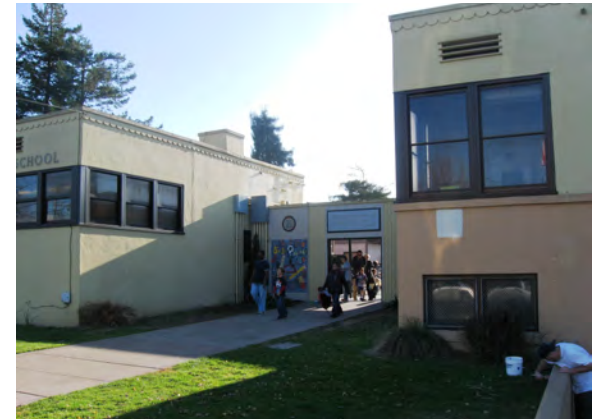
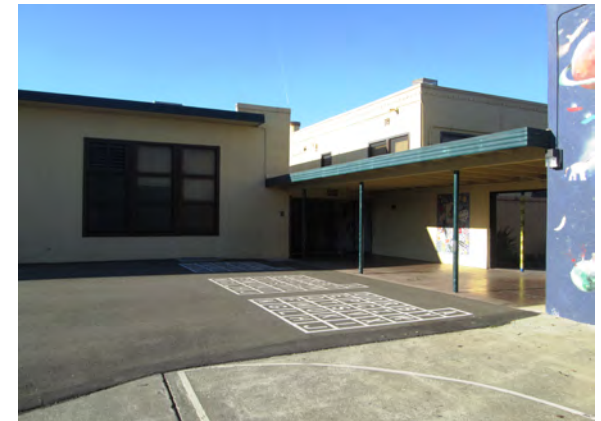
Edison Elementary School - Master Plan Summary

Facilities Infrastructure	New administration and classroom buildings, expanded multi-purpose building, renewed HVAC systems and campus energy-management system.

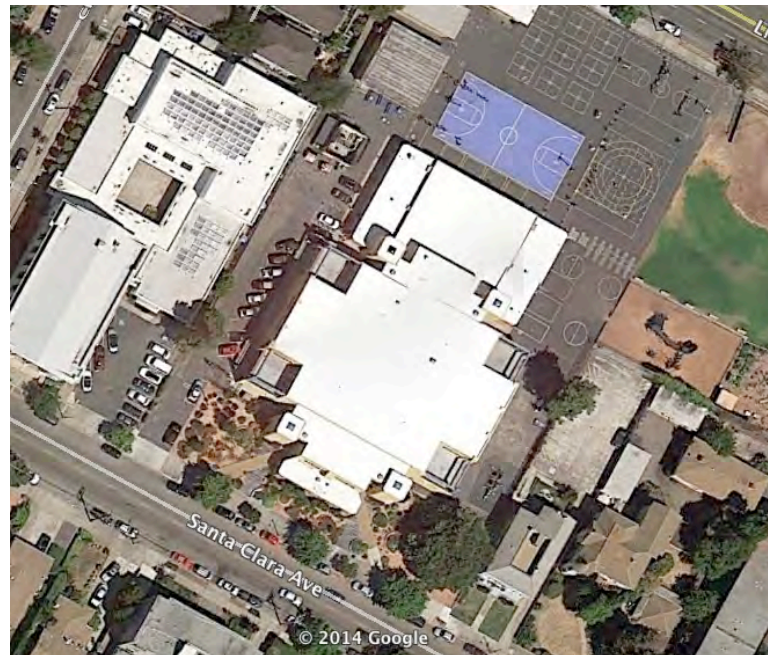
Henry Haight Elementary School - Existing Conditions Summary

- Asphalt playgrounds exceed allowable accessibility cross-slope.
- A portion of the two-story building requires the addition of fire sprinklers.
- South-facing windows leak and all are at end of their service life.
- Slab-on-grade contains excessive moisture and has damaged the gym floor covering.
- Second floor southwest facing deck leaks.
- There are several second floor accessibility barriers.
- Stair tower exterior concrete block walls leak.
- Exterior doors and finishes are at end of their service life.
- Portable building foundations have dry rot and need to be replaced.

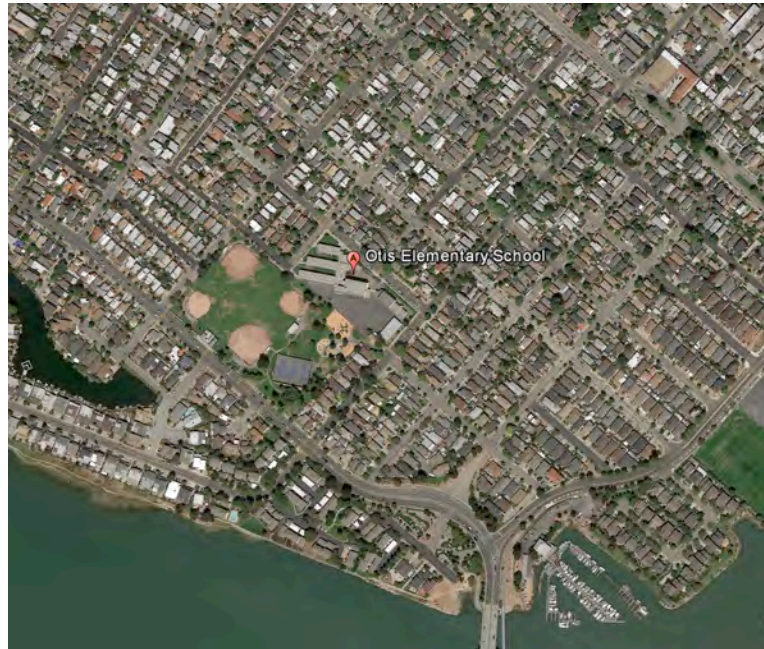
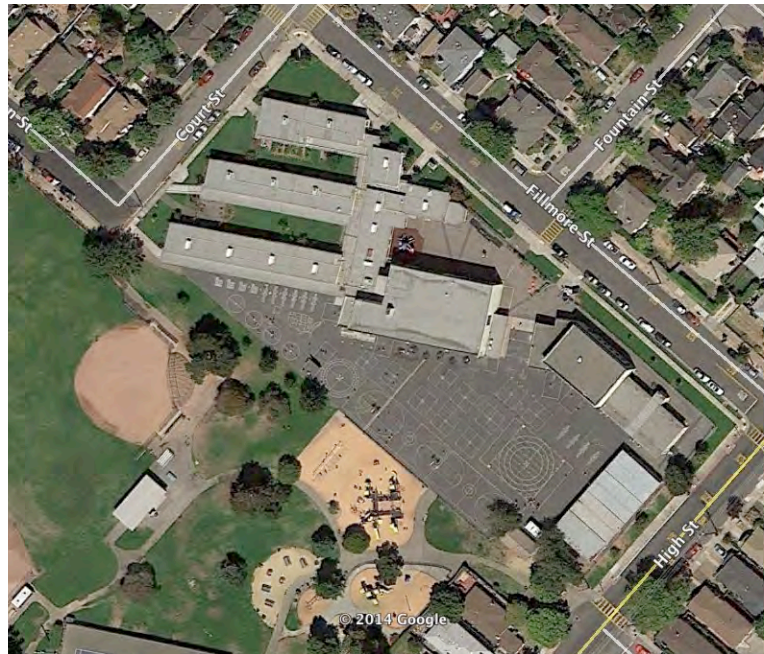
Frank Otis Elementary School - Existing Conditions Summary

- Exterior windows, doors, roofing, and plaster walls are at the end of their service life.
- Insufficient hydrant coverage and fire area requires additional fire sprinklers.
- Modular classrooms are at the end of their service life.
- Mechanical and plumbing fixtures are at the end of their service life.

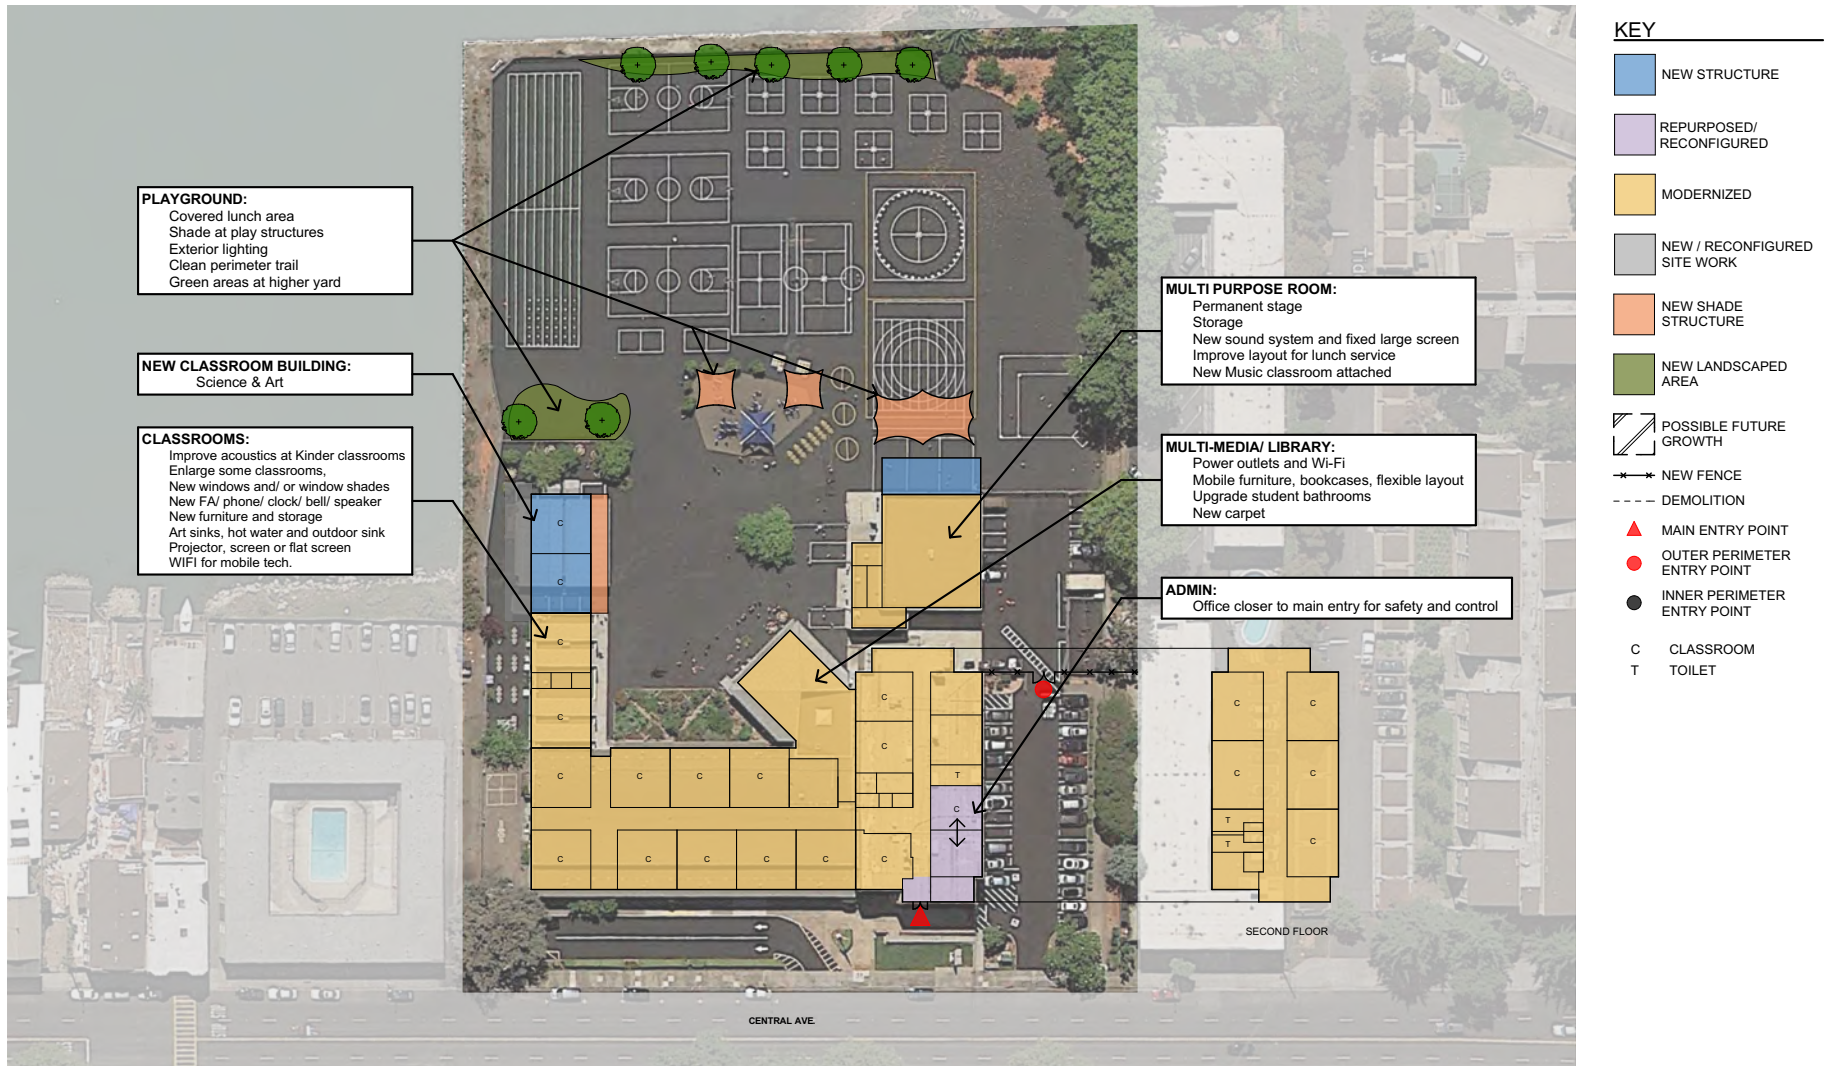
WILLIAM G. PADEN ELEMENTARY SCHOOL SITE PLAN

- Dedicated art/science classroom
- Permanent stage with storage and dedicated music room, ideally adjacent to multi-purpose room
- Green areas at upper play yard
- Replace portable classrooms with permanent classrooms.
- Improved noise control between classrooms, possible addition of doors between classrooms at existing openings
- Reconfigure the circulation at the library/media center to improve control and circulation.
- Additional skid resistance on stair flooring
- New ball wall for PE use
- Possible implementation of a previously proposed landscape plan to include greenbelt, amphitheater, interpretative learning areas, and pedestrian dock on the Bay.

William G. Paden Elementary School - Facilities Needs Spreadsheet

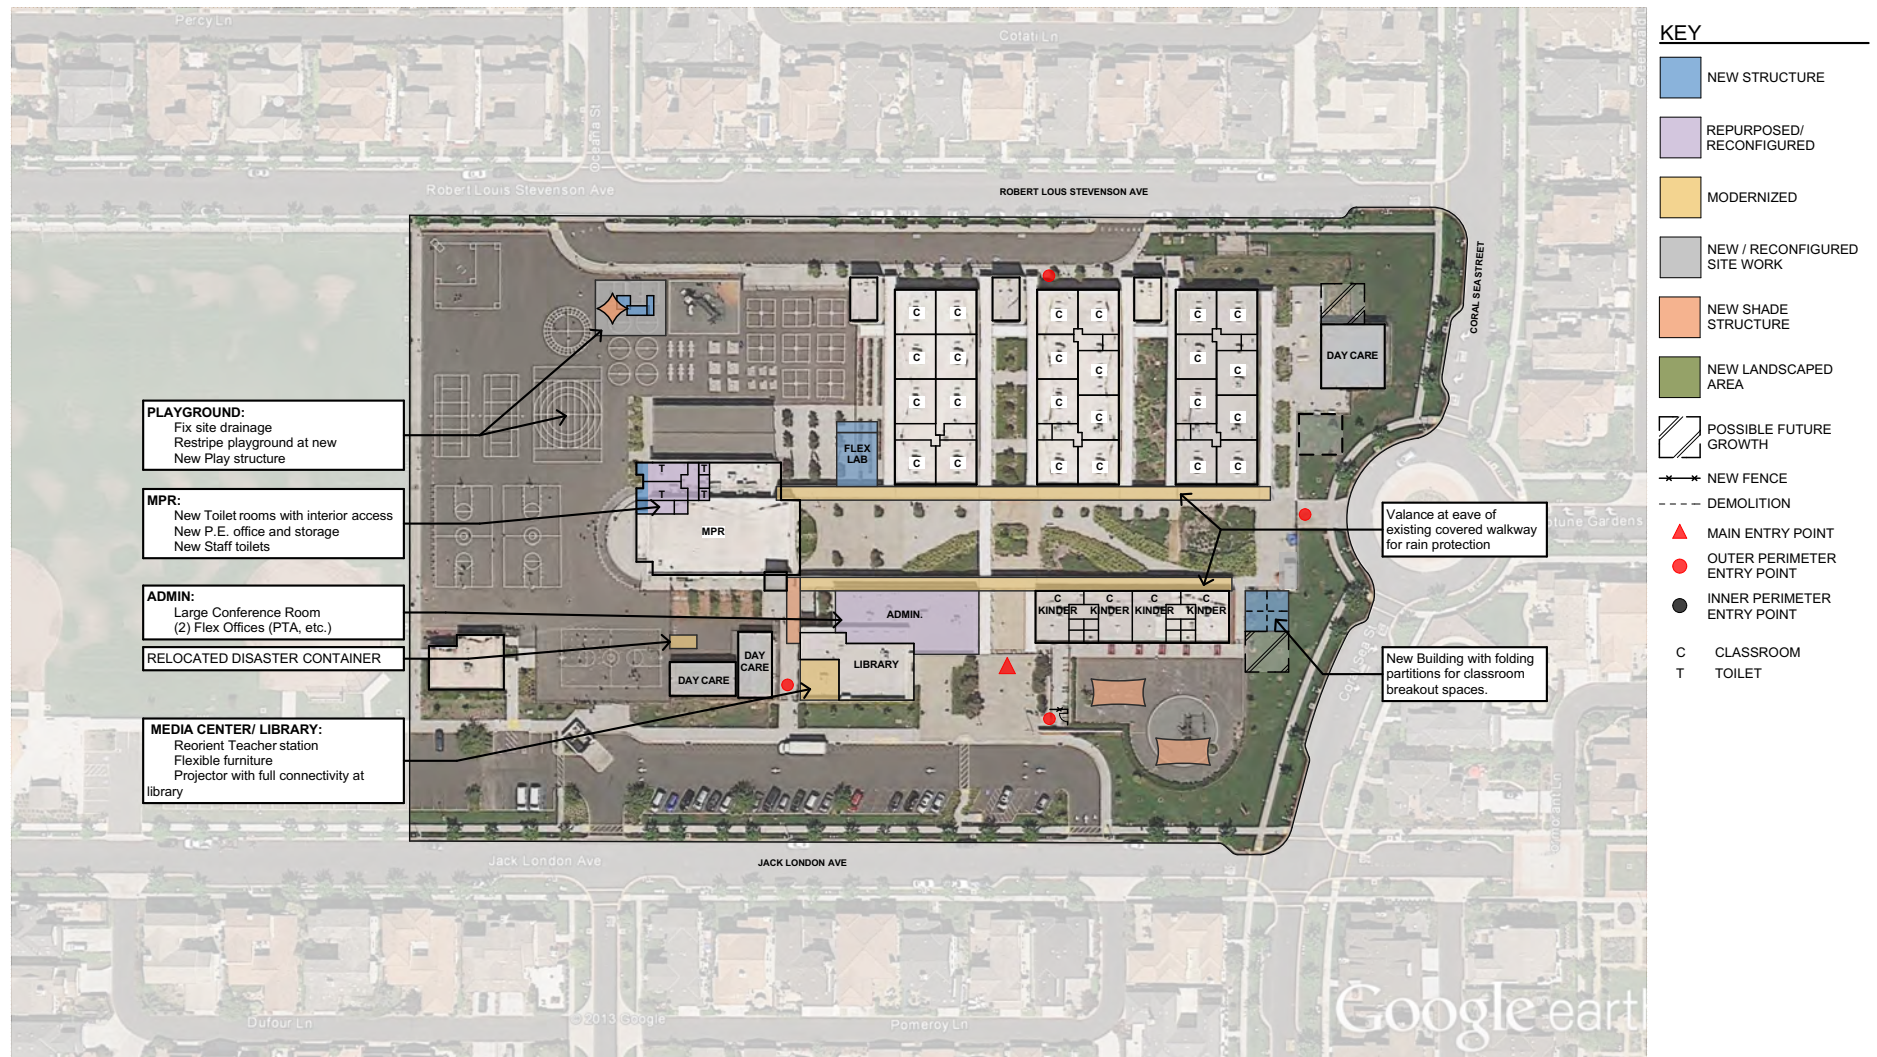
RUBY BRIDGES ELEMENTARY SCHOOL SITE PLAN

- Install a buzzer/intercom system at select gates.
- Provide a new science lab/“Di Vinci” space.
- Add a covered walkway to media center entrance.
- Install a second play structure.
- Install improved rain protection at covered walks.
- Install an electric digital marquee.

Ruby Bridges Elementary School - Facilities Needs Spreadsheet

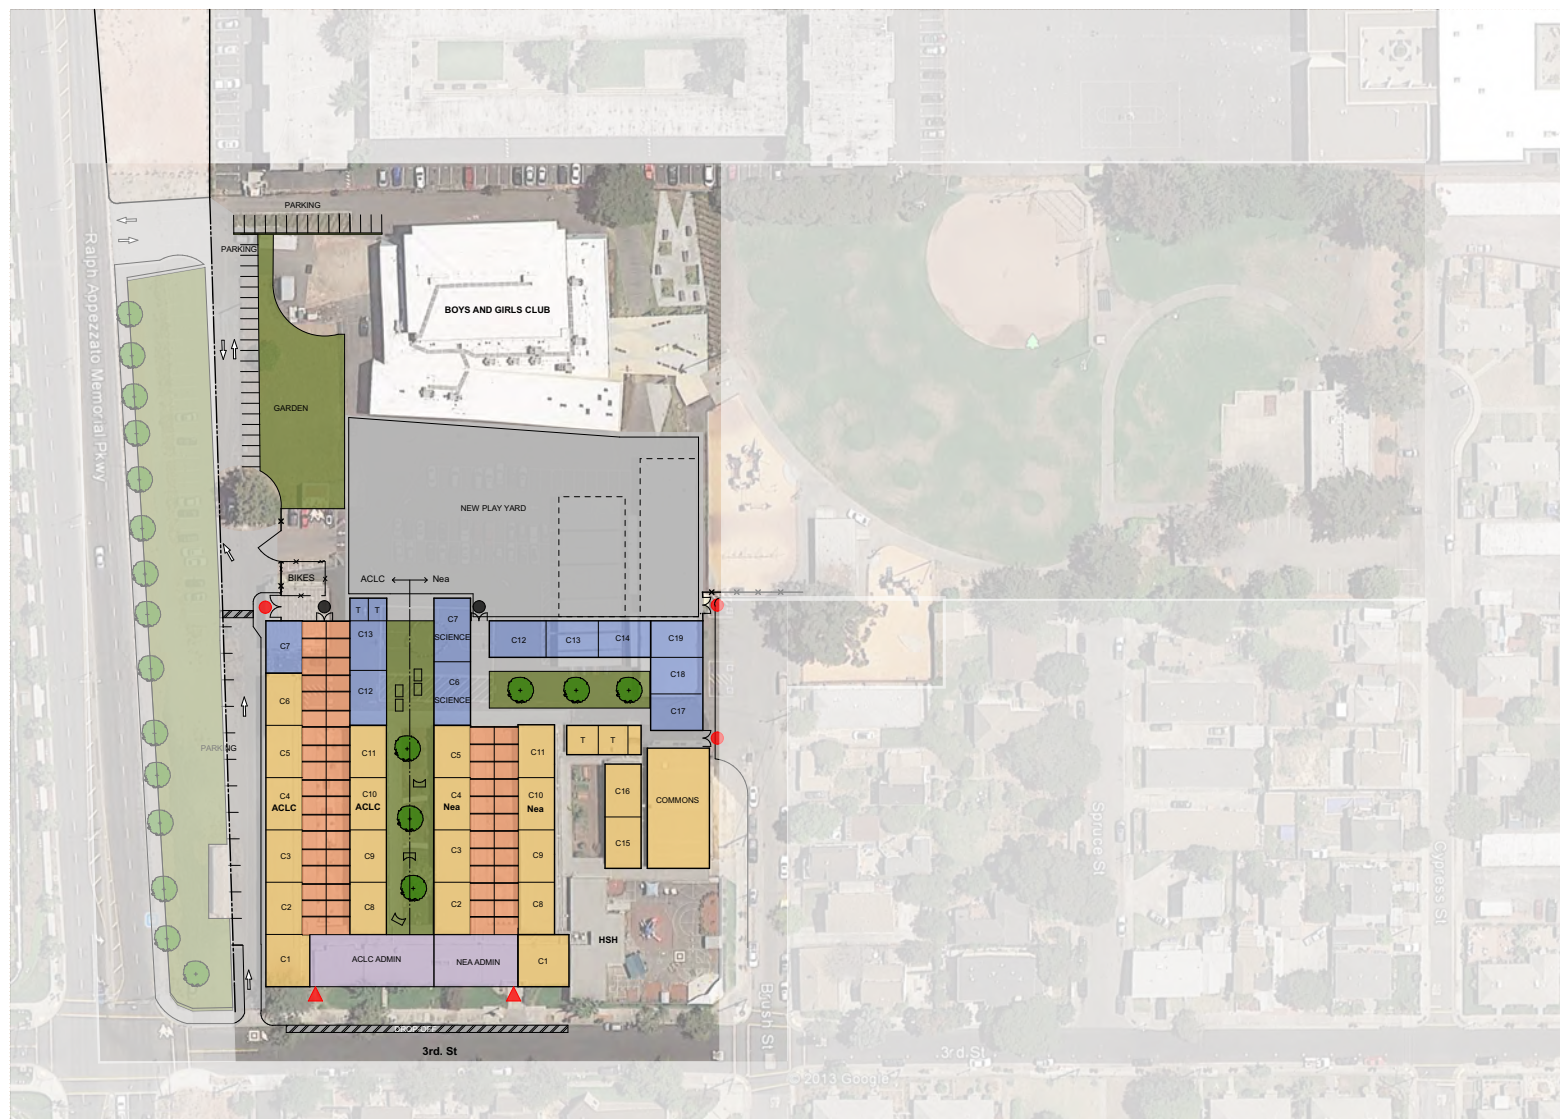
ACLC/ Nea SITE PLAN

- Art classroom
- Outdoor learning areas and gardens
- Kitchen available for staff use
- Gymnasium, possibly a multi-purpose room with accommodation for physical education and performances
- Renovate and reconfigure play fields on school site.
- Staff, visitor and student parking

ACLC/Nea - Facilities Needs Spreadsheet

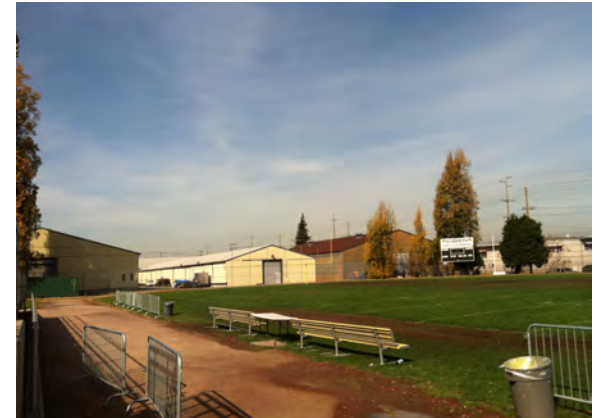
Bleachers

- There are significant accessibility issues that exist and will require mitigation measures.
- The structural integrity of the bleachers requires further analysis.
- The site has limited potential for increased seating capacity.

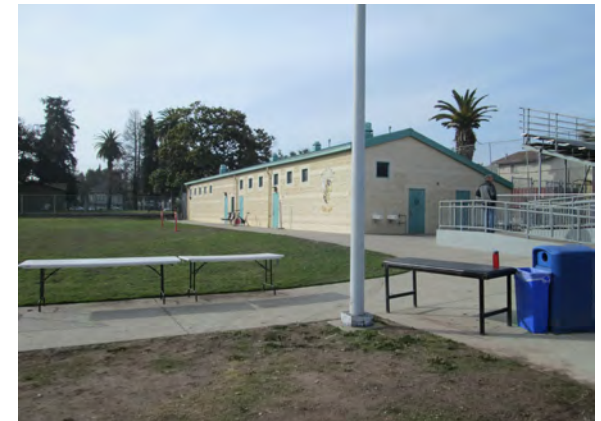
Locker Rooms

- Accessibility issues
- Structural integrity requires further analysis.
- Comprehensive utility upgrade required.

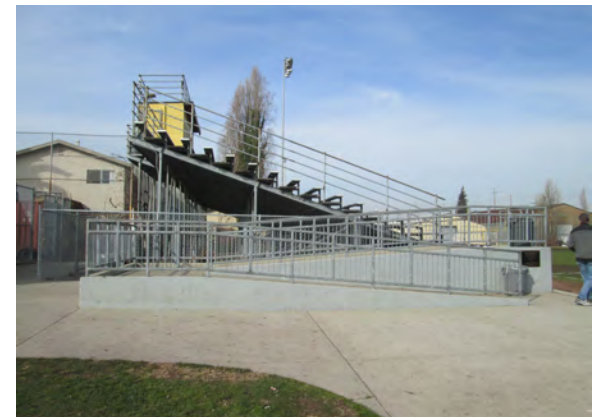
Field Access

- Accessibility issues
- Exiting capabilities require modifications to fence and gate locations.

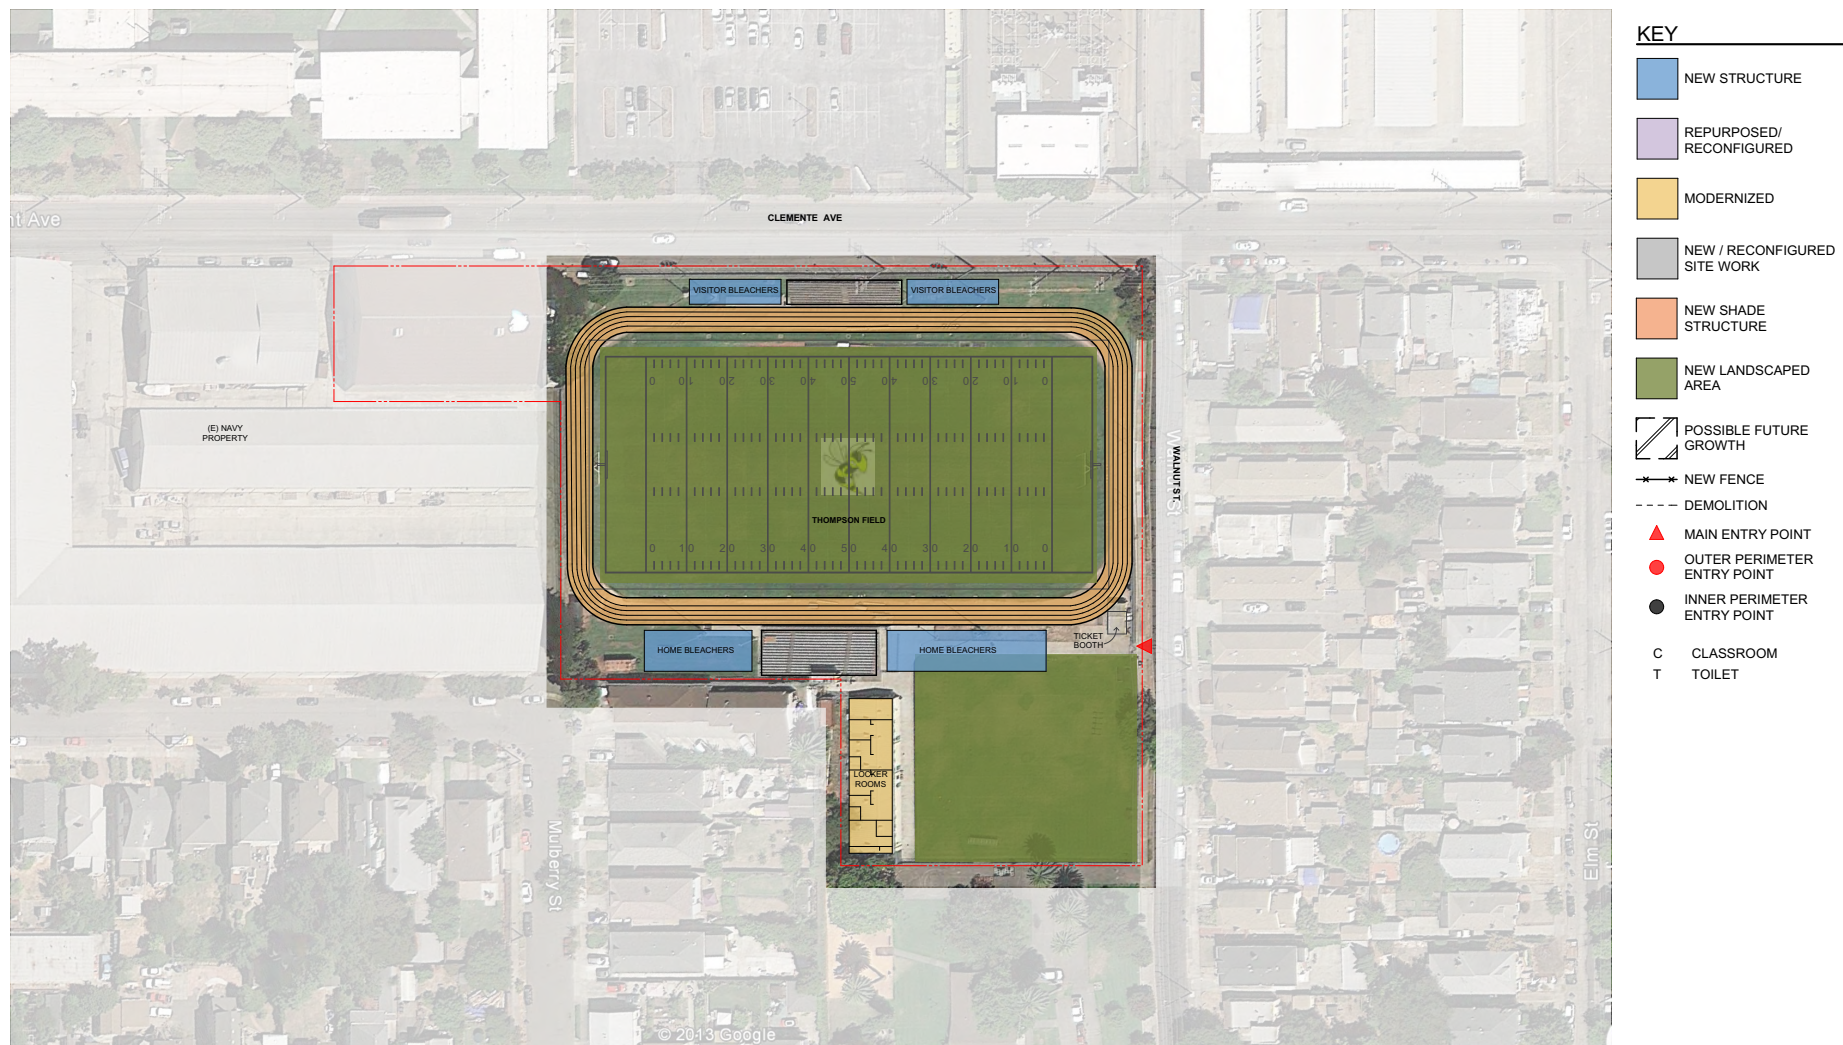
THOMPSON FIELD SITE PLAN

The Thompson Field property is composed of a football field, bleachers, locker room building, and adjacent practice/athletic field. There is a track around the football field, but it is not regulation size. The field is lit by pole lights that are set back from the field and straddle the existing bleachers.
