Six-Month AHERA Asbestos Periodic Surveillance

Fairfield Public Schools
Fairfield, Connecticut

April 2023

Re: Six-Month AHERA Asbestos Periodic Surveillance
Inspection Date: April 3, 2023 to April 7, 2023
Fairfield Public Schools, Fairfield, CT
Fuss & O'Neill Project No. 20190061.A40

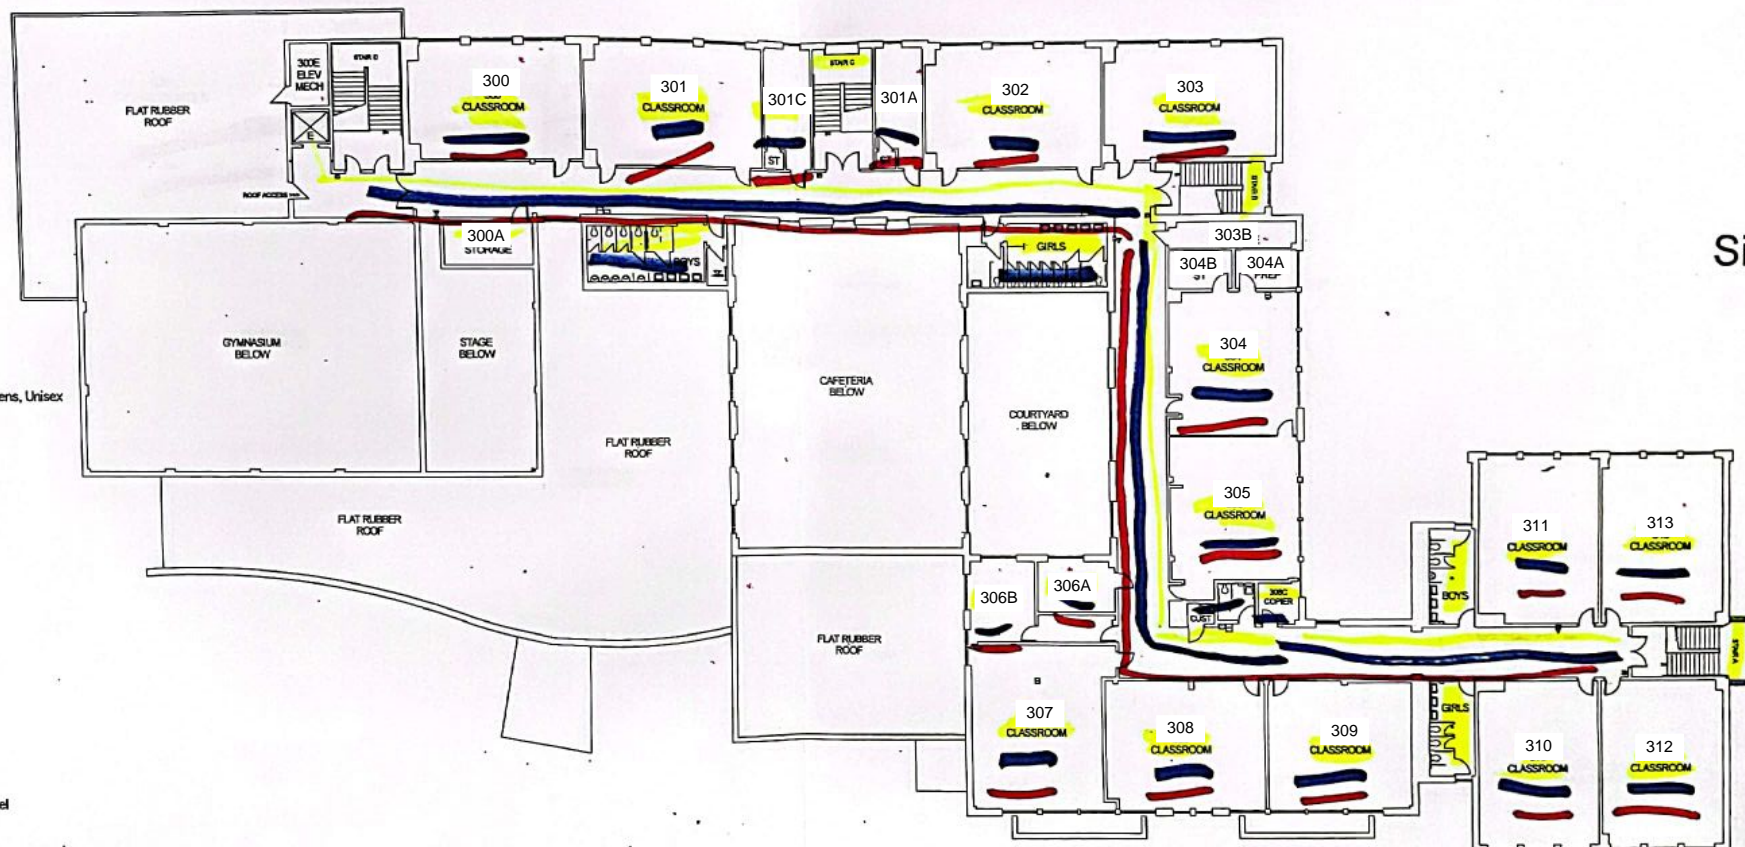
Upper Floor Plan

Access Controlled
Doors are displayed
in **ORANGE**
