DERRY TOWNSHIP SCHOOL DISTRICT

Granada Building Feasibility Study

January 2018 – CRA Project No. 3073

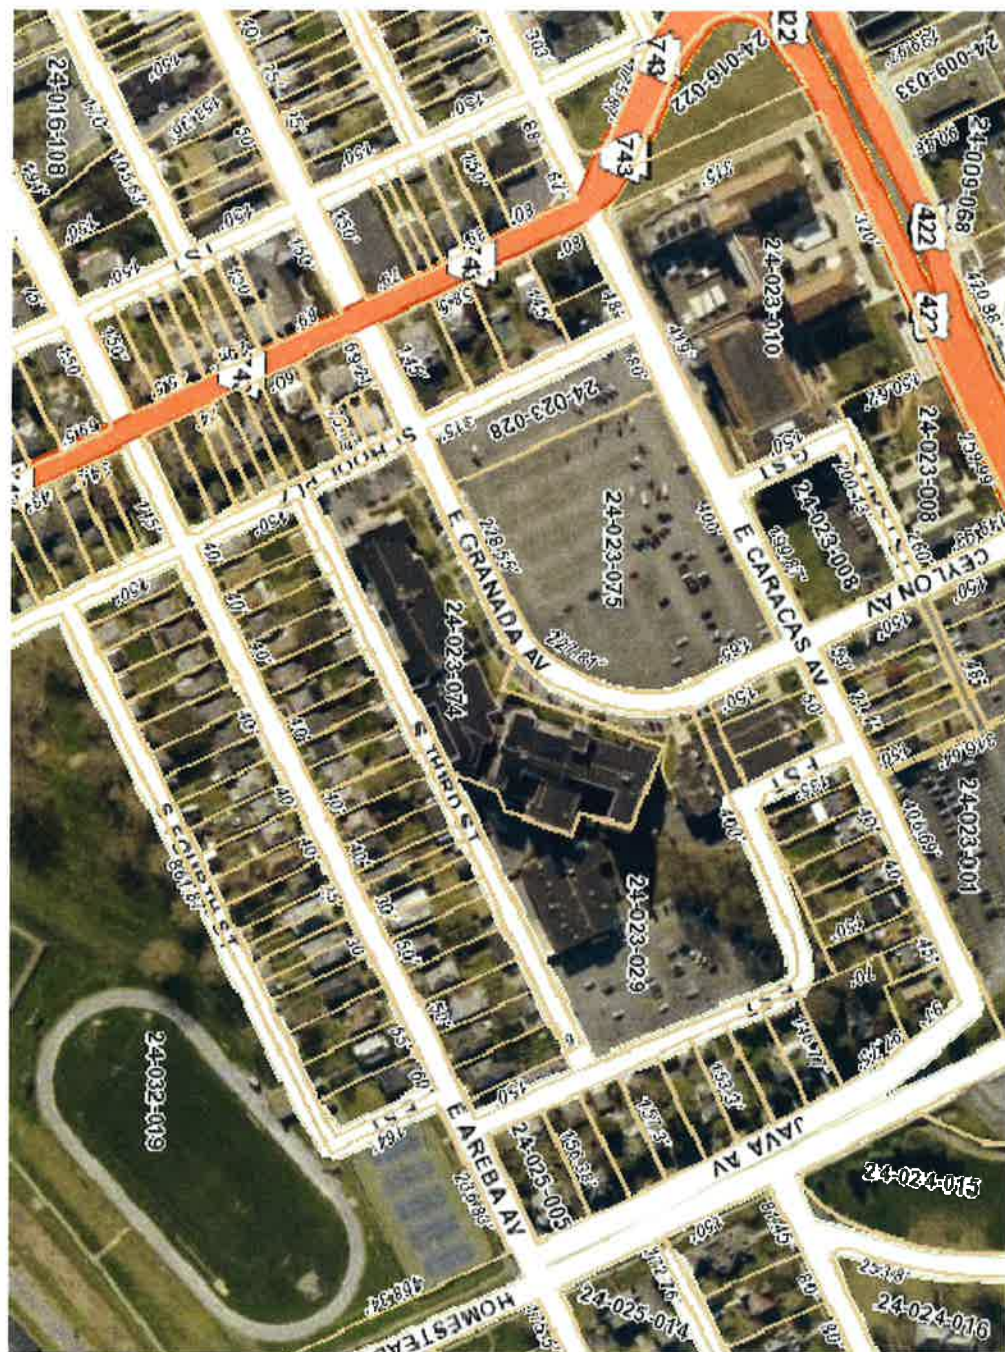
Appendix A

**Dauphin County Tax Assessment Office Parcel Map and
Property Boundary, Access, Existing On-Property Parking Spaces**

The property is located at 30 E. Granada Avenue and contains three existing buildings identified as Building A, B, C in the report. The property is also referenced as Parcel #24-023-074 by the Dauphin County Tax Assessment Office. A location map is provided in **Appendix A**.

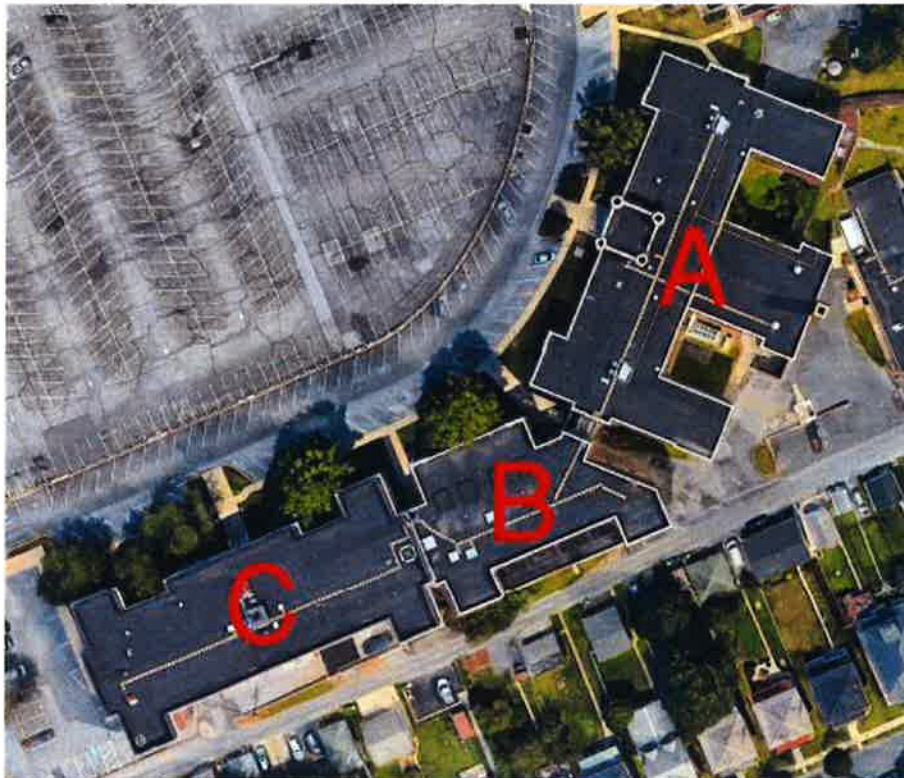
For purposes of this study, the existing facility has been broken down into three areas, as indicated below:

- Building Section “A” – Penn State Health, Milton S. Hershey Medical Center
- Building Section “B” – Vacant
- Building Section “C” – Derry Township School District Administration

The building complex also shares the site with two other structures: a gymnasium/Power Train business to the north, and the district’s building and grounds center to the southeast.
