## PRELIMINARY FACILITY ASSESSMENT

BOOKLET 2 OF 4

## Orangeburg County School District - Preliminary Facility Assessments

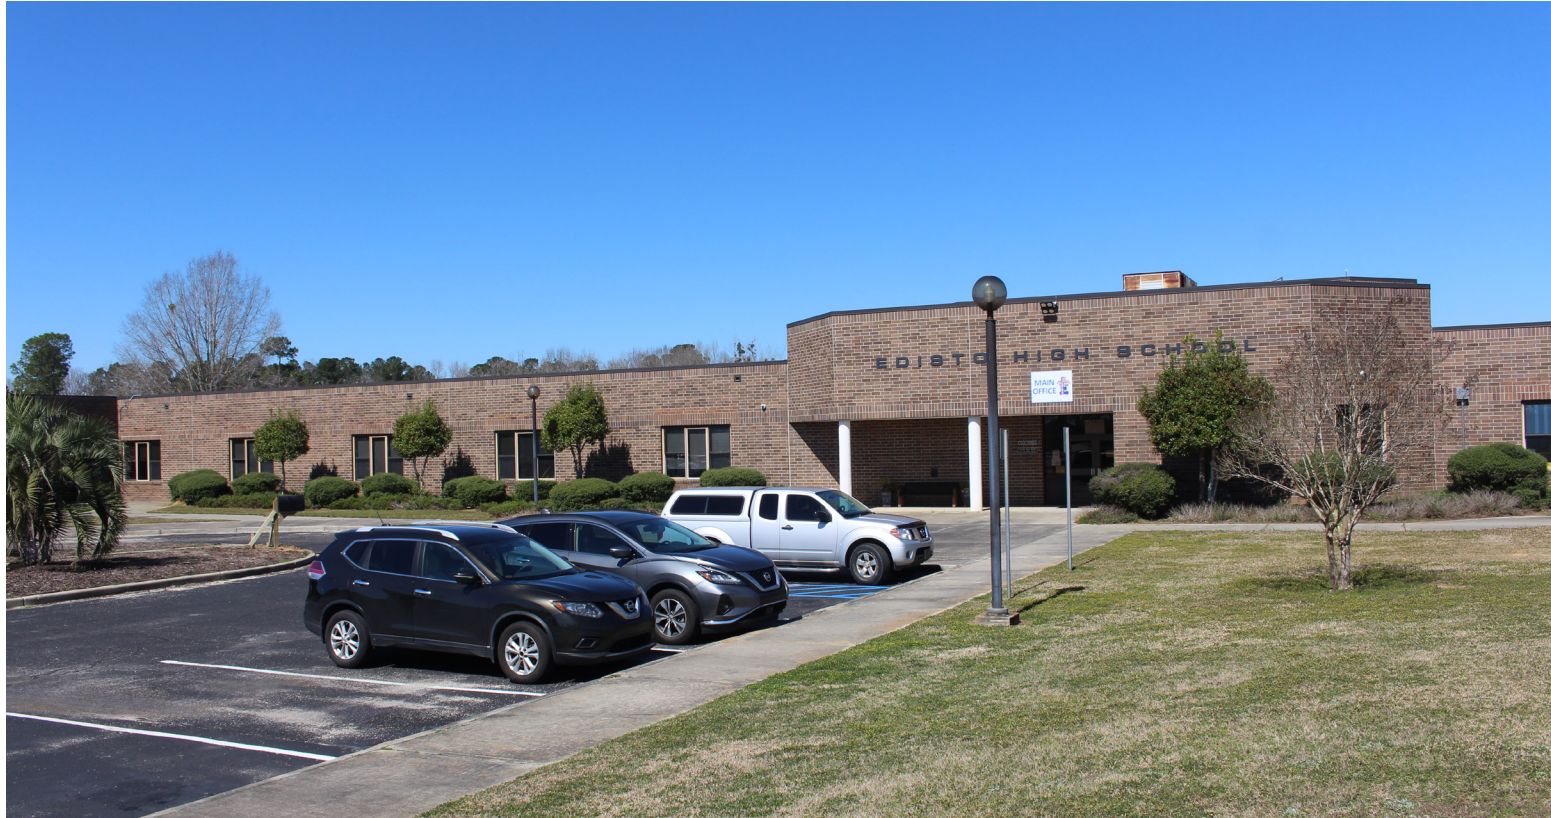
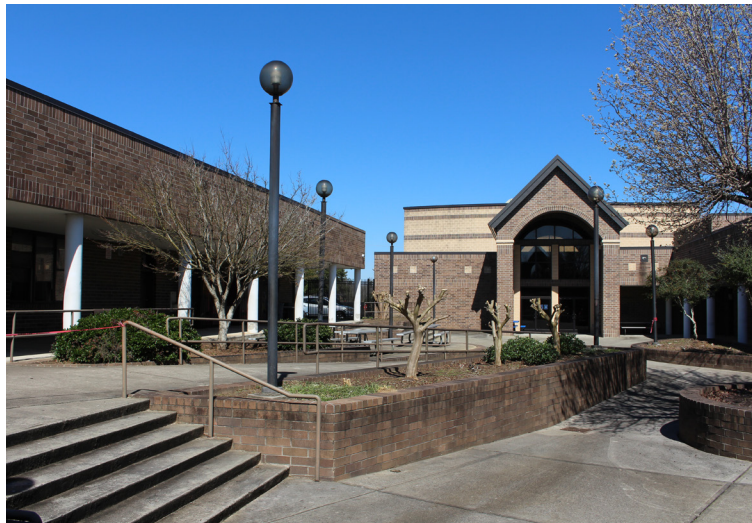
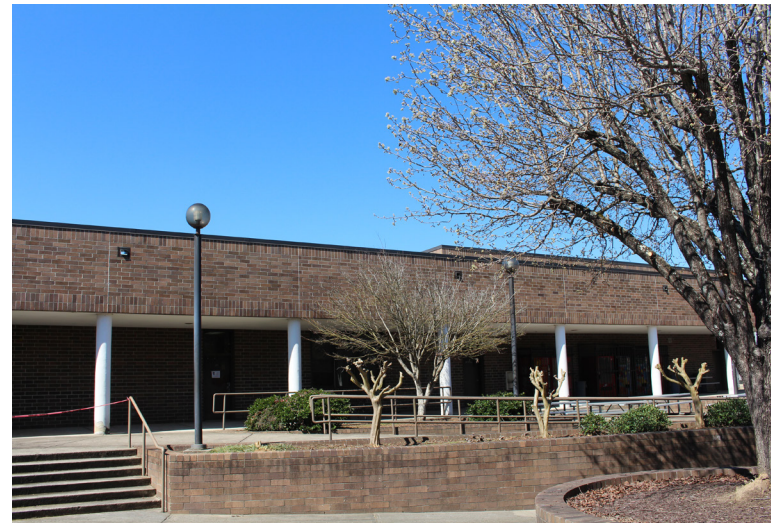
## Edisto HS:

- It has a modified BIT roof system with a few roof leaks throughout this school. The downspouts and gutters could use some minor repairs.
- The exterior building envelope has a standard modular face brick veneer system (brown color) and appears to be in good condition.

- The windows are a wood aluminum cladded system. These are the original windows and appeared to be in bad condition. We noted that there are several classrooms at the front of the school that they tried to fix by replacing flashing above these windows, but were unsuccessful. There are still leaks at these windows. Would recommend replacing these throughout the facility.

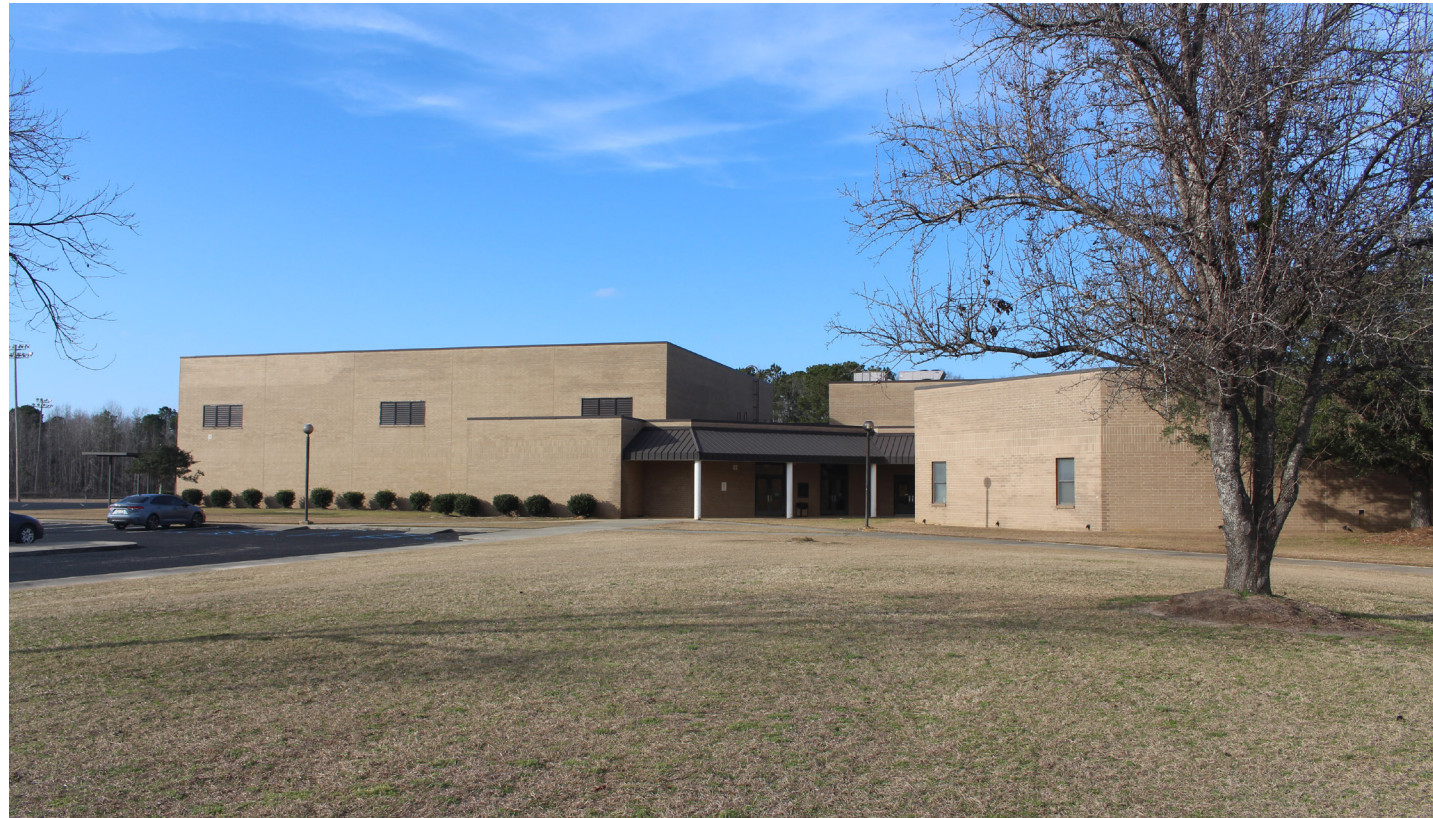
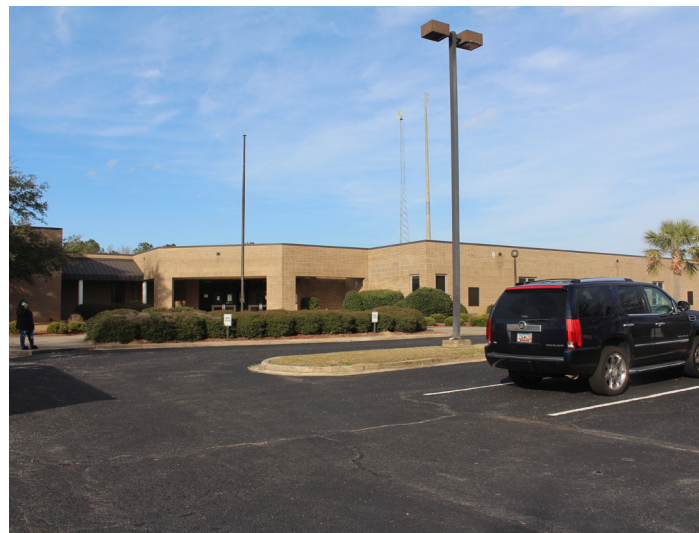
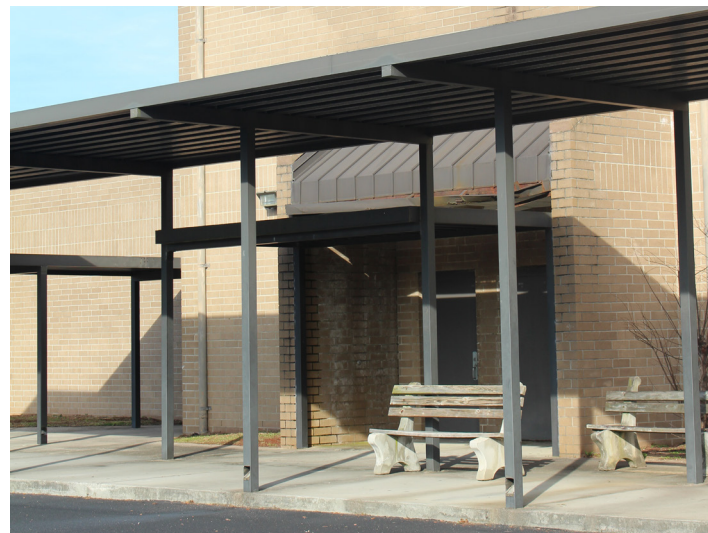
ELLOREE ES-MS

Conclusion: overall the school is in good condition, but needs some updating and minor repairs.

However, the baseball field is in bad shape. The football field and stadium bleachers need to be updated and/or repaired. Possibly replace these. And the track is in really bad shape as well.

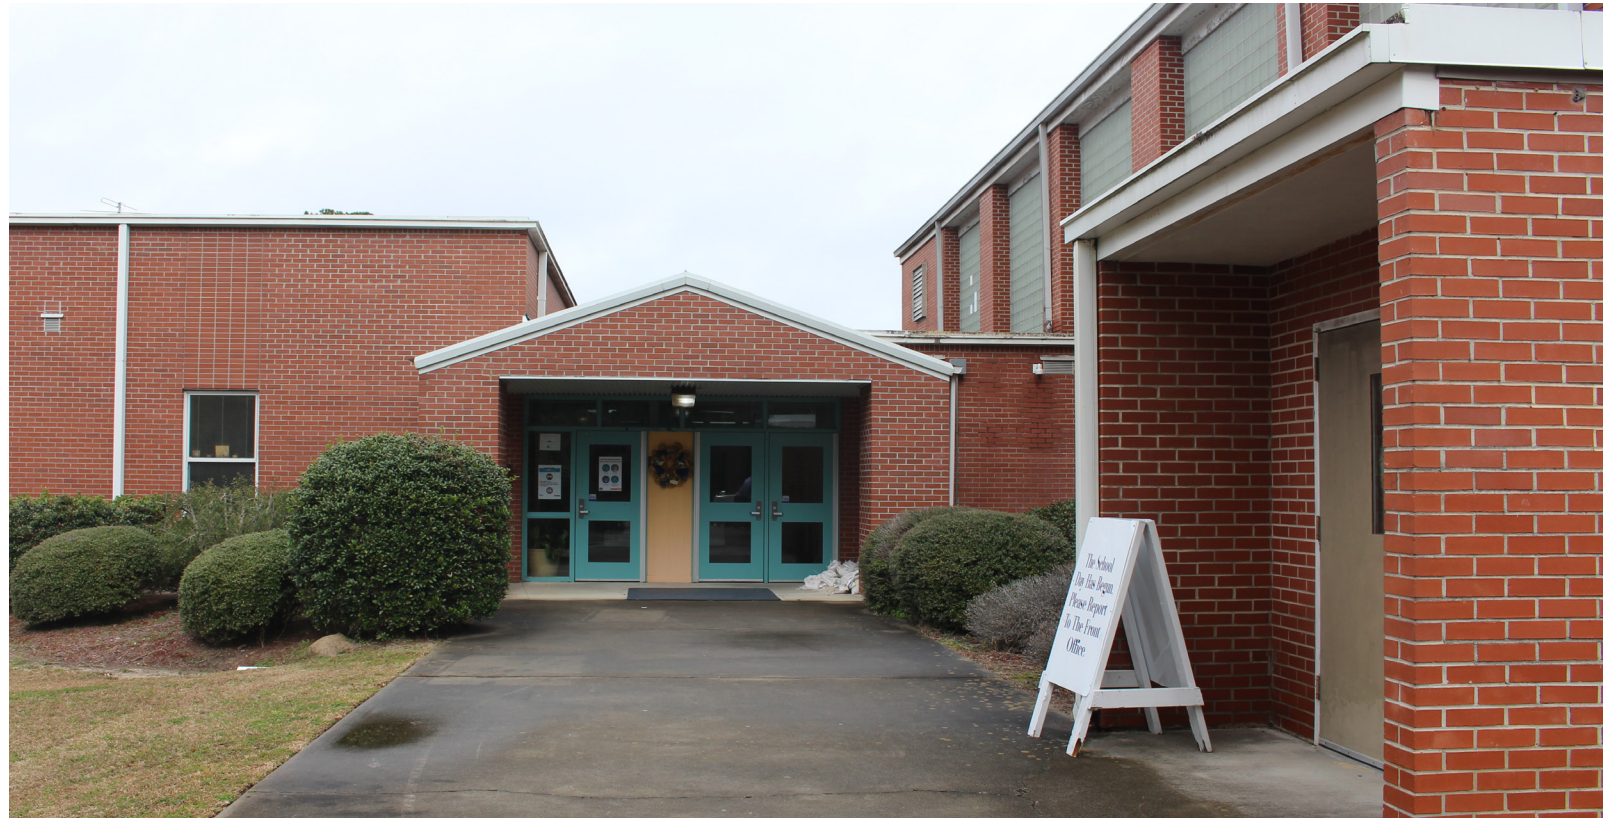
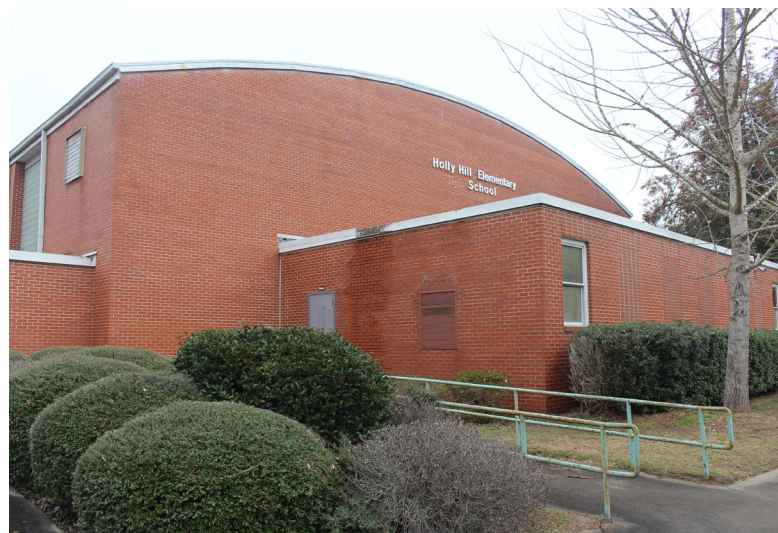
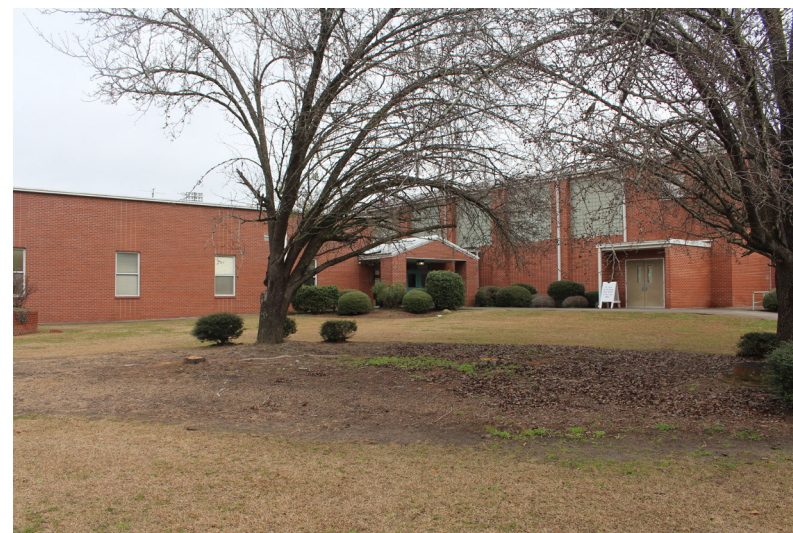
## Holly Hill ES:

- This school was built in 1954 and renovated in 1996. The school has 93,774 SF. We also got information that this school use to be a High School.
- It has a low slope modified bit roofing system. There are visible signs of roof leaks (and/or possibly mechanical units above ceiling) throughout this school. See photos. The downspouts and gutters need some repairs.

- The exterior building envelope has standard modular face brick veneer system (red color) and appears to be in good condition.
- The building has aluminum windows (single hung/ operable) and they appeared to be in good condition.

- The manufactured walkway covers and canopies at the bus loop and stadium need some minor repairs.
- Playground equipment is old and outdated therefore recommend replacing it.

- There is a football stadium with press box and bleachers. These are very old and dated. There is no running track.
- Due to the liabilities associated with the existing conditions of the press box and bleachers, we recommend tearing down and removing these items in their entirety.

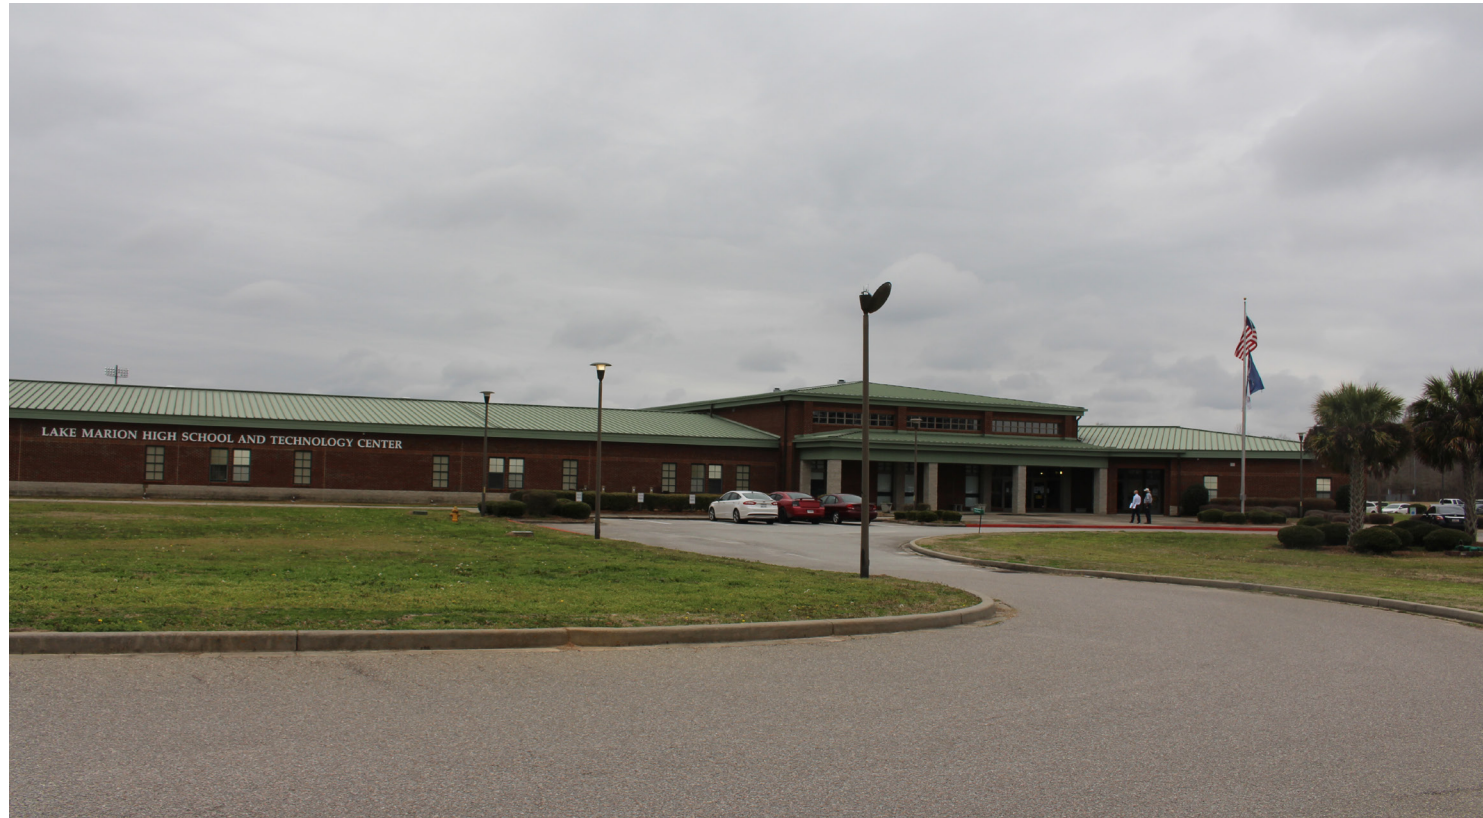
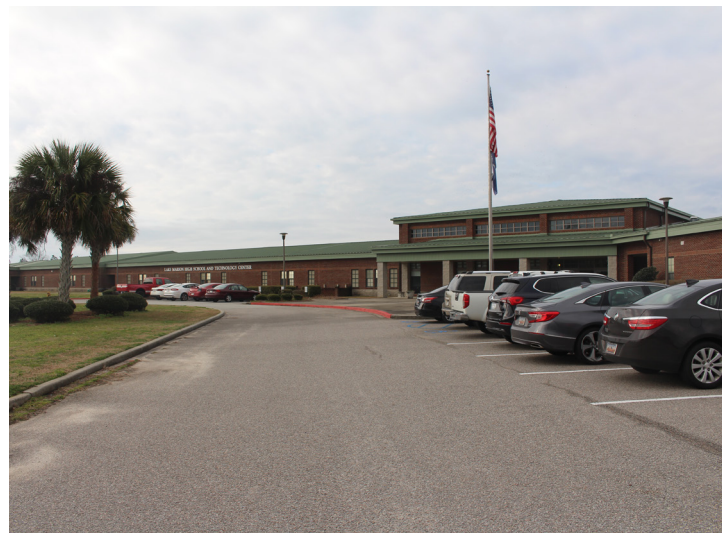
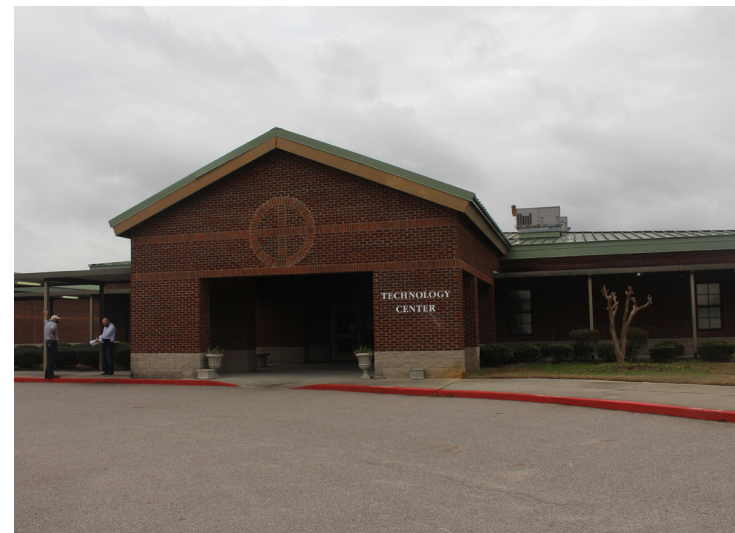
# LAKE MARION HS AND TECHNOLOGY CENTER

- The exterior building envelope has standard modular face brick veneer system (dark red color) and cmu split-face base (light color). These appear to be in good condition.

- Vocational classrooms: these consisted of Home Ed, Health/sports medicine, Cosmetology, ROTC, Food Service, Construction and Automotive Shop. Overall, most of these spaces were in good condition.
