**Riverview Pagea Magnet School  
Saint Paul Public Schools**

**Lead-Based Paint Inspection**

**Inspection Dates: 2/13/97, 2/14/97**

**MEC Project # 62/0197I**

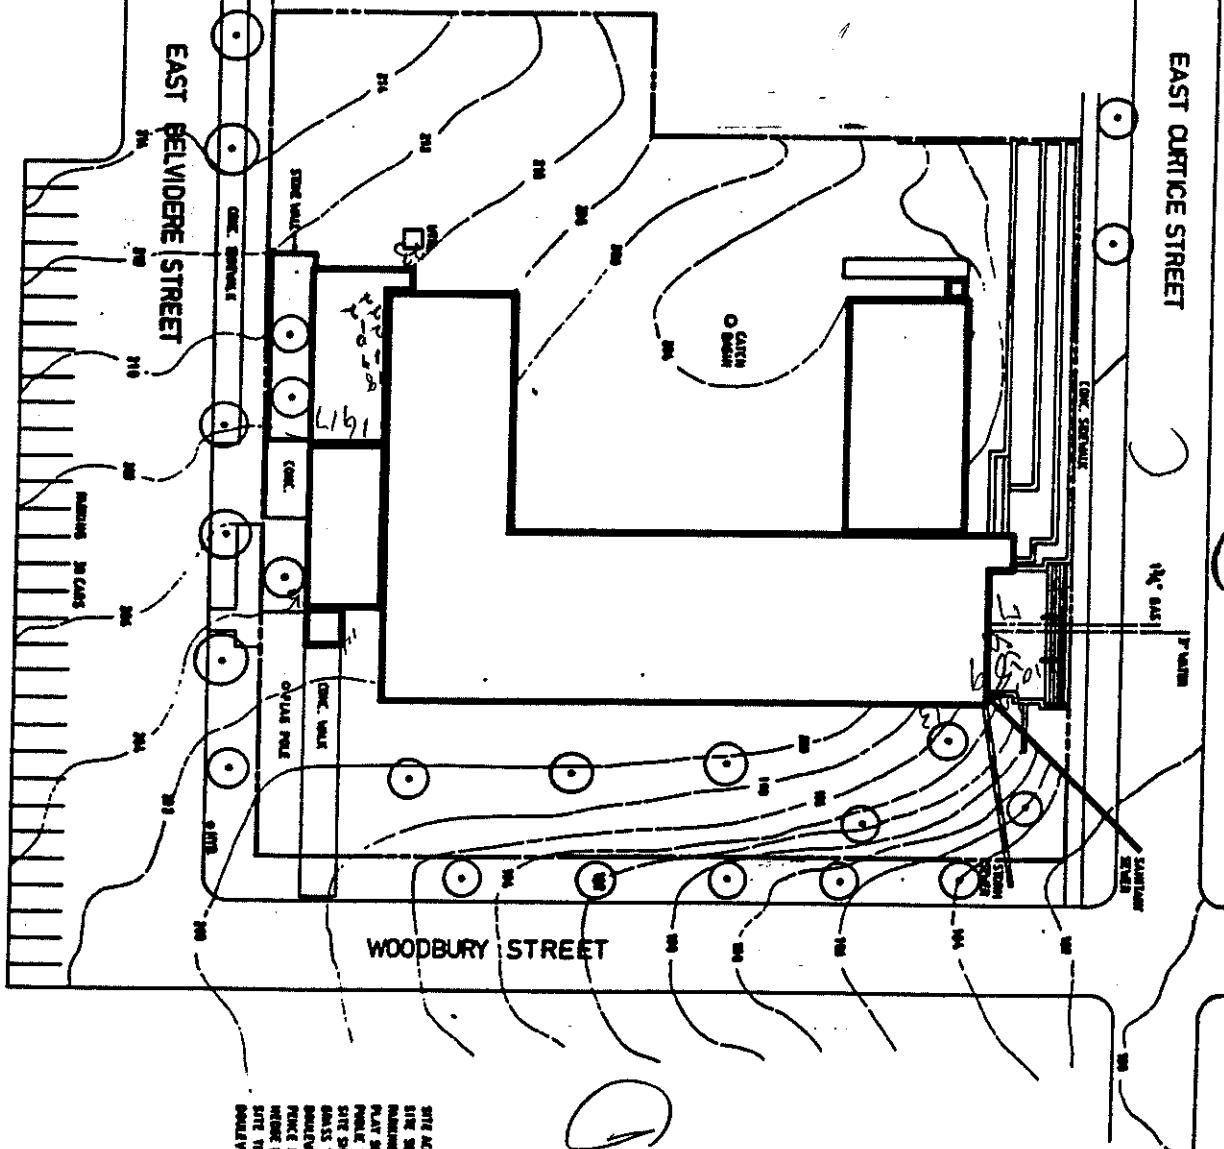
SITE PLAN

HARVARD STREET

EAST CURTICE STREET

All room and area designations used in this report are depicted on sampling maps found in Appendix A.

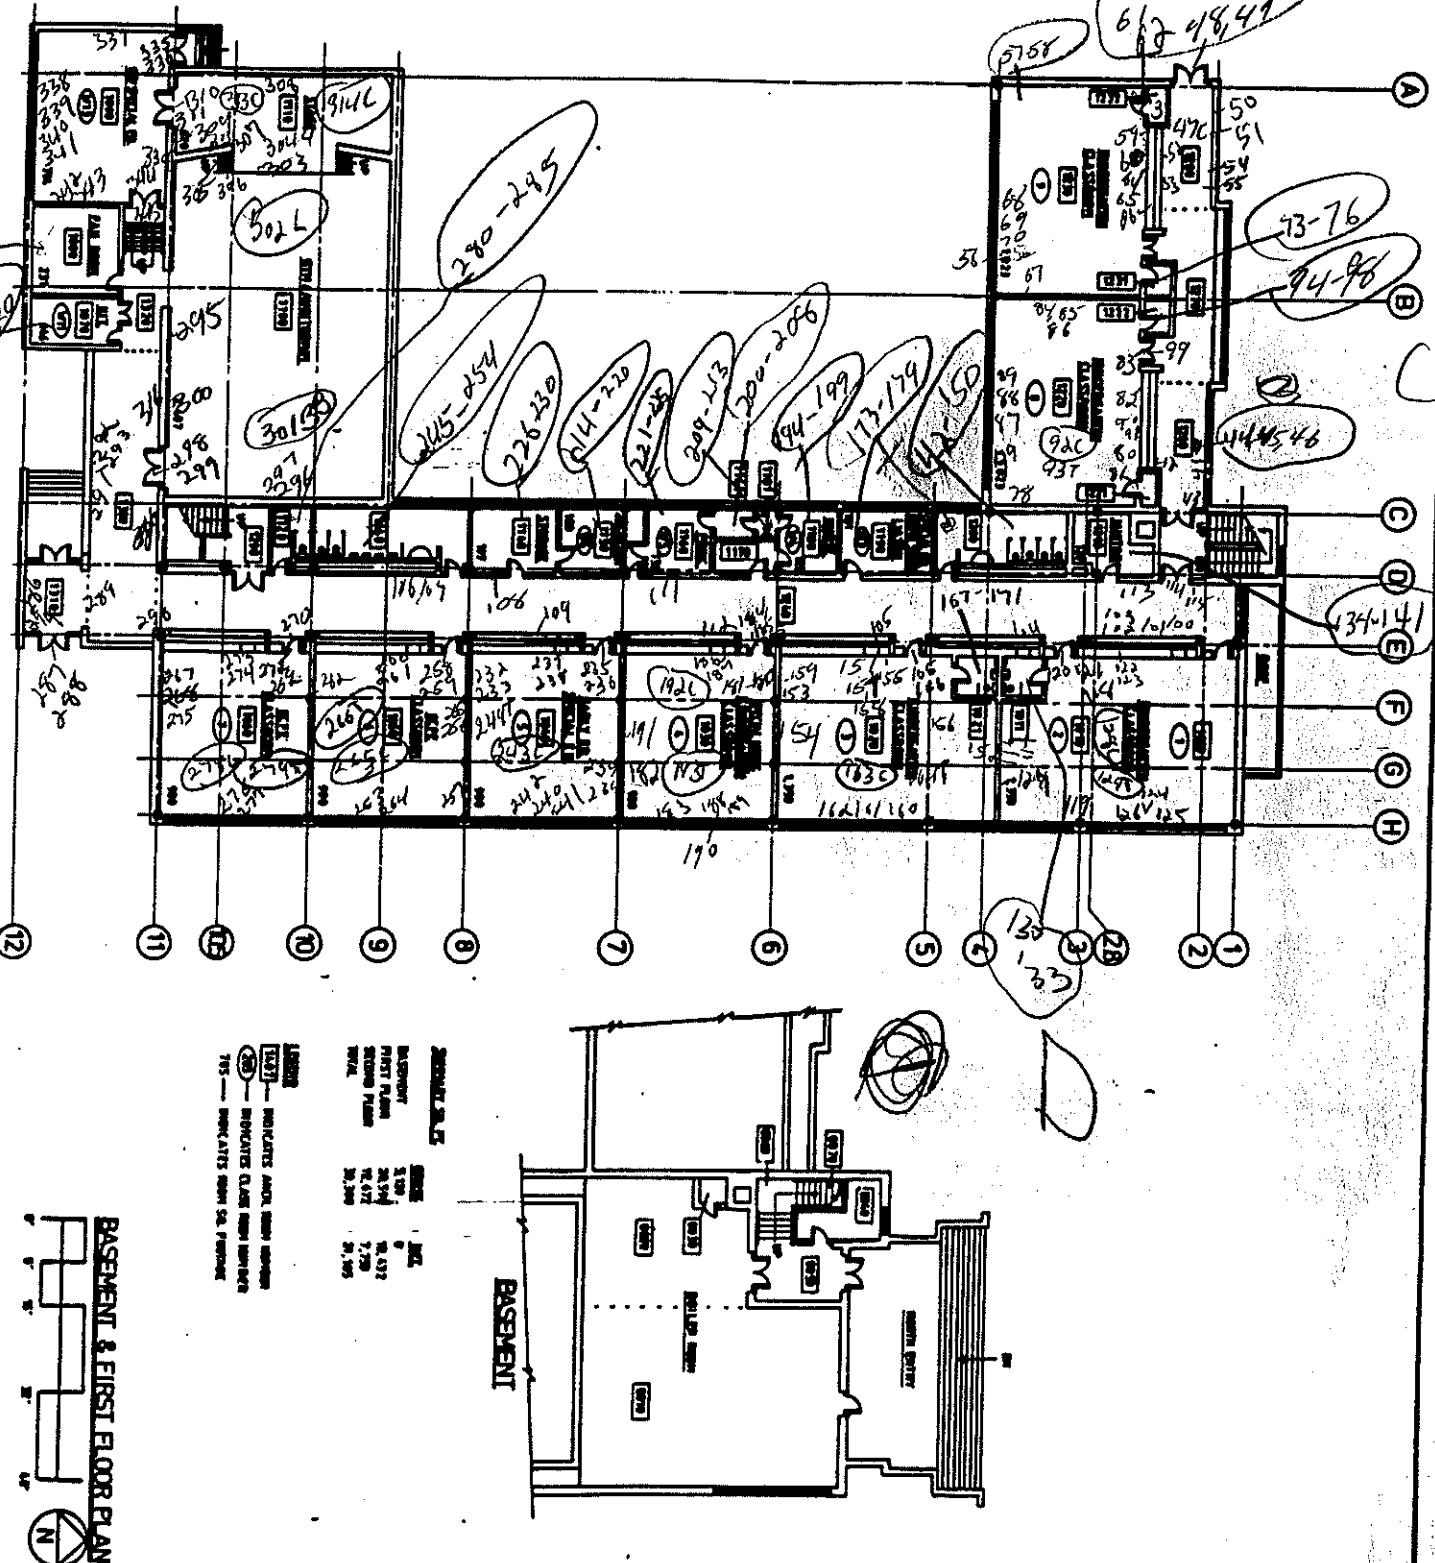
Sheet 1  
4

RIVERVIEW ELEM. SCHOOL  
271 EAST BELVIDERE ST.  
ST. PAUL, MINNESOTA

CONSTRUCTED: 1953

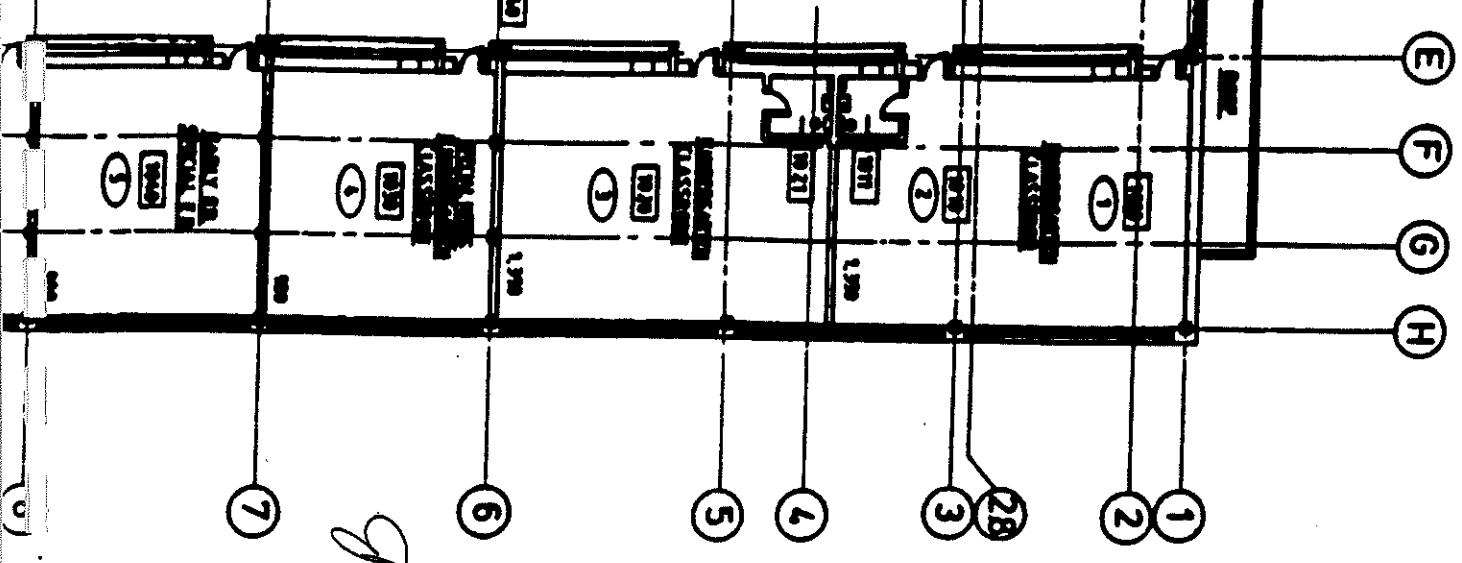
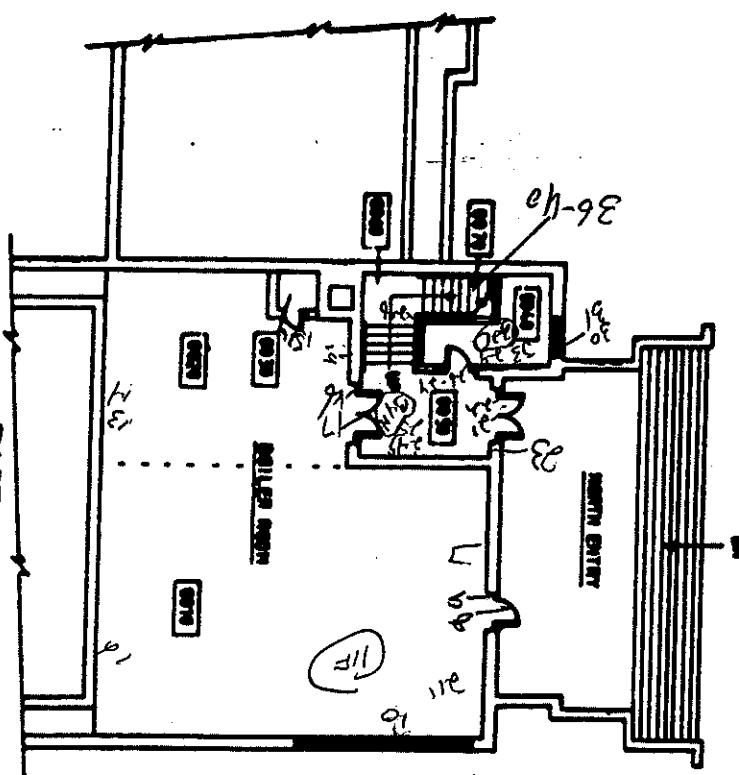
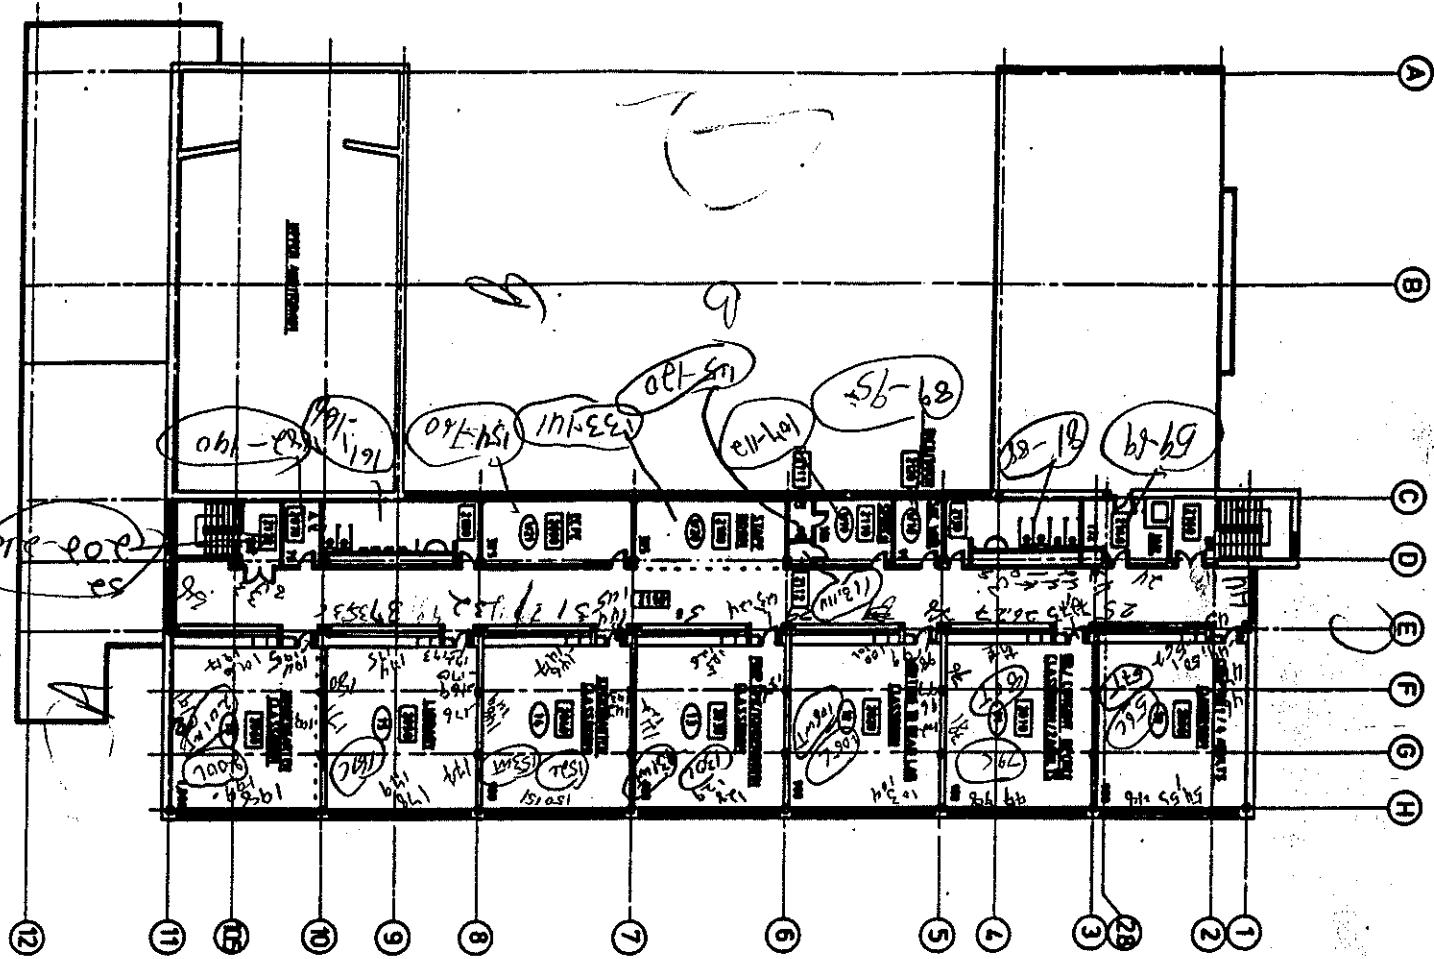
2  
4

RIVERVIEW ELEM. SCHOOL  
71 EAST BELVIDERE ST.  
ST. PAUL, MINNESOTA

CONSTRUCTED: 1953
