**East Consolidated  
Saint Paul Public Schools**

**Lead-Based Paint Inspection**

**MEC Project # 62/0197T**

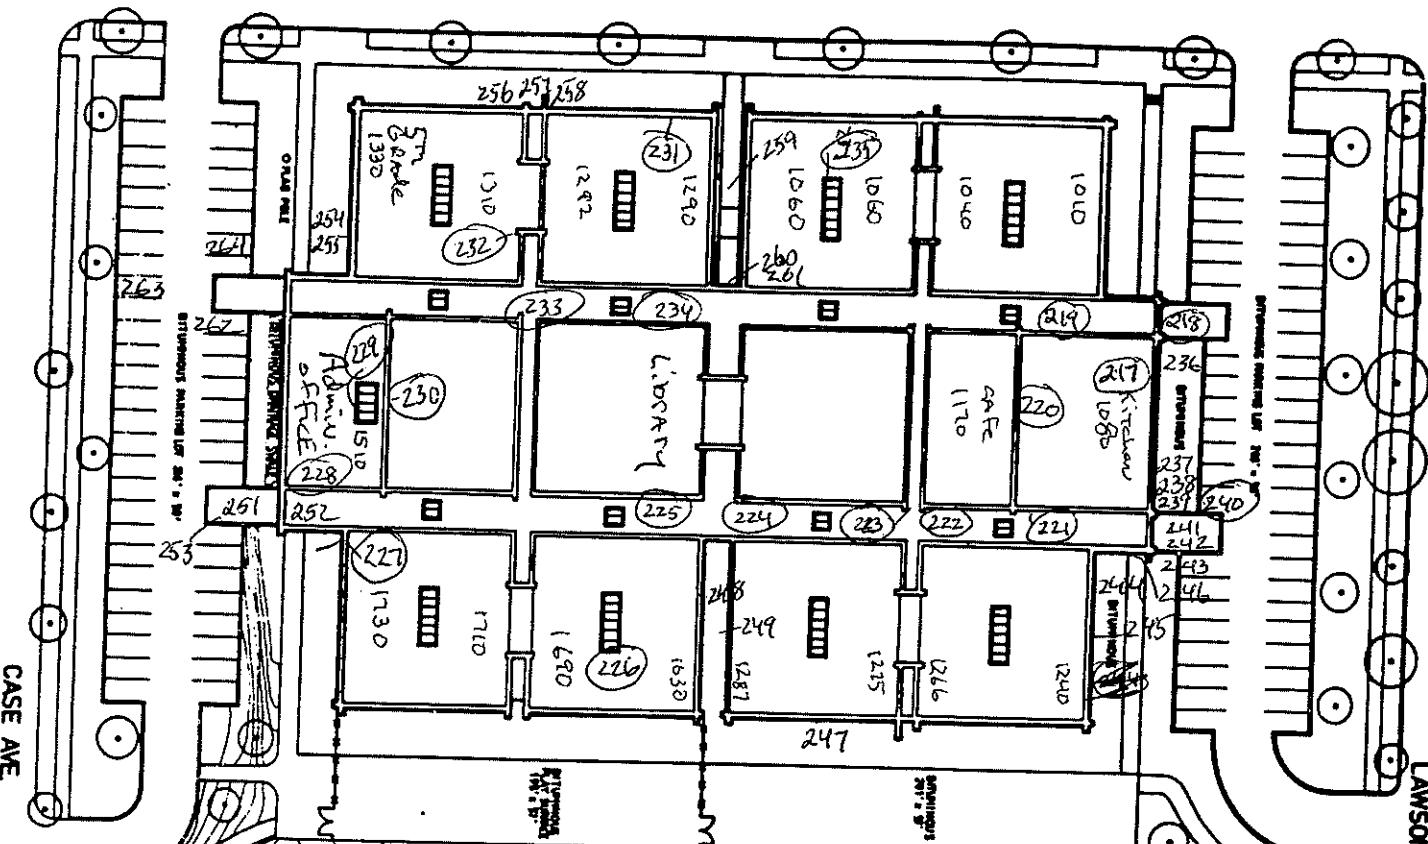
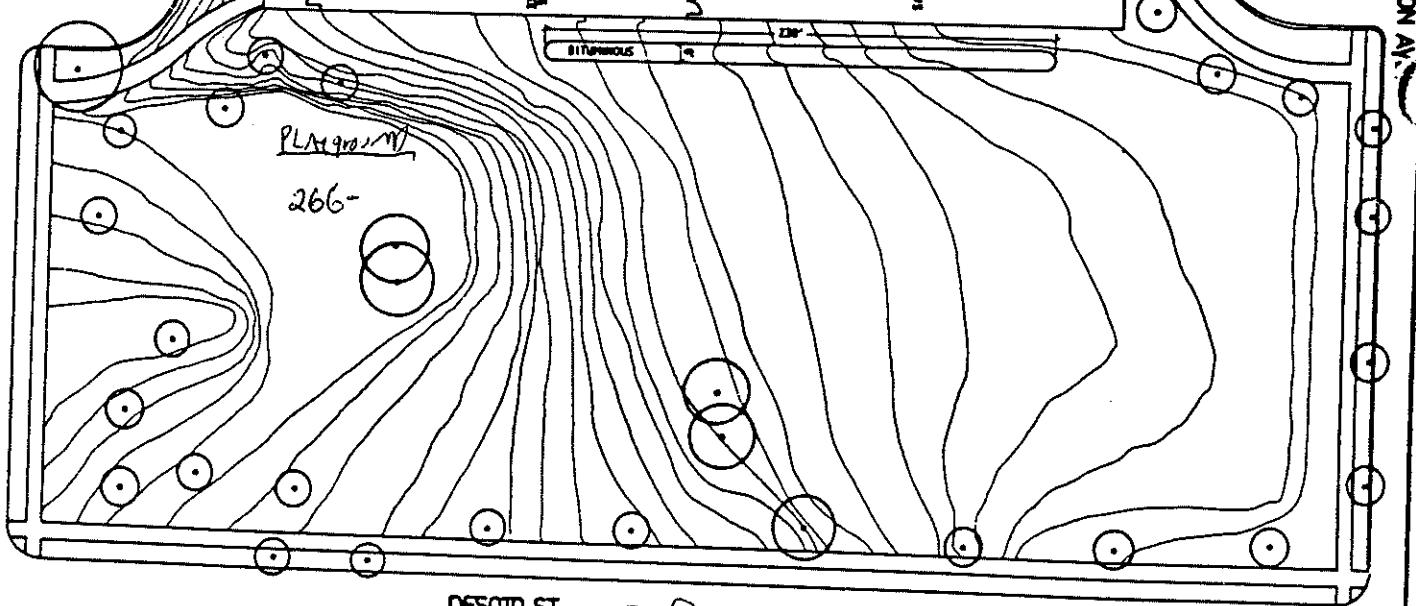
Drawing 1

Roof Top = Circle Sample #  
Building Exterior Assay #  
4-3-97

All room and area designations used in this report are depicted on sampling maps found in Appendix A.

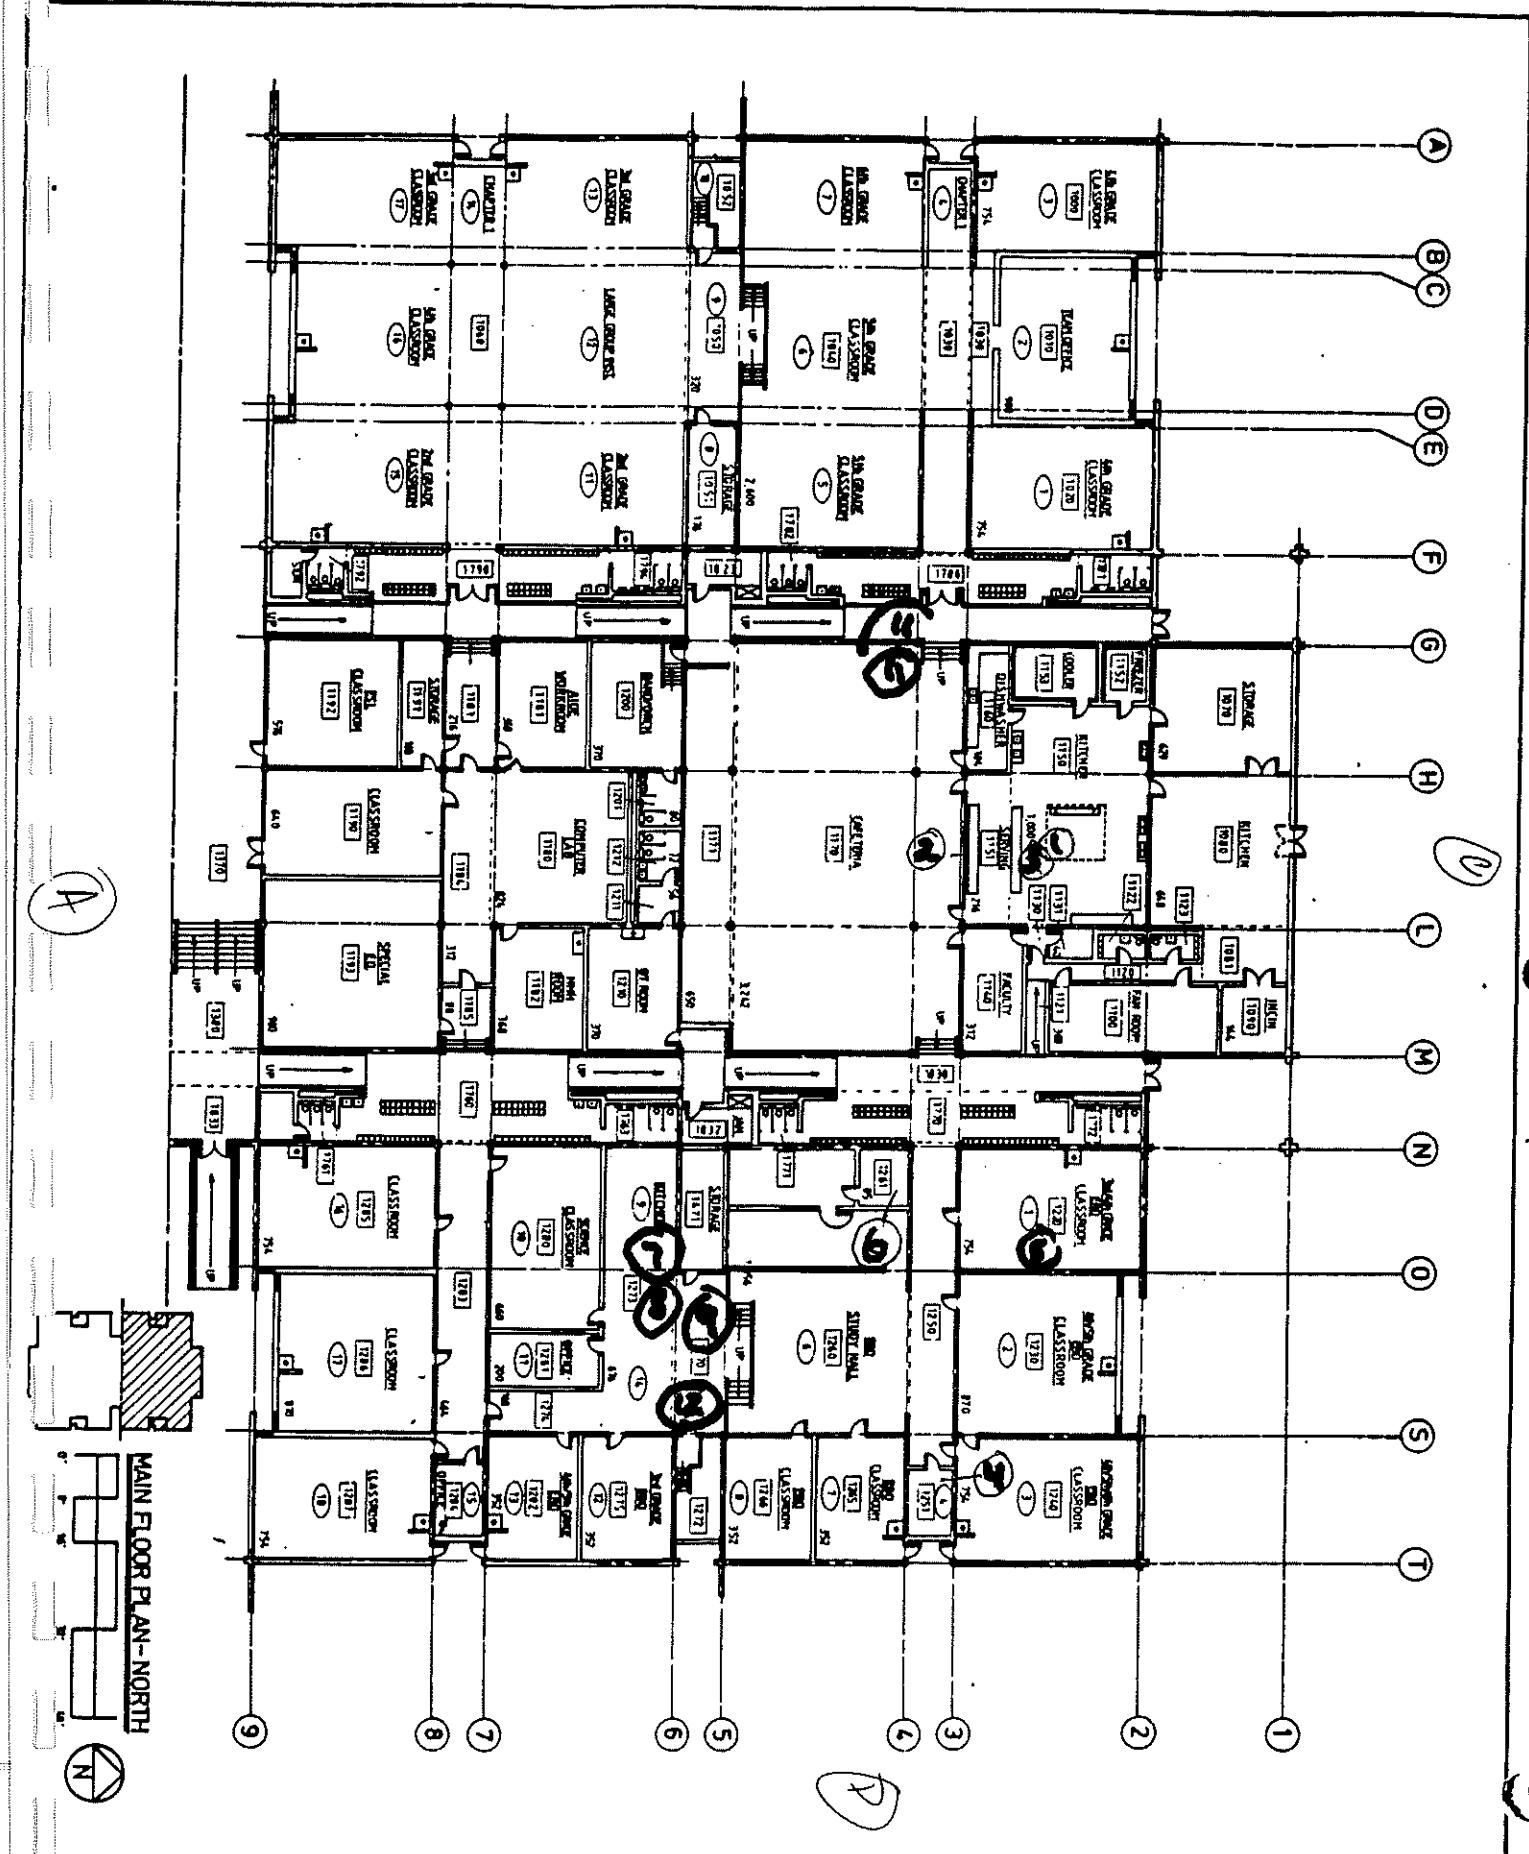
PART  
1  
6

INTERIOR PLANS - EAST LIPPS ELEMENTARY - LOCATIONS

CONSTRUCTED 1971

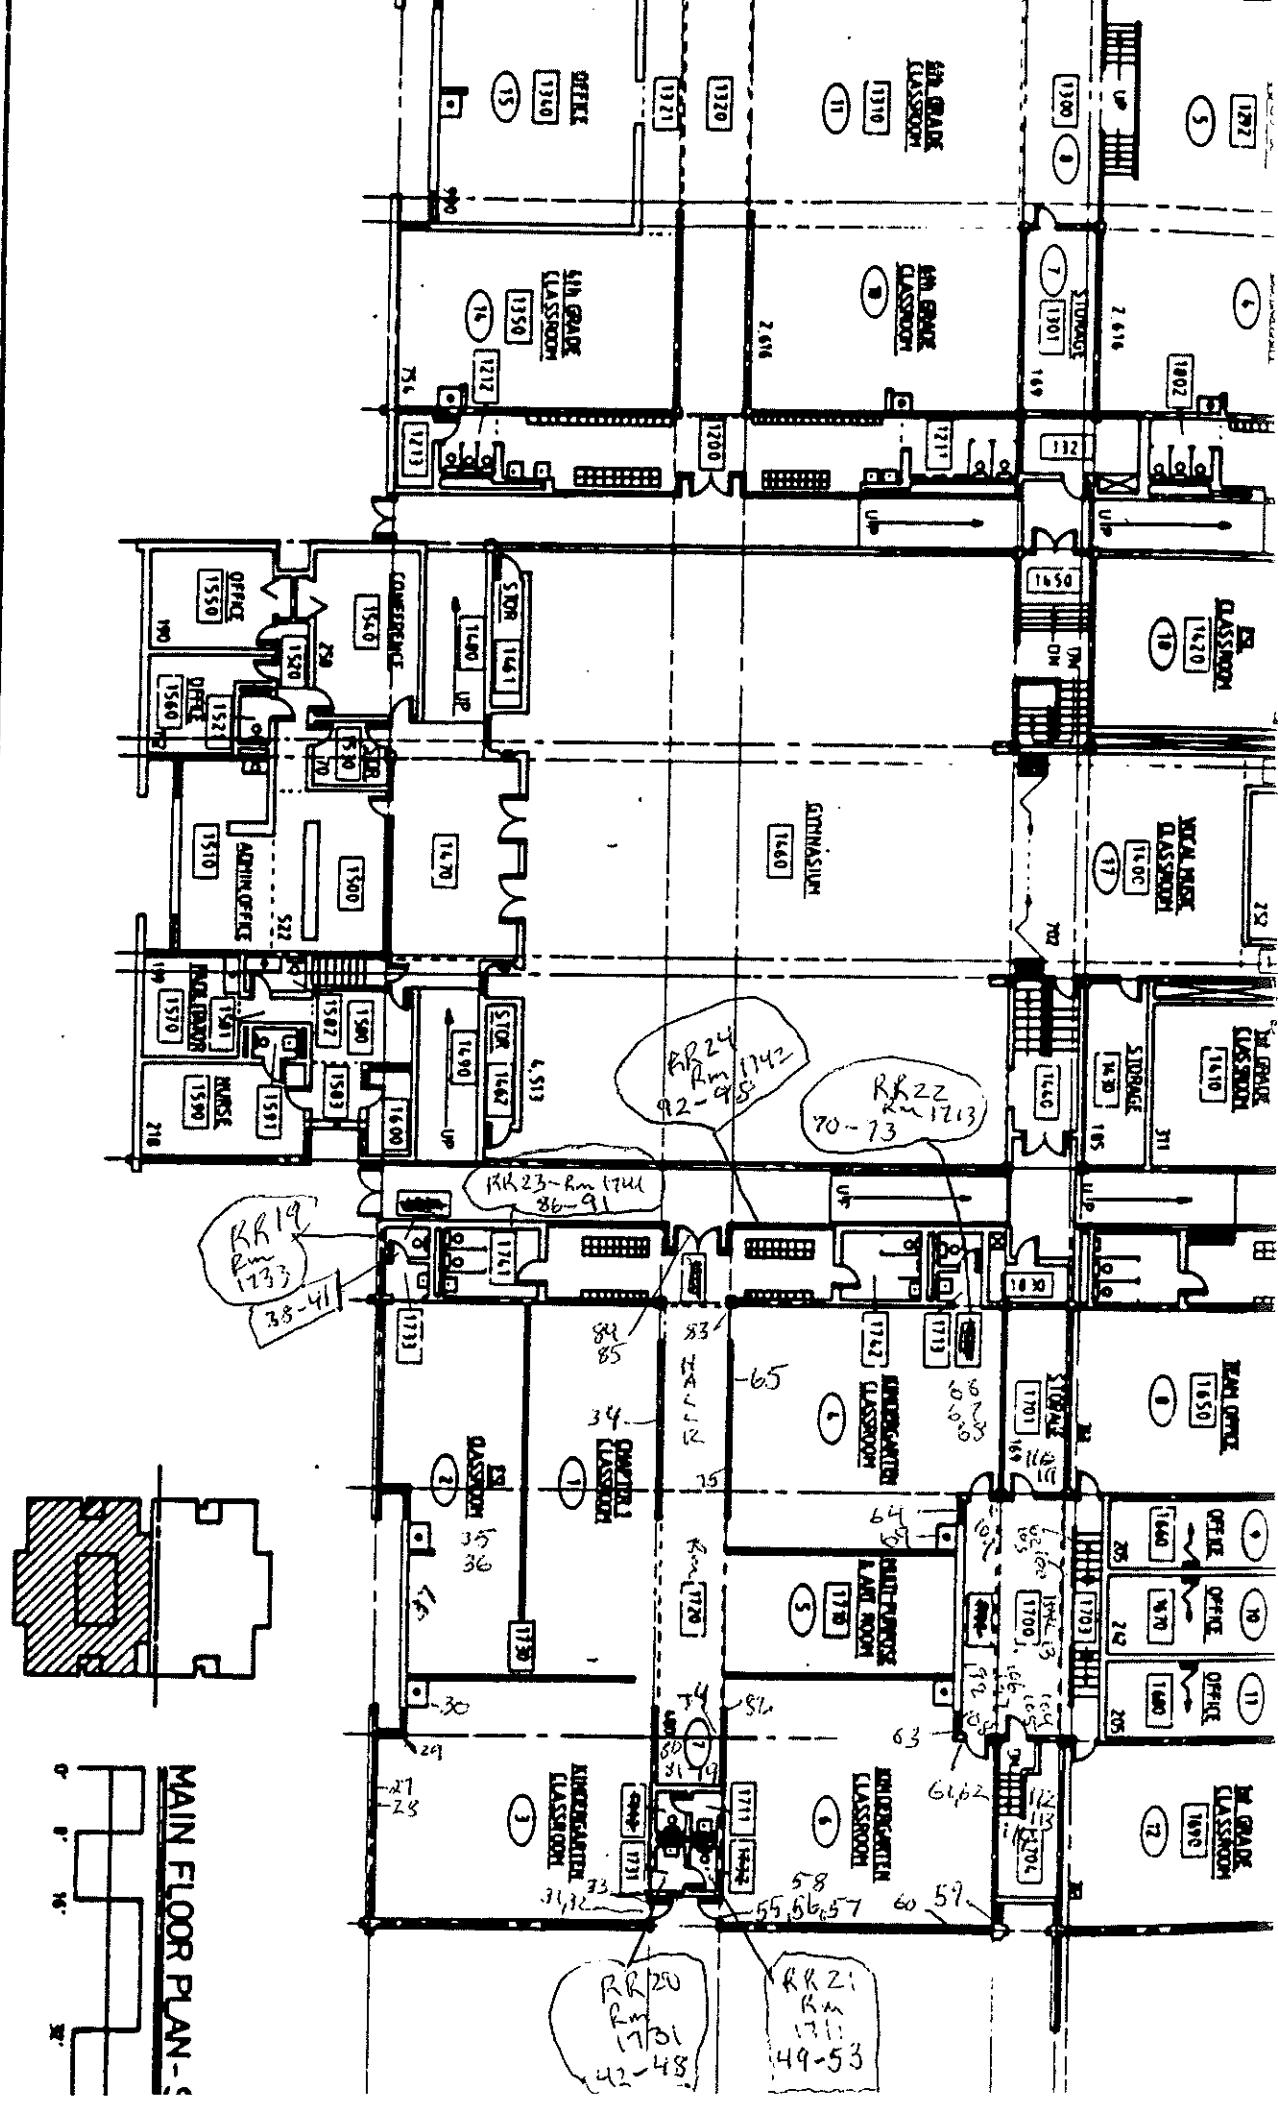
DRAWING 8

East Consolidated

313697 = O

41297 = " "

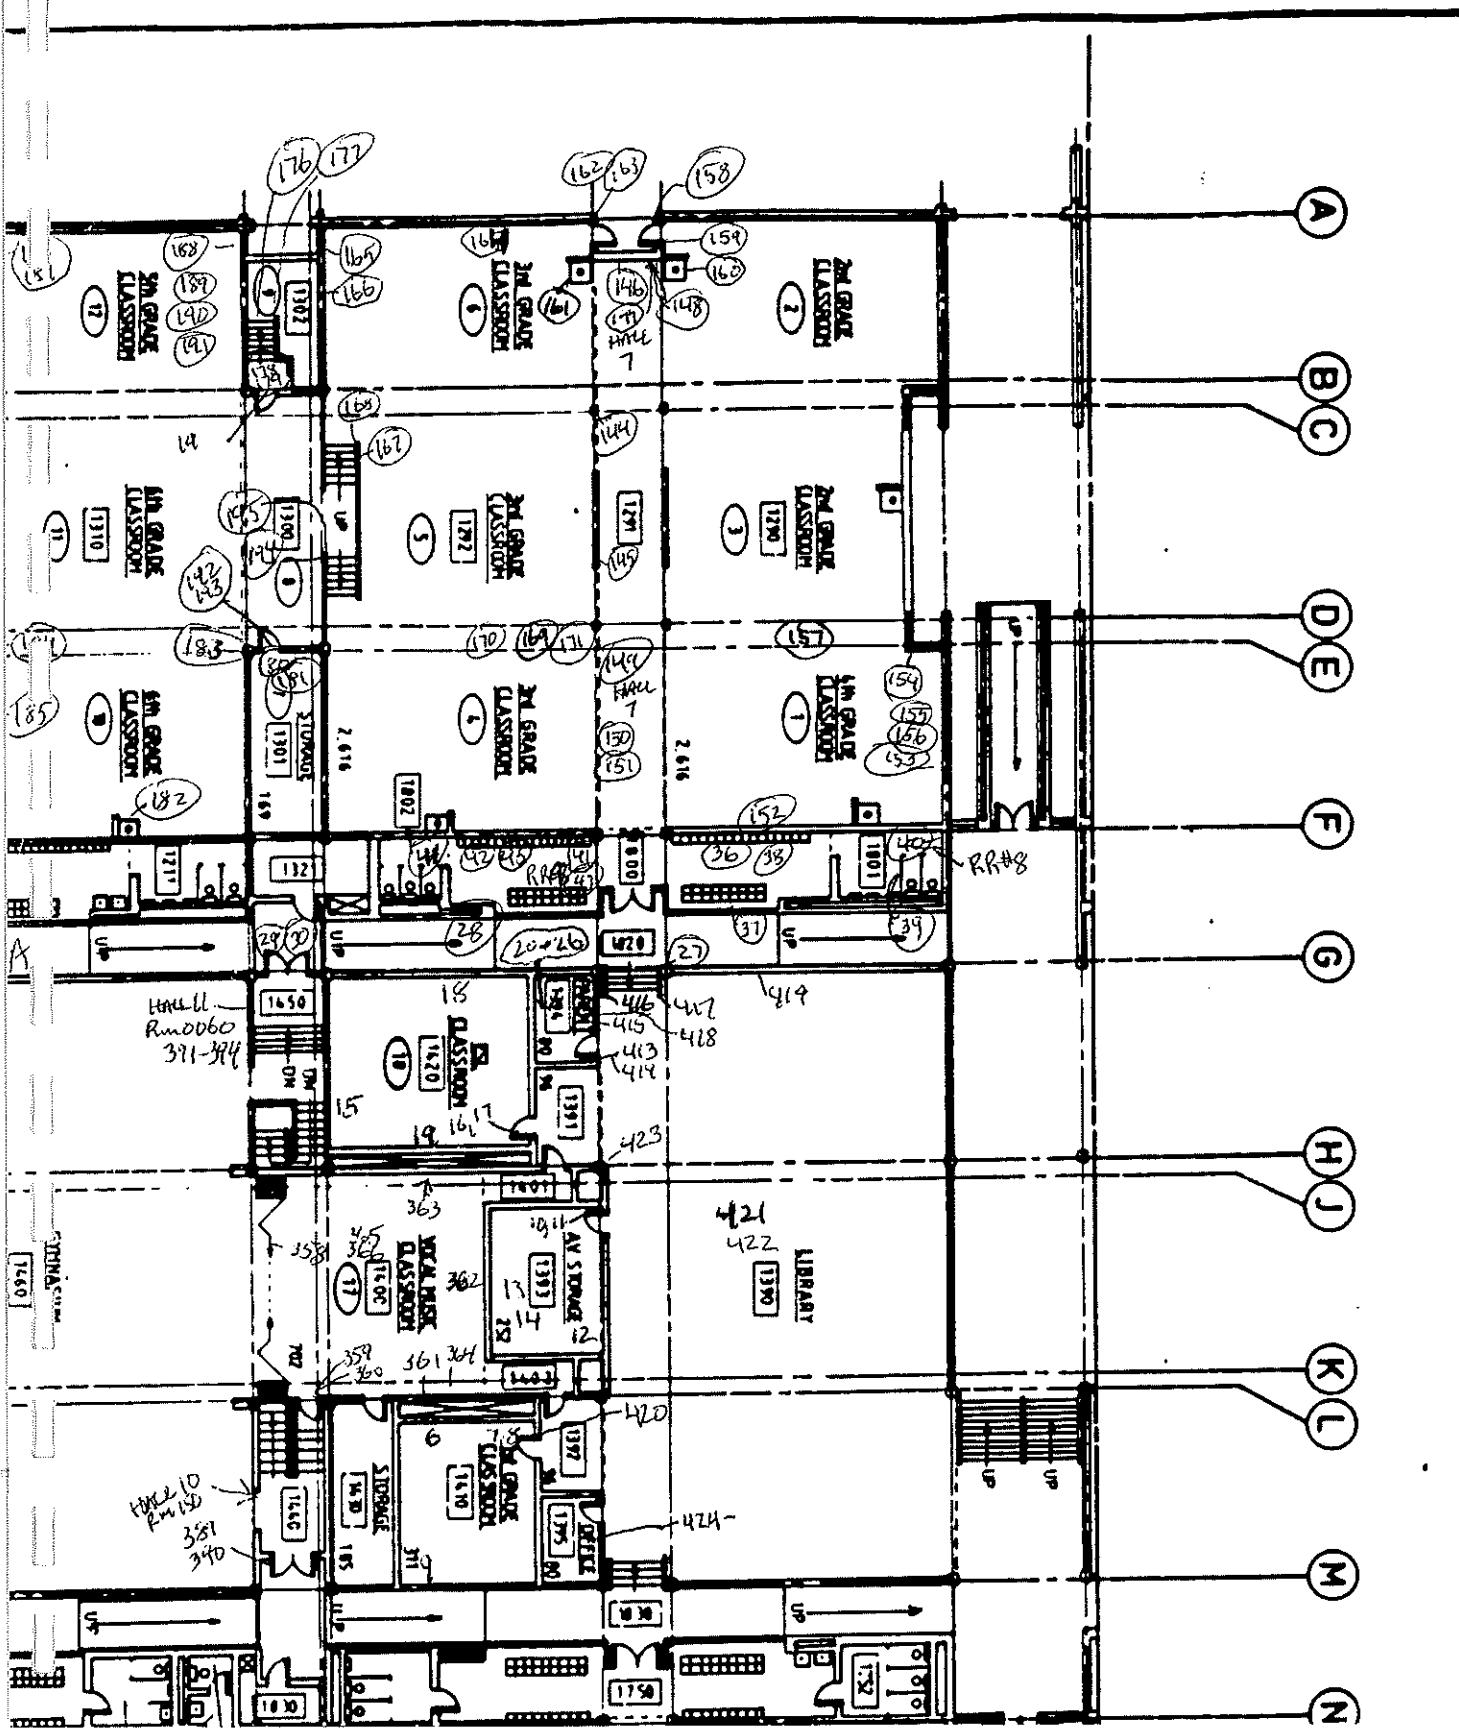
DRAWING 9

EAST  
CONSTRUCTED  
from 4/2/97

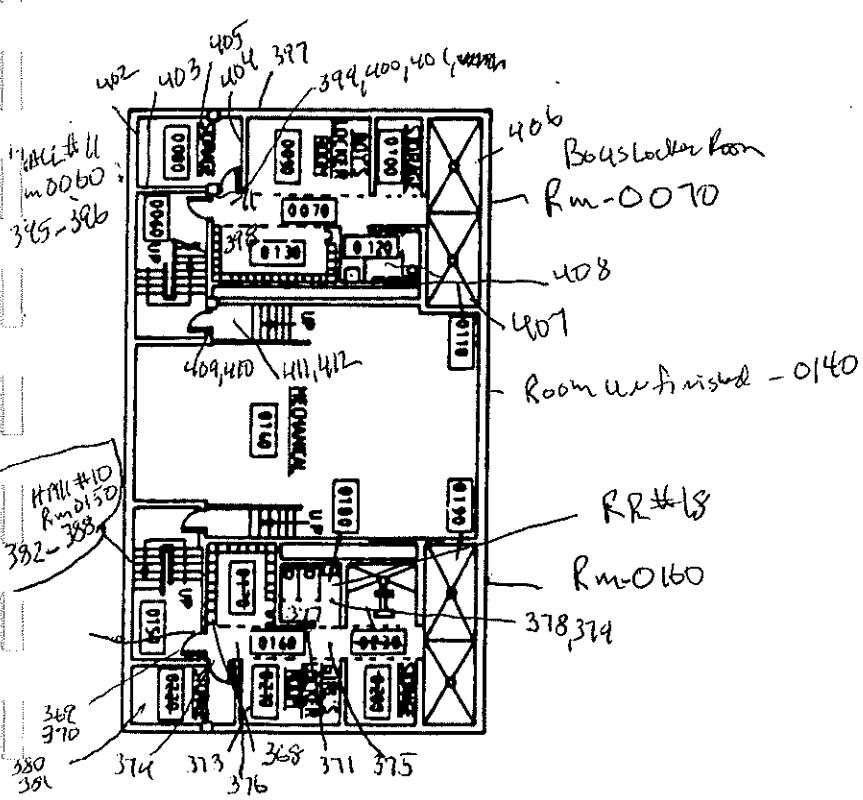
Drawing 7

GIRLS MECHANICAL

BOYS MECHANICAL

East Consolidated Elem  
3/30/92 - ○  
4/1/92 - # no circle  
neg. with 222

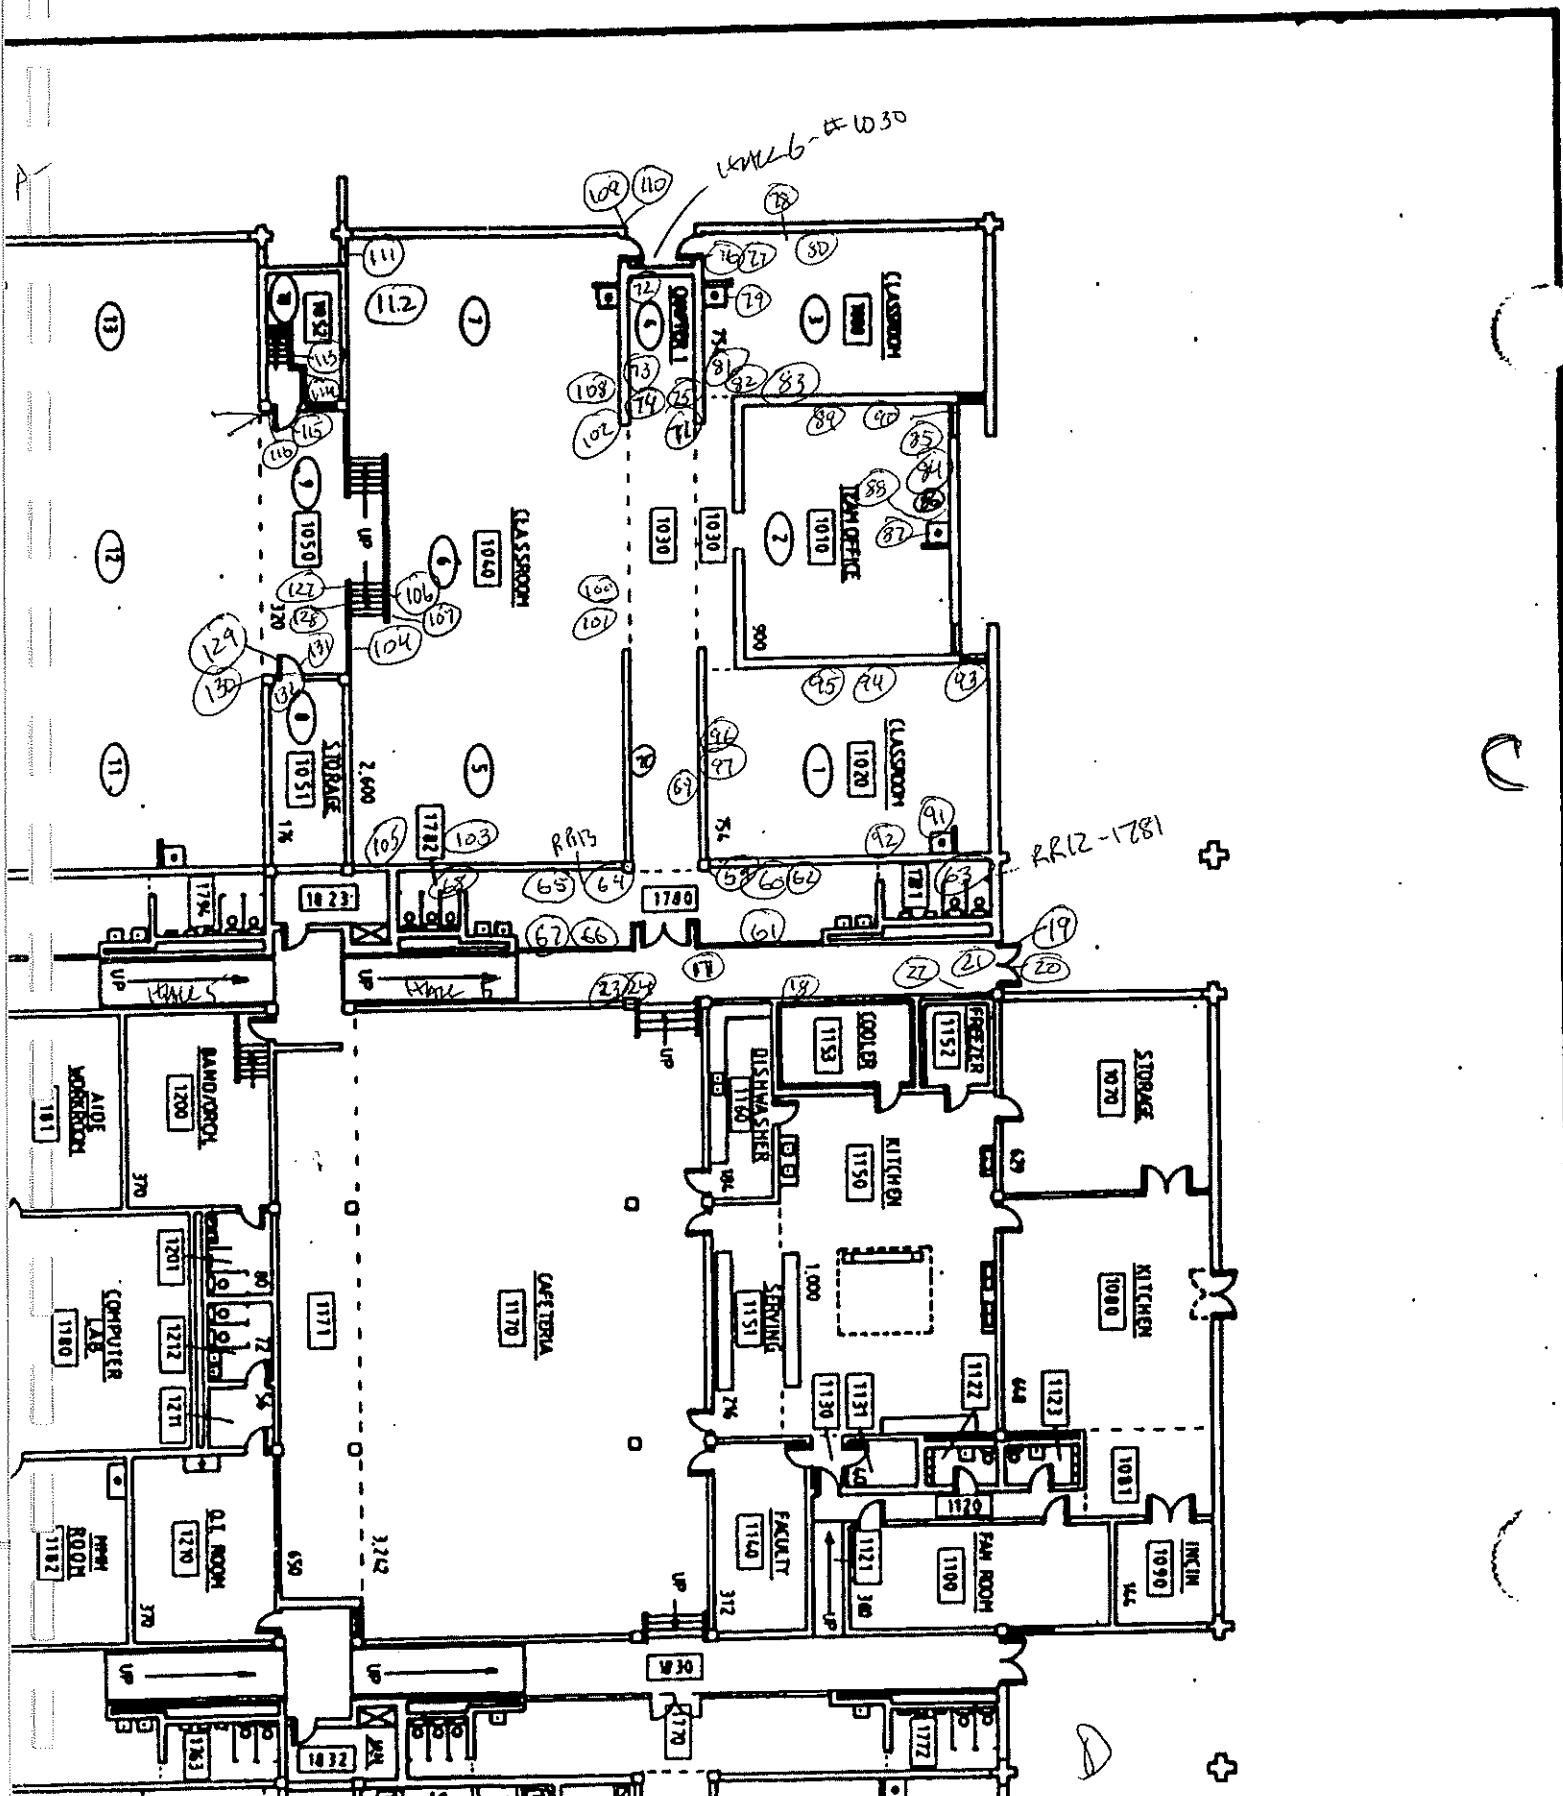
EAST CONSOLIDATED  
DRAWING 4

3/18/97

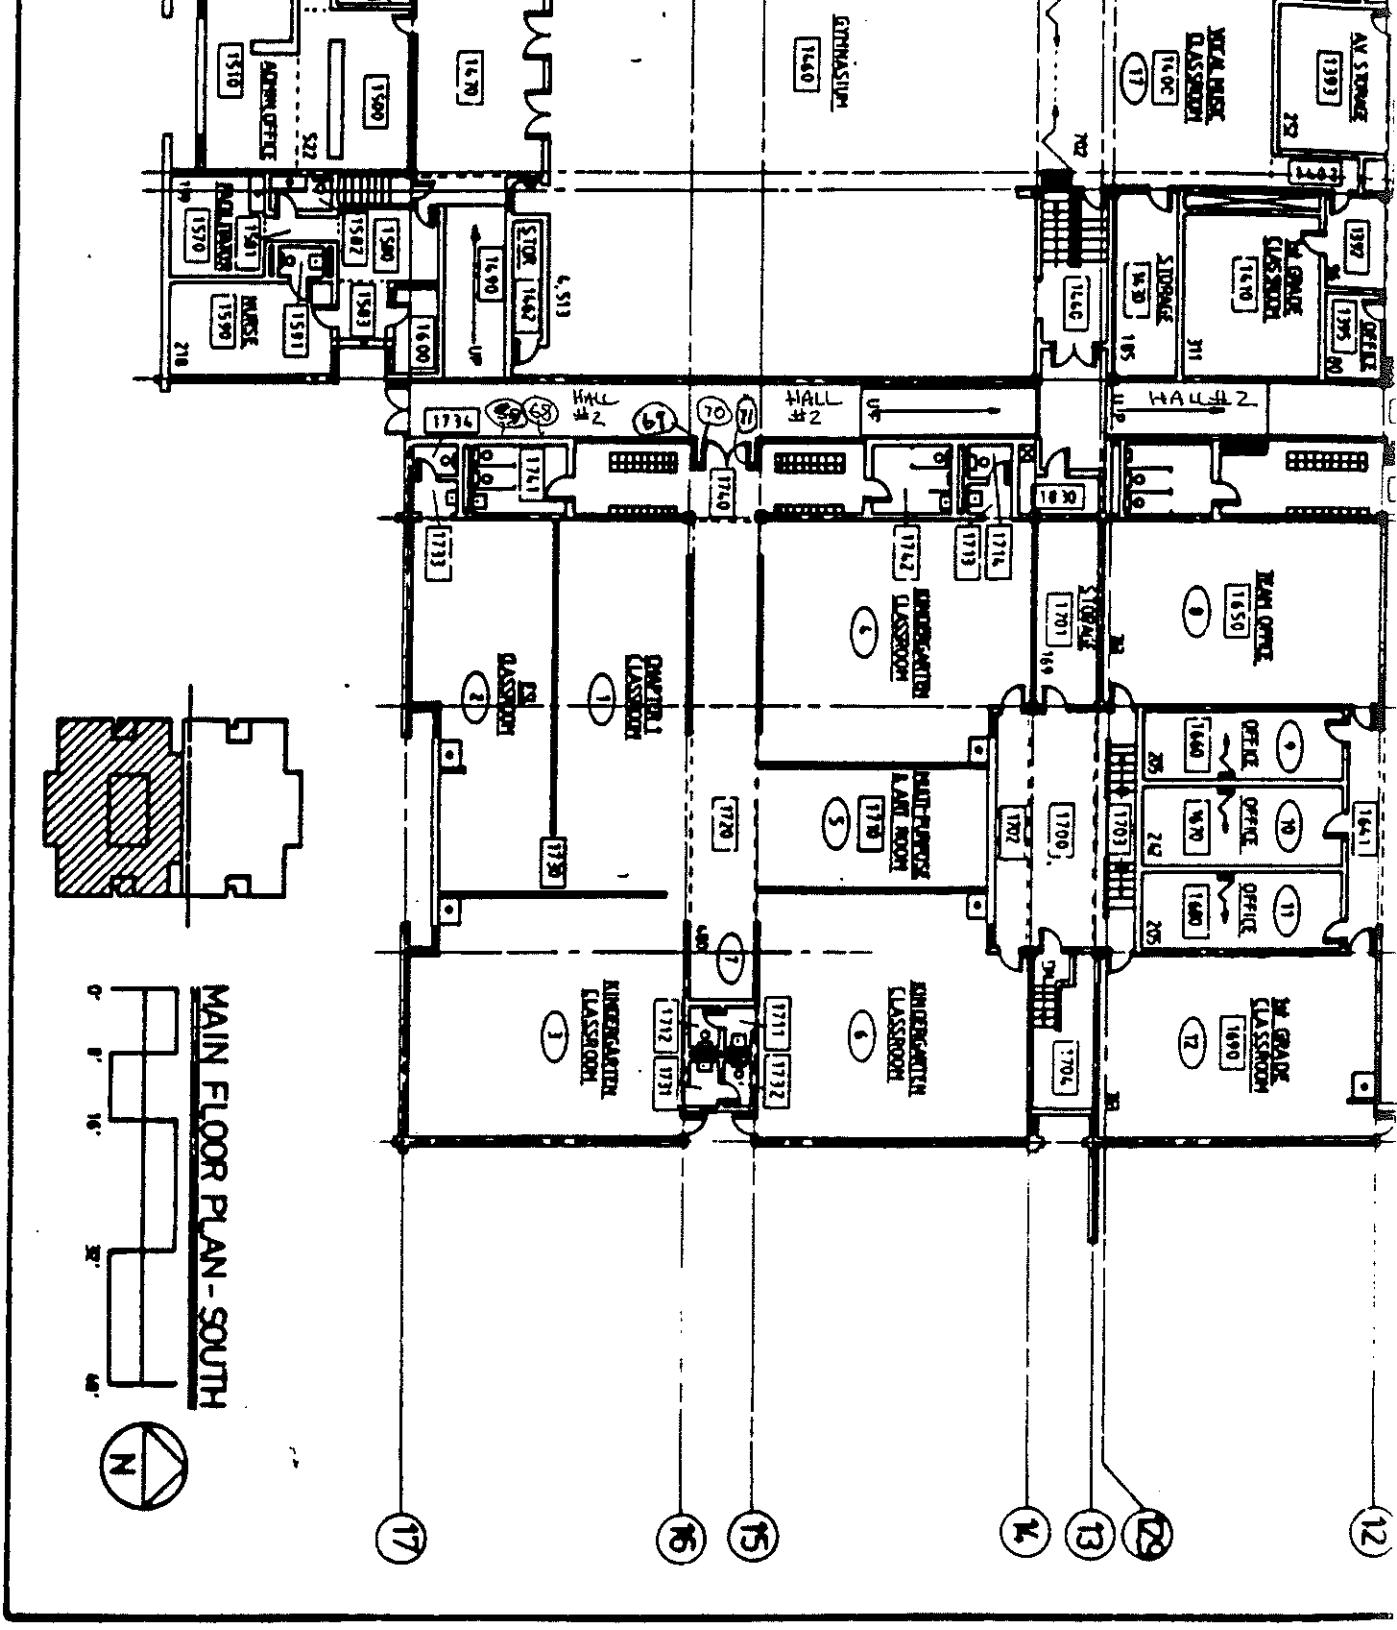
DRAwing 3

3/18/97 - no circle
