**Chelsea Heights Elementary School
Saint Paul Public Schools**

Lead-Based Paint Inspection

MEC Project # 62/0197E

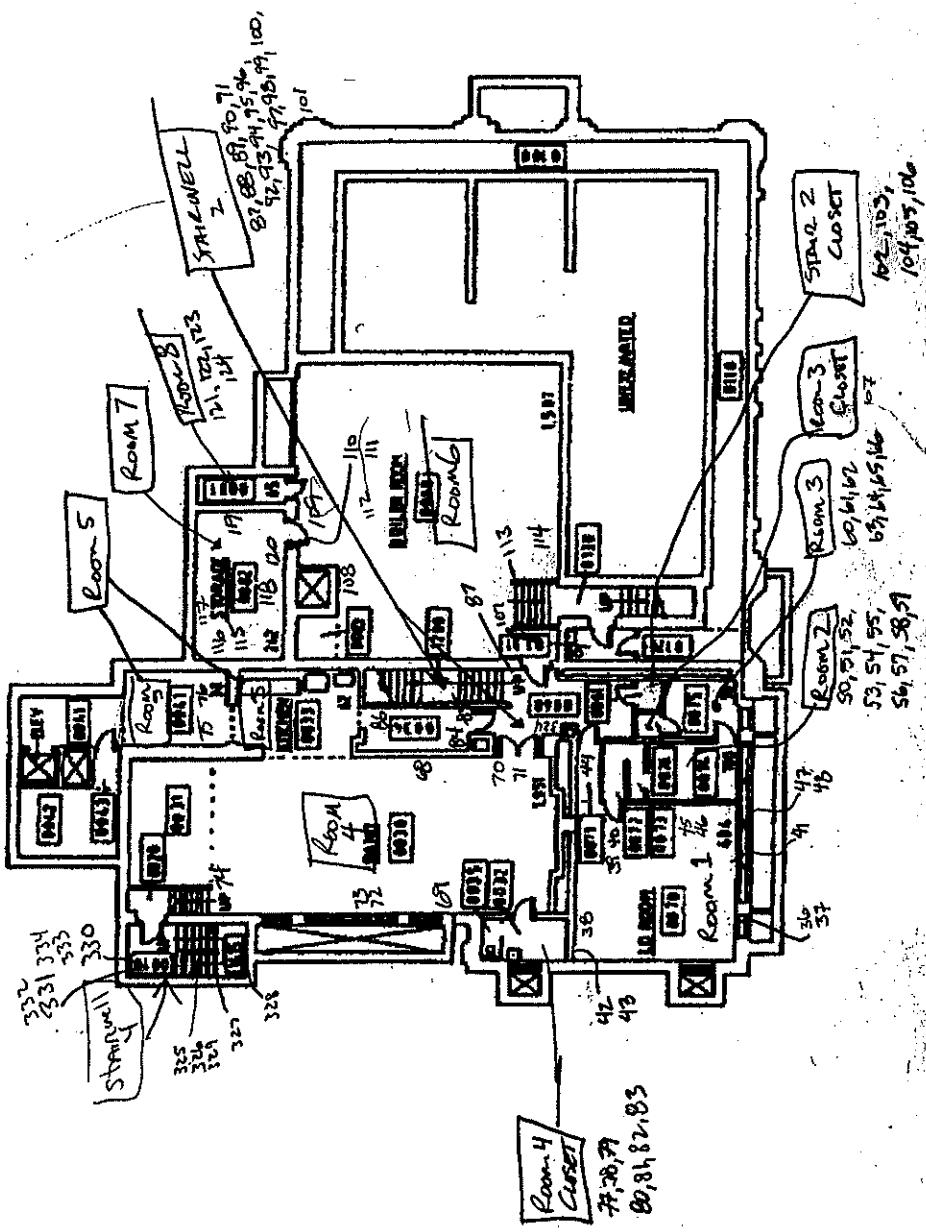
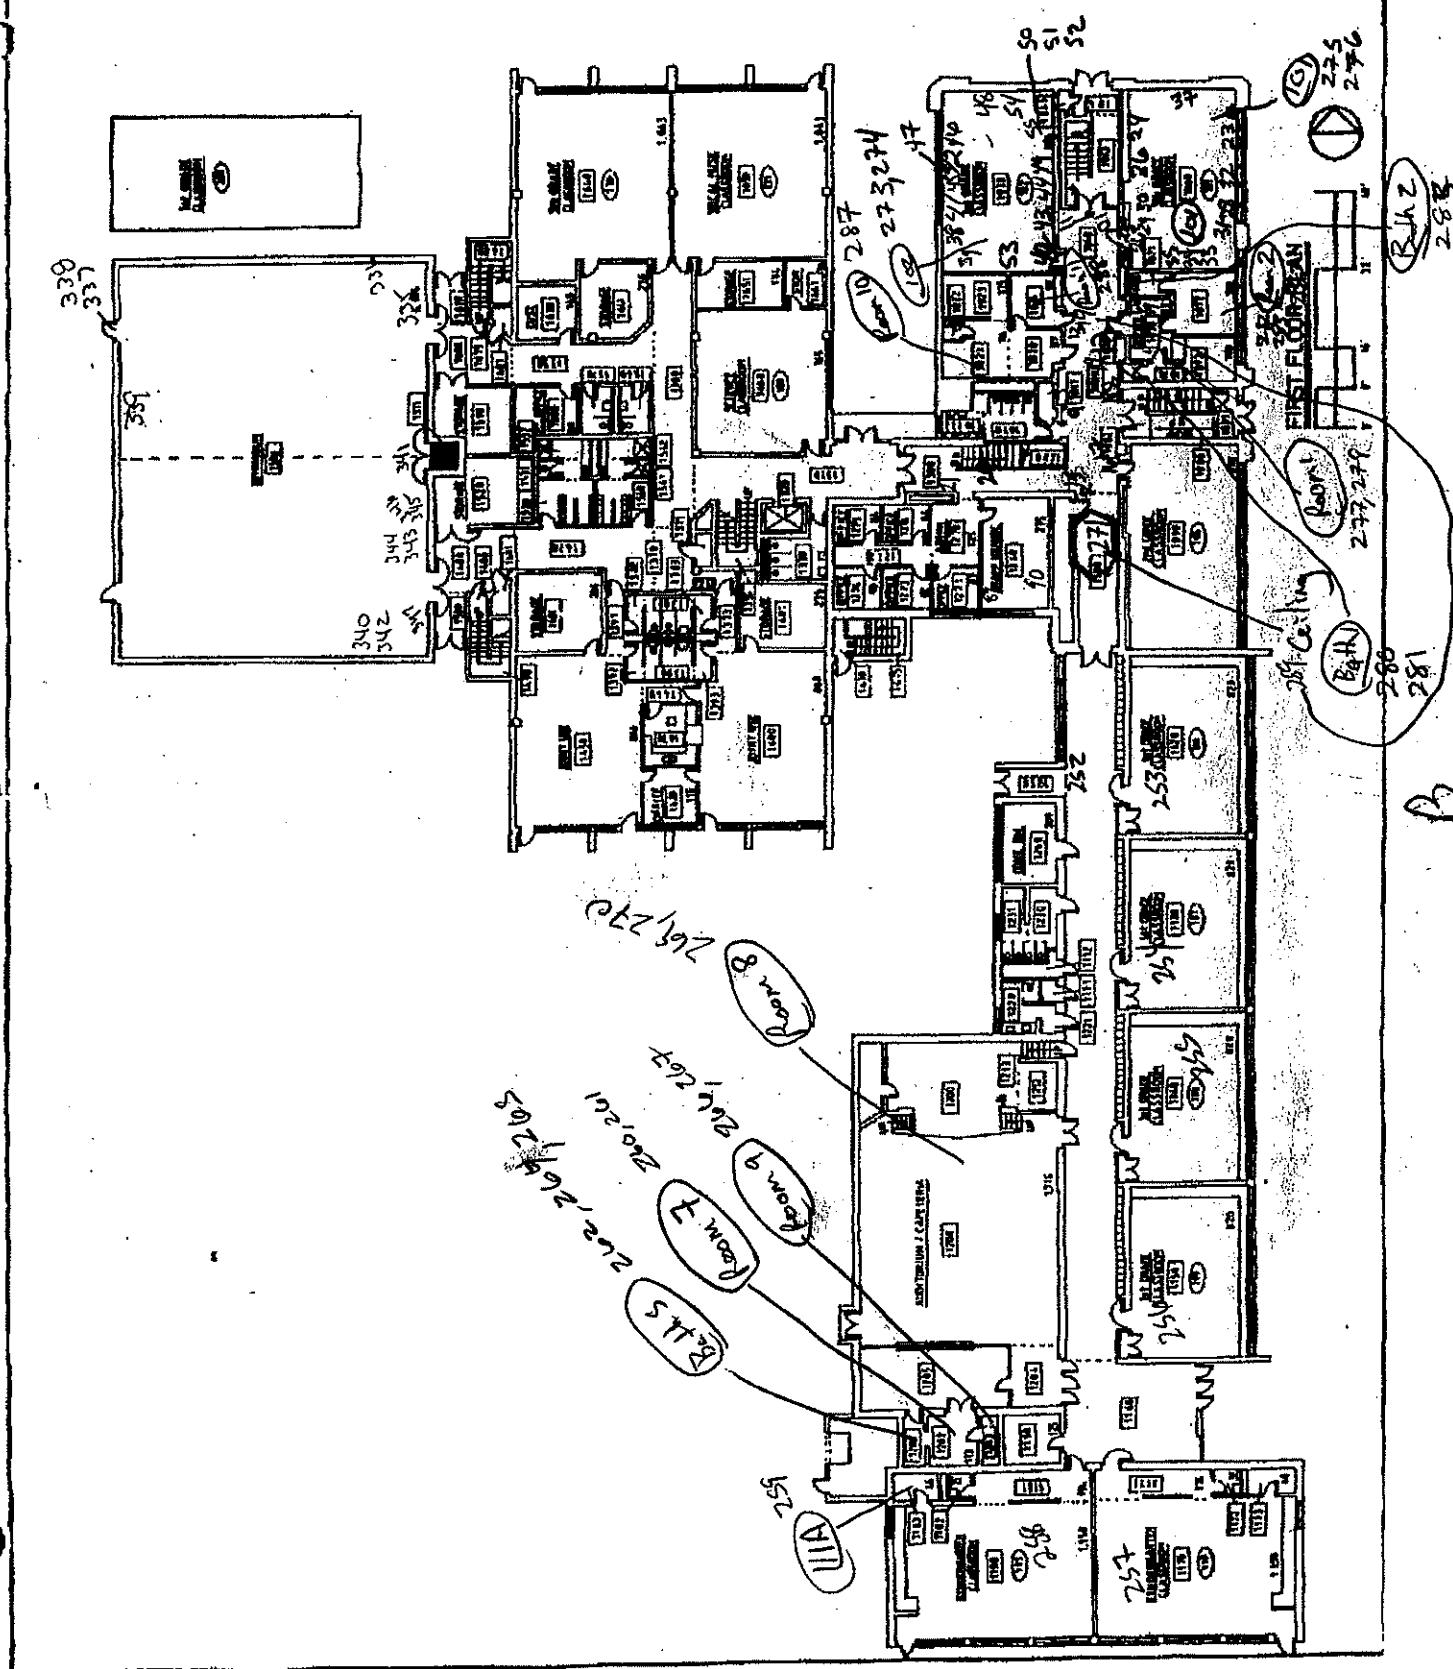
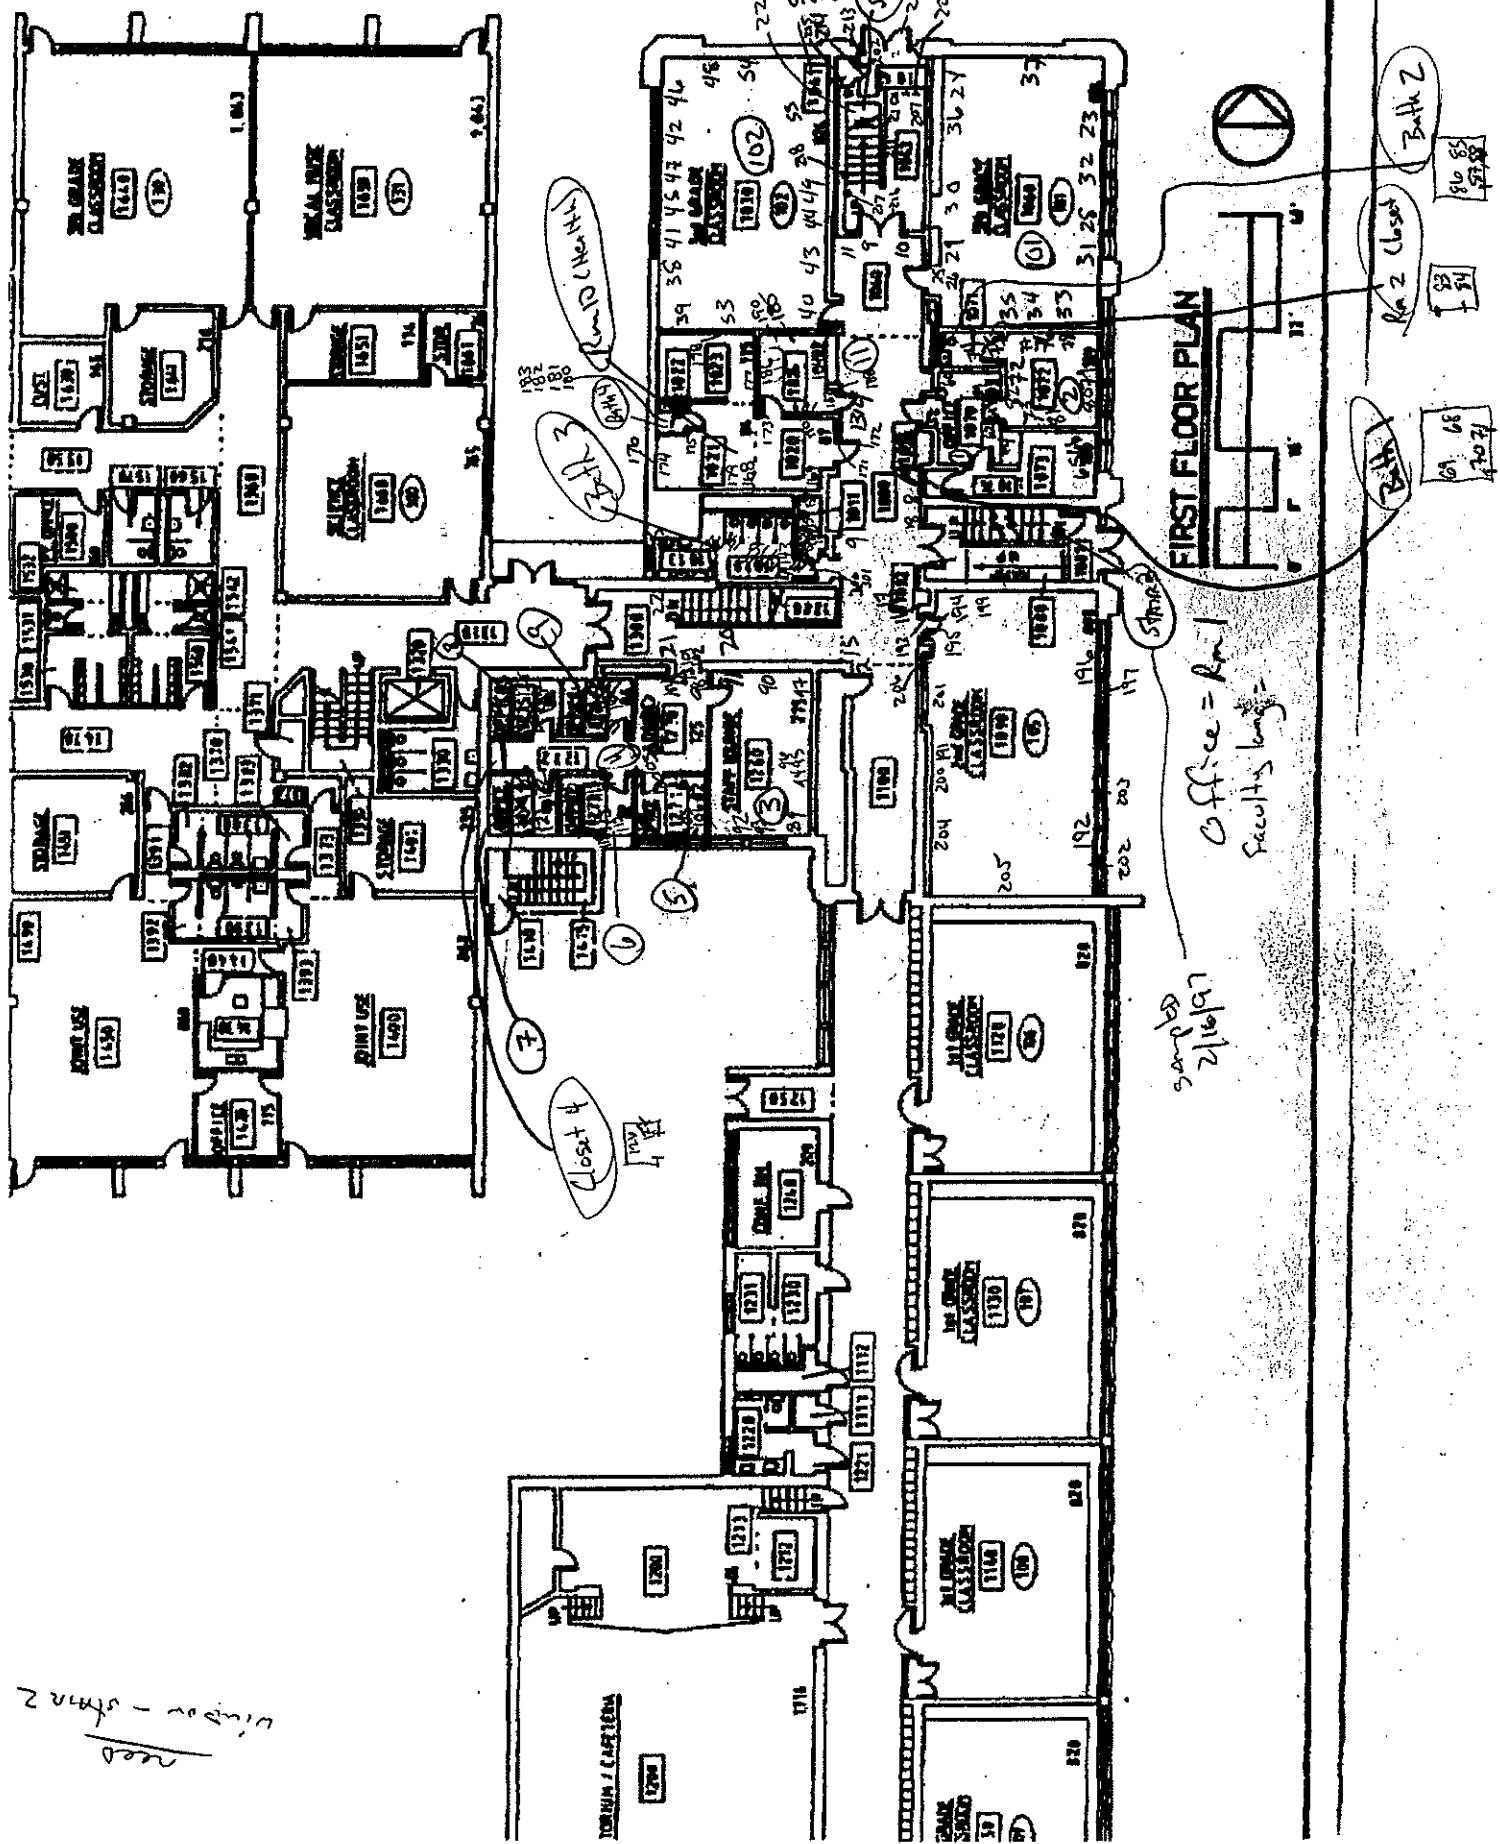
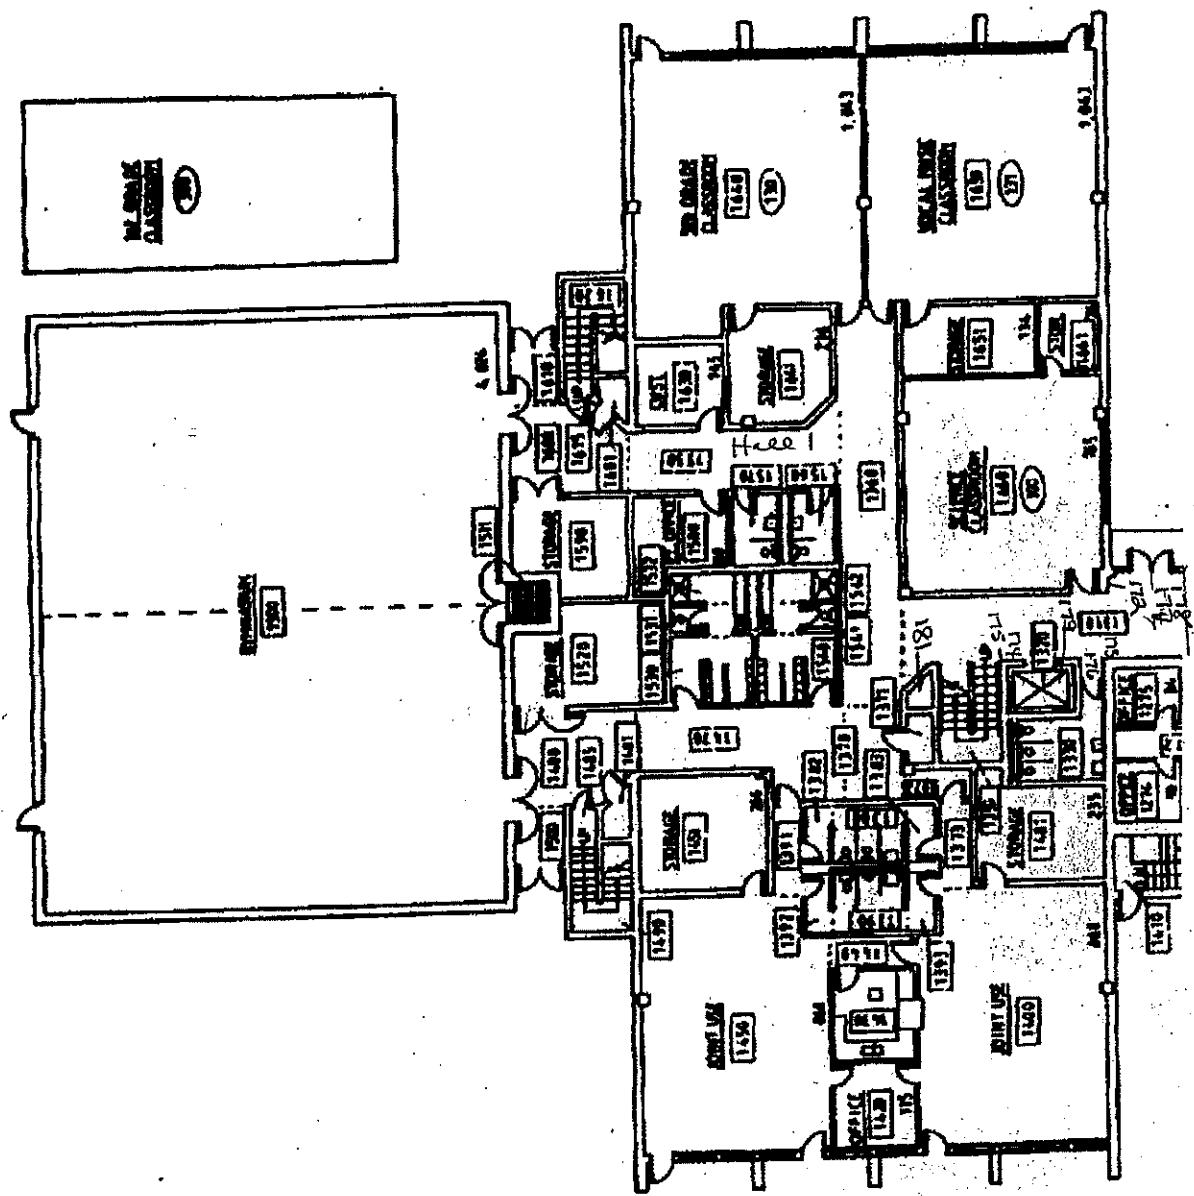
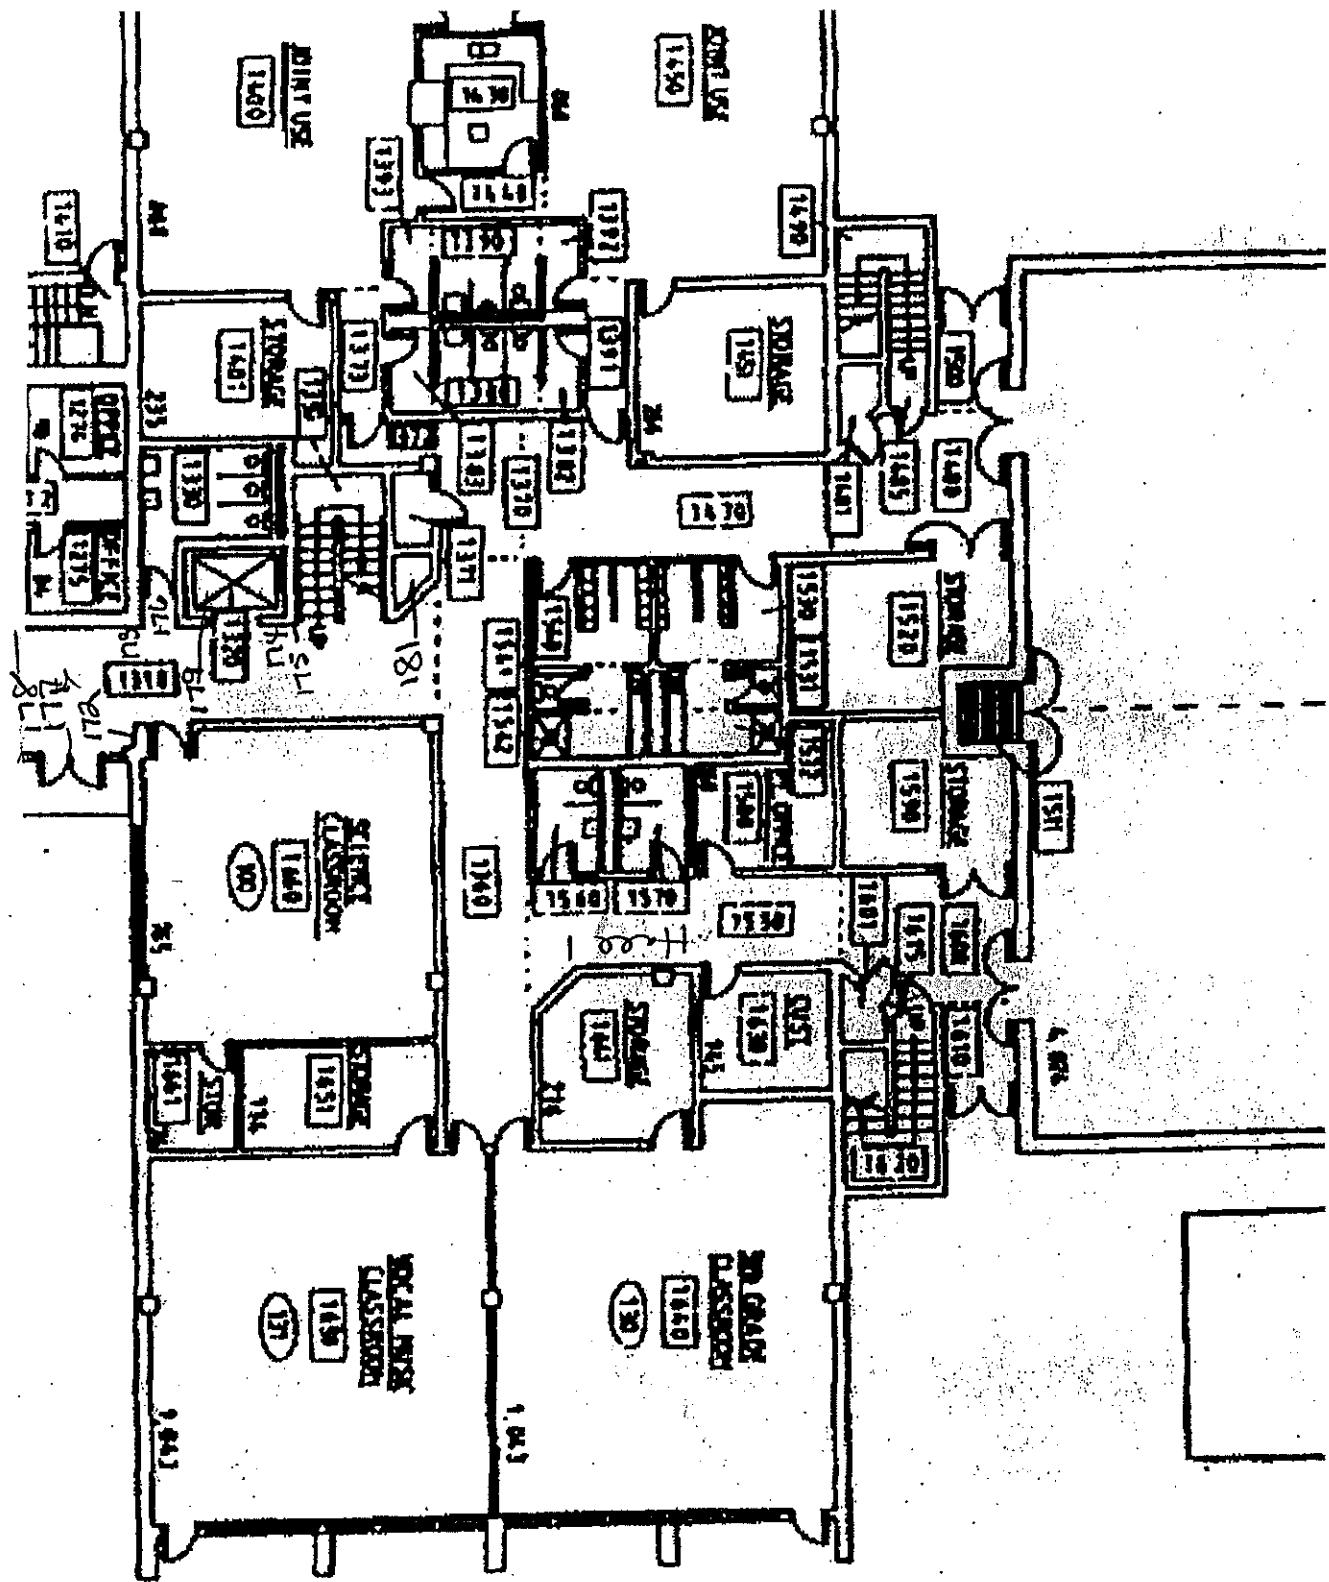
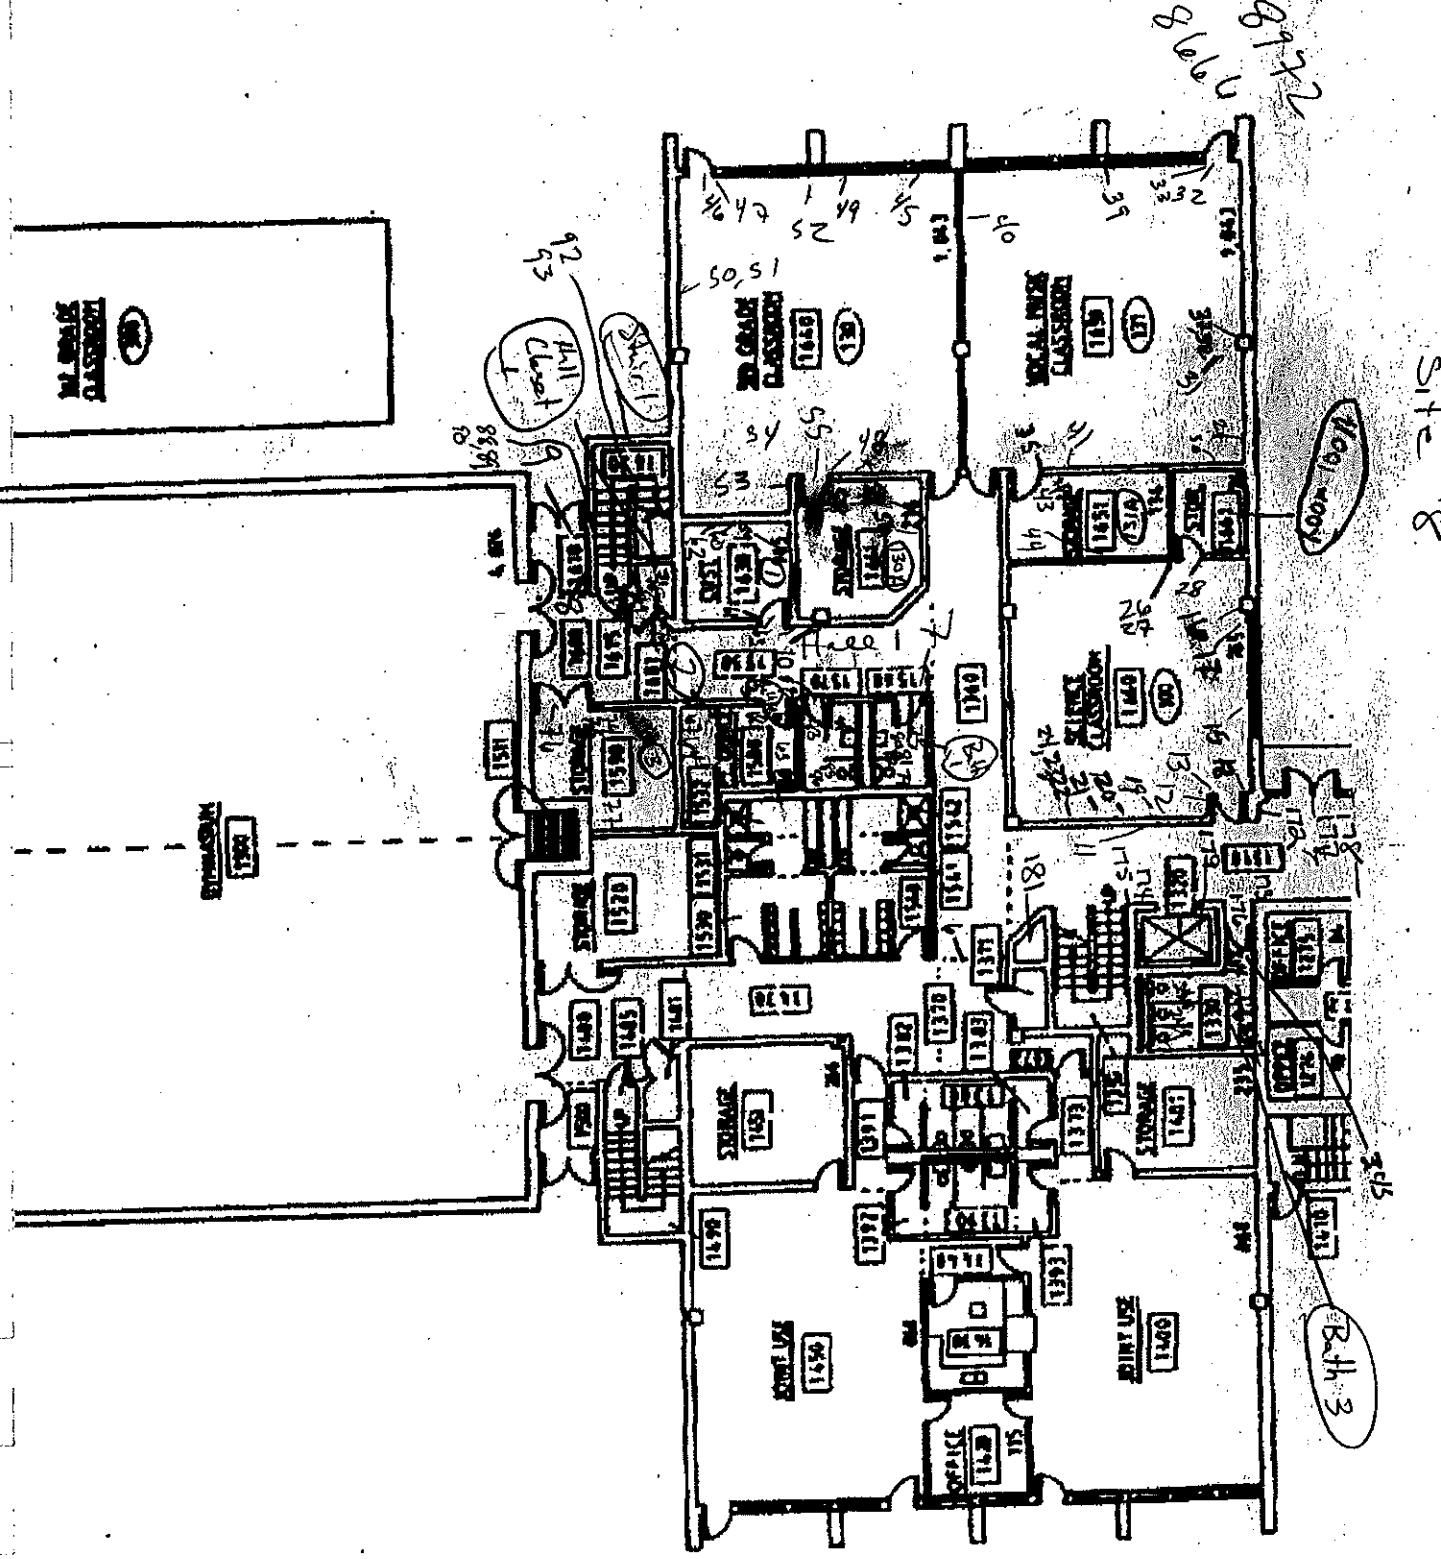
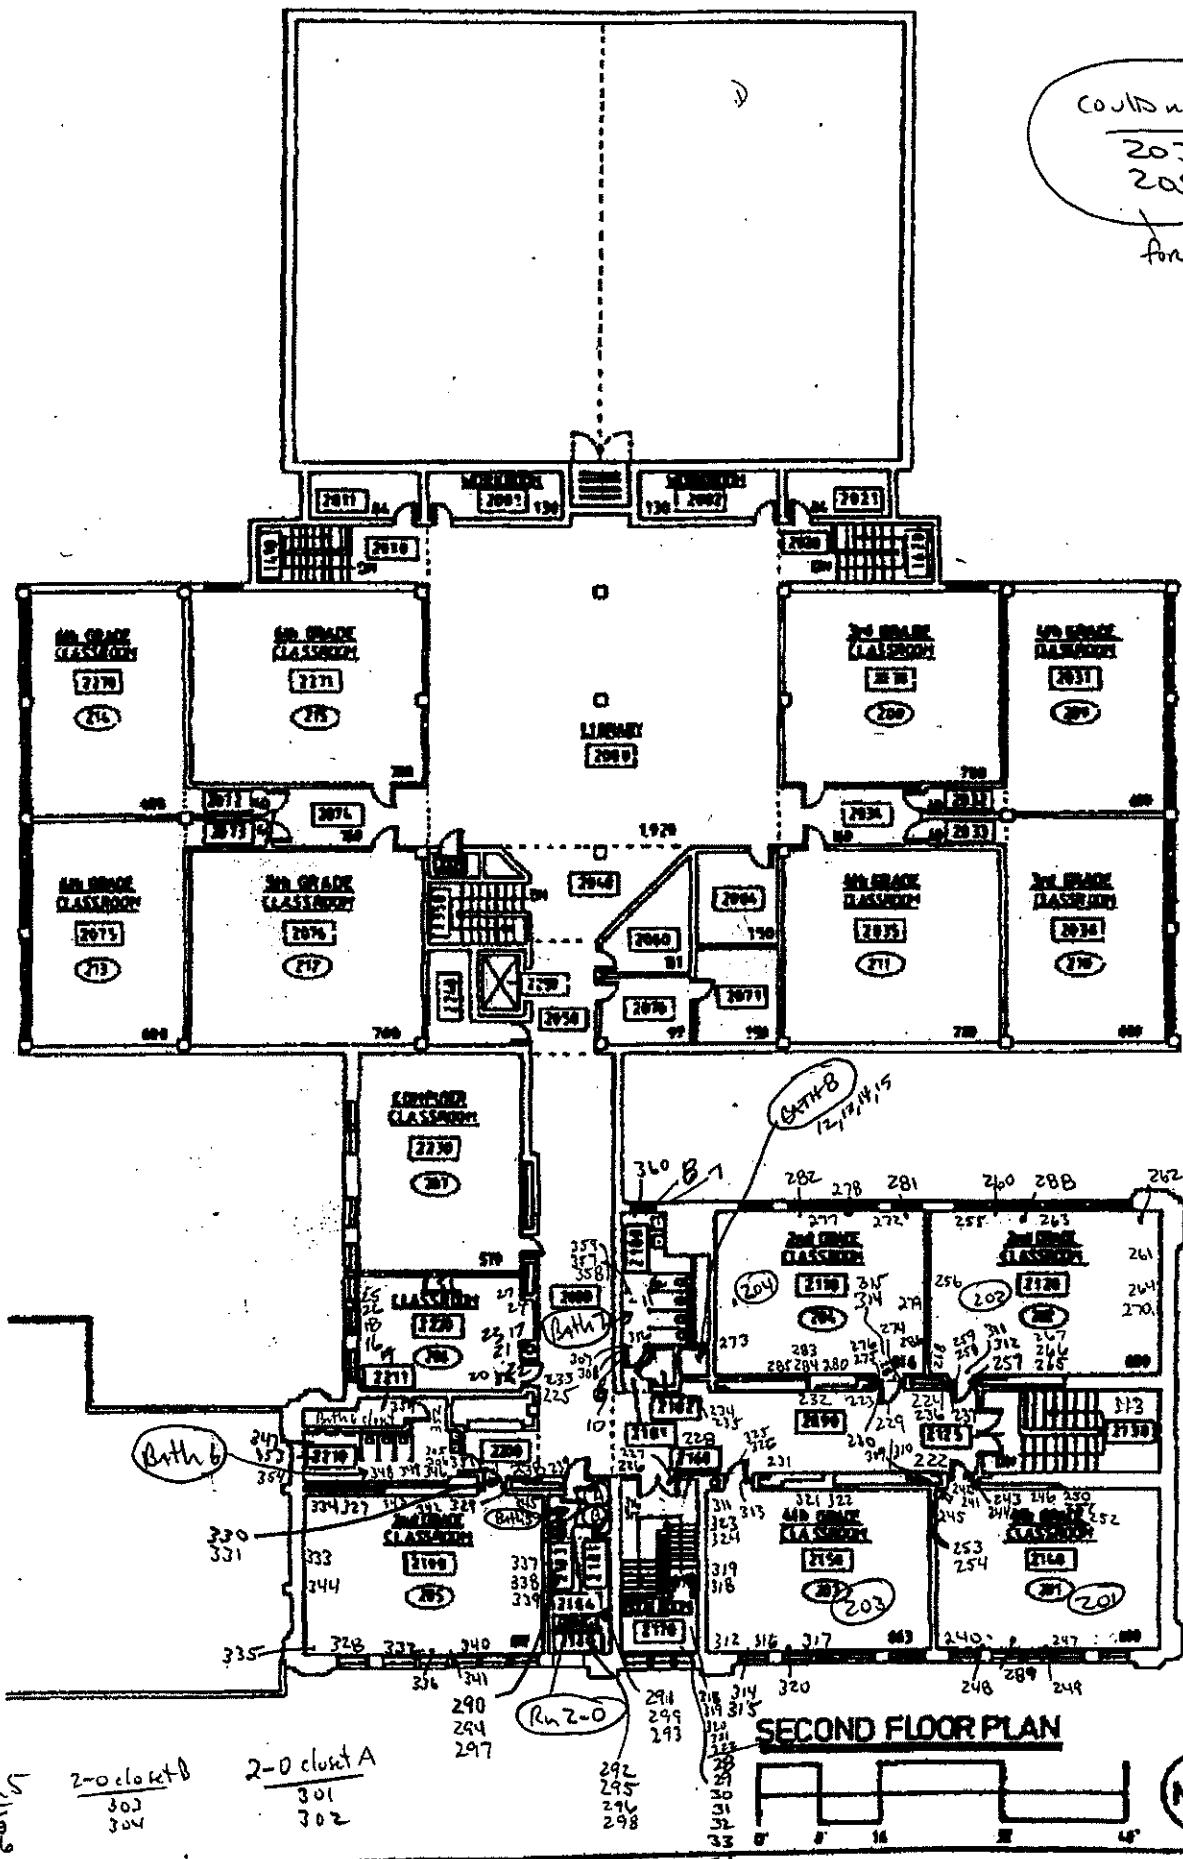
LOCATION MAPS

All room and area designations used in this report are depicted on sampling maps found in Appendix A.
