**River Front Educational Center
Saint Paul Public Schools**

Lead-Based Paint Inspection

Inspection Dates: 6/10/97, 6/11/97, 6/12/97, 6/13/97, 6/16/97

MEC Project # 62/0197AI

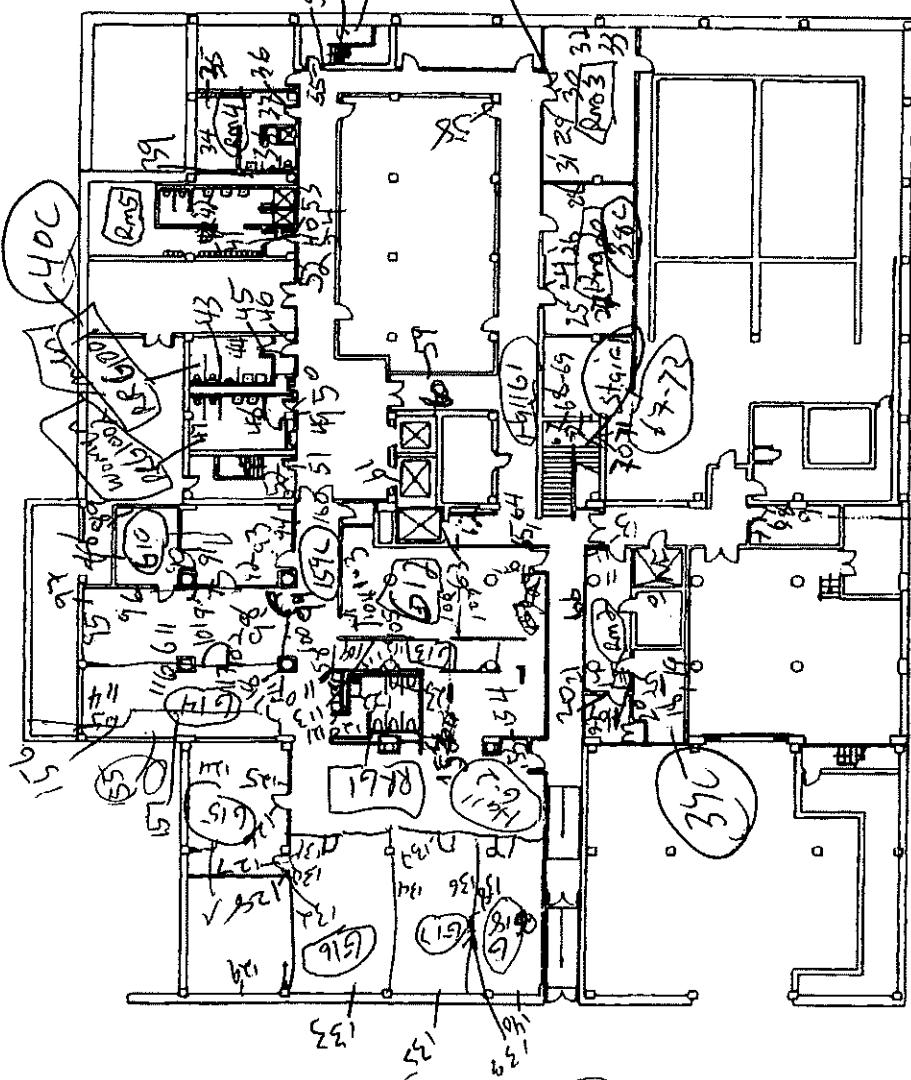
GROUND FLOOR PLAN

XRF TESTING DATA WITH LOCATION MAPS

All room and area designations used in this report are depicted on sampling maps found in Appendix A.
