**Eastern Heights Elementary  
Saint Paul Public Schools**

**Lead-Based Paint Inspection**

**Inspection Dates: 6/5/97, 6/3/97, 6/6/97, 6/7/97**

**MEC Project # 62/0197AH**

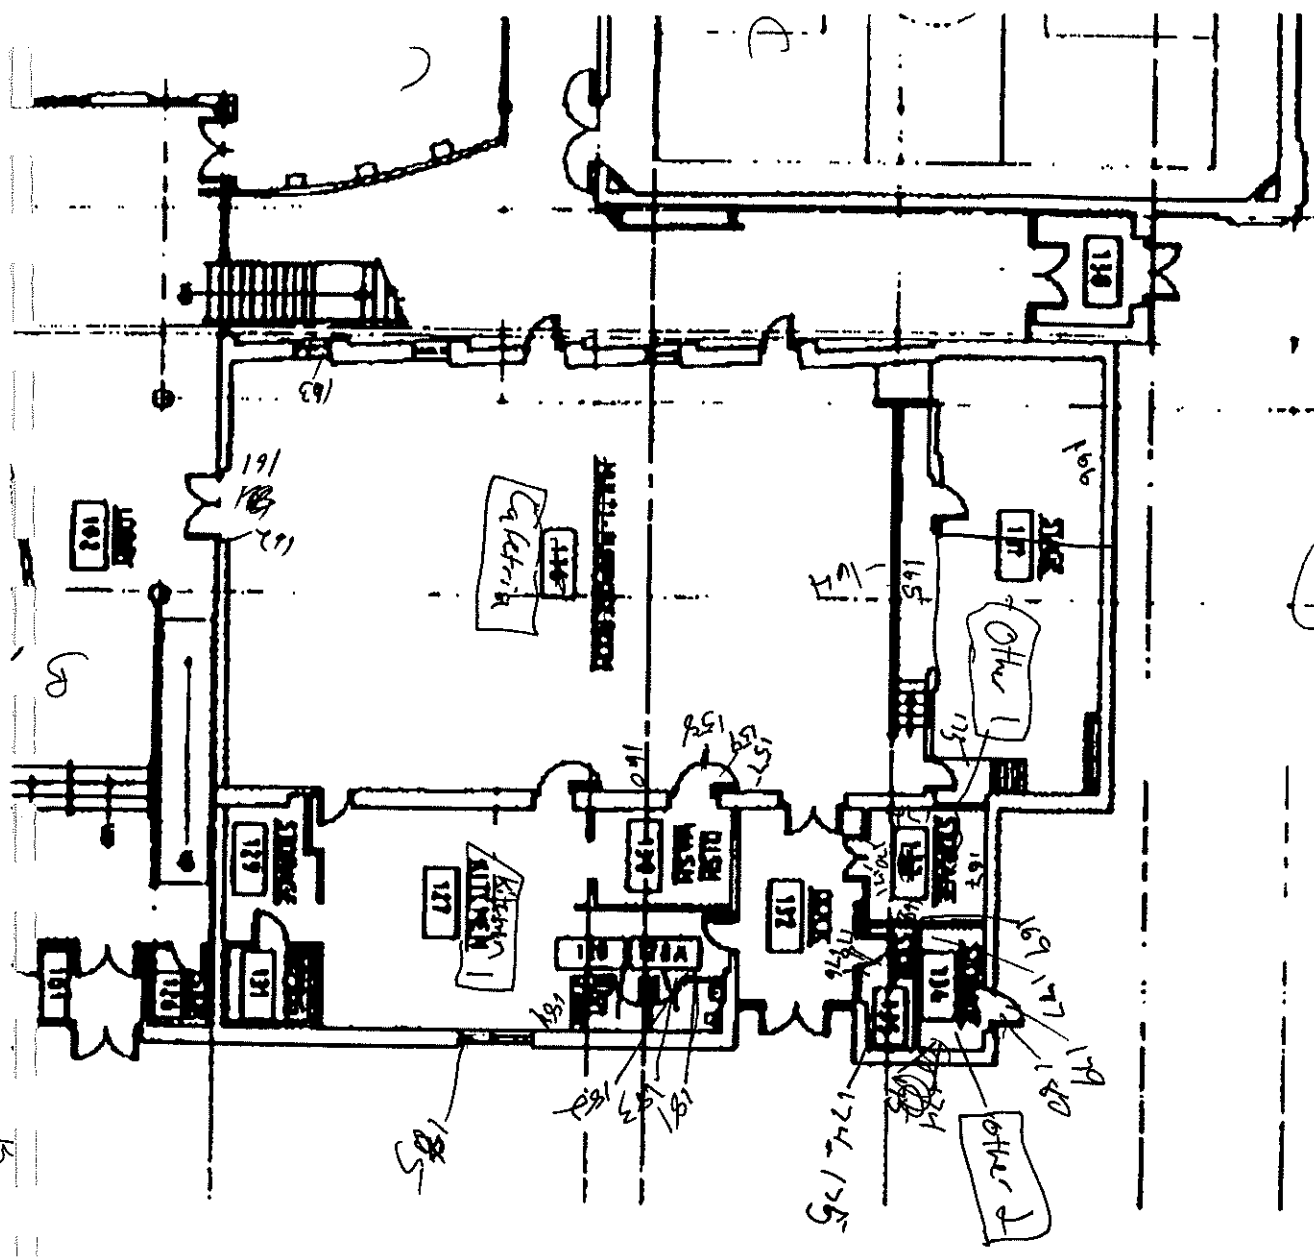
FIRST FLOOR

6-3-97  
1st Floor

All room and area designations used in this report are depicted on sampling maps found in Appendix A.

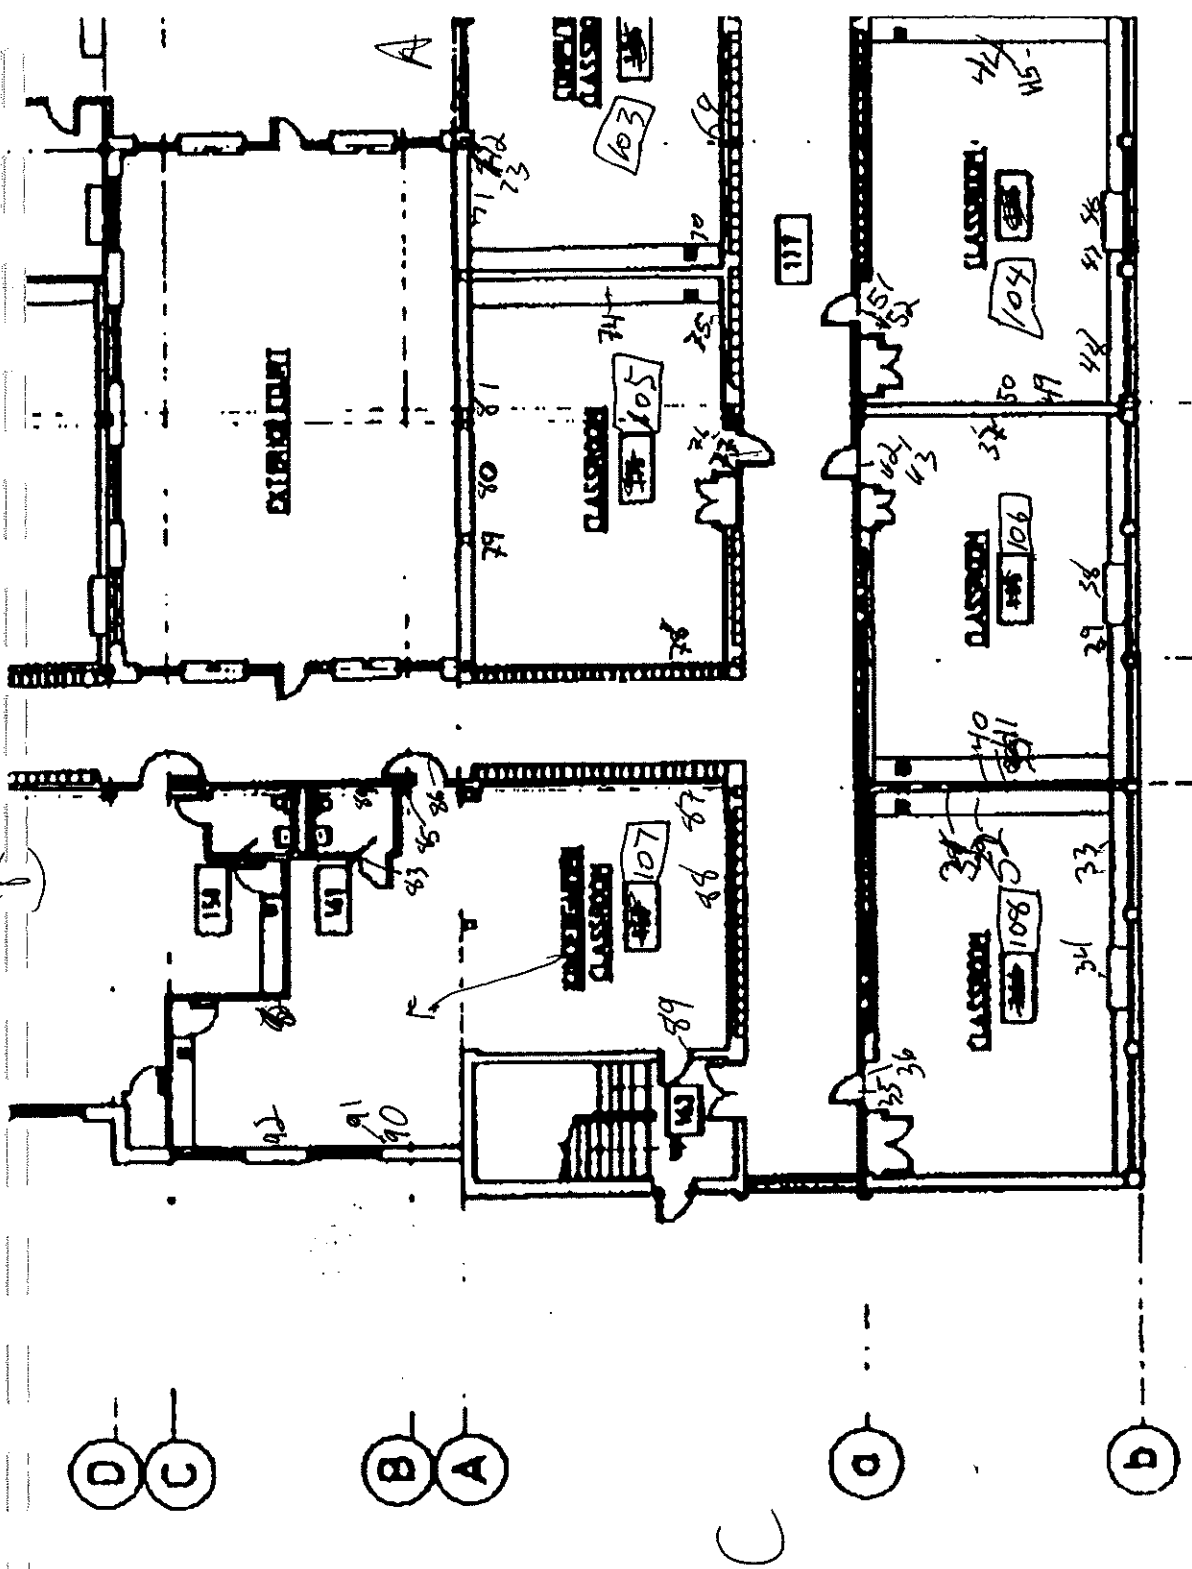
SECOND FLOOR

6-3-97  
1st Floor
