**Jackson Preparatory Magnet School
Saint Paul Public Schools**

Lead-Based Paint Inspection

MEC Project # 62/0197AR

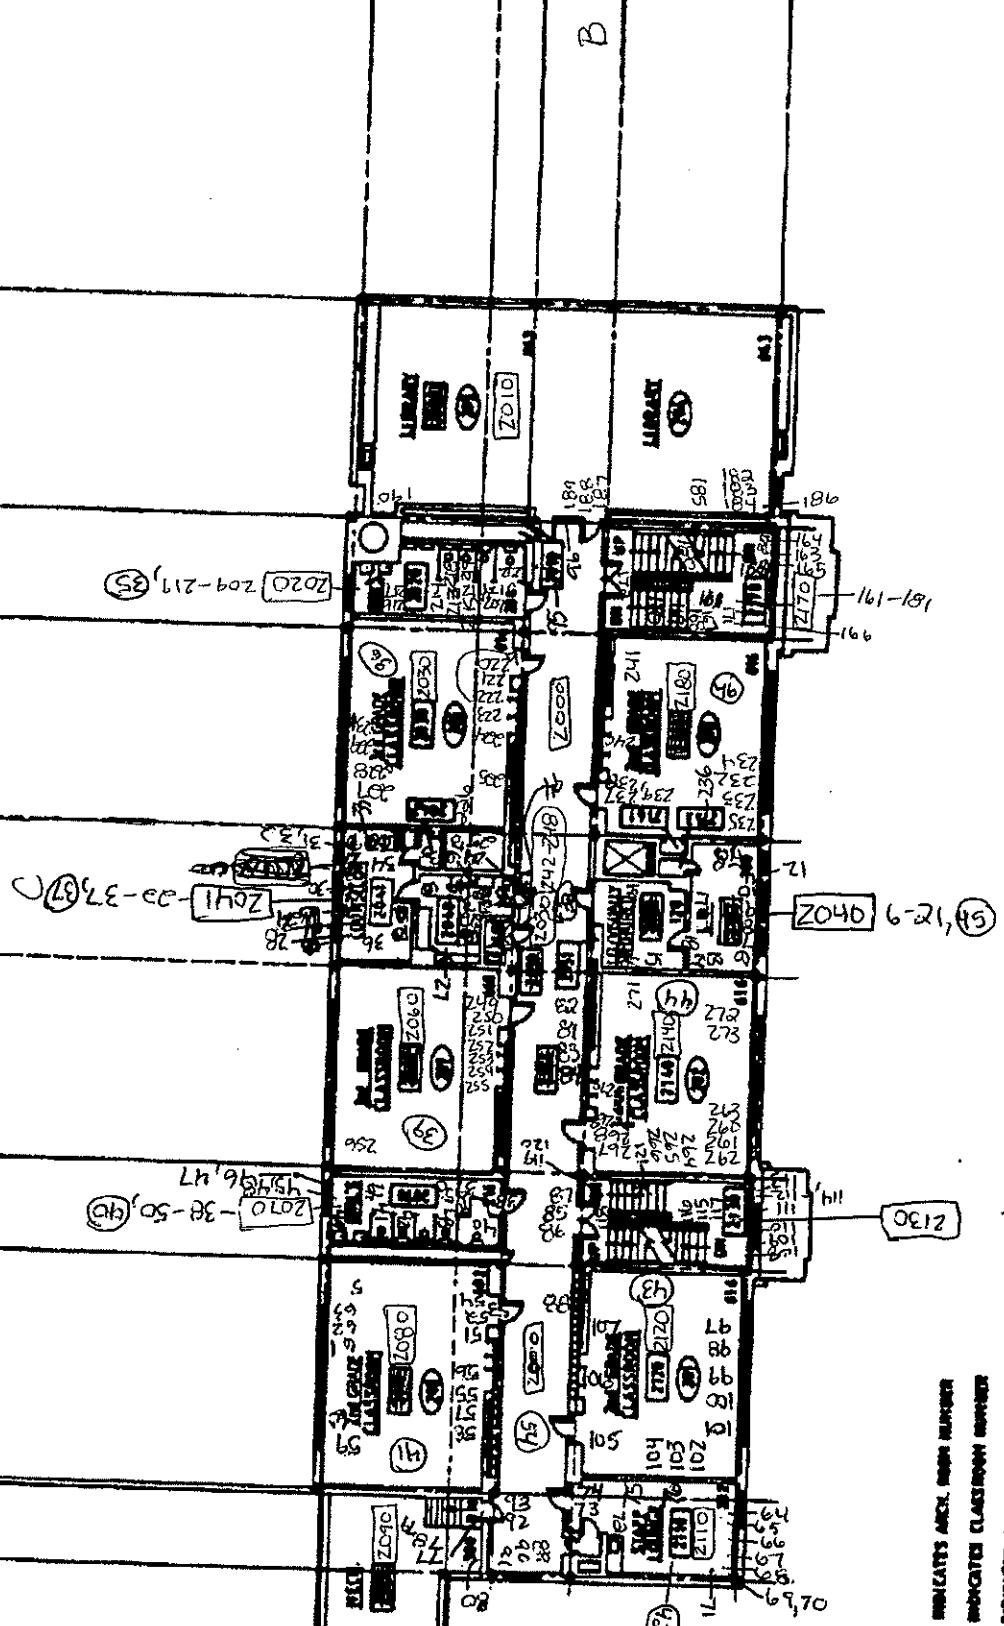
FIRST FLOOR PLAN

- Legend:
■ INDICATES AREA WITH NUMBER
 INDICATES CLASSROOM NUMBER
 INDICATES NUMBER IN PENTAKE

All room and area designations used in this report are depicted on sampling maps found in Appendix A.

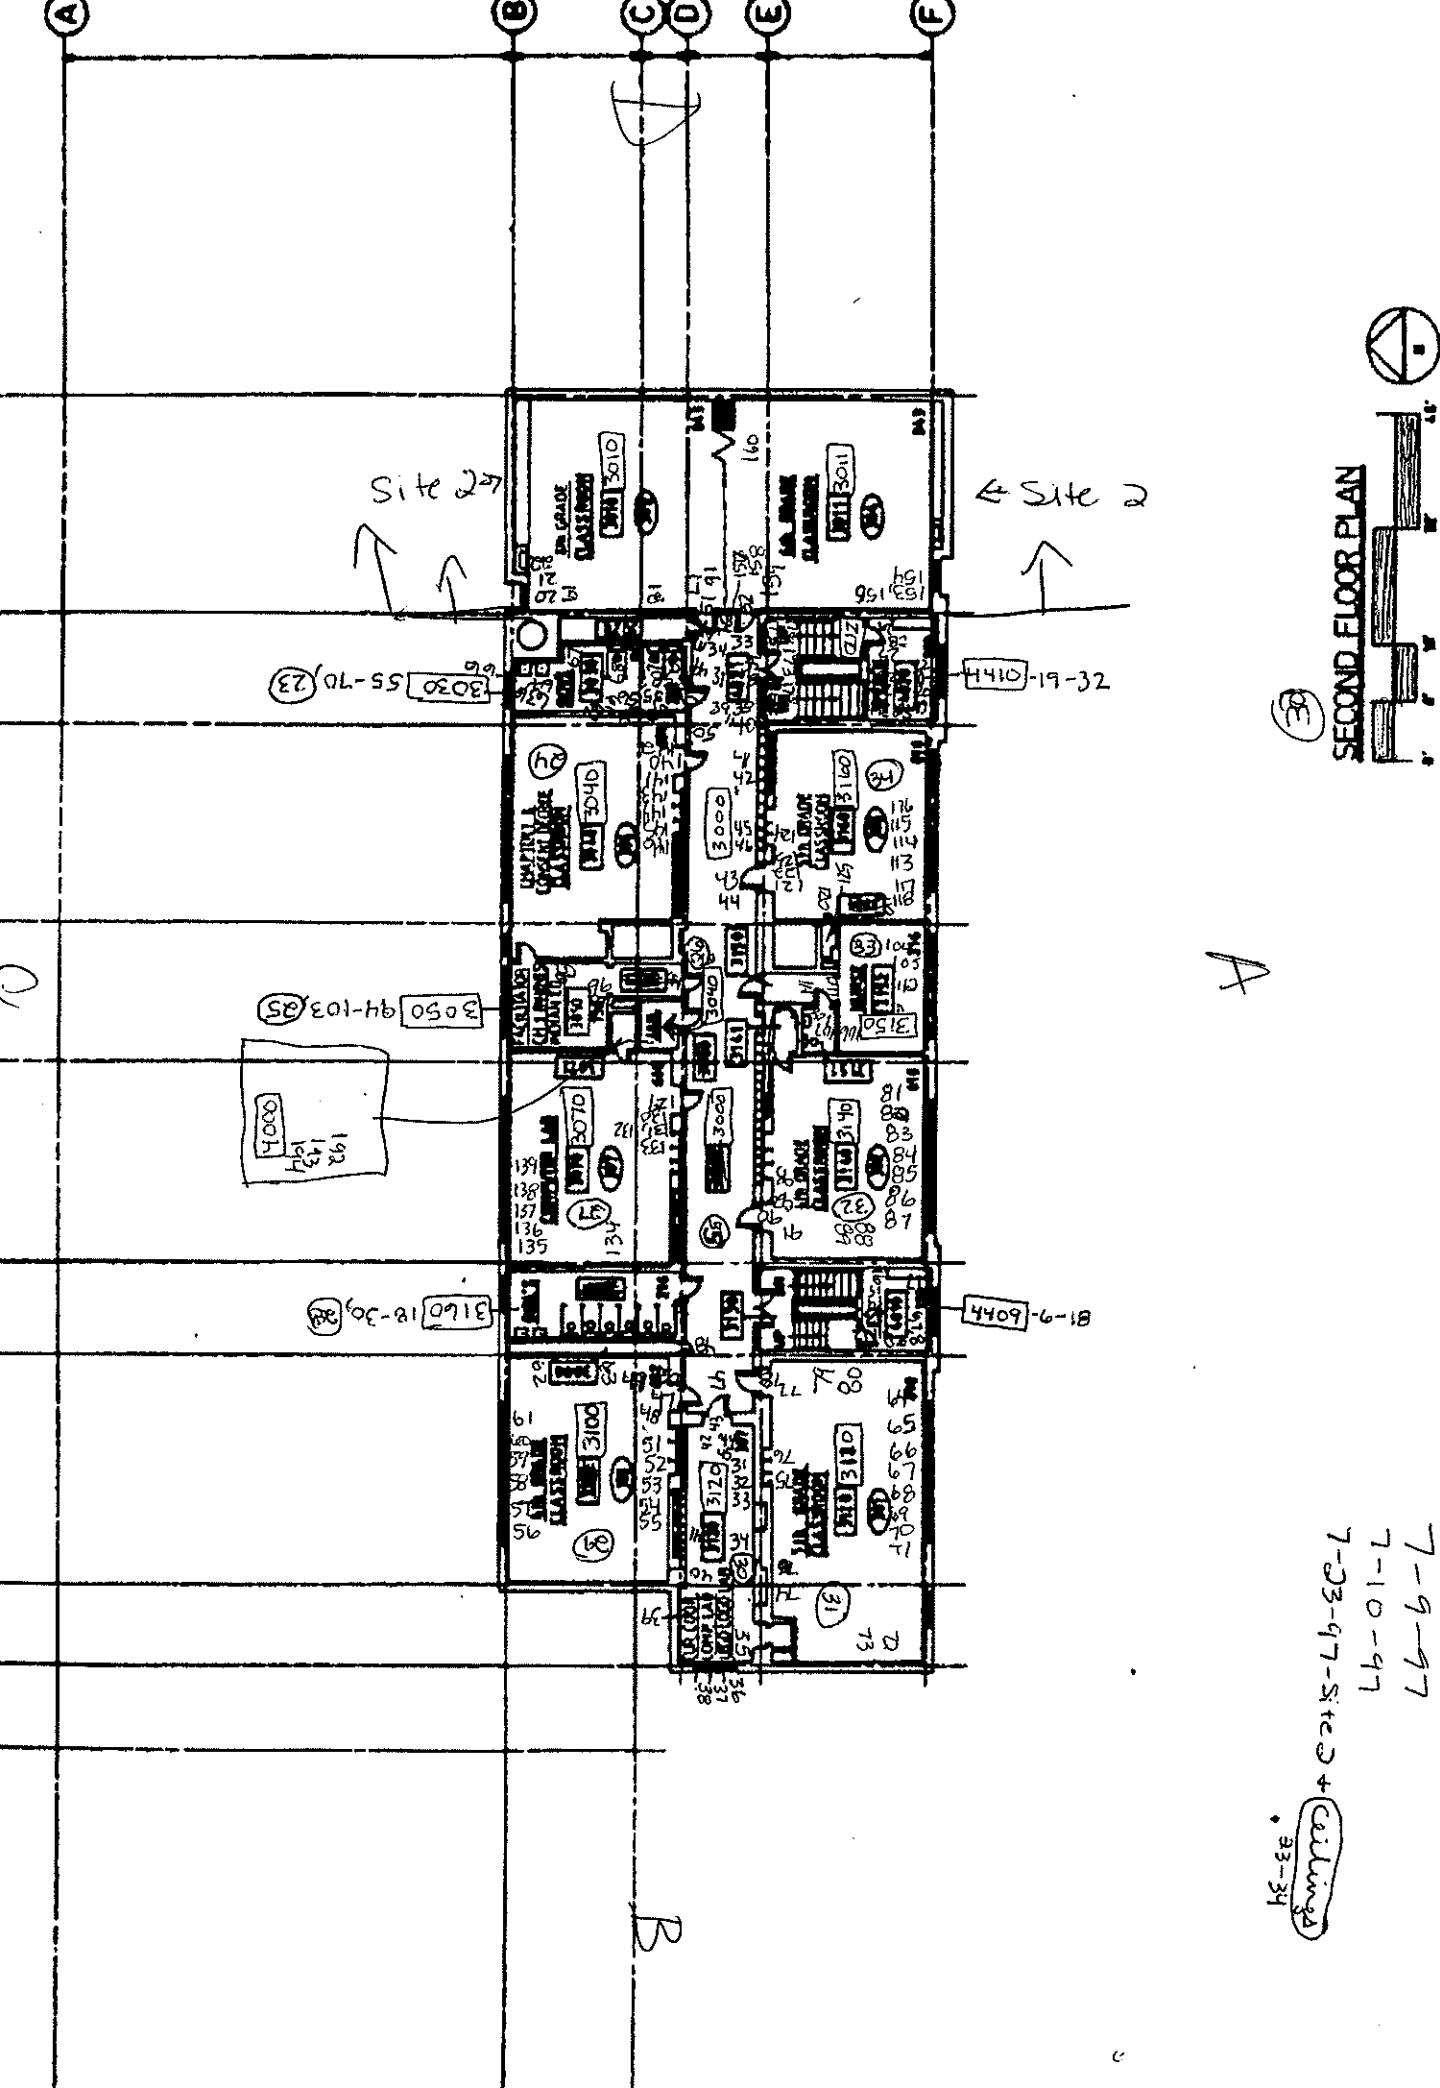
SECOND FLOOR PLAN

* majority of Paint Chip sample on wood
had Varnish Substrate layer
