**Galtier Magnet  
Saint Paul Public Schools**

**Lead-Based Paint Inspection**

**Inspection Dates: 8/4/97, 8/5/97, 8/19/97, 8/25/97, 9/4/97**

**MEC Project # 62/0197AJ**

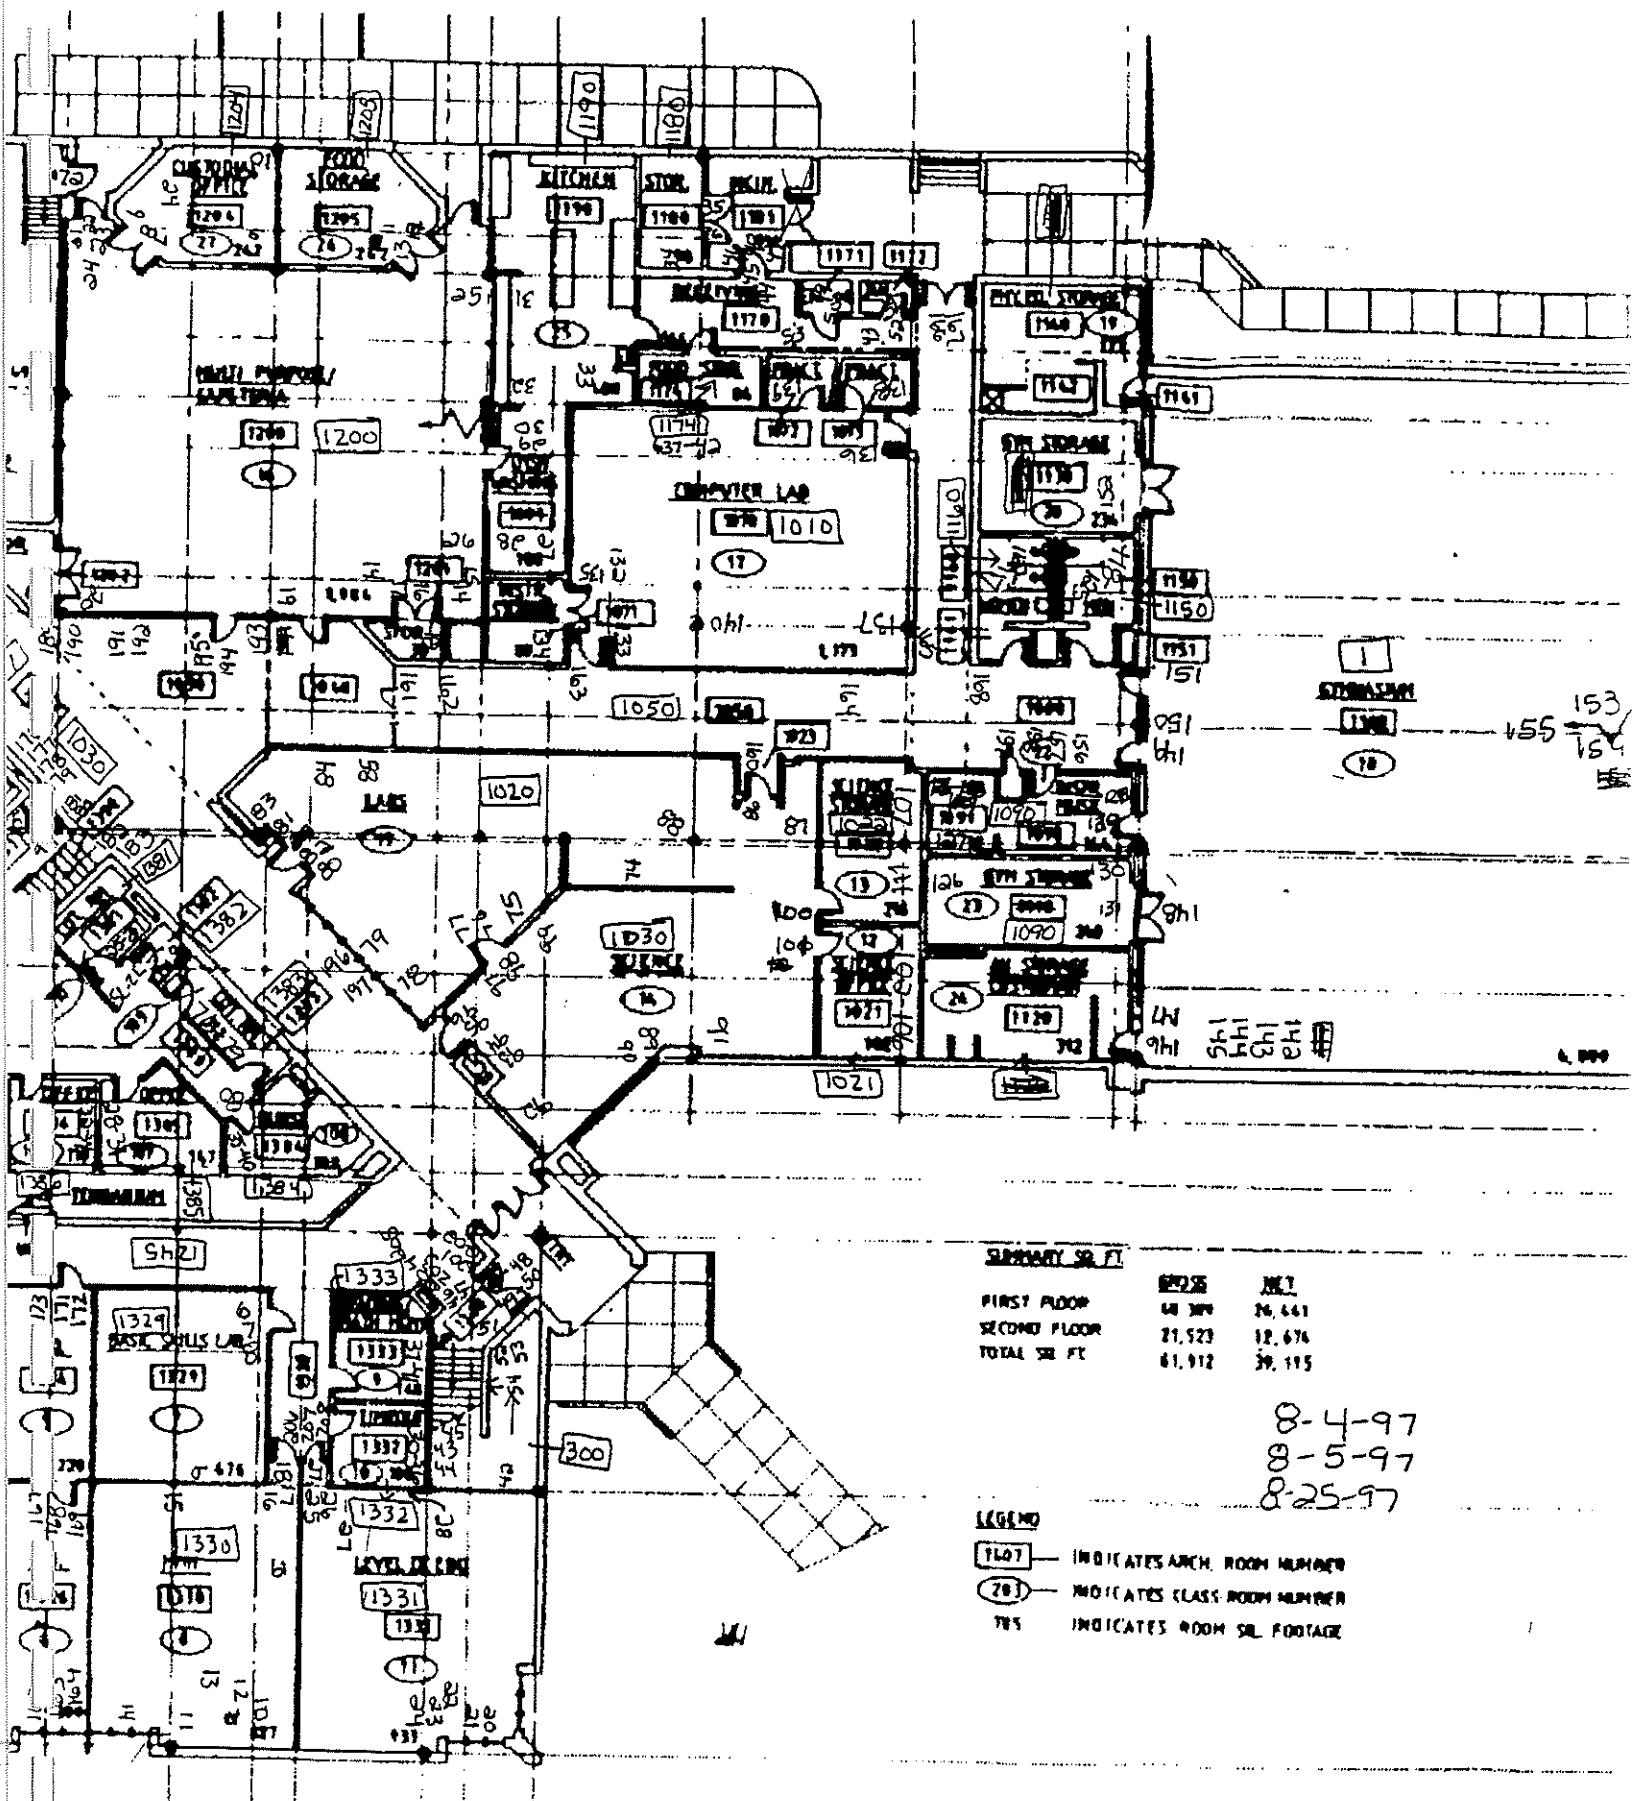
FIRST FLOOR PLAN

- [FLOT] INDICATES ARCH. ROOM NUMBERS
- [ZOT] INDICATES CLASS ROOM NUMBER
- [TFS] INDICATES ROOM SFL FOOTAGE

All room and area designations used in this report are depicted on sampling maps found in Appendix A.
