**Farnsworth Outcome Based Education Magnet School  
Saint Paul Public Schools**

**Lead-Based Paint Inspection**

**Inspection Dates: 4/4/97, 4/5/97, 4/6/97**

**MEC Project # 62/0197L**

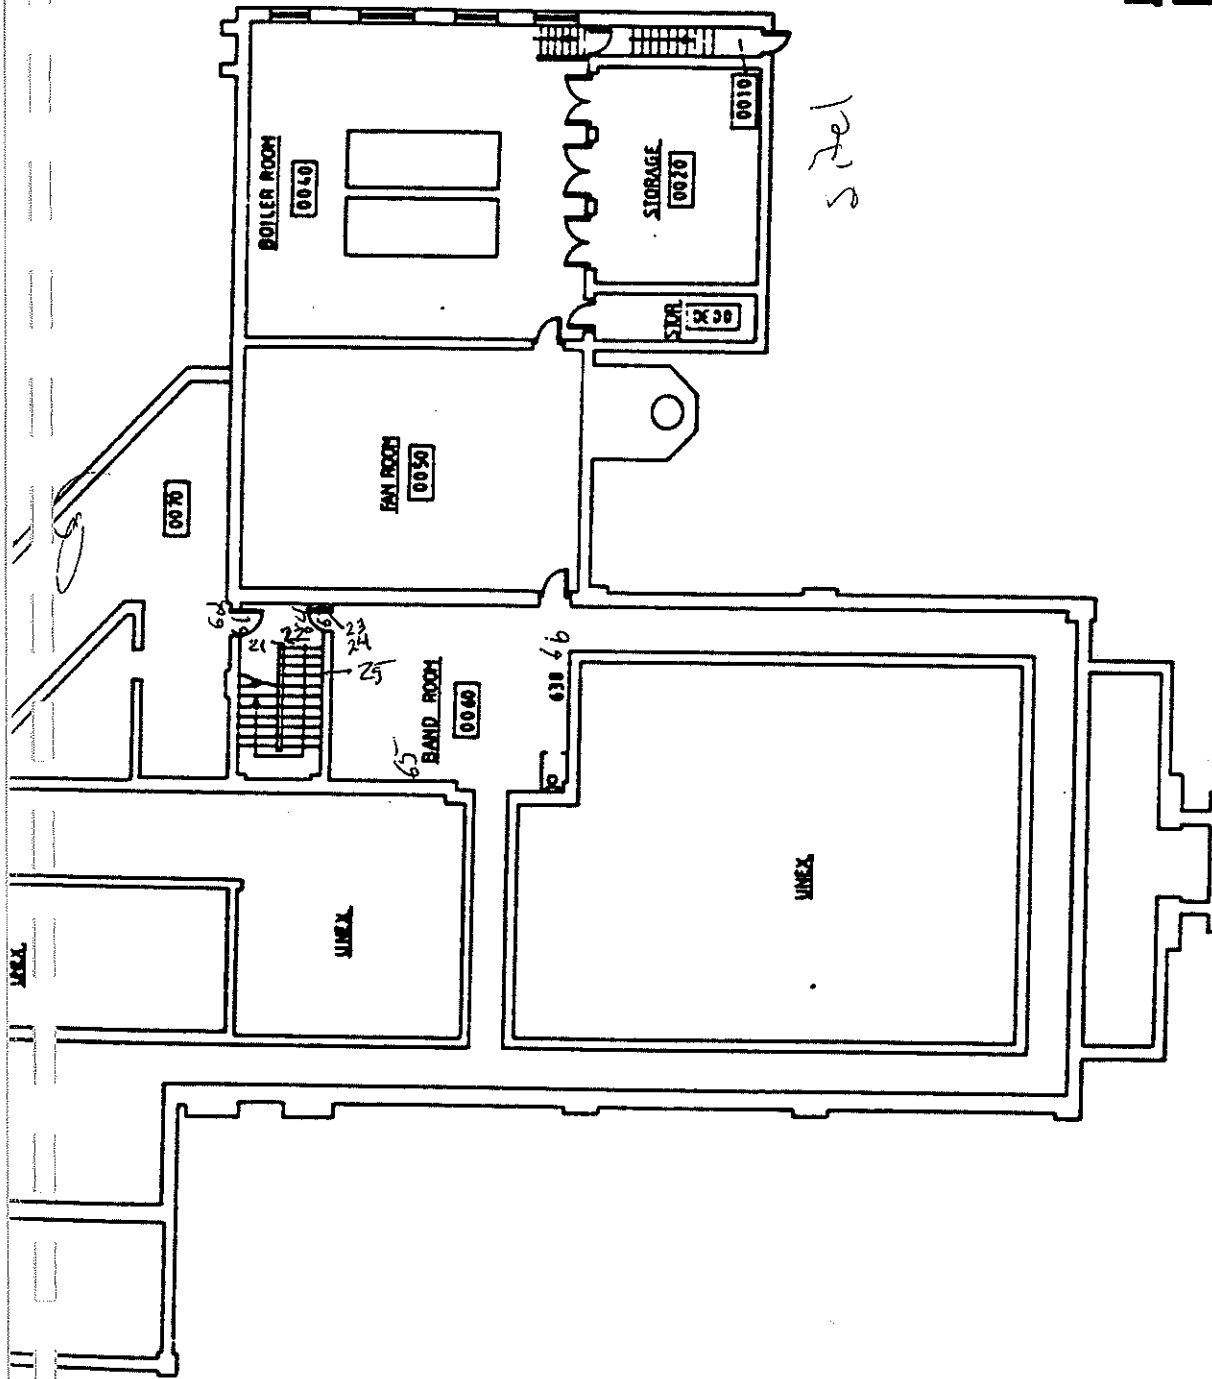
BASEMENT FLOOR PLAN

All room and area designations used in this report are depicted on sampling maps found in Appendix A.
