**Groveland Park Elementary
Saint Paul Public Schools**

Lead-Based Paint Inspection

MEC Project # 62/0197U

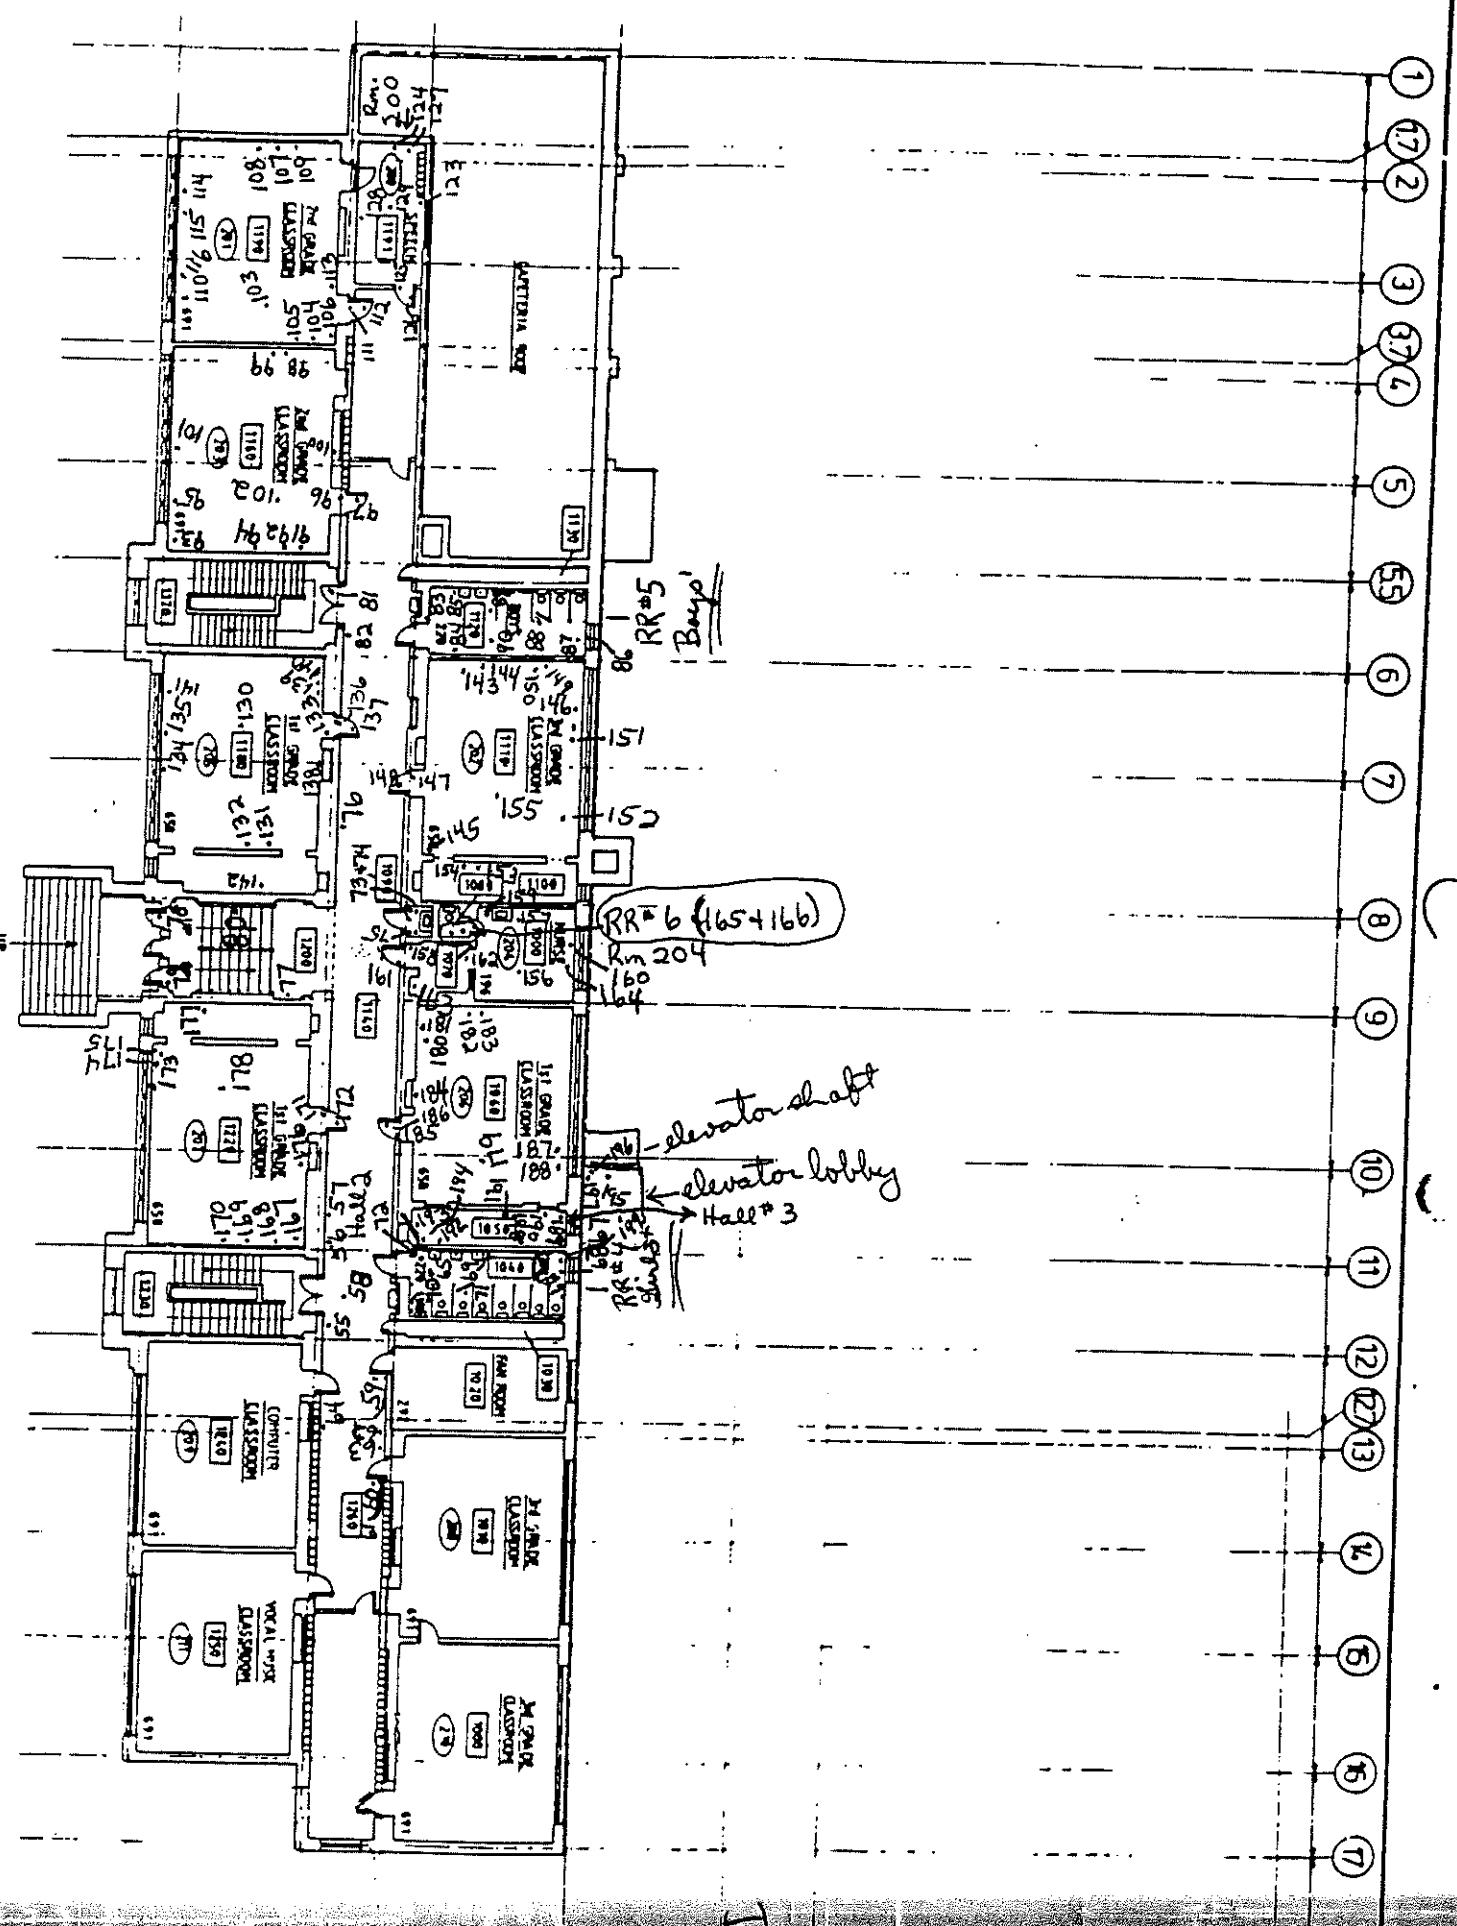
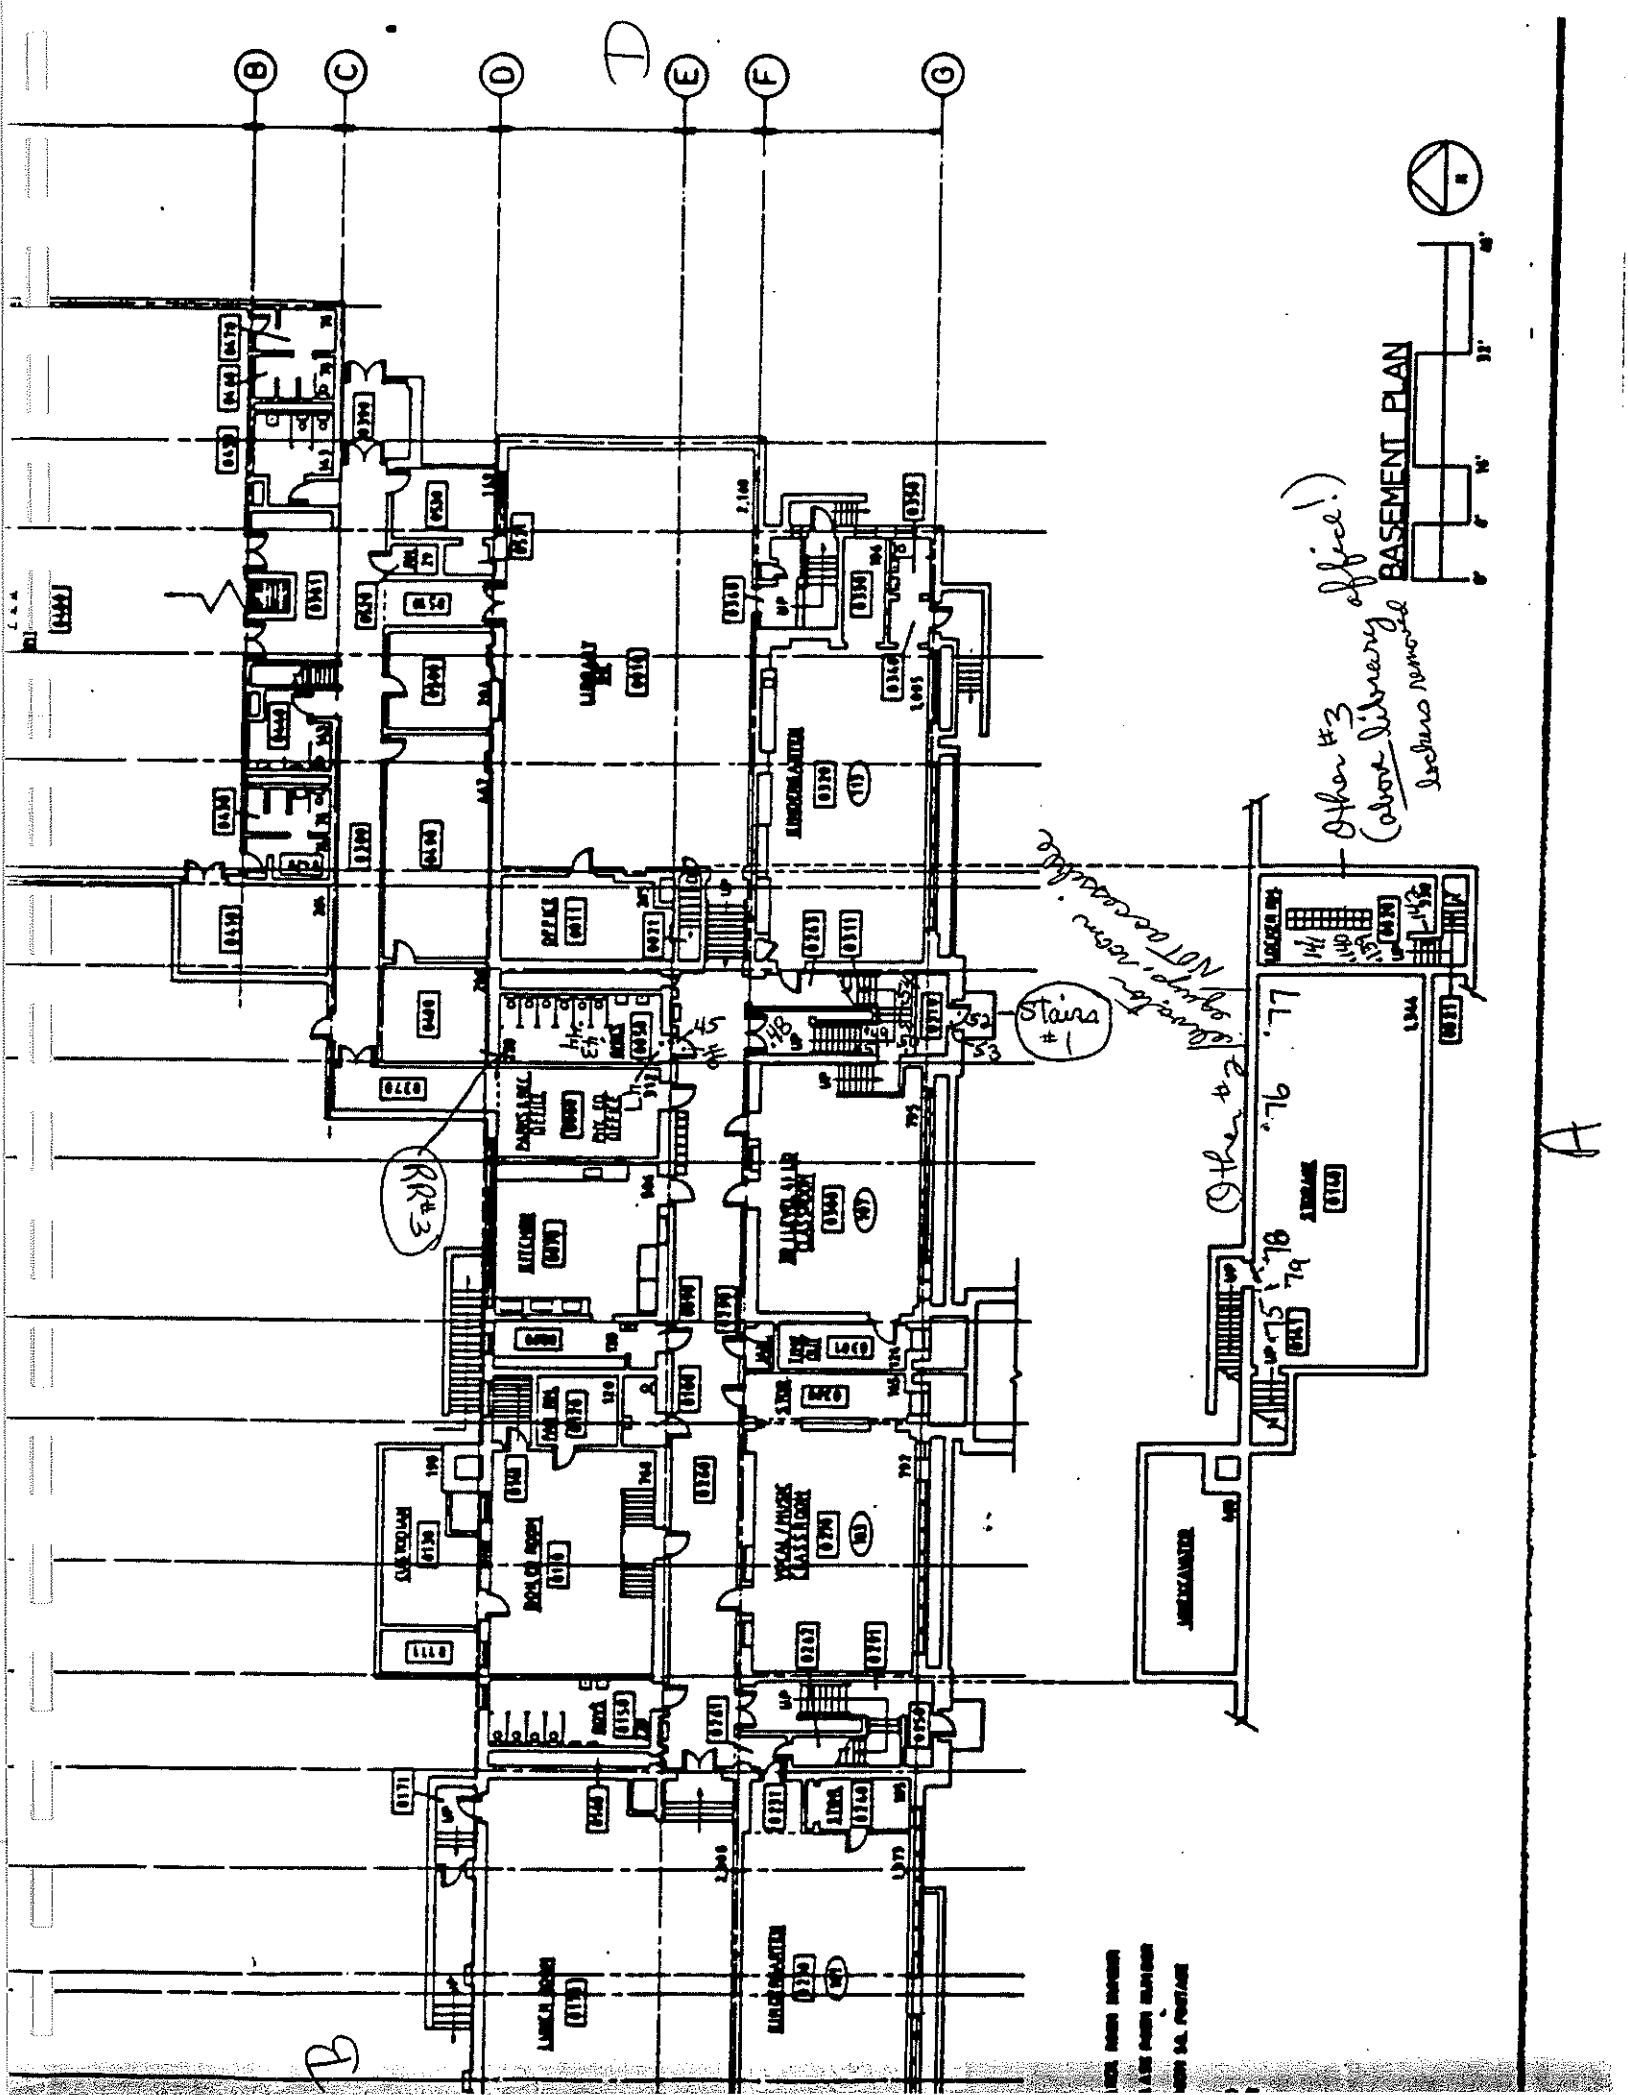
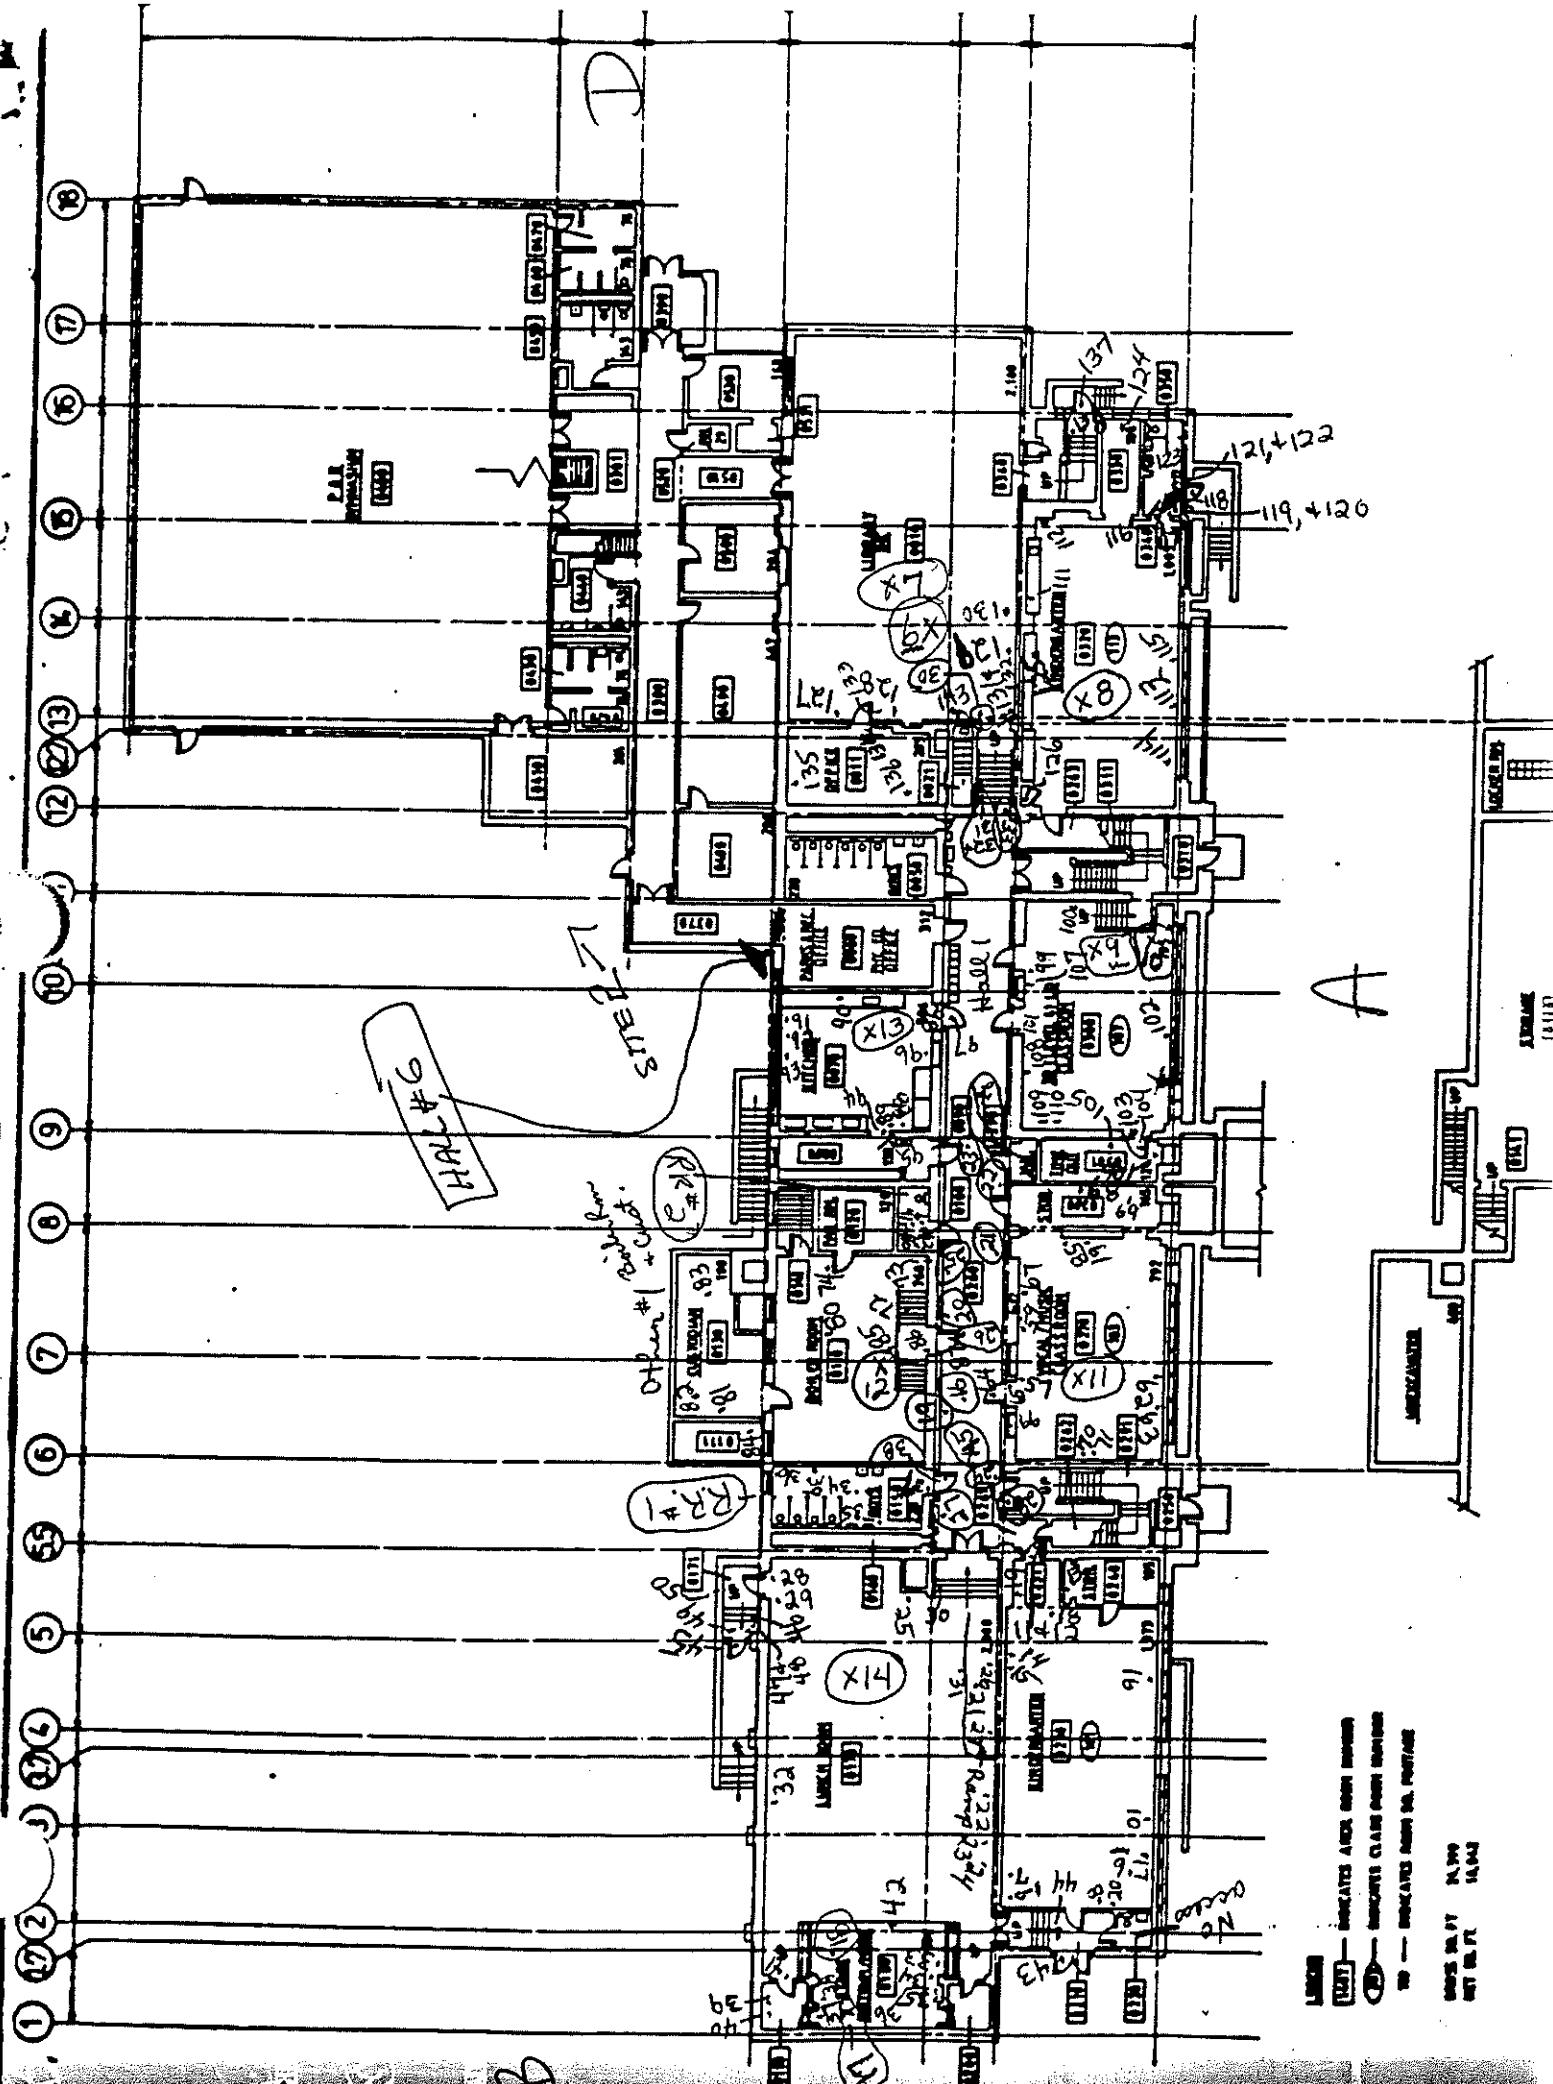
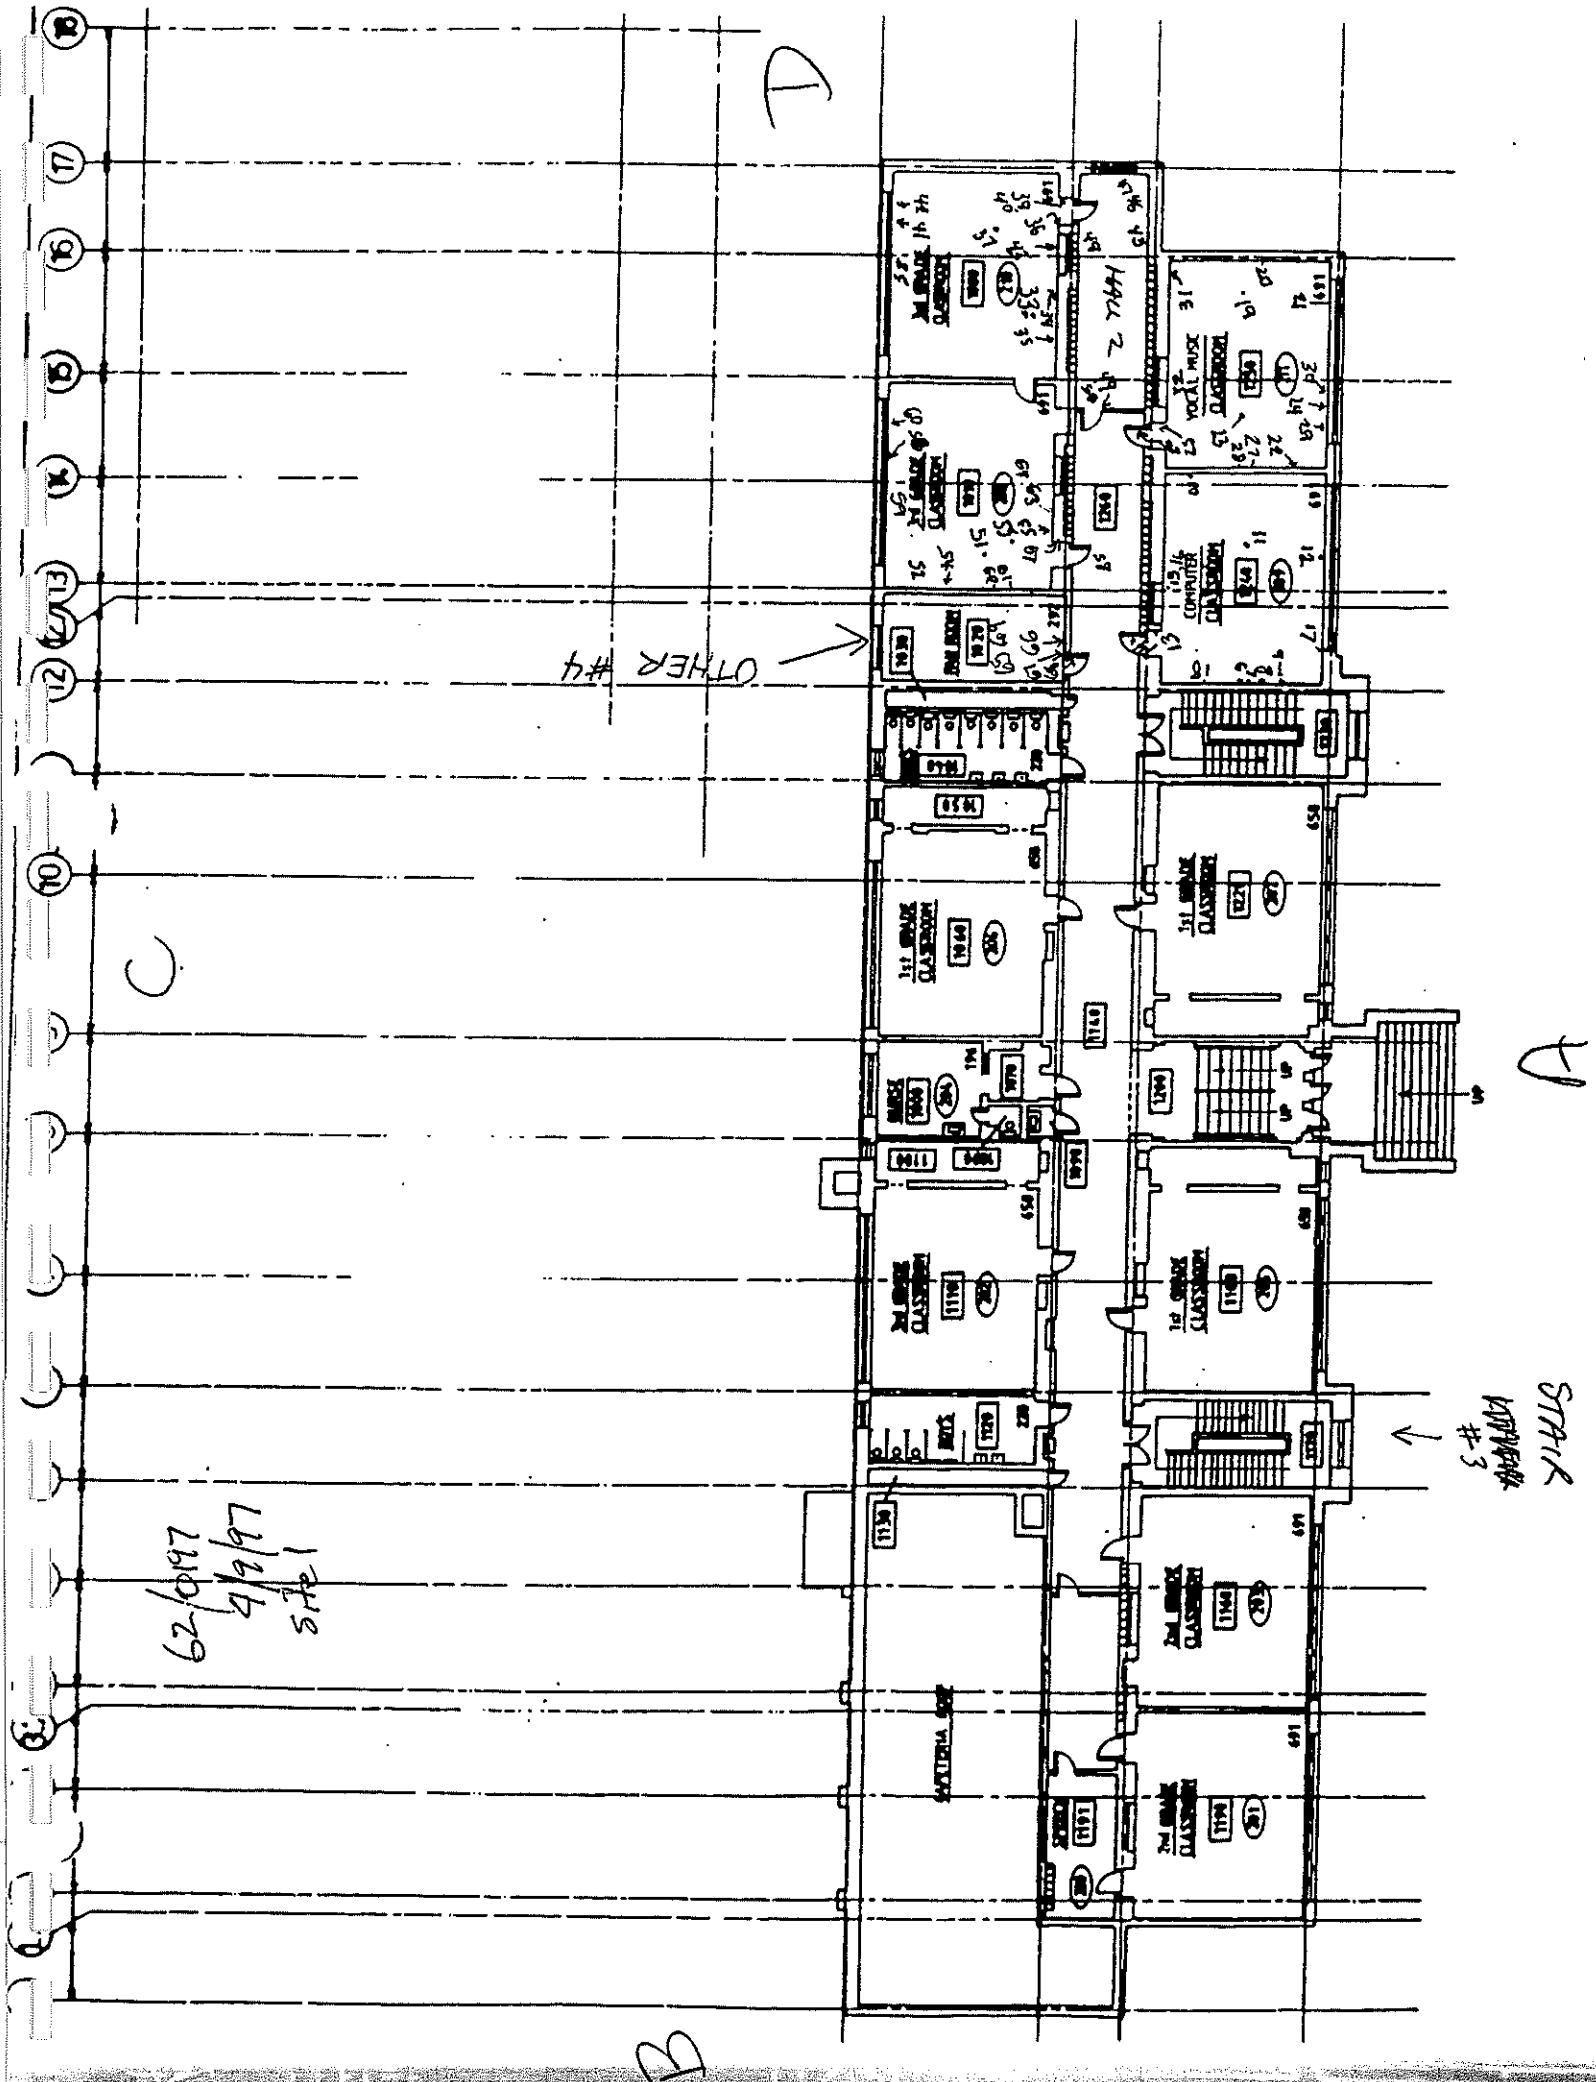
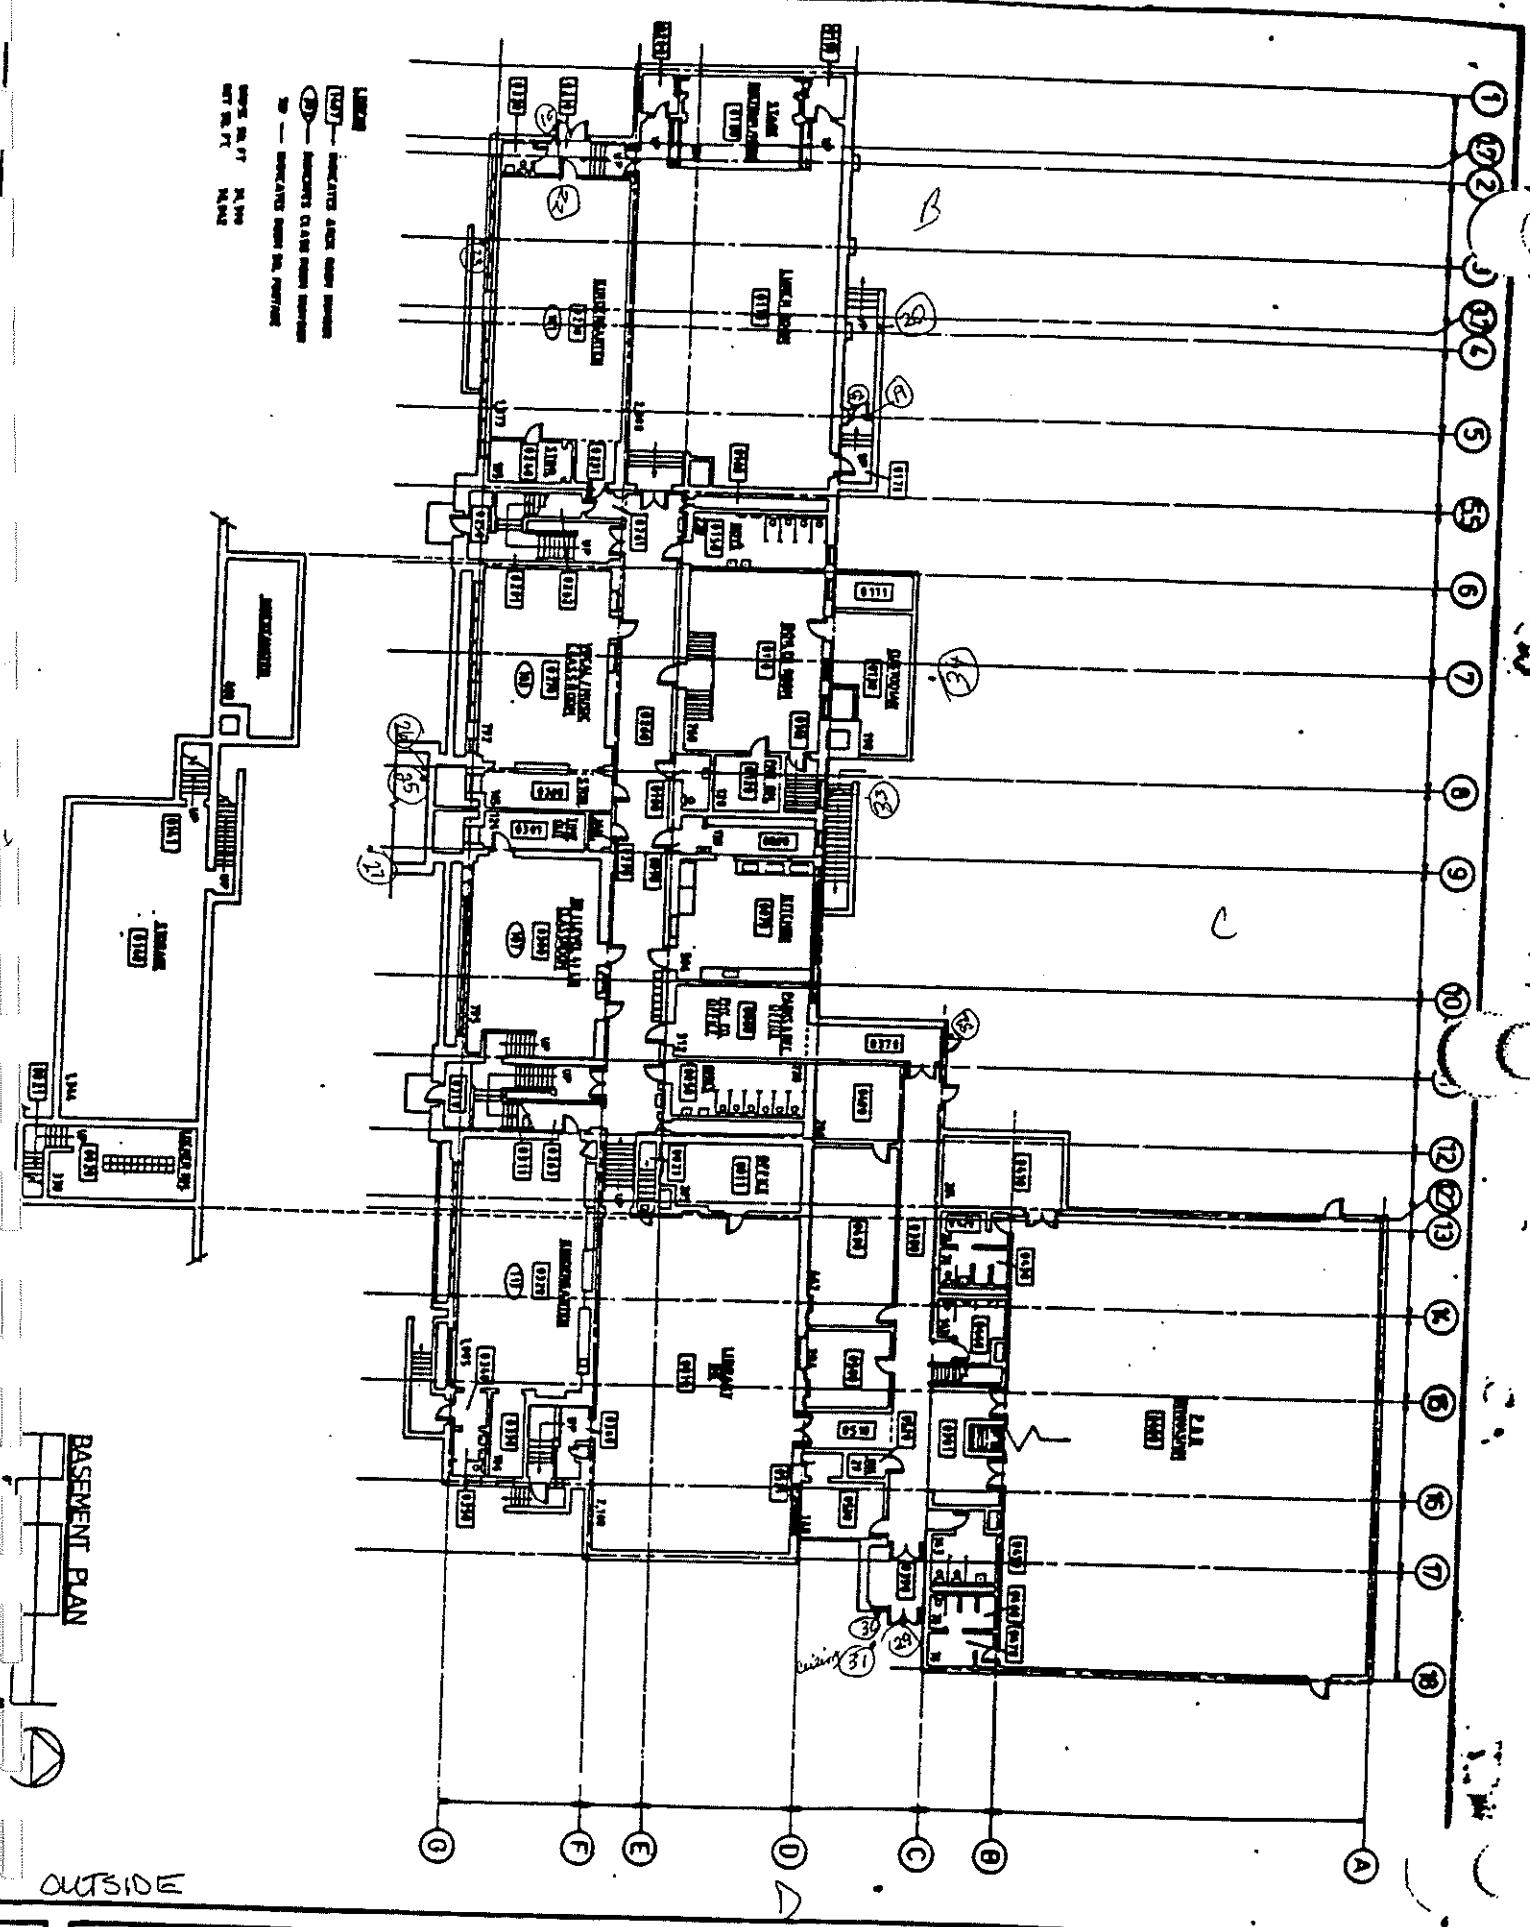
XRF TESTING DATA WITH LOCATION MAPS

All room and area designations used in this report are depicted on sampling maps found in Appendix A.
