**Hayden Heights Elementary  
Saint Paul Public Schools**

**Lead-Based Paint Inspection**

**Inspection Dates: 2/3/97, 2/4/97, 2/7/97, 2/8/97, 2/9/97, 2/10/97**

**MEC Project # 62/0197B**

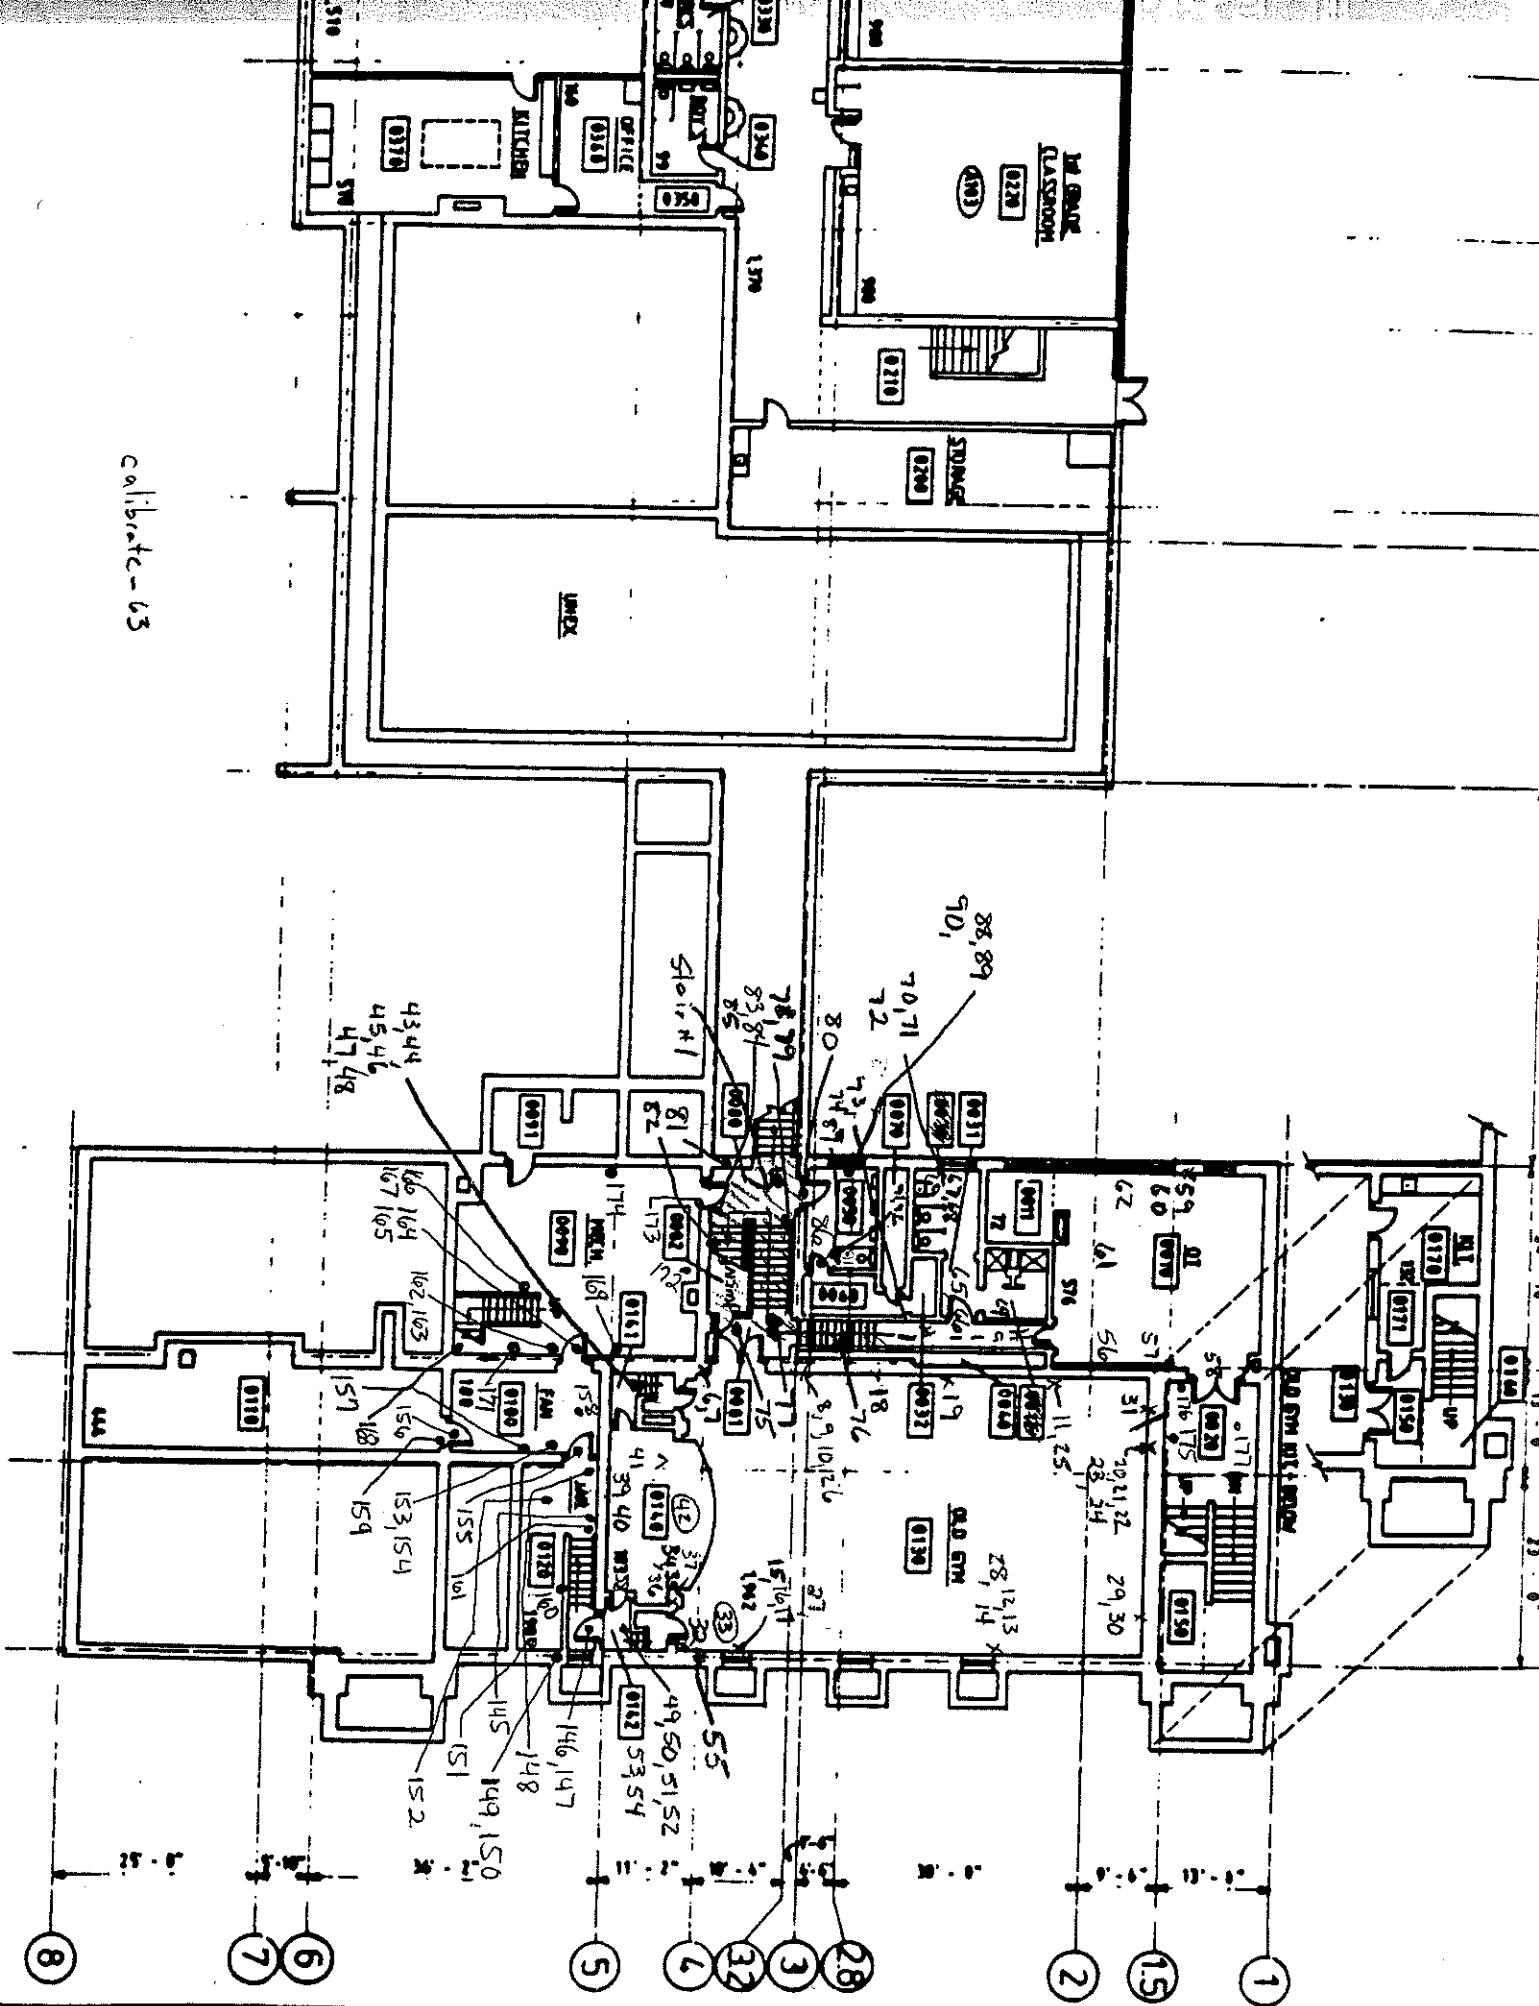
THIRD FLOOR PLAN

HAYDEN HEIGHTS ELEMENTARY

CONSTRUCTED: 1923, 25, 41, 54, 66

All room and area designations used in this report are depicted on sampling maps found in Appendix A.

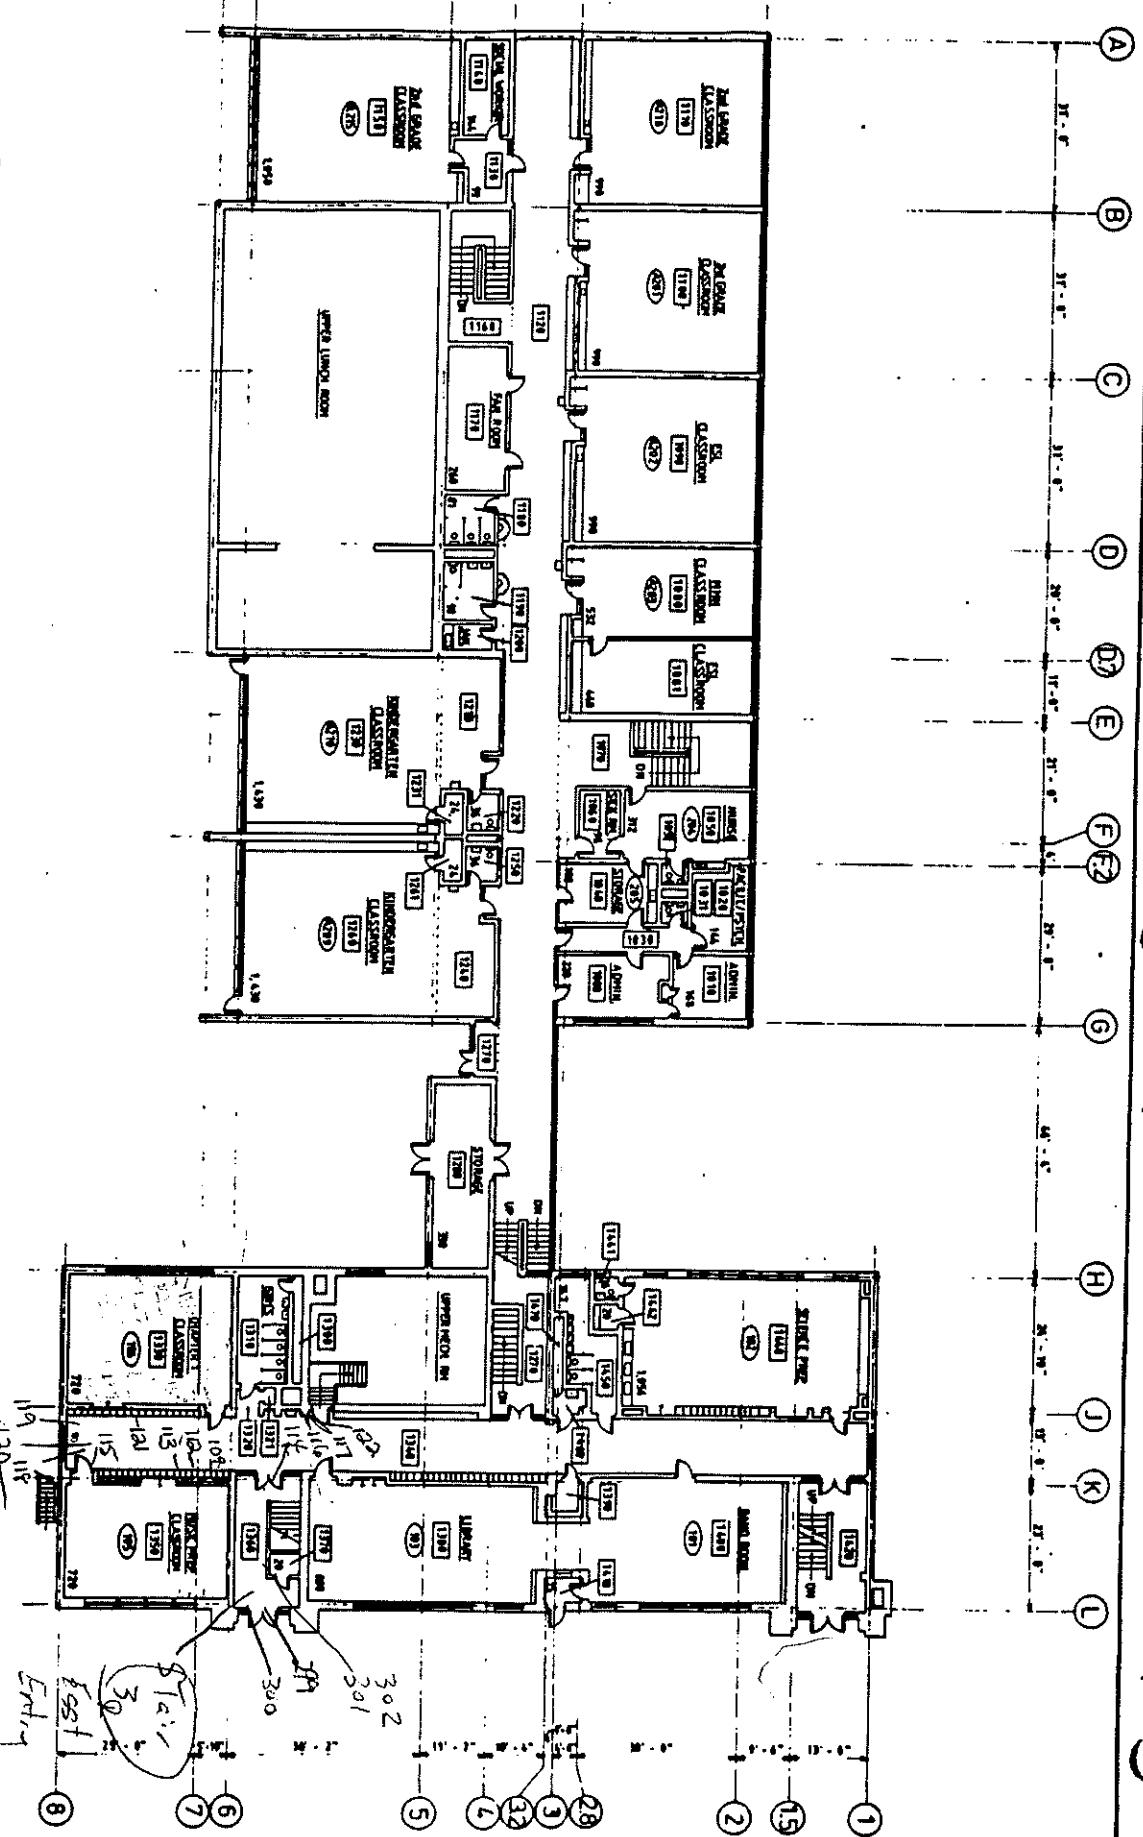
BASEMENT FLOOR PLAN

HAYDEN HEIGHTS ELEMENTARY  
N. HAZEL & CLEAR AVE.  
ST. PAUL, MINNESOTA 55119

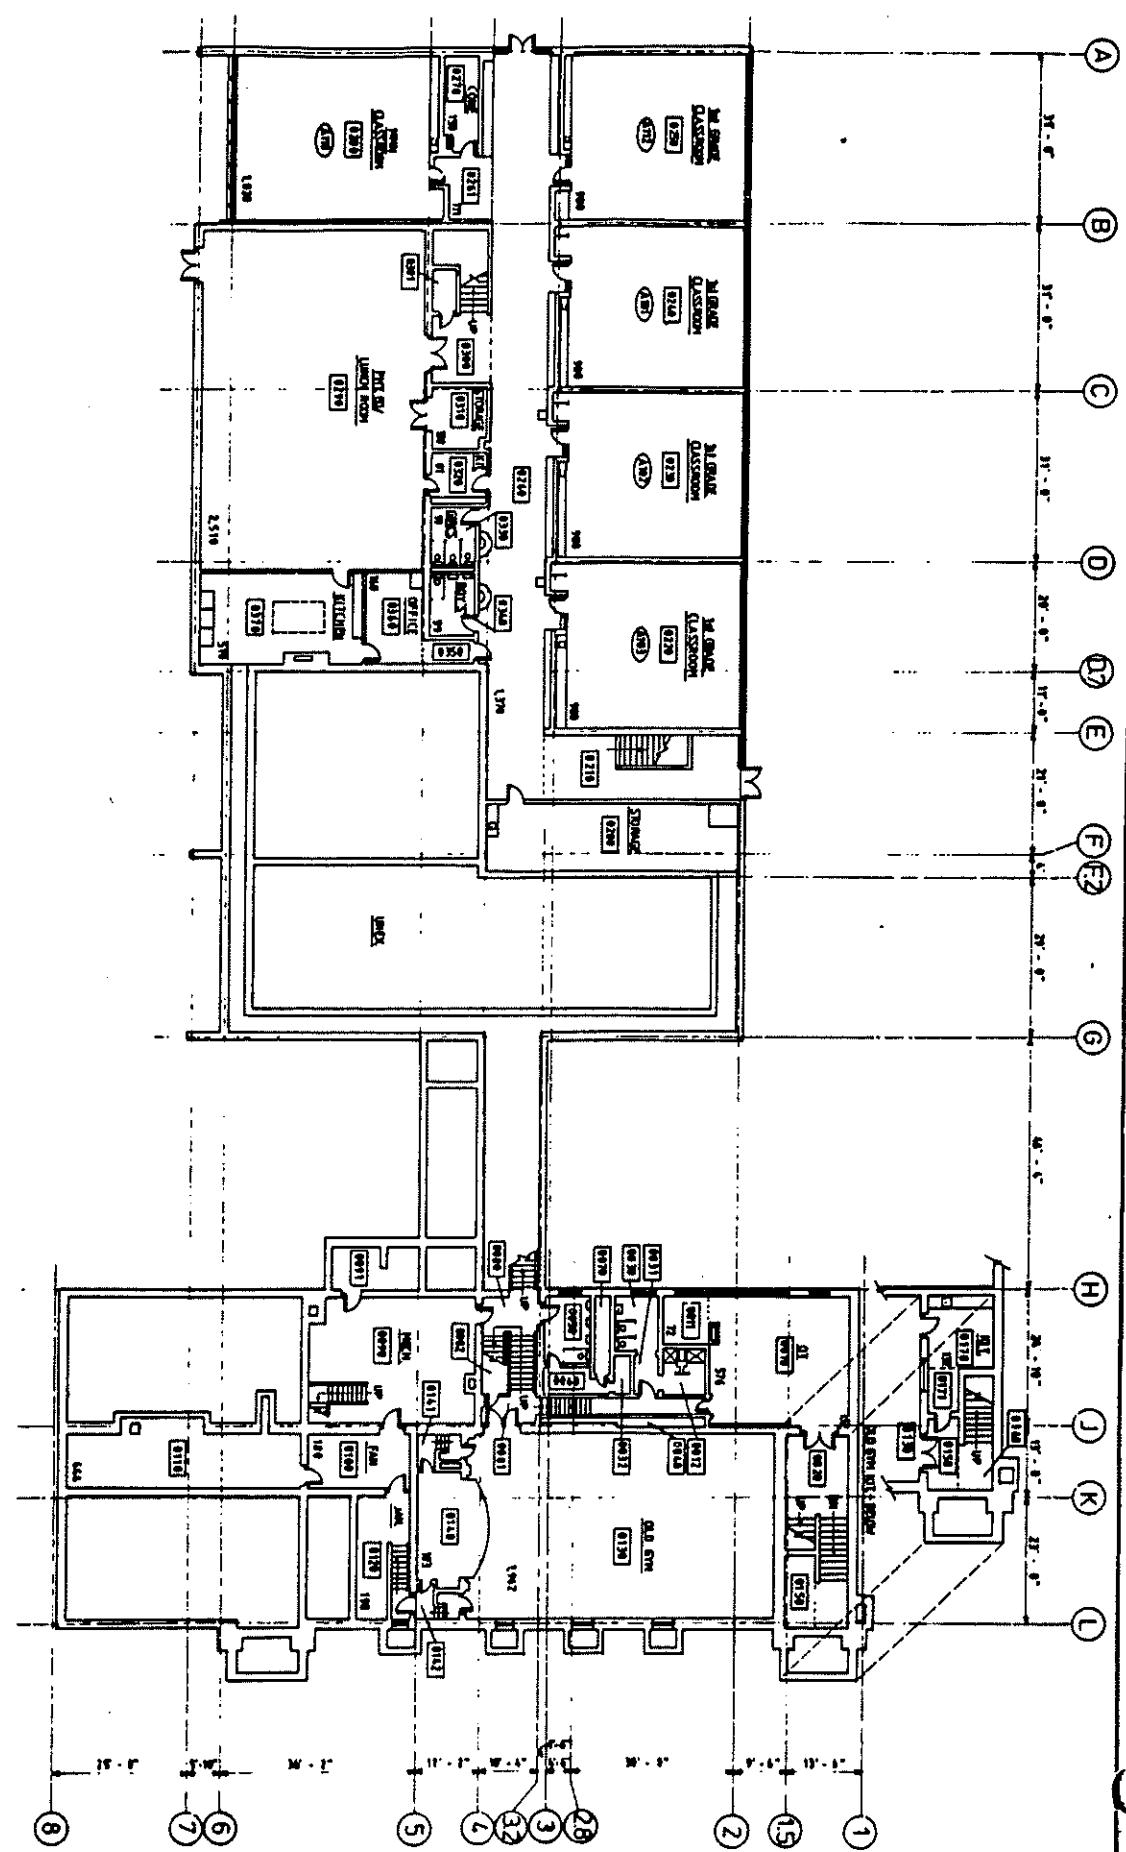
HAYDEN HEIGHTS ELEMENTARY  
N. HAZEL & CLEAR AVE.  
ST. PAUL, MINNESOTA 55119

CONSTRUCTED: 1923, 25, 41, 54, 66
