**Highland Park Elementary  
Saint Paul Public Schools**

**Lead-Based Paint Inspection**

**MEC Project # 62/0197A**

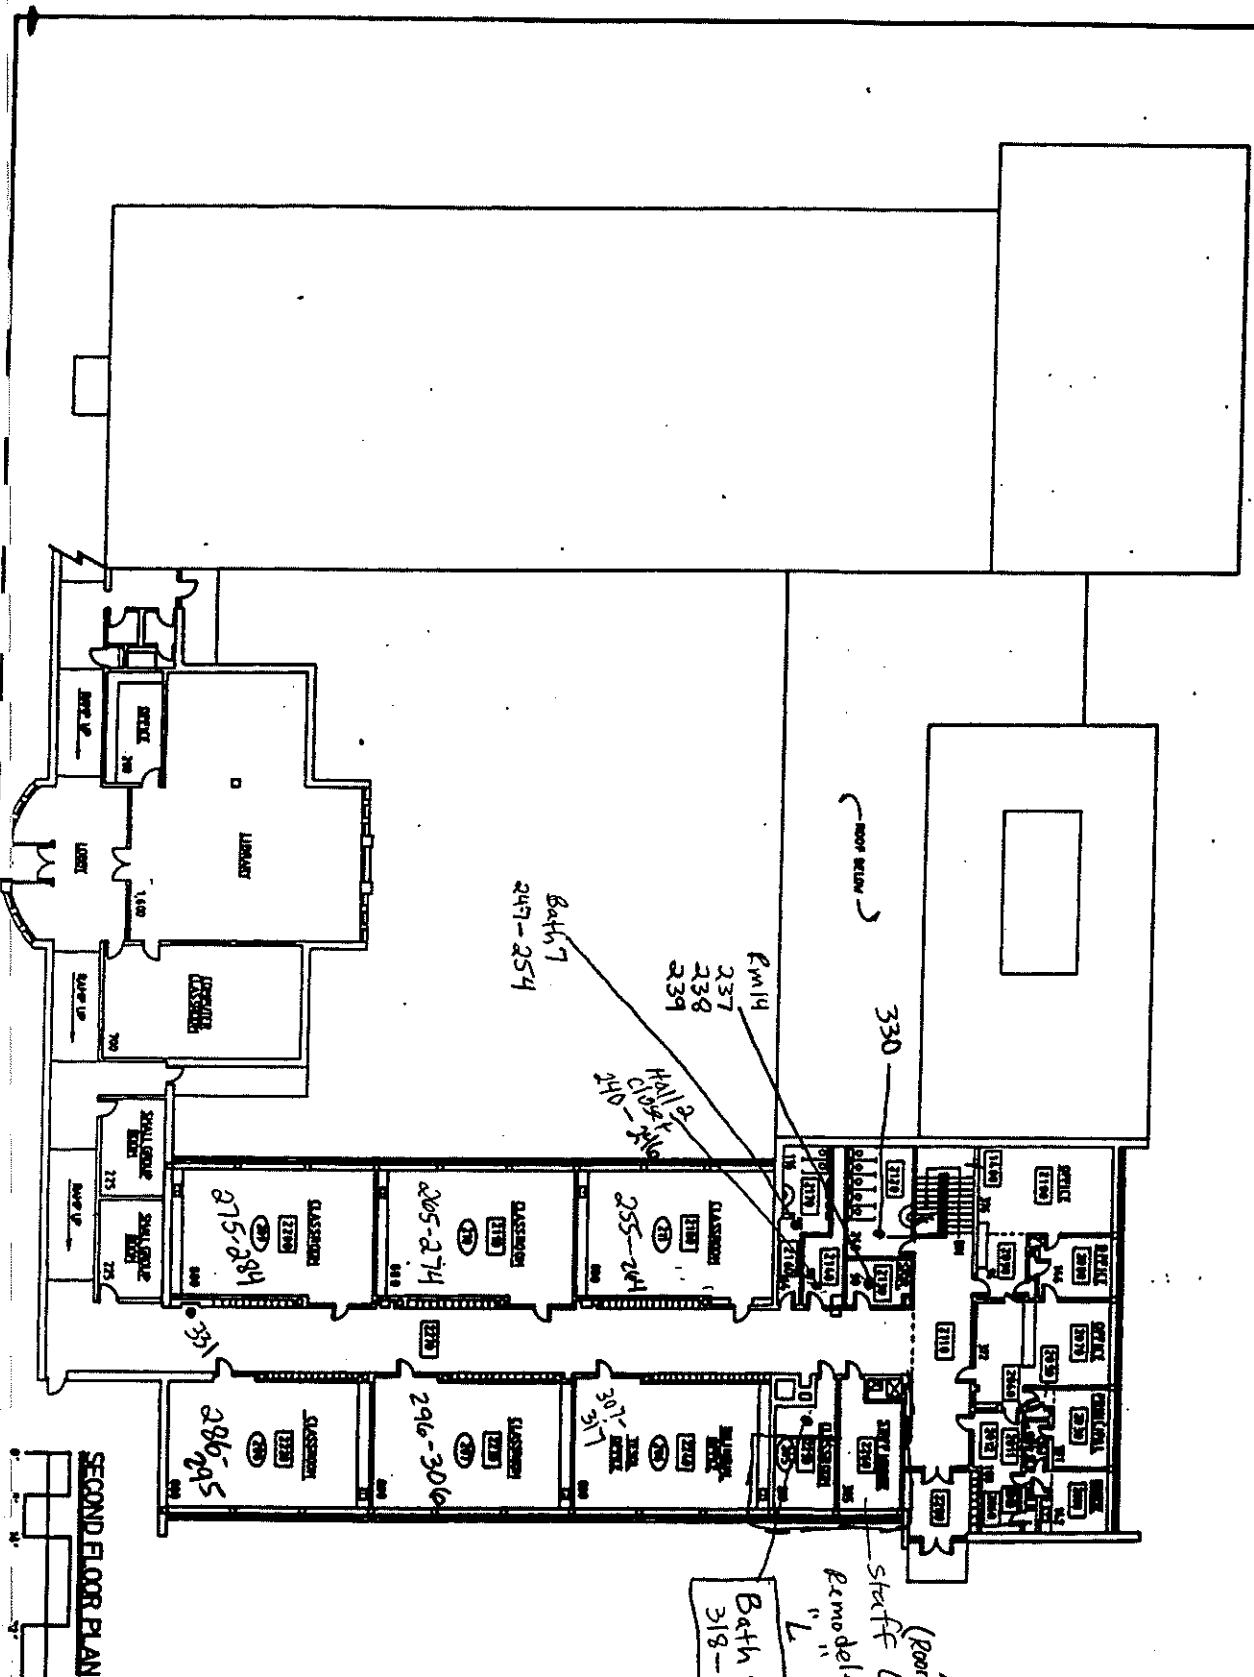
change to \*  
7-329  
(Room 15) 3rd fl.  
staff lounge  
remodeled to  
"L" shape

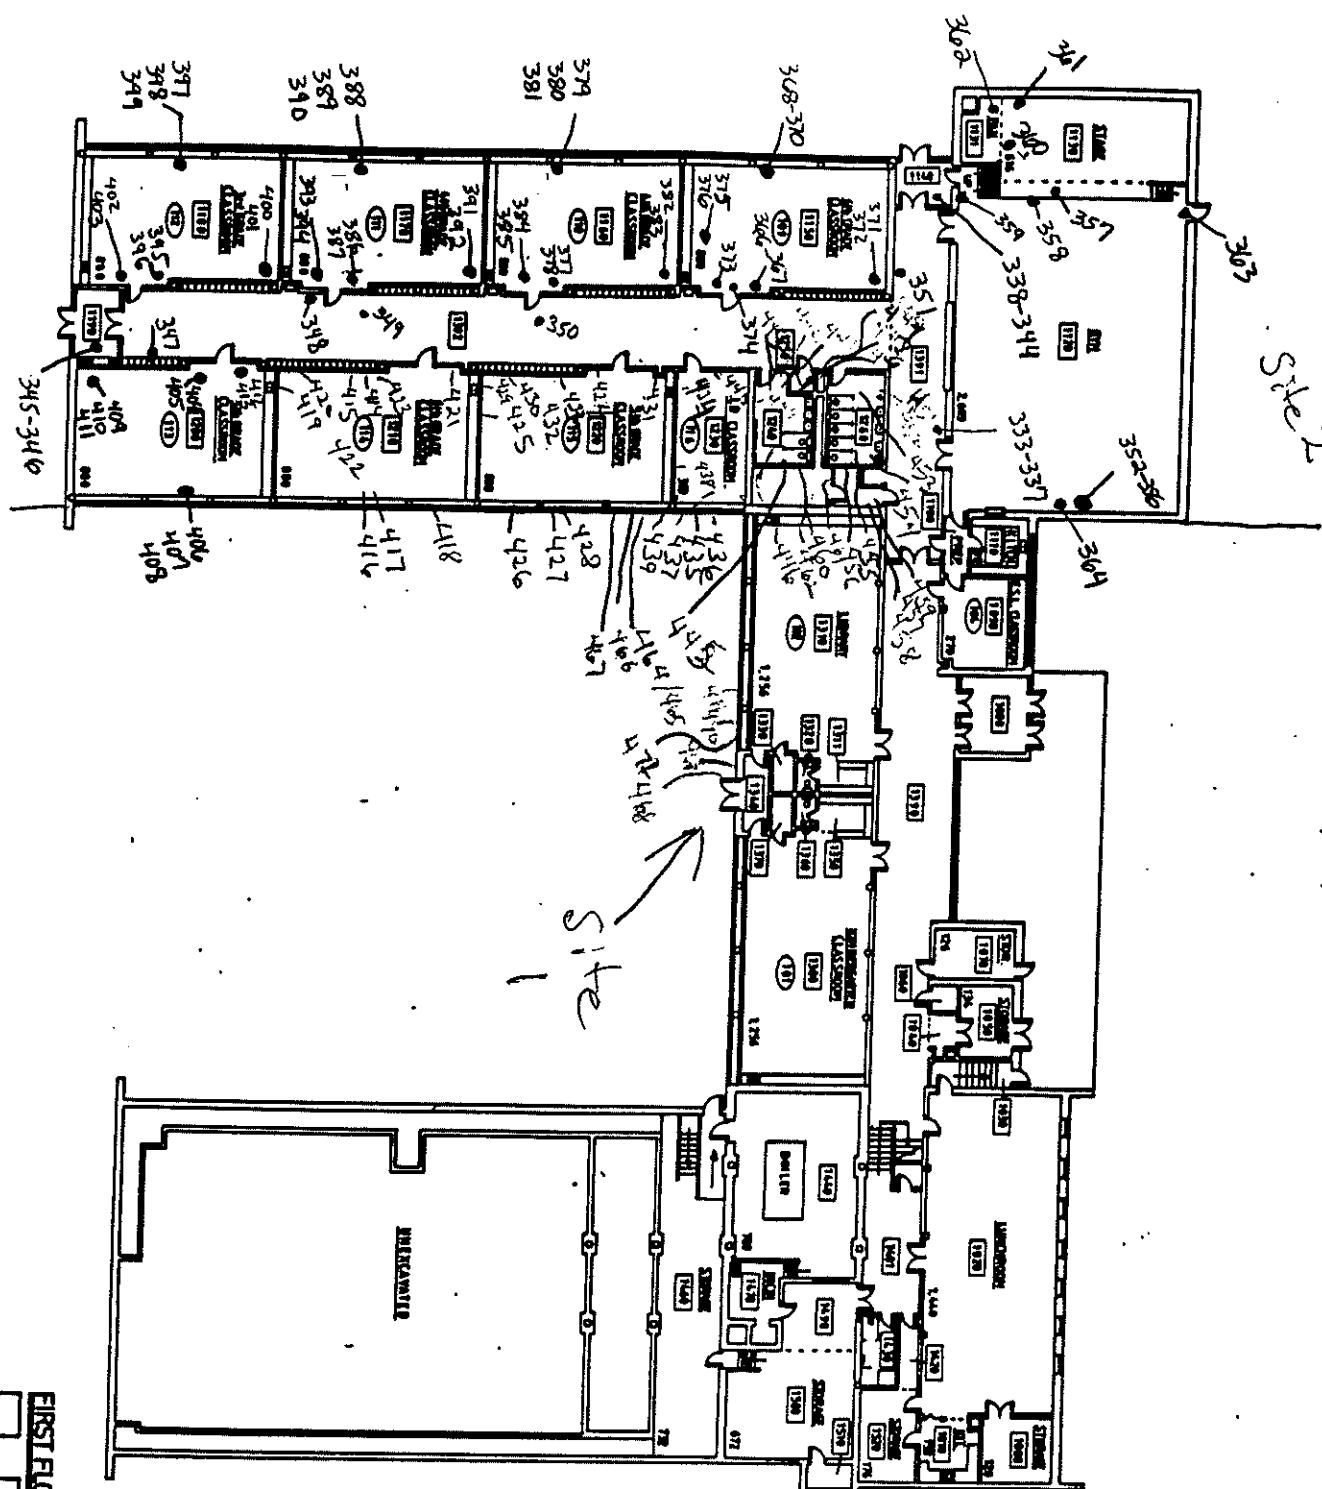
## FIRST FLOOR PLAN

All room and area designations used in this report are depicted on sampling maps found in Appendix A.
