**Humboldt Secondary Complex SH
Saint Paul Public Schools**

Lead-Based Paint Inspection

Inspection Dates: 2/26/97, 2/27/97, 3/1/97, 3/2/97

MEC Project # 62/0197P

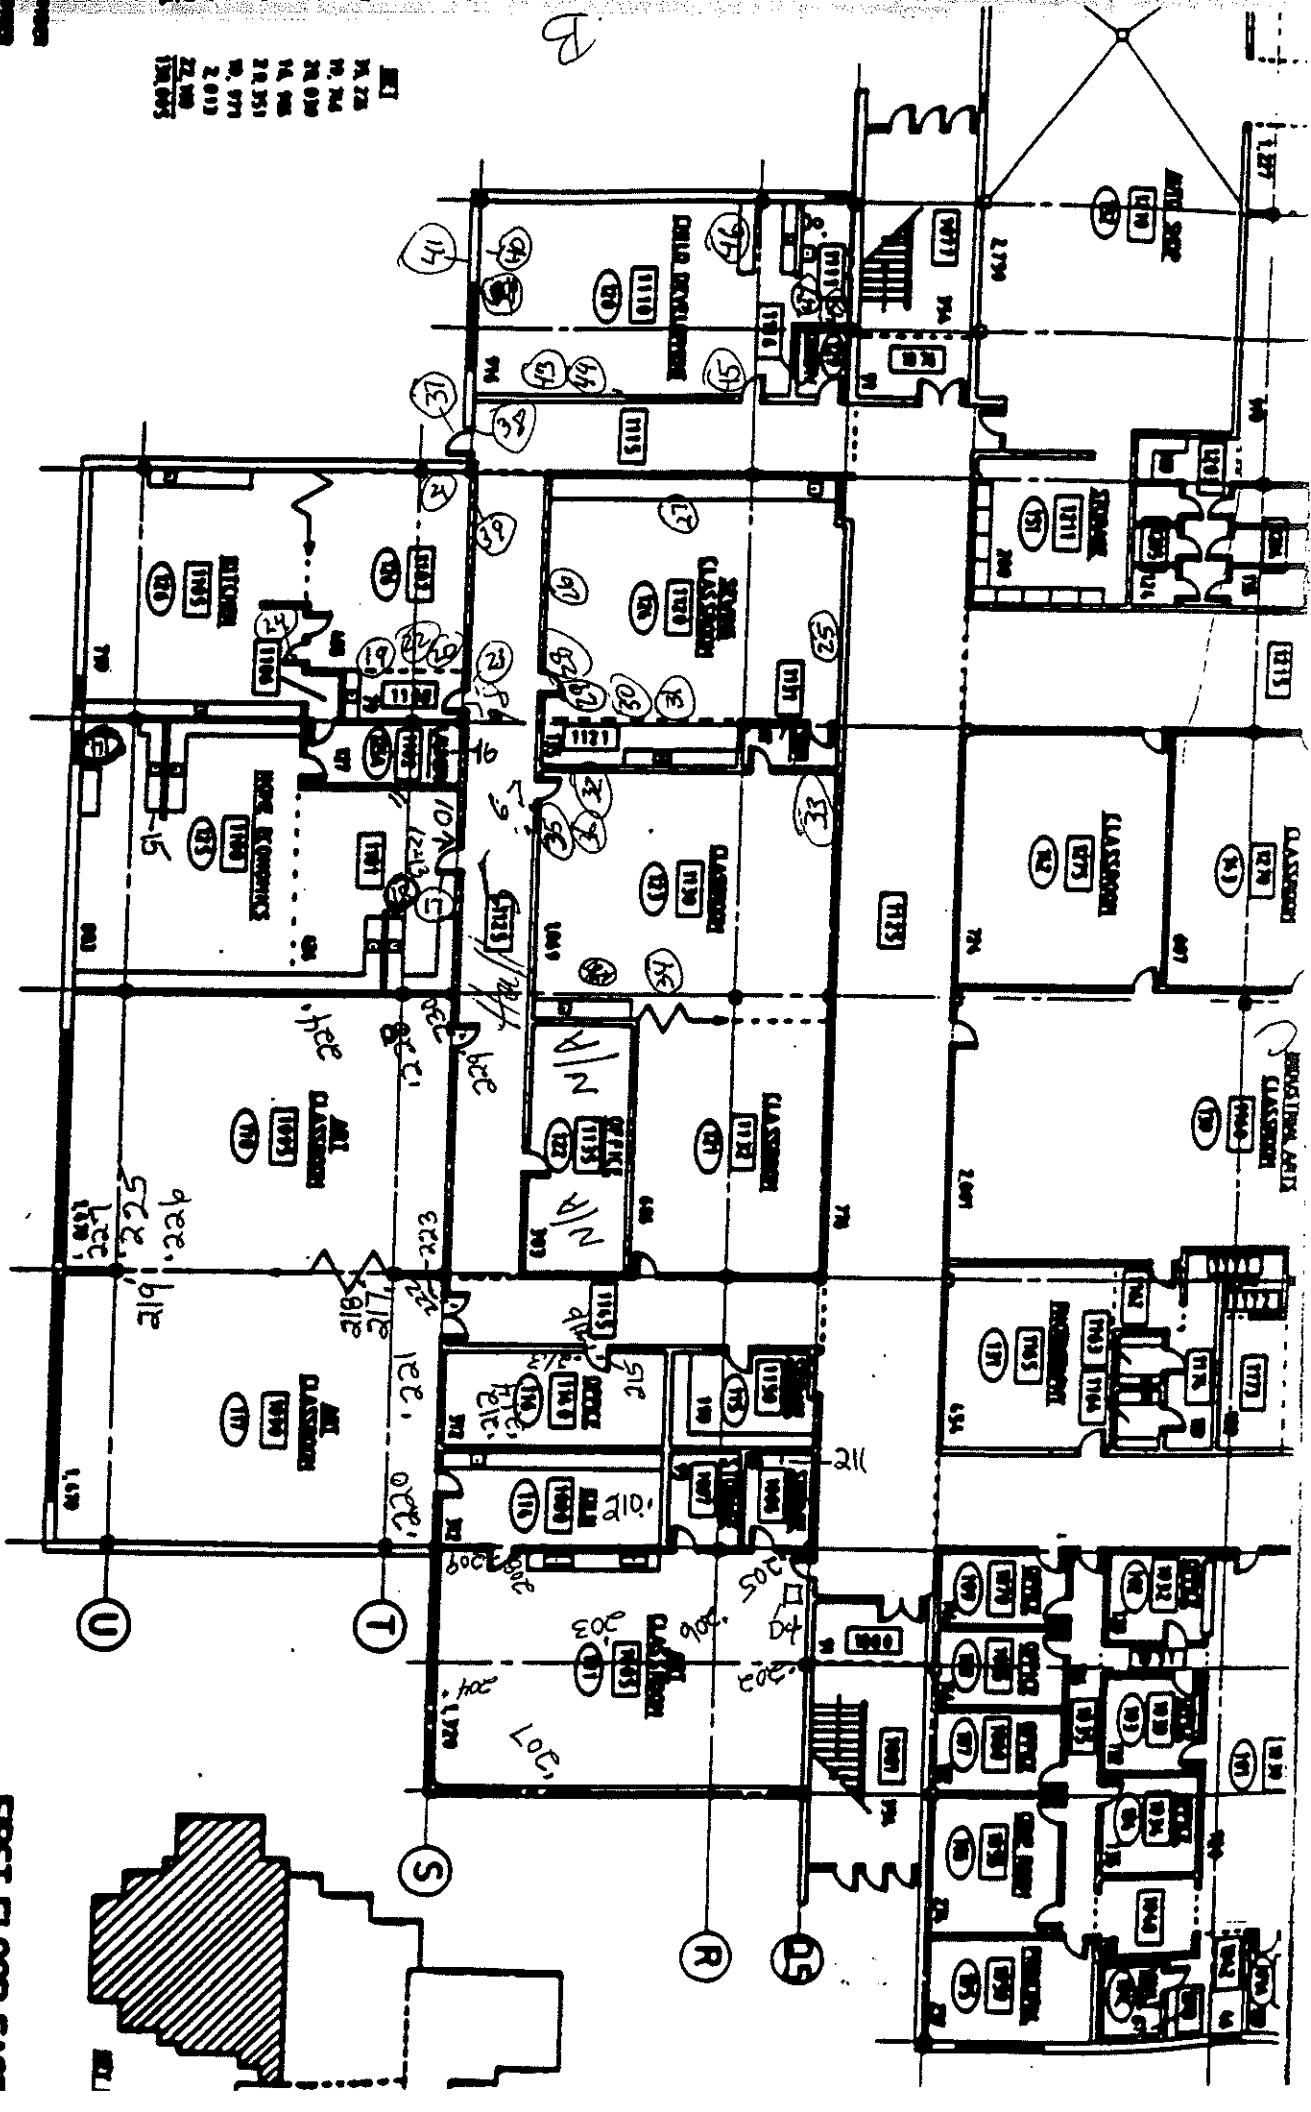
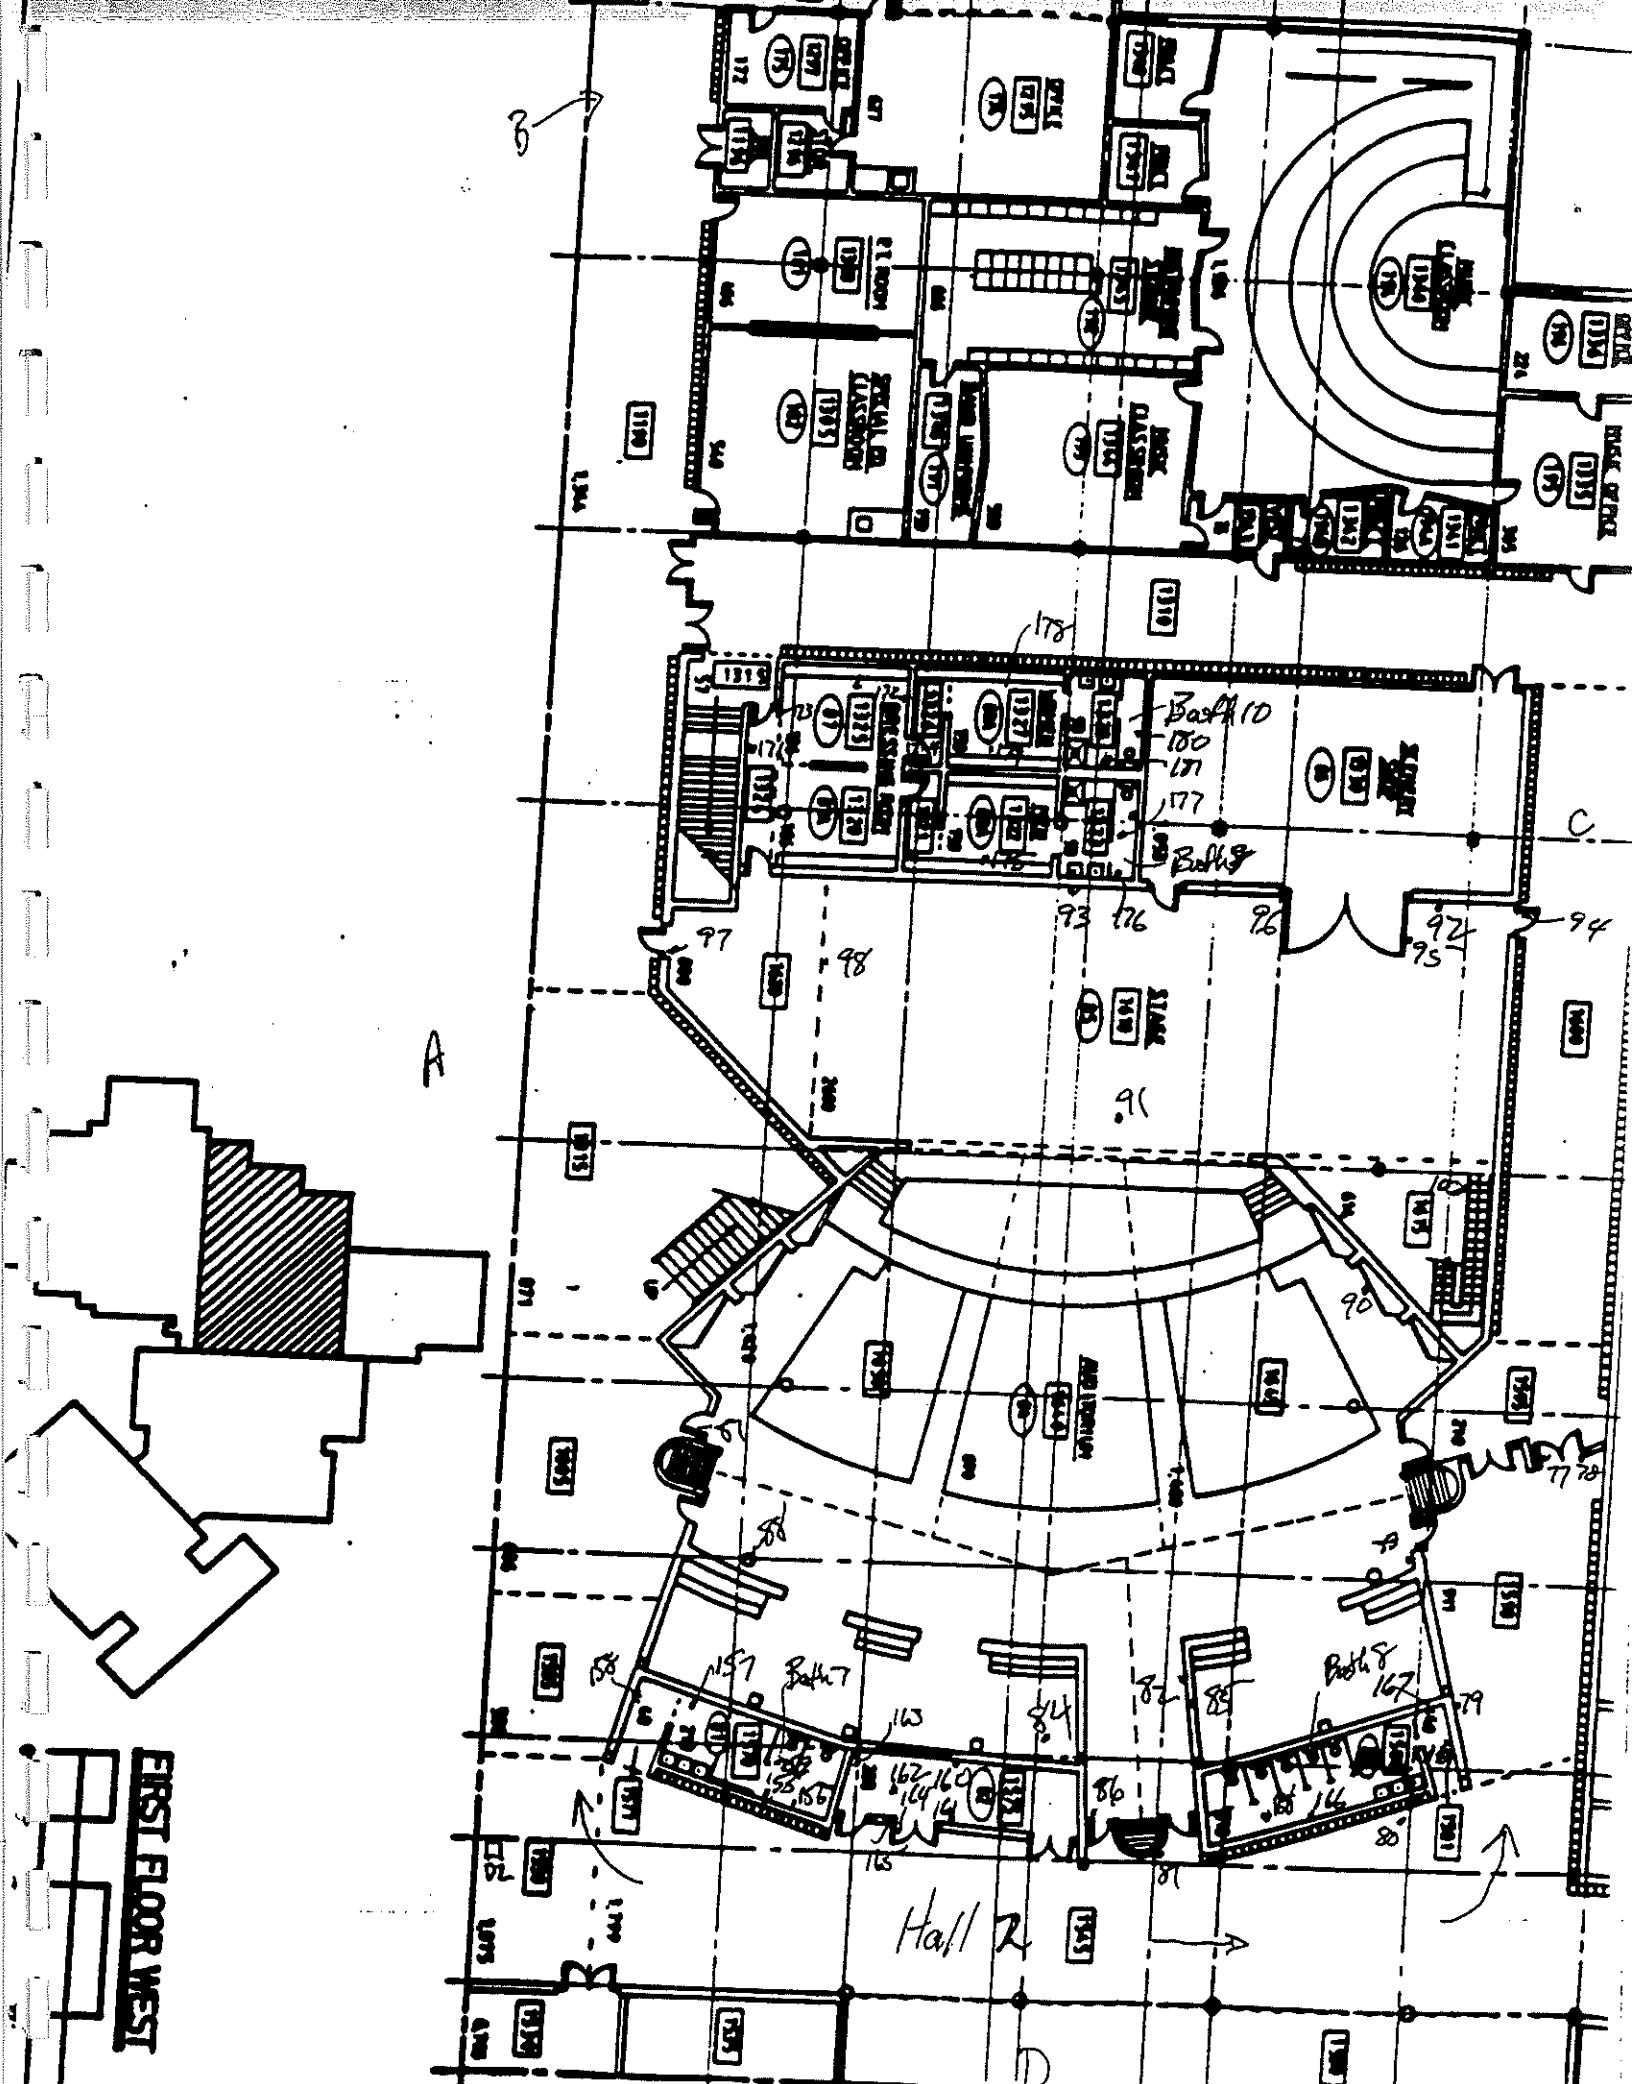
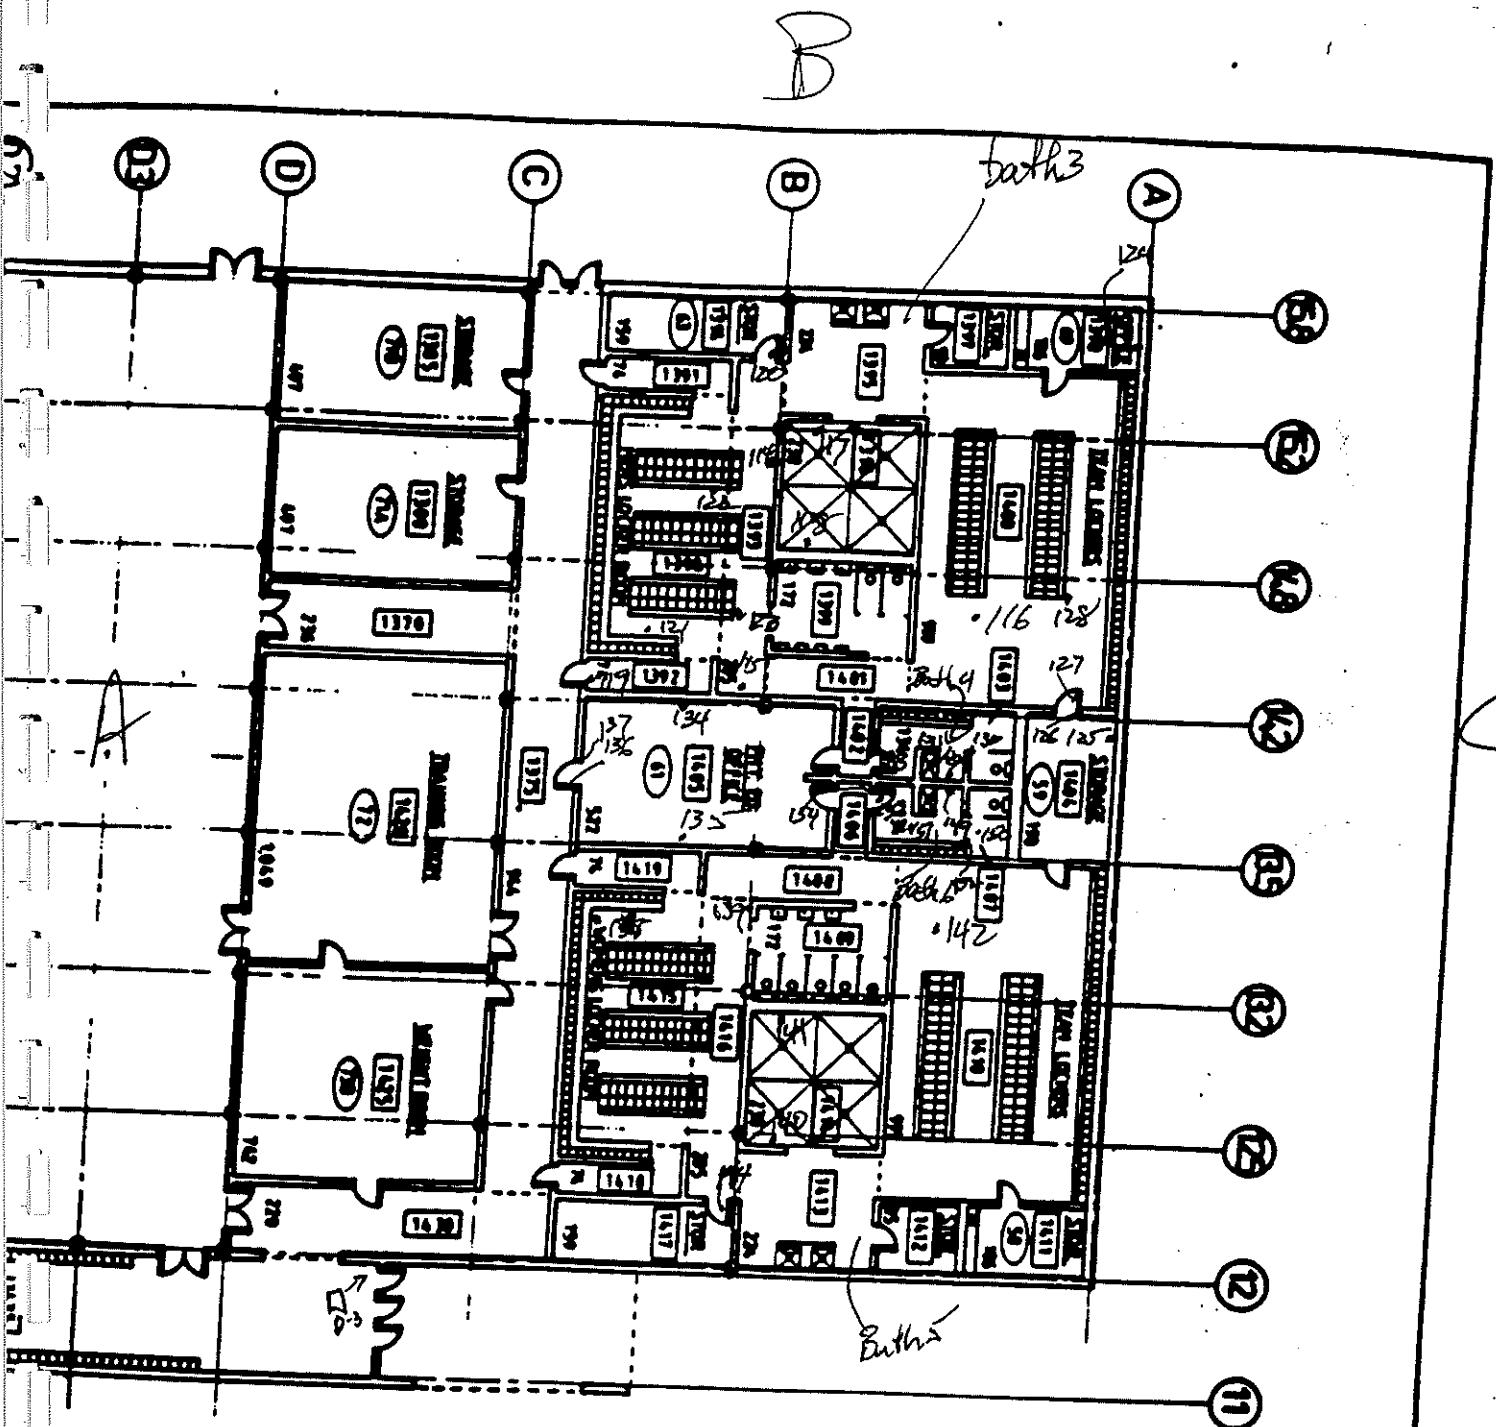
FIRST FLOOR EAST

All room and area designations used in this report are depicted on sampling maps found in Appendix A.
